RECLAIMED GLASS AGGREGATE DEMONSTRATION PROJECTS

In 1996 and 1997, TxDOT and its partners conducted three test projects using reclaimed glass aggregate, or glass cullet, in the cities of Devine and Abilene and in Orange County.

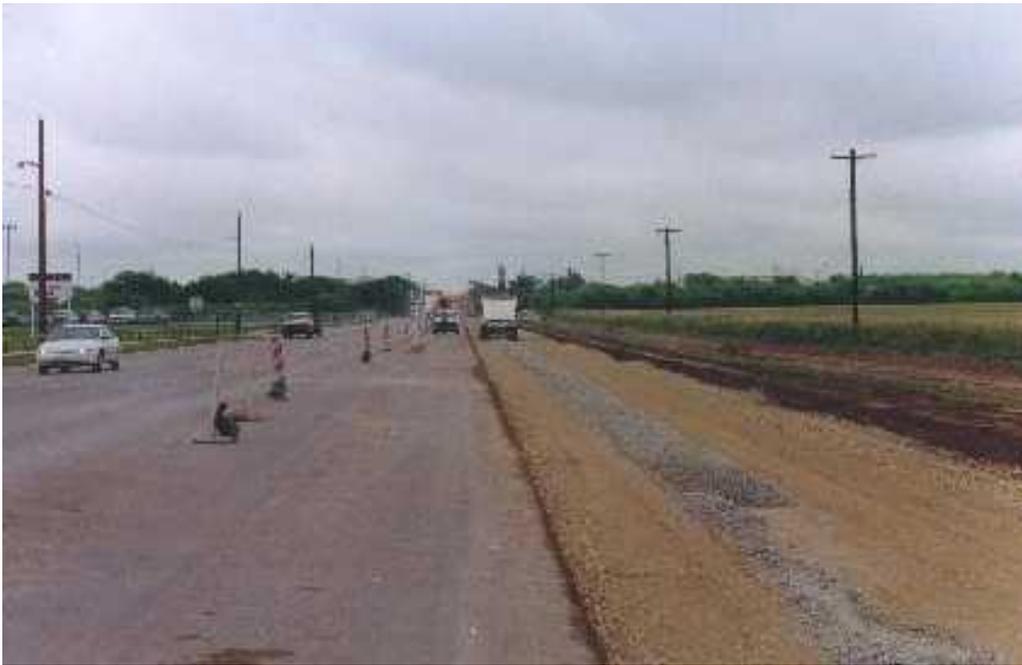
Figure 5.3. Dumping of Glass-Cullet by a Belly Dump Truck

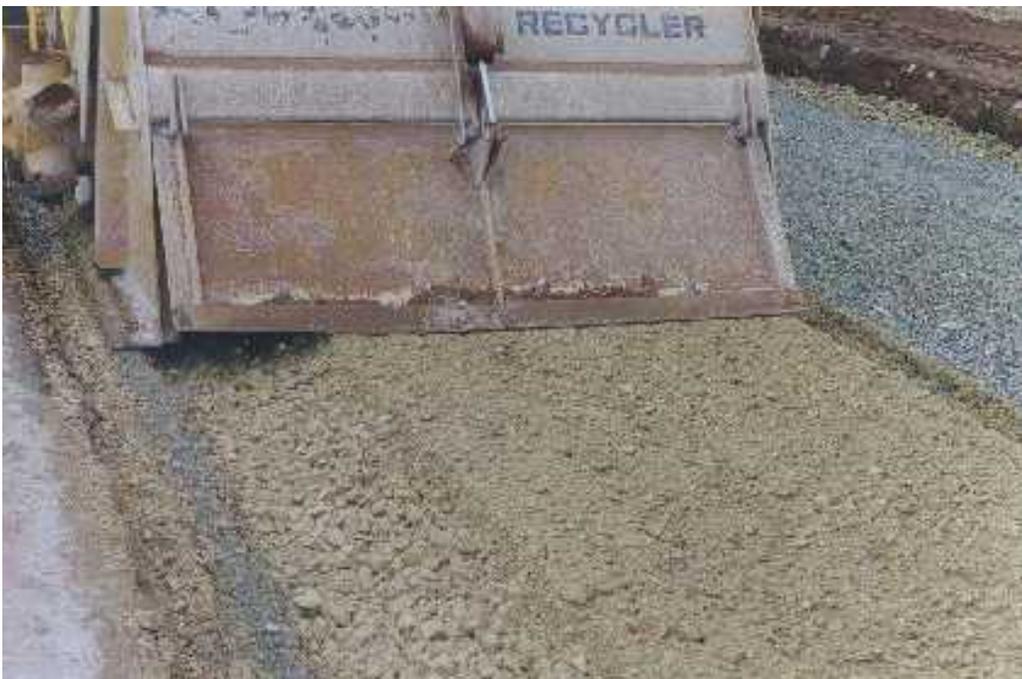
Figure 5.4. Mixing of Glass with Limestone

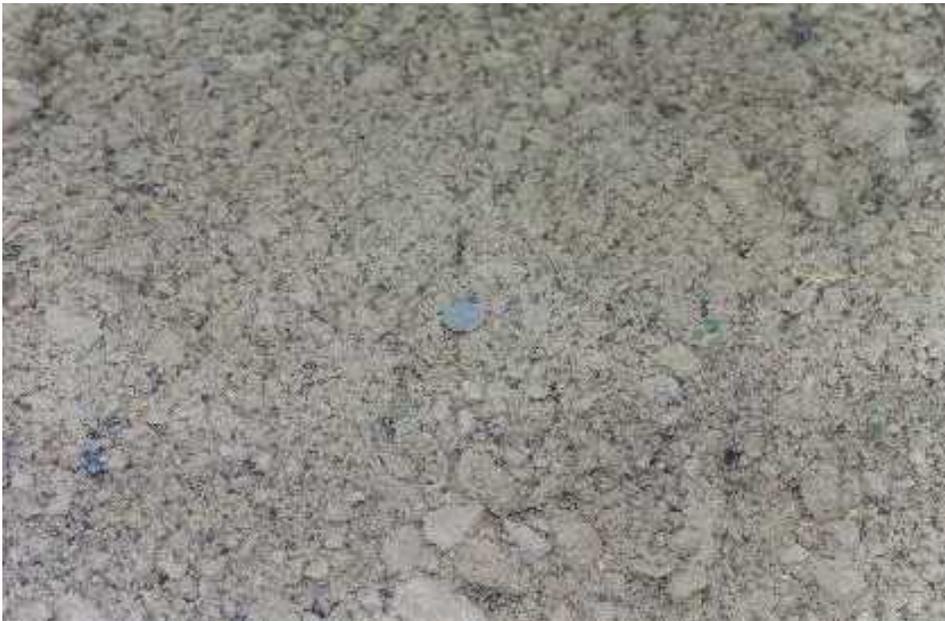
Figure 5.5. Compacted Limestone-Glass Base

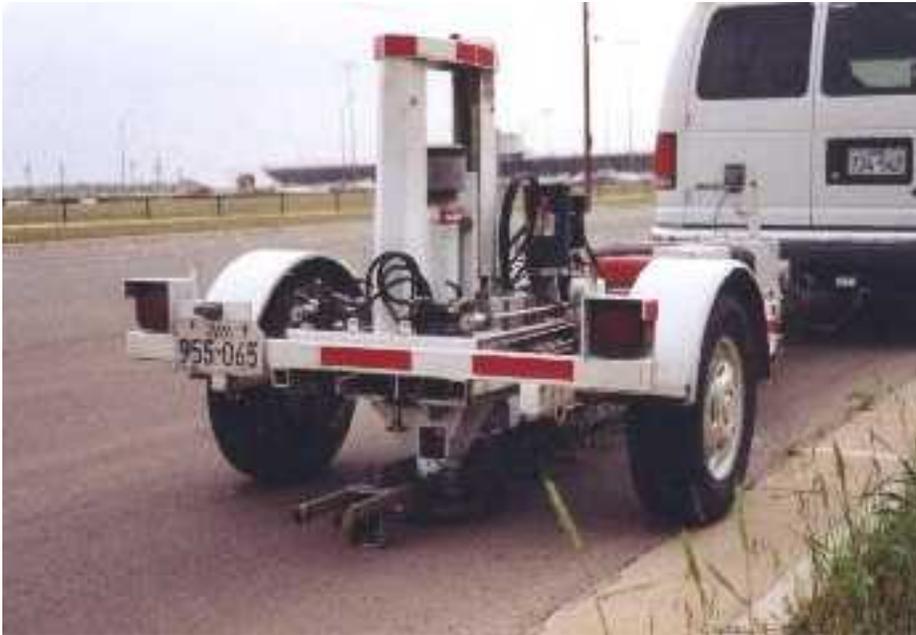
Field Test Results: Falling Weight Deflectometer (FWD) testing was performed on limestone-glass flexible base section in April of 1999. Figure 5.6 shows FWD testing at the test section. A control (non-glass) section was also chosen to the east of 10% glass section for comparison with the glass-cullet sections. Results are shown in Figure 5.7.

Figure 5.6. Falling Weight Deflectometer Testing on Antilley Road, 1999

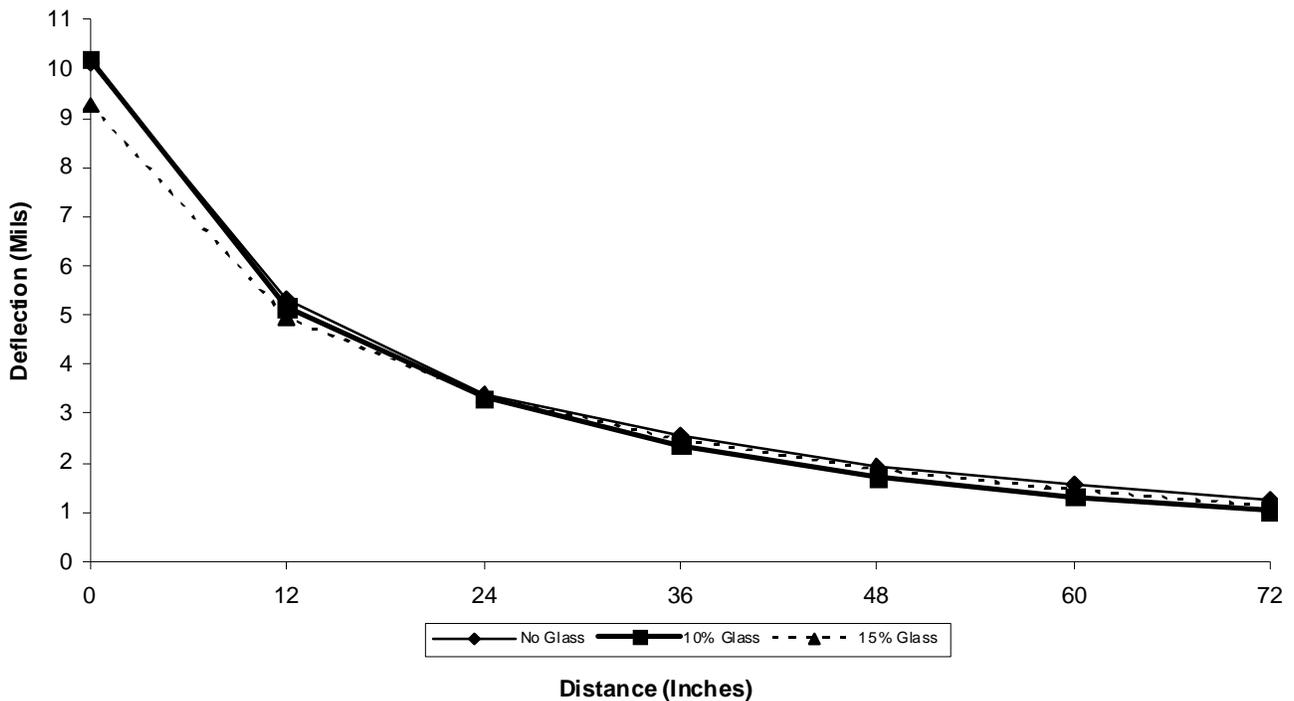
Figure 5.7. FWD Test Result on Antilley Road, 1999

The glass-cullet project on Antilley Road, Abilene is performing well and no significant non-routine maintenance was required in these sections since it opened to traffic (Condry, 1999). FWD tests on these sections show no significant difference in structural integrity among no glass, 10% & 15% glass cullet sections (Figure 5.7).
