2015
Annual Inspection of the
South Orient Rail Line
Under Lease to
Texas Pacifico Transportation Company

May 11 - 14, 2015

South Orient Annual Inspection

Inspection Dates May 11 – 14, 2015

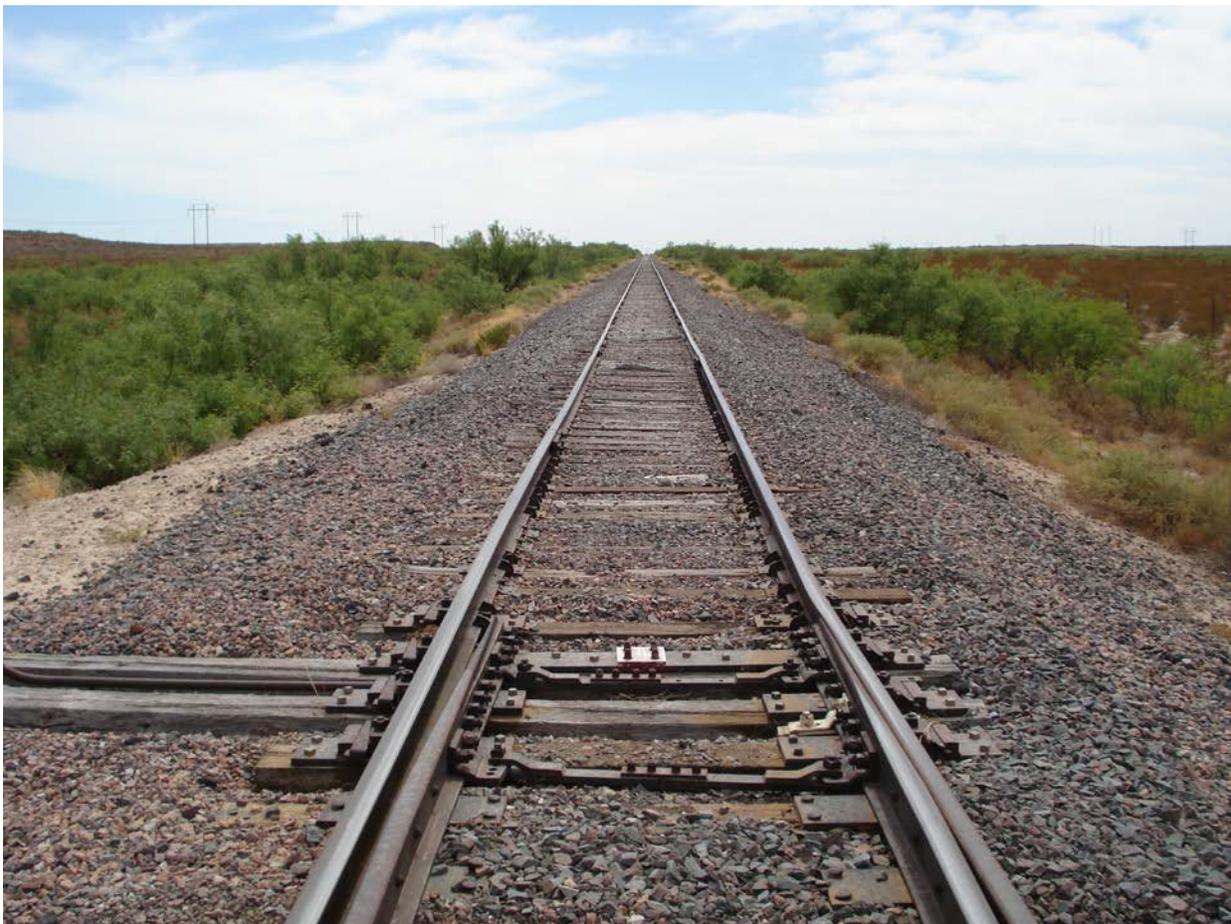
Figure 9 - MP 869.4, Sulphur Junction

The tracks are constructed with substandard (for today's carloadings and tonnage), 70# rail beginning just west of the switch at Sulphur Junction at MP 869.4 (Figure 9). TxDOT has developed a project to replace the 70# rail from MP 869.4 to MP 881.92 (through Fort Stockton) in order to improve speed and capacity on this section of the line. Funding has not been secured at this time, though TxDOT is pursuing both state and federal appropriations.

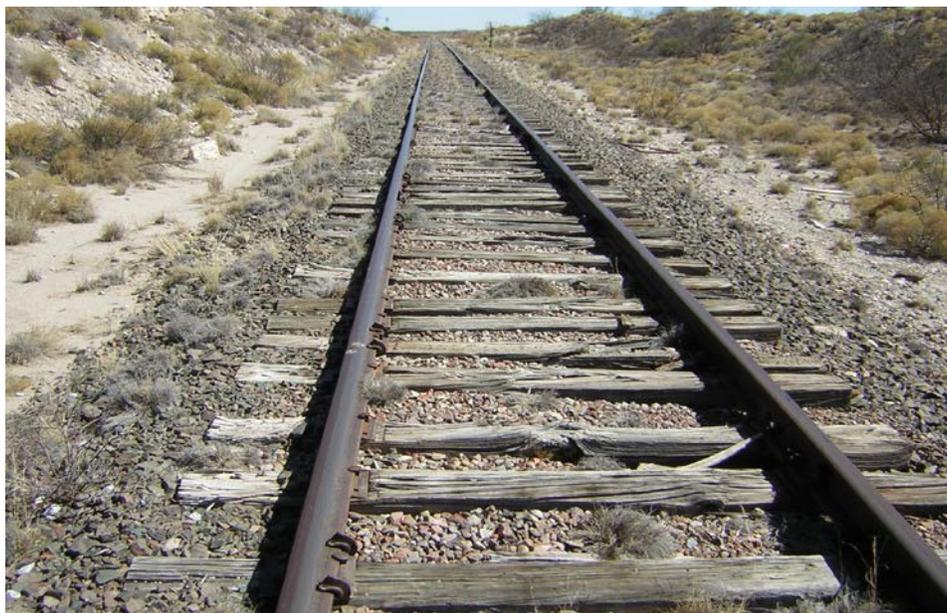
Figure 13 – MP 968.0

The ties for the first 11 miles south of Paisano Junction are in generally poor to bad condition (Figure 13).

- 1) 90# jointed rail manufactured 1929
- 2) 3,362 ties installed by TXPF, 2003
- 3) Ties in poor to fair condition

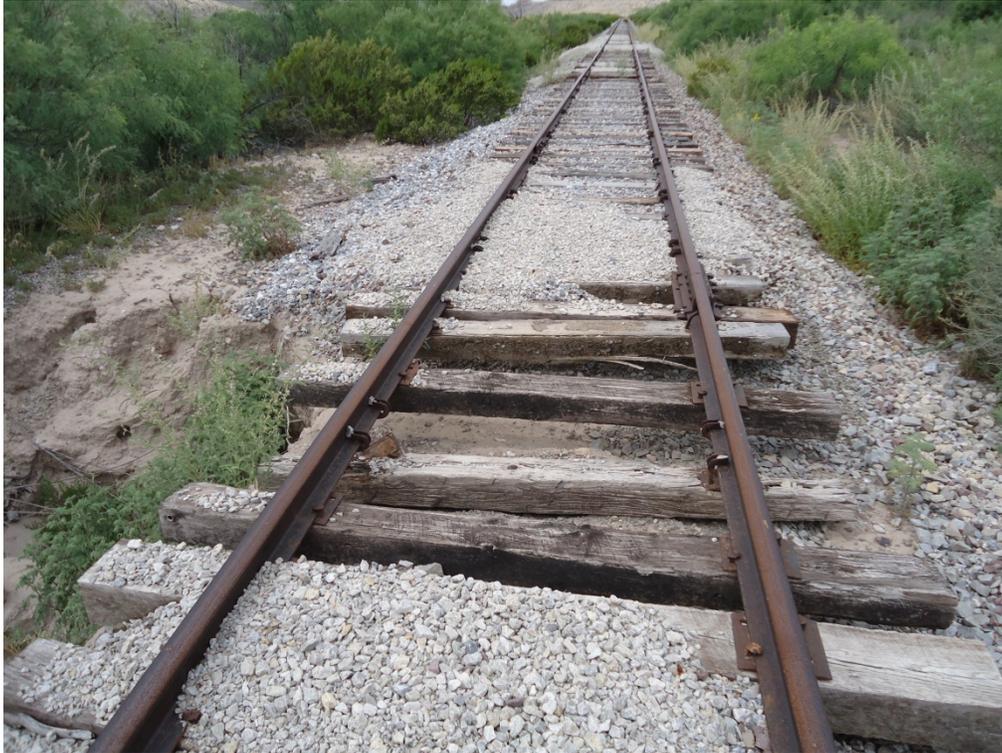
Figure 14 – MP 1006.2, Washout

Numerous track washouts exist in Presidio County as a result of flash floods.

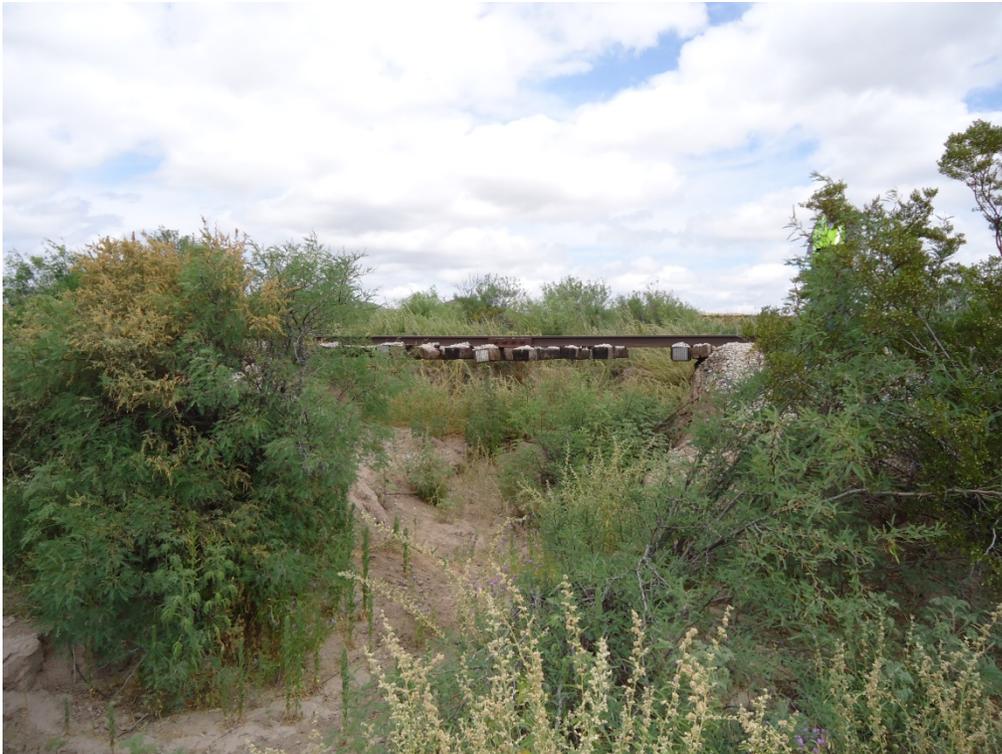
Figure 15 – MP 1006.5, Washout

The roadbed has completely washed away at MP 1006.5 due to heavy rains (Figure 14). The rail line is impassable by train traffic (Figure 15).

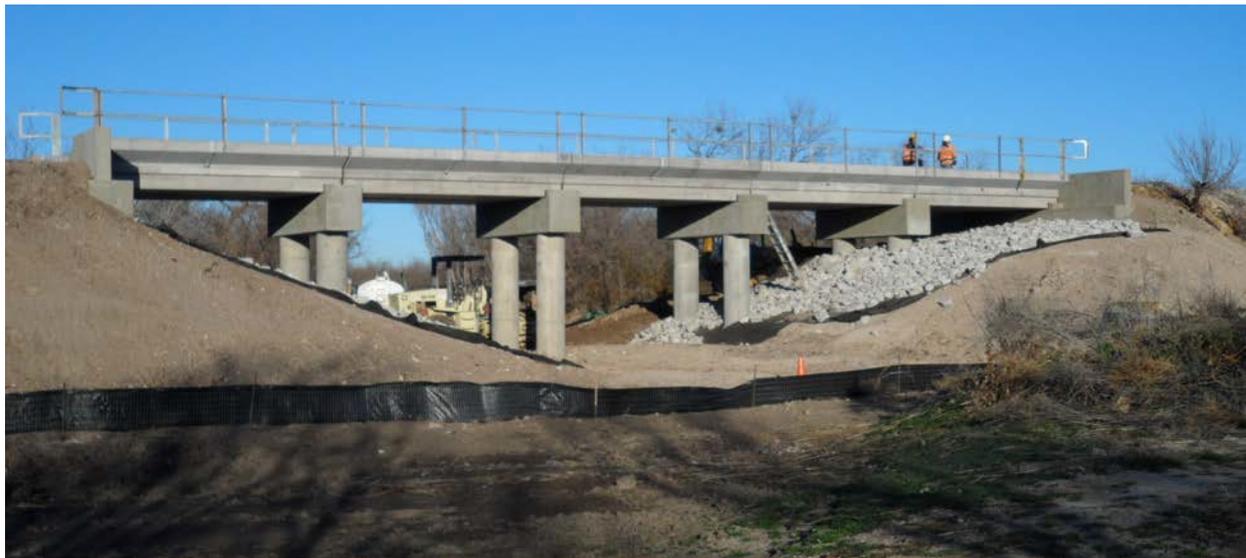
TxDOT's work on the east end of the line included rehabilitation work to 30 bridges, the replacement of a structurally deficient bridge with corrugated metal pipe, the replacement of a decayed, timber box culvert with corrugated metal pipe, other drainage repairs, and the replacement of a fire-damaged bridge at MP 715.1 with a concrete structure (Figure 19). Ties were also replaced on all open-deck bridges (Figure 20) and on most ballasted deck bridges.

Figure 19 – MP 715.1, Bridge Replaced

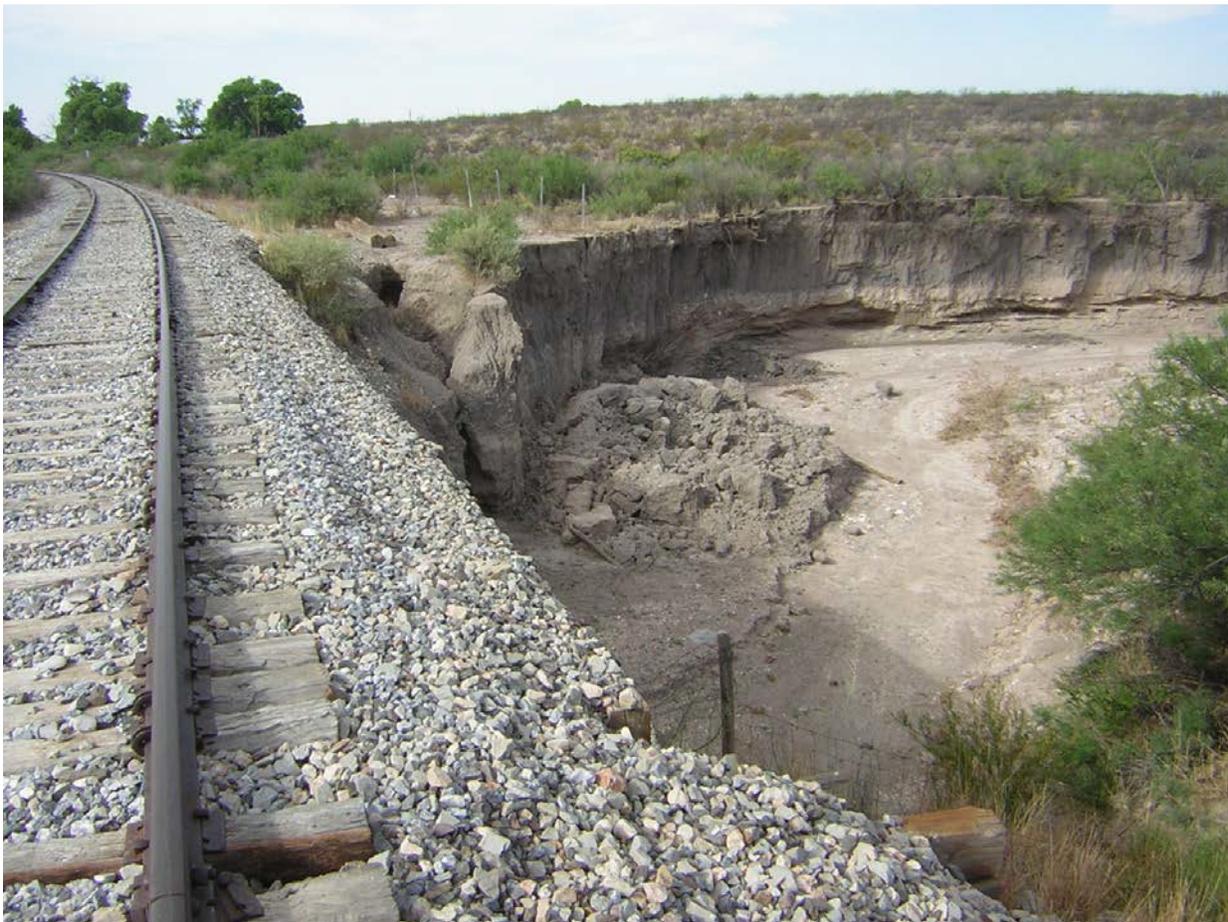
There are various locations west of Fort Stockton where bridge and drainage structure issues exist (Figures 21, 22, & 23). These issues will need to be addressed as traffic develops along portions of the line that are currently out-of-service.

Figure 21 – MP 985.9, Channel Erosion

- 1) 90# jointed rail manufactured 1929
- 2) 11,979 ties installed – TxDOT 2006
- 3) Remaining ties in fair to good condition
- 4) MP 985.9 channel north side of bridge continues deterioration

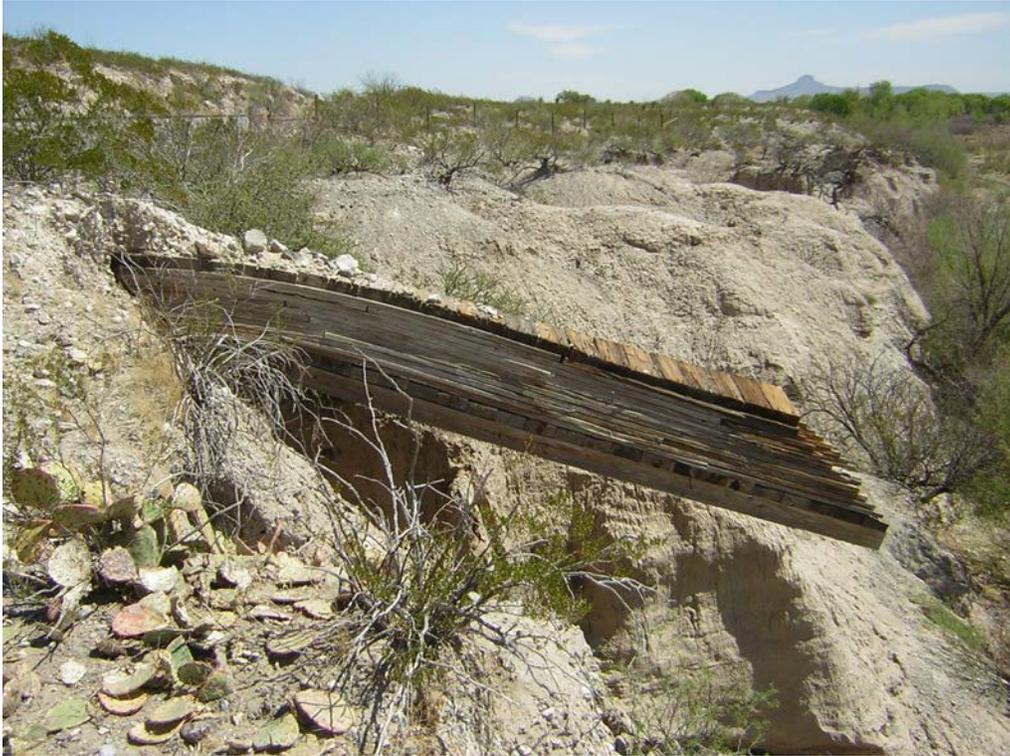
Figure 22 – MP 1007.4, Erosion of Road Bed at Box Culvert

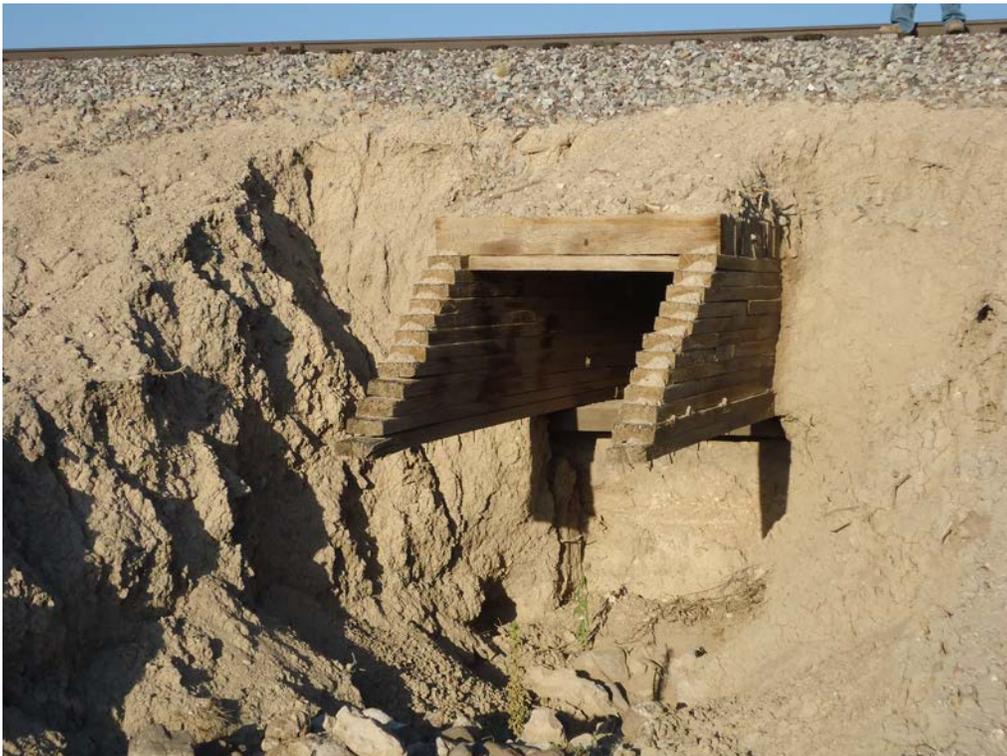
Figure 23 – MP 1011.8, Roadbed Damage at Box Culvert

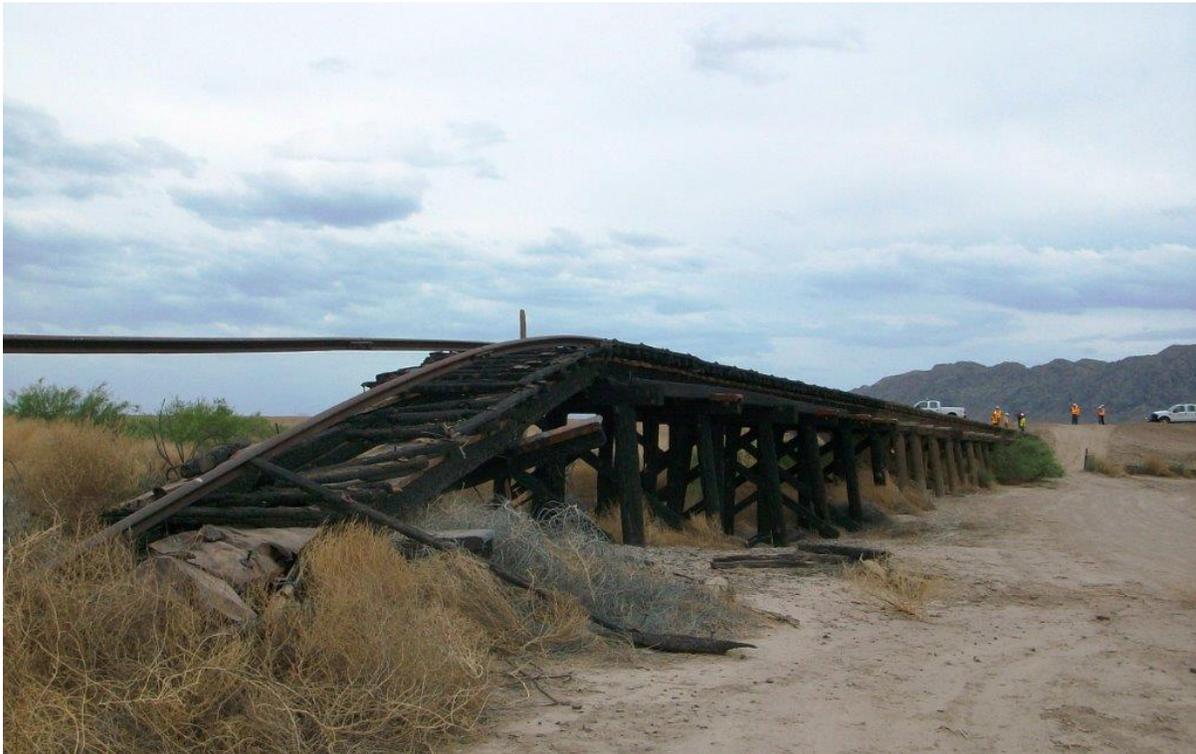
TxDOT and TXPF are in the process of replacing the U.S. portion of the international rail bridge over the Rio Grande at Presidio, which was damaged by fire on February 29, 2008 and March 1, 2009. TXPF is developing the plans and specifications while TxDOT is working on an environmental approval. Once those efforts are complete, TxDOT will coordinate project review and approval with state and federal agencies, TXPF will be responsible for reconstructing the bridge. A timber portion of the bridge just north of the levee still stands (Figure 24), though 15 bents on the extreme north end were damaged by the March 1, 2009 fire.

Figure 24 – MP 1029, Timber Structure North of Levee

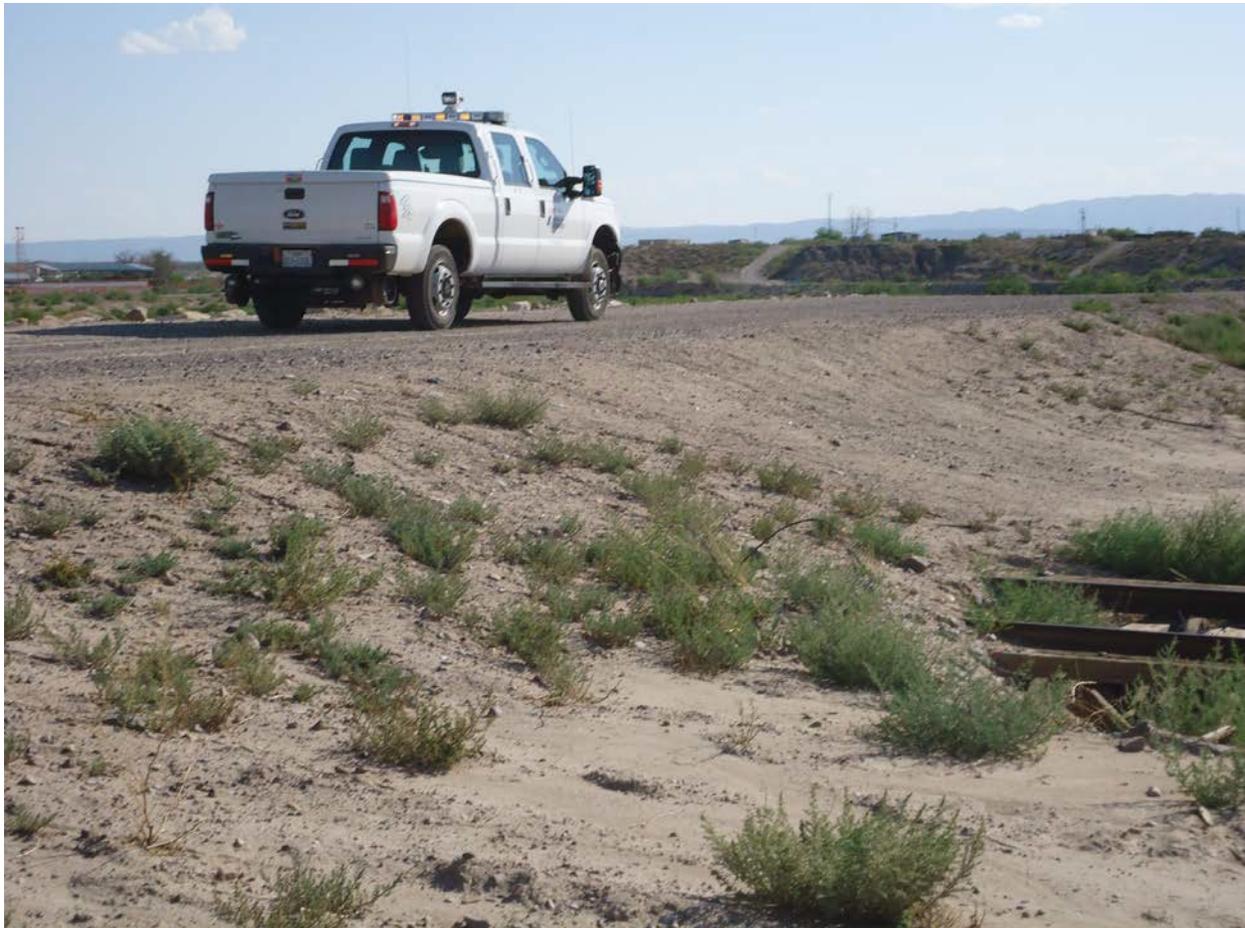
The International Boundary and Water Commission made improvements to the levee system in Presidio which has resulted in the tracks being buried in the levee (Figure 25). TxDOT's plans will include the removal of this fill material and the installation of flood gates or stop blocks over the tracks to retain the integrity of the levee system.

Figure 25 – MP 1029, Tracks Buried in Levee

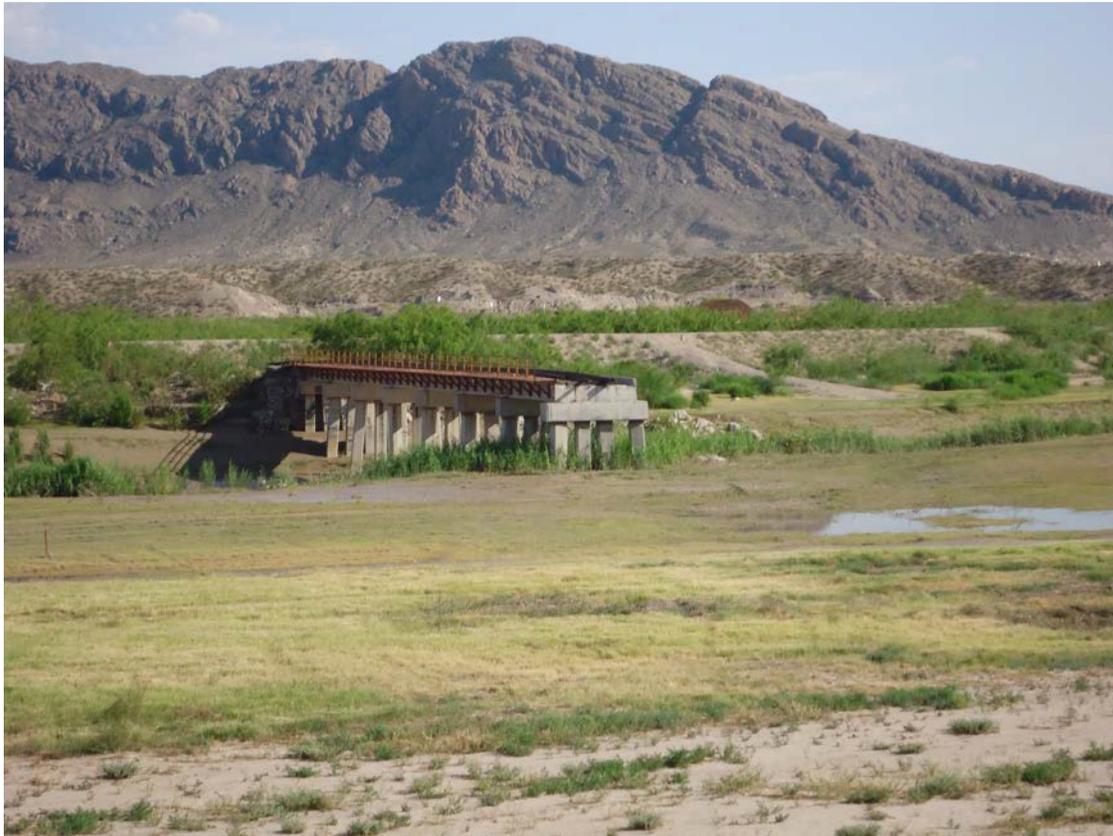
The U.S. portion of the bridge, south of the levee, was completely destroyed by the February 29, 2008 fire. The Mexico portion, made of concrete, still stands (Figure 26), though it is reported that the bridge approaches from that side of the border were washed out during a recent flood event.

Figure 26 – MP 1009, U.S. International Rail Bridge Location & Remaining Mexico Structure
