ANNUAL INSPECTION OF THE SOUTH ORIENT RAIL LINE
UNDER LEASE TO TEXAS PACIFICO TRANSPORTATION COMPANY

May 16 - 19, 2016

Calendar Year 2015

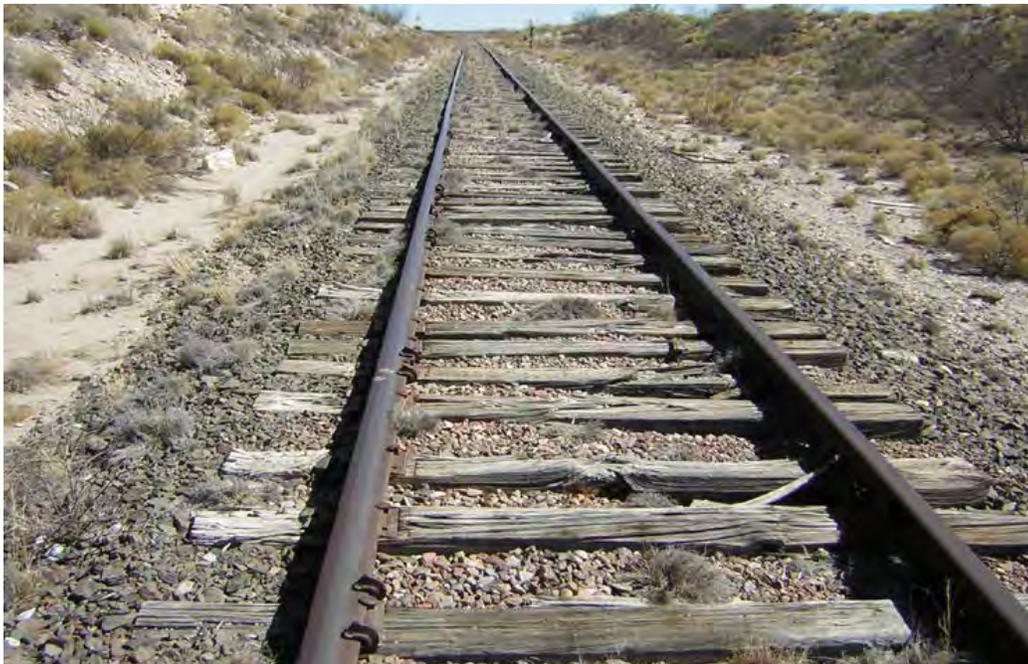
The ties for the first 11 miles south of Paisano Junction are in generally poor to bad condition (Figure 26).

Figure 26: MP 968.0 - South of Paisano Junction

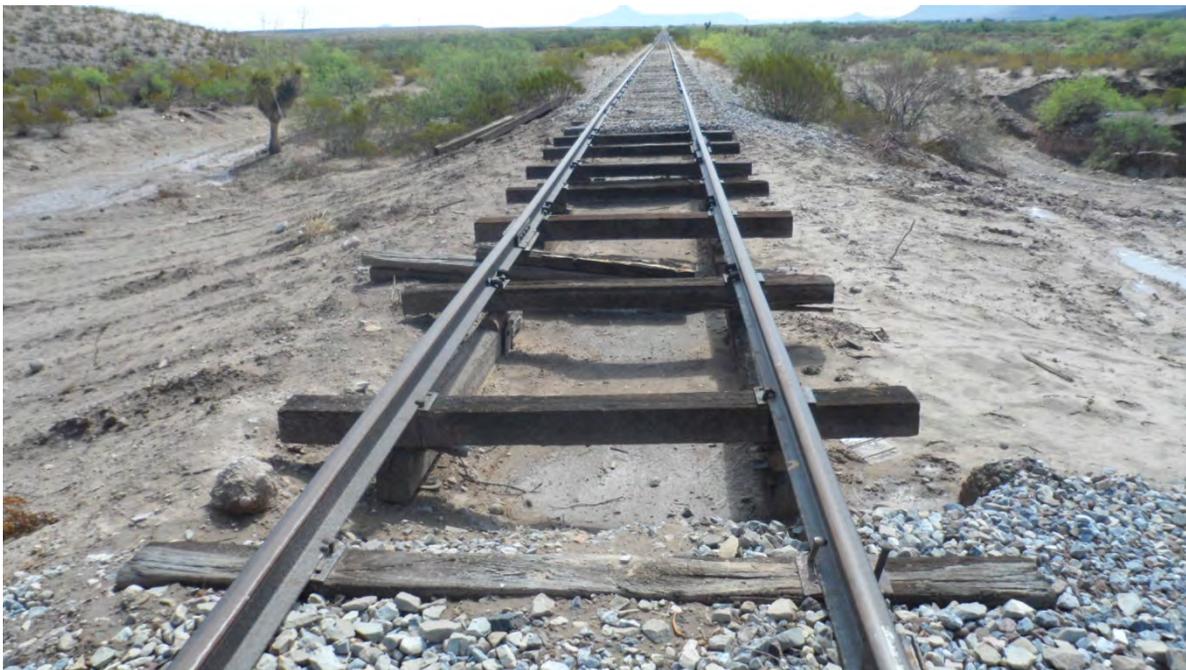
Numerous track washouts existed in Presidio County as a result of flash floods, changes in erosion patterns, and insufficient drainage across the track.

In several areas, the roadbed had been completely washed away due to flood erosion, making the rail line impassable. Various repairs were made by TXPF to the washouts in this area, and are now passable by excepted traffic. Due to geologic soil conditions in this area, heavy rainfall events are likely to generate the need for additional subgrade repairs in the future. A handful of locations already repaired this year will need additional work for this very reason (Figure 27, Figure 28, Figure 29, Figure 30).

Figure 27: MP 1007.7 – Washout (previously repaired)

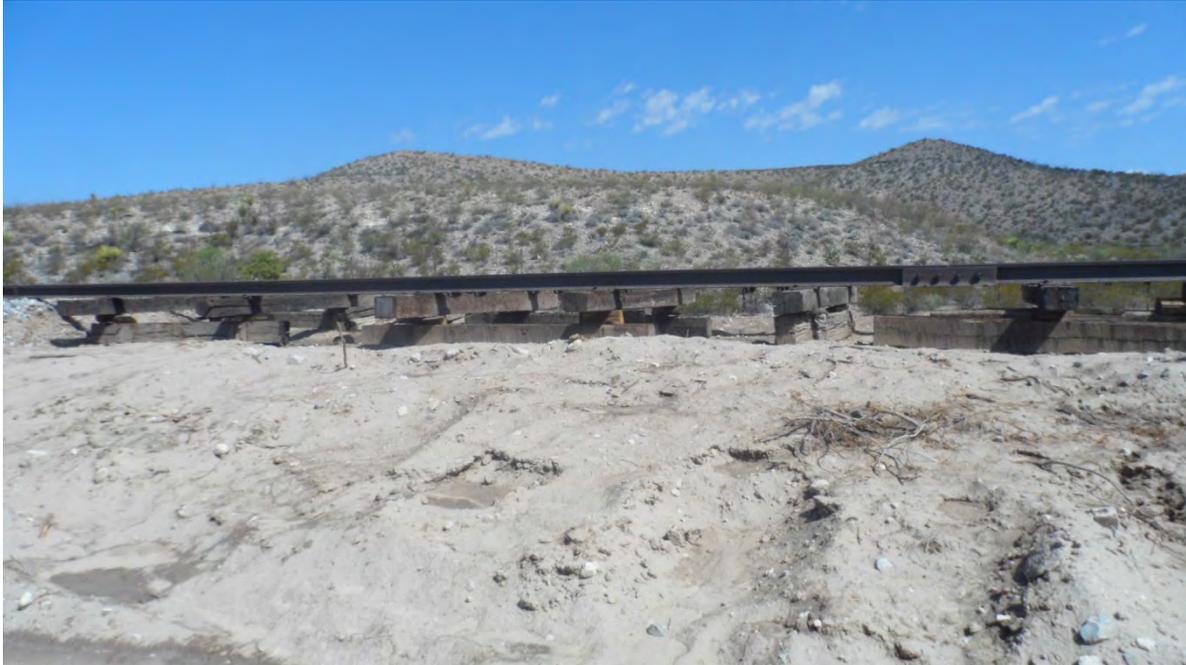
Figure 28: MP 1007.7 – Washout (previously repaired)

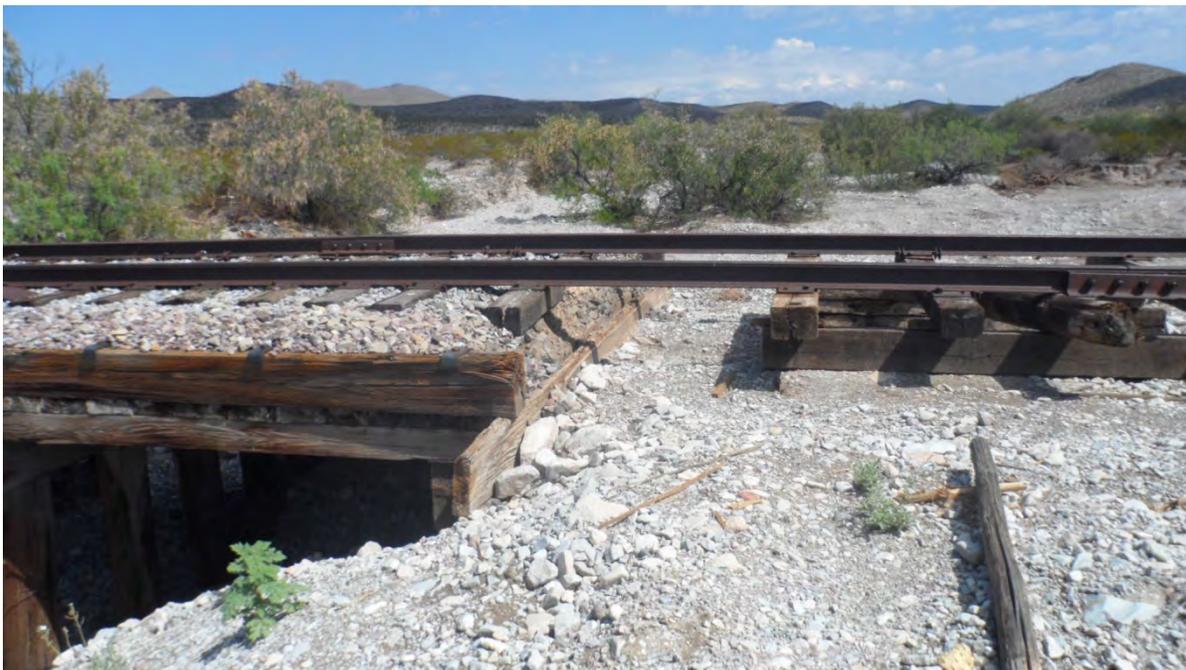
Figure 29: MP 1006.4 – Washout on bridge approach

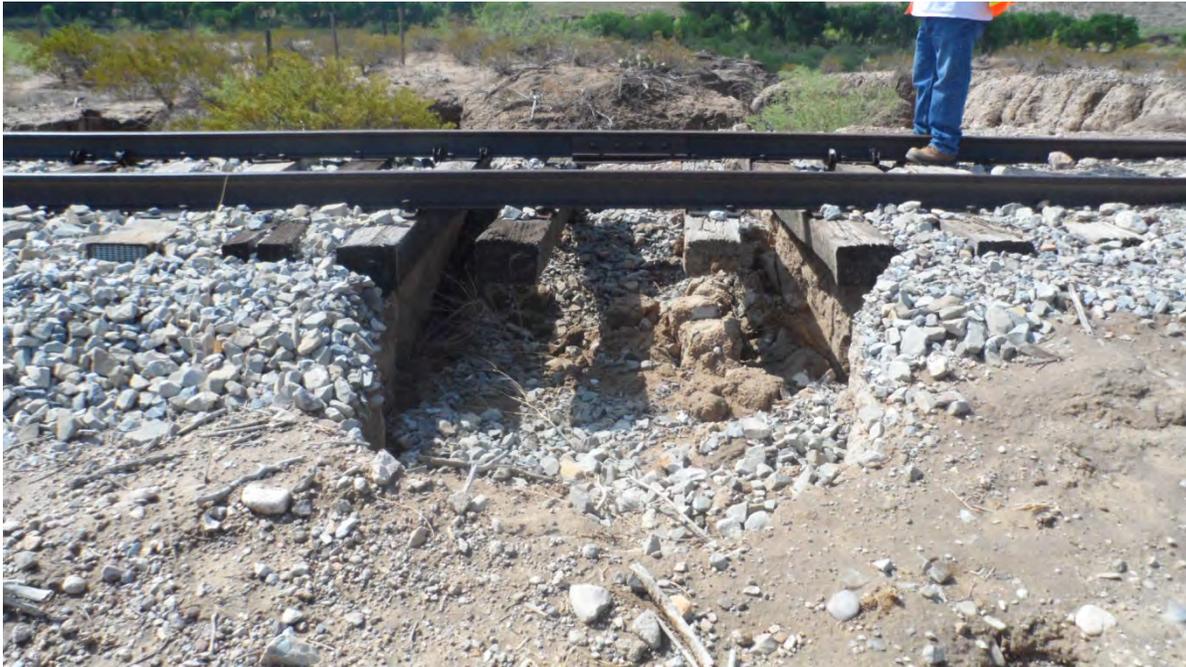
Figure 30: MP 1007.8 - Subgrade sinking

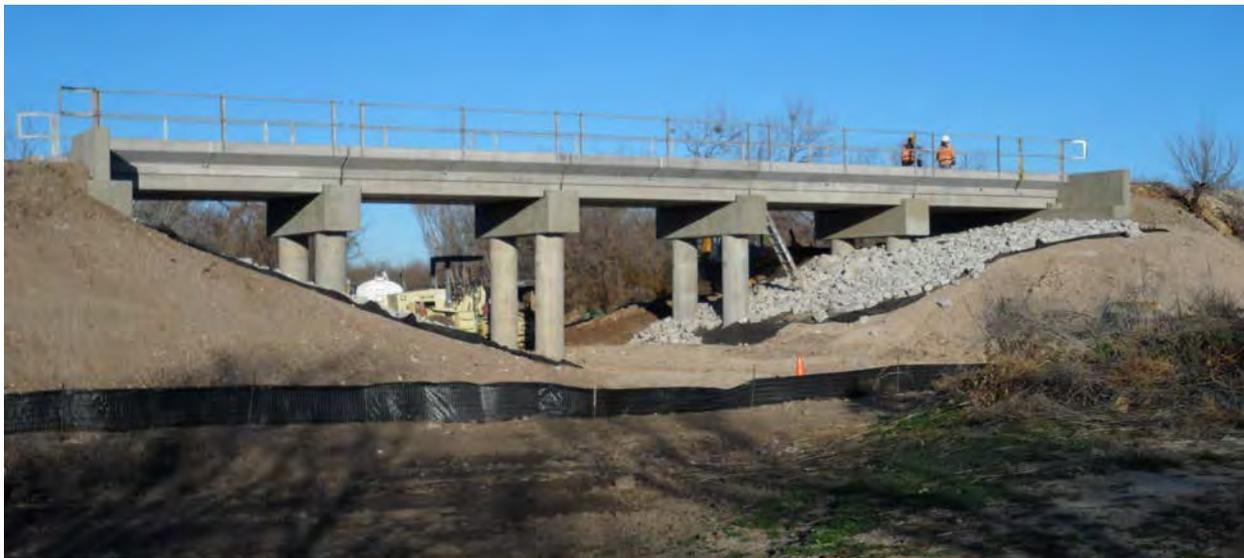
Figure 32: MP 715.1, Bridge Replaced

TxDOT's work on the east end of the line included rehabilitation work to 30 bridges, the replacement of a structurally deficient bridge with corrugated metal pipe, the replacement of a decayed, timber box culvert with corrugated metal pipe, other drainage repairs, and the replacement of a fire-damaged bridge at MP 715.1 with a concrete structure (Figure 32). Ties were also replaced on all open-deck bridges (Figure 33) and on most ballasted deck bridges.

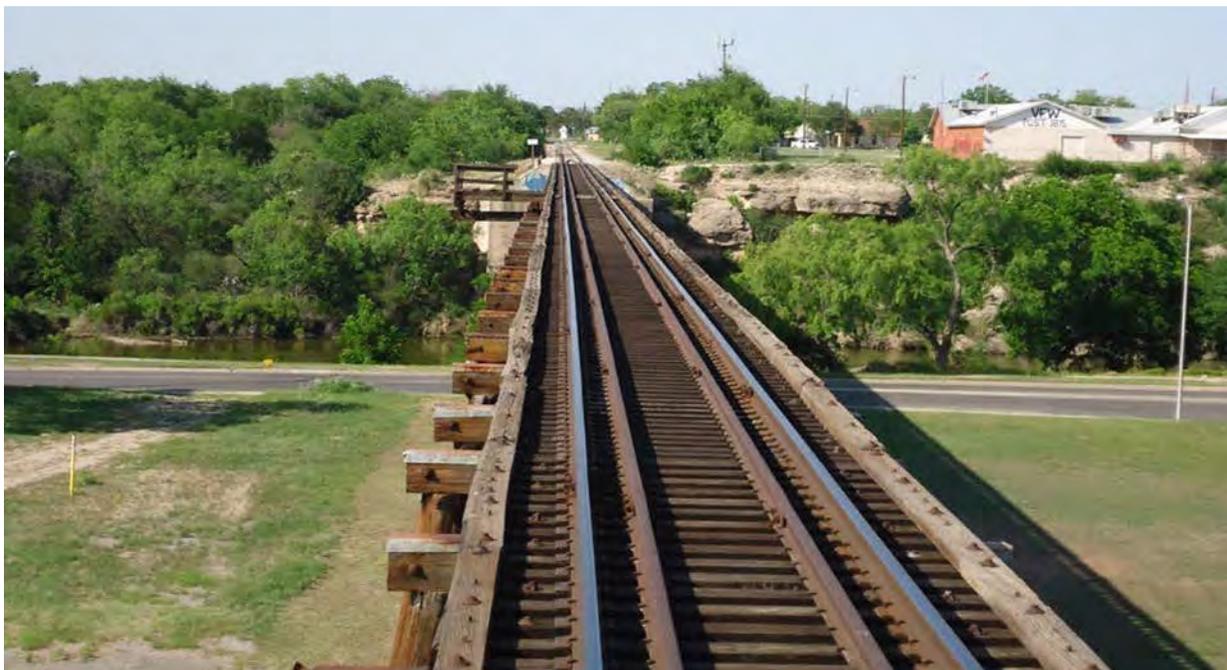
Figure 33: MP 716.6 – Rehabilitated bridge structure

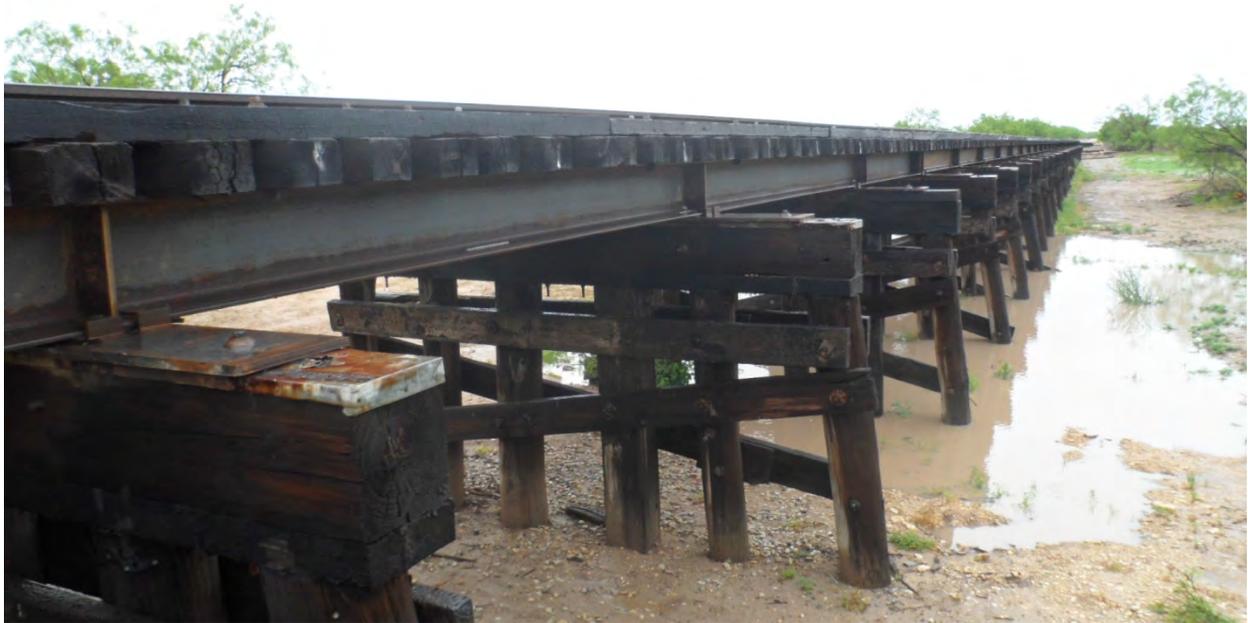
Figure 34: MP 777.9 - Bridge repair, replaced wooden stringers with steel girders

TXPF has developed a bridge management program which was reviewed and approved by the FRA. In 2015, TXPF spent \$1.5M on routine maintenance and repairs to bridges that were necessary to assure the safety of trains and hazardous materials cars between Fort Stockton and Alpine. Figure 34 and Figure 35 show some typical bridge repairs performed in the last year.

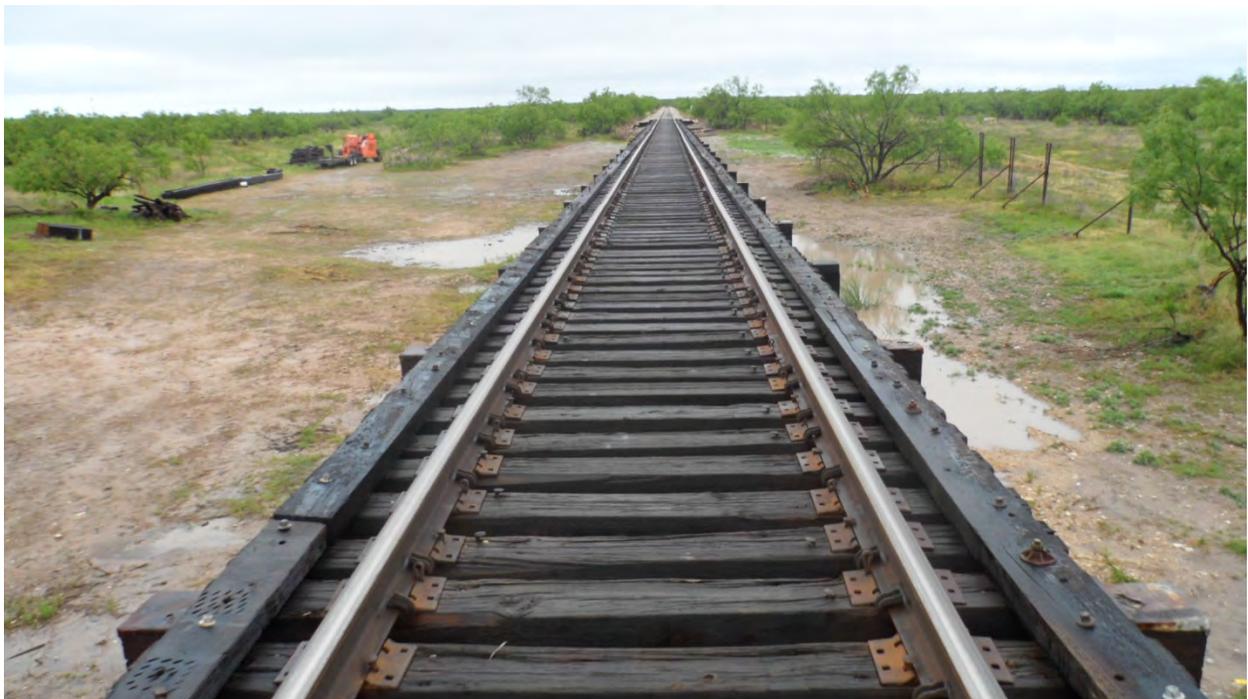
Figure 35: MP 777.9 - Bridge repair, top view

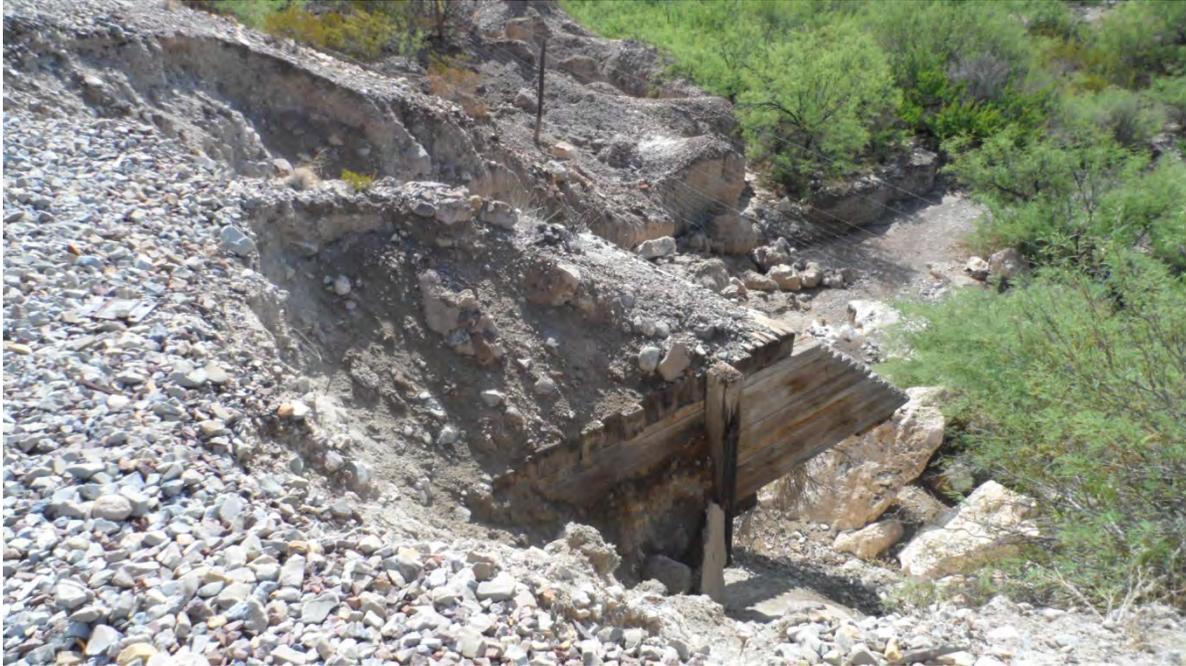
There are various locations west of Fort Stockton where bridge and drainage structure issues still exist (Figure 36, Figure 37, Figure 38, Figure 39). These issues will need to be addressed as traffic develops along portions of the line that are currently out-of-service.

Figure 36: MP 1008.4 – Erosion around wooden box culvert (undertrack drainage)

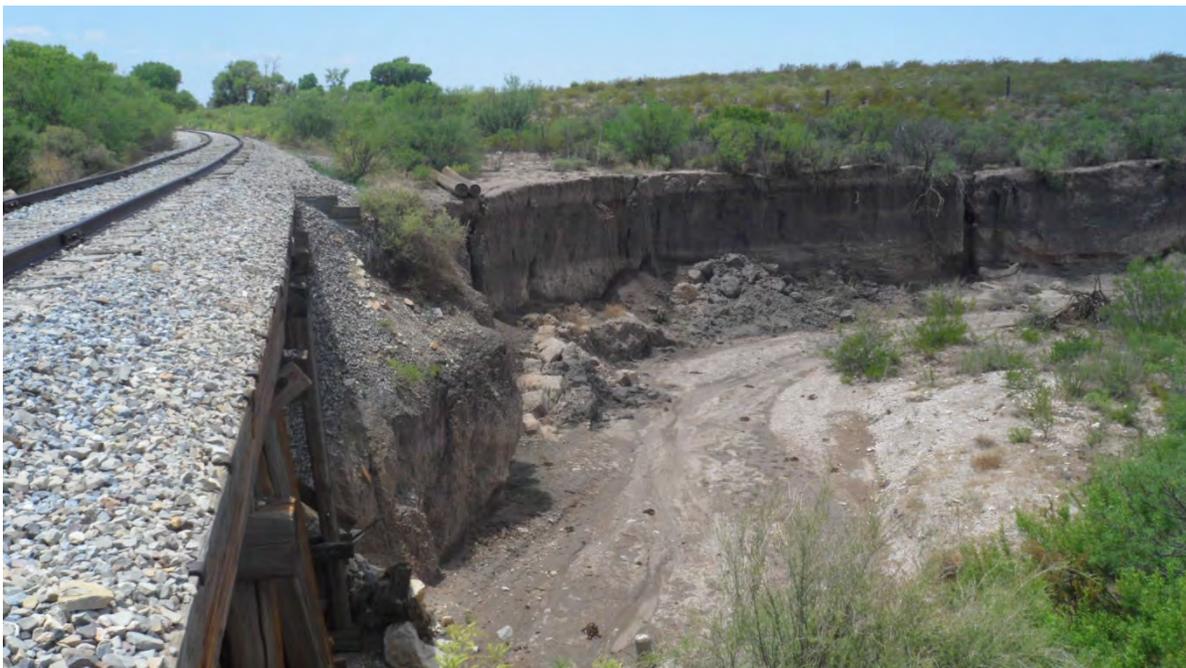
Figure 37: MP 985.9 – Meandering bank erosion near bridge structure

1. 90# jointed rail manufactured 1929
2. 11,979 ties installed – TxDOT 2006
3. Remaining ties in fair to good condition
4. MP 985.9 channel north side of bridge continues deterioration

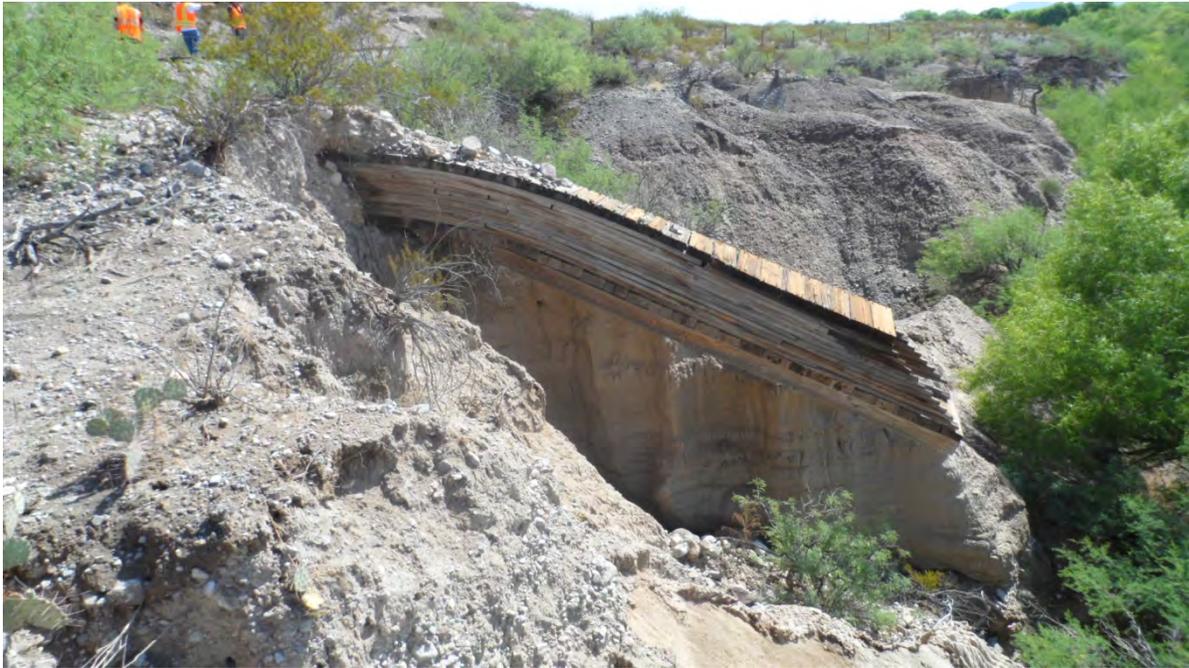
Figure 38: MP 1007.9 – Erosion of wooden drainage culvert (2016)

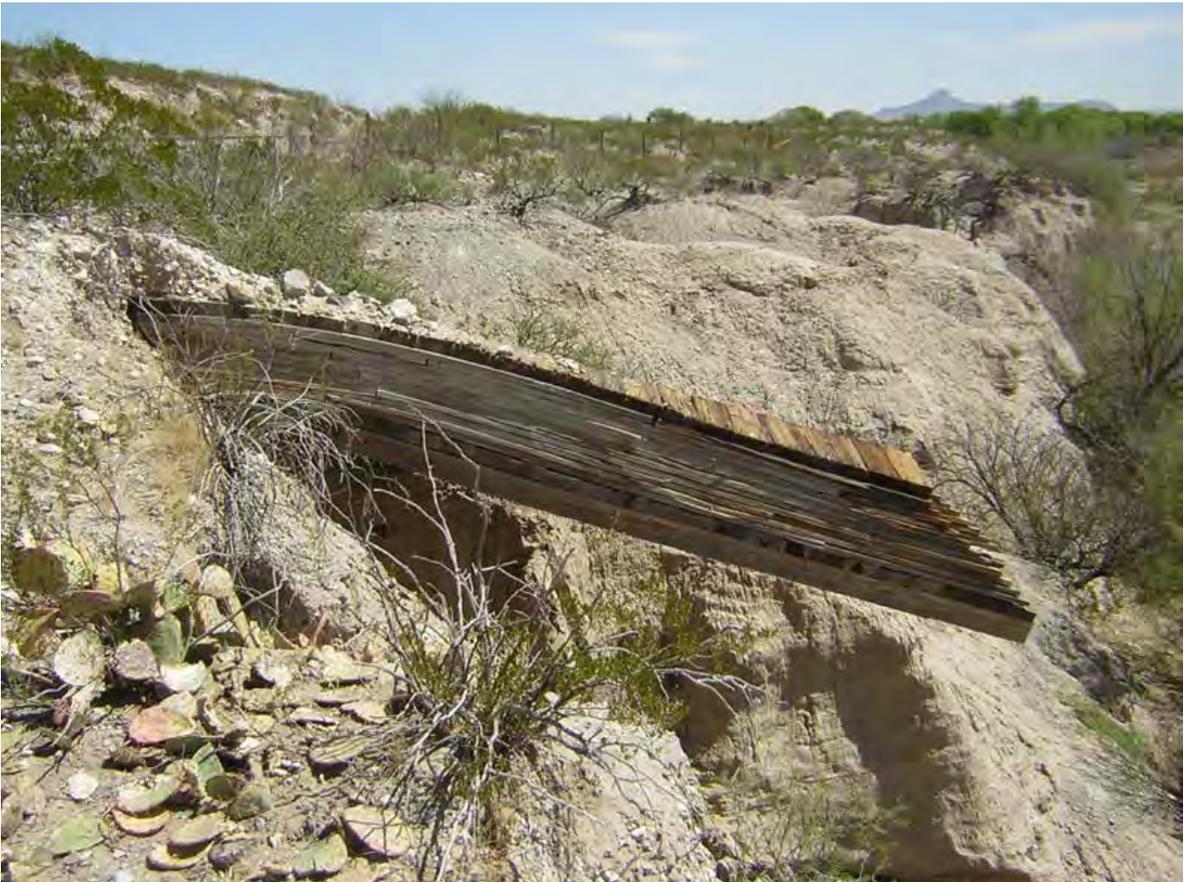
Figure 39: MP 1007.9 - Erosion of wooden drainage culvert (2013)

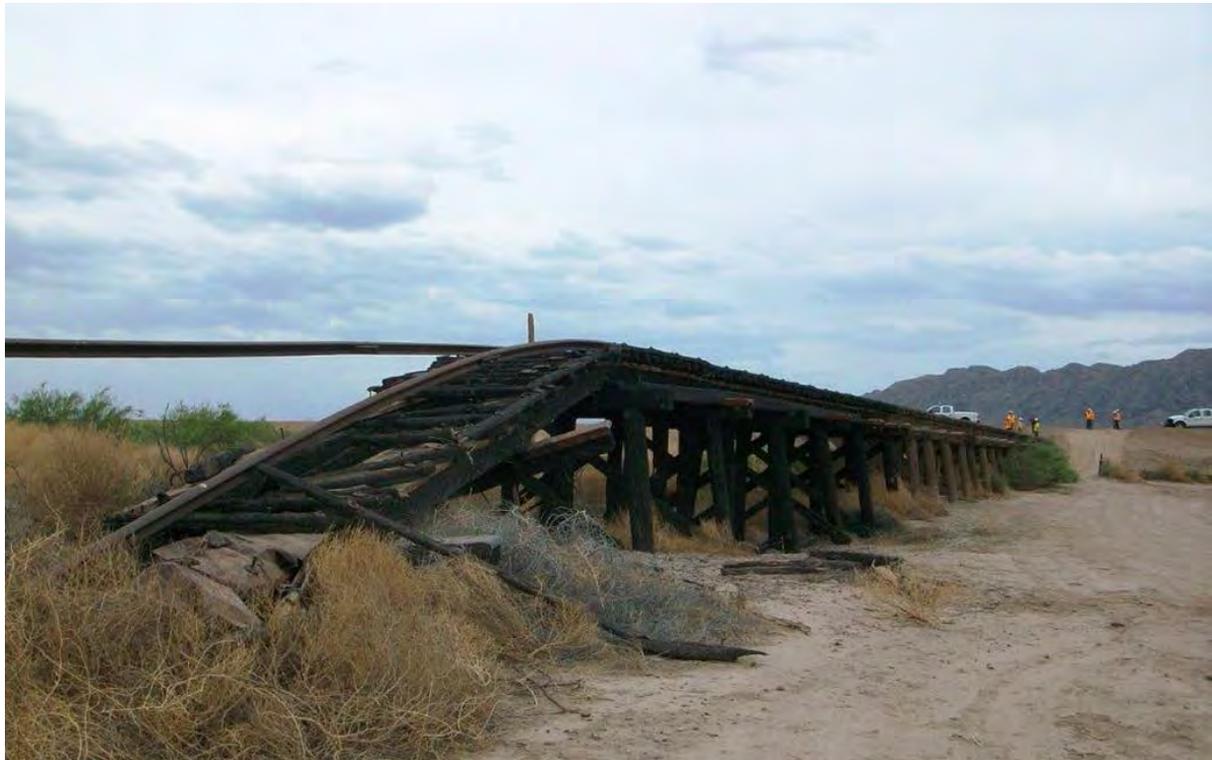
TxDOT and TXPF are in the process of replacing the U.S. portion of the international rail bridge over the Rio Grande at Presidio, which was damaged by fire on February 29, 2008, and March 1, 2009. TXPF is developing the plans and specifications while TxDOT is working on an environmental approval. Once those efforts are complete, TxDOT will coordinate project review and approval with state and federal agencies, TXPF will be responsible for reconstructing the bridge. A timber portion of the bridge just north of the levee still stands (Figure 40), though 15 bents on the extreme north end were damaged by the March 1, 2009 fire.

Figure 40: MP 1029 - Timber Structure North of Levee

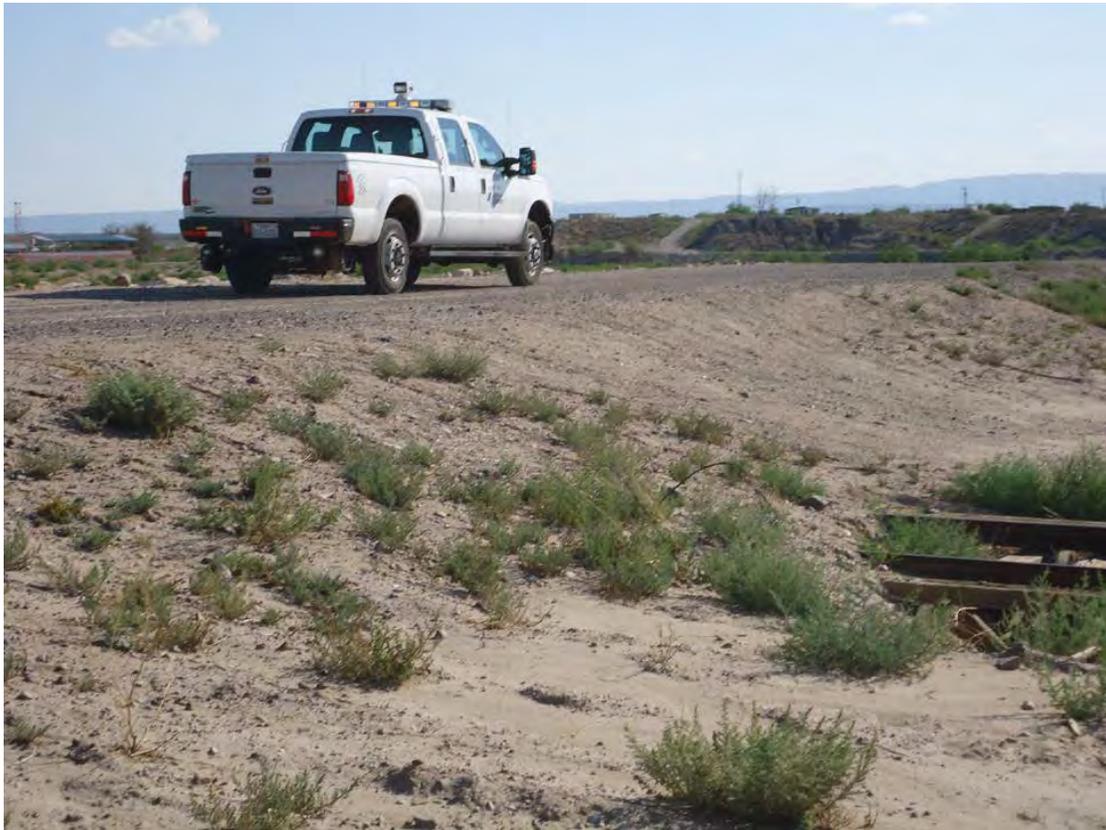
The International Boundary and Water Commission made improvements to the levee system in Presidio which has resulted in the tracks being buried in the levee (Figure 41). TXPF's design will raise the bridge and both side approaches by almost 9 feet to cross the levee at grade.

Figure 41: MP 1029 - Tracks Buried in Levee

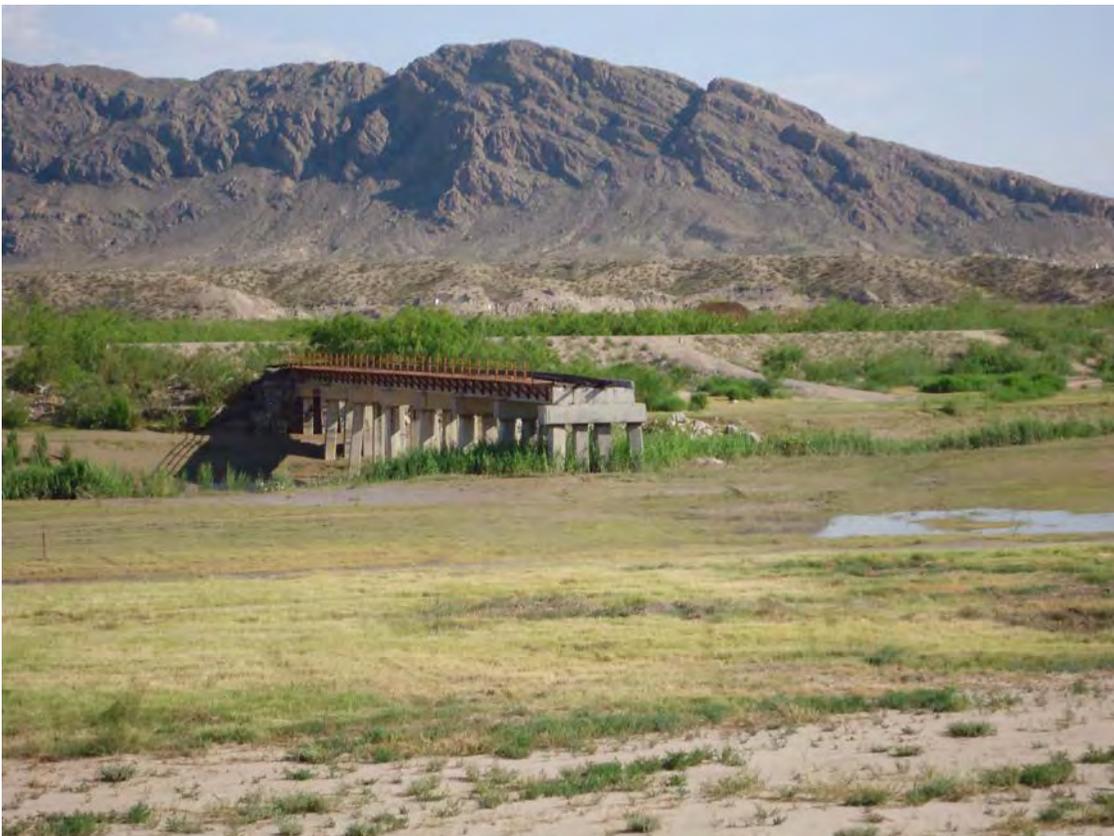
The U.S. portion of the bridge, south of the levee, was completely destroyed by the February 29, 2008 fire. The Mexico portion, made of concrete, still stands (Figure 42), though it is reported that the bridge approaches from that side of the border were washed out during a recent flood event.

Figure 42: MP 1009 - Remaining structure (Mexican approach) of the international bridge

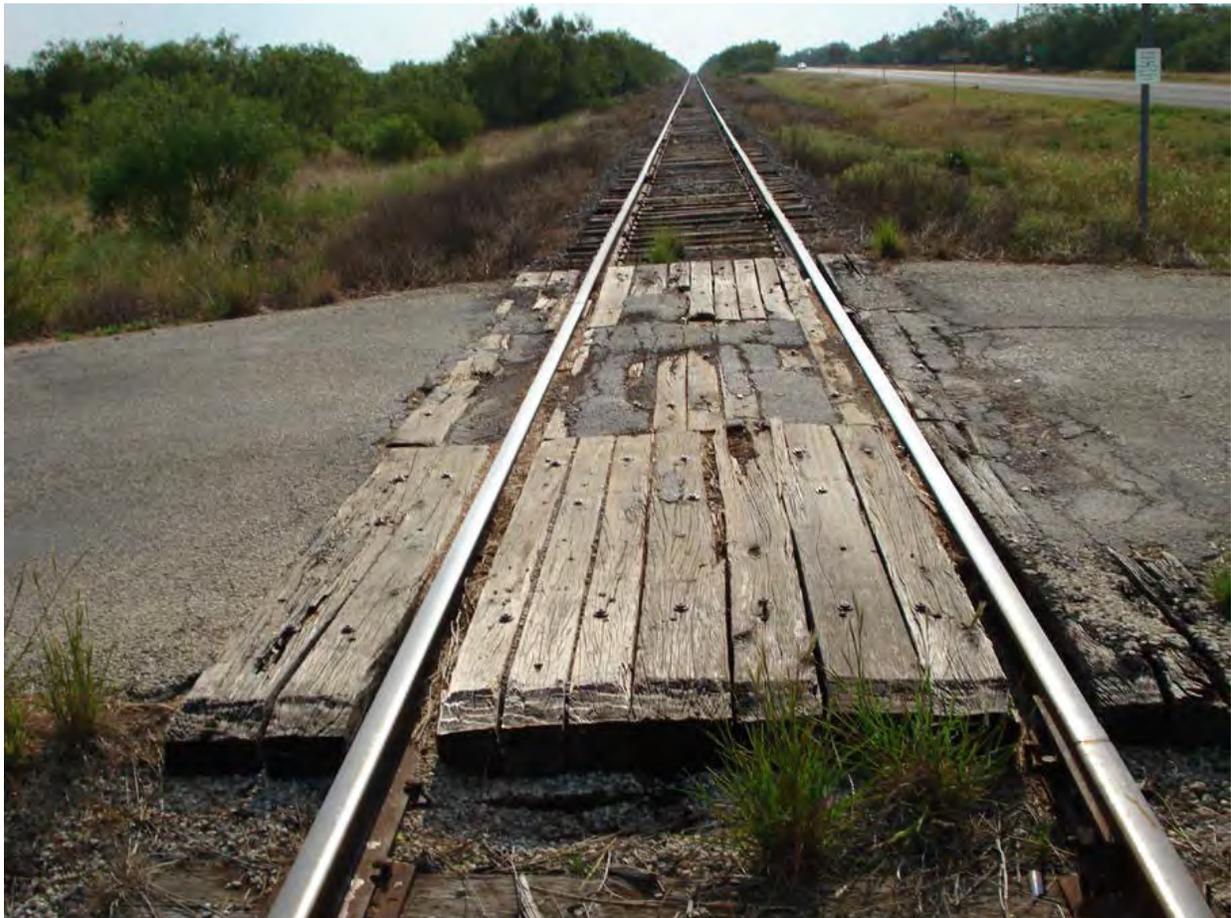
TxDOT's rehabilitation project on the east end included the reconstruction of 119 grade crossings between San Angelo Junction (MP 0) and the west side of San Angelo (MP 721.52). In the latest project completed by TxDOT, 19 crossings were either repaired or replaced between MP 722 and MP 757. Many more still need attention and will be addressed as the rehabilitation program continues. Figure 43 shows a typical crossing in need of repair and Figure 44 shows one that has been completely replaced. The need for reconstruction of these crossings is impacted by the inability of small local governments to fund crossing rehabilitation projects.

Figure 43: MP 735.1 - Grade crossing in poor condition
