# Texas Pacifico Transportation South Orient Rail-line Infrastructure Assessment

January 2015

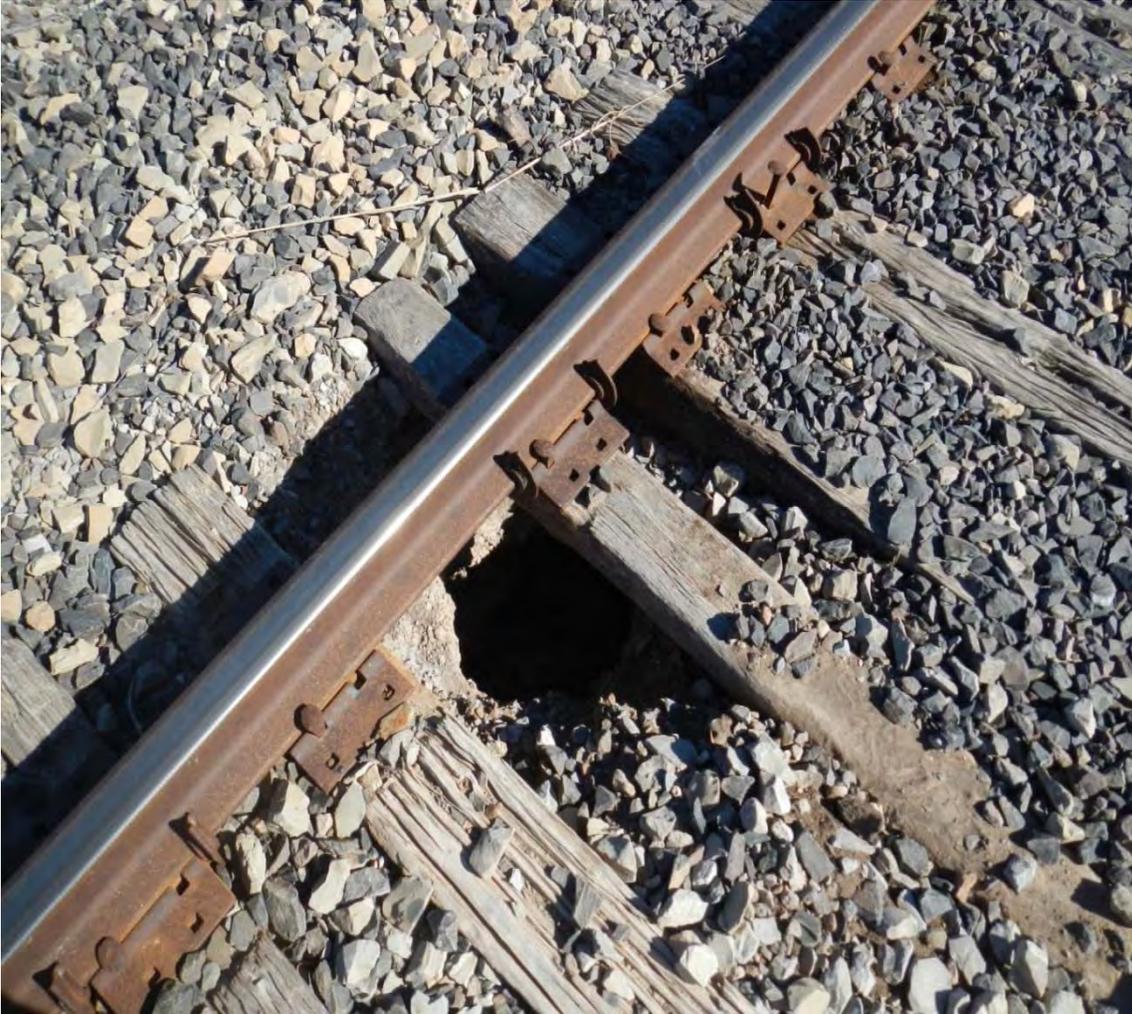
A total of 5 drainage structure observations were performed. TXPF did not provide inspections records for drainage structures. These observations were made as the team hi-railed the study area. A collapsed culvert was observed at milepost 764.10 resulting in an approximate 16-inch deep opening in the gauge of the track with no ballast supporting the ties as shown in Photo 1. This collapsed culvert warranted corrective action of which TXPF was notified.

Photo 1: Collapsed Culvert at Milepost 764.10

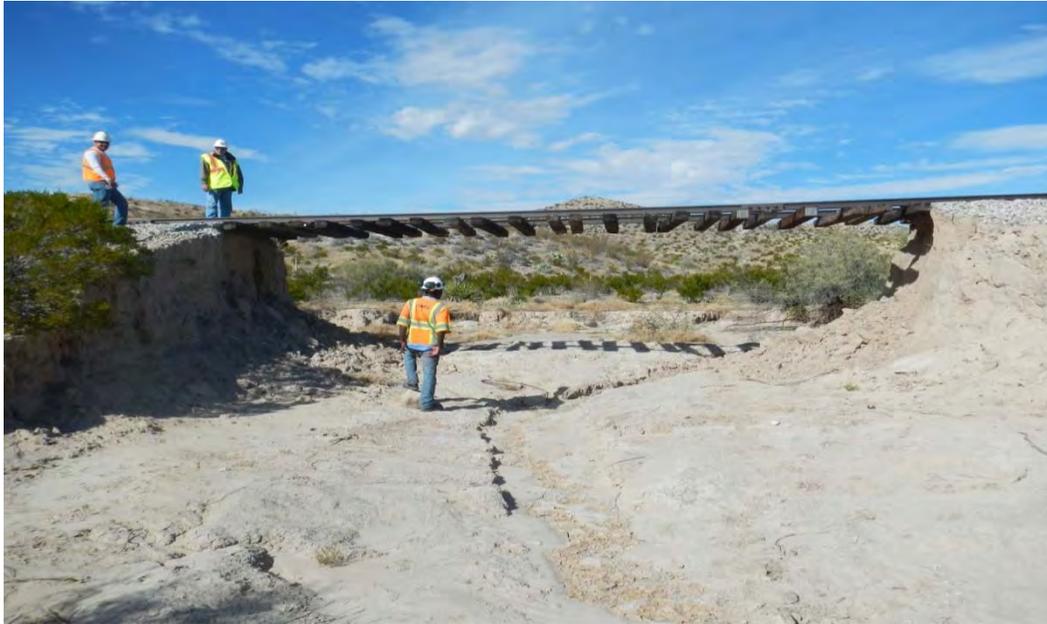
Based on the observations performed and bridge inspection records, it appears timber component replacement is critical and will be an on-going effort for this line segment. With the potential to place this portion of track back into service with the possibility of operating 286 kip car loadings, it is suggested a formal 'heavy' bridge component replacement program be put in place. The drainage area also presents unique problems with accelerated deterioration of bridge components as a result of erosion in and around substructure components. Unsupported timber sills, exposed timber piling and undermining of timber back-walls were observed in many areas. This heavy bridge component replacement does not include entire bridge replacements. Photo 2 was taken at milepost 1006.50 where subgrade was washed away and rail is now 'hanging'. This may be a location for a new bridge. Photo 3 was taken at Bridge 985.90 where the streambed under the bridge is being eroded away exposing more of the driven timber piles.

Photo 2. Milepost 1006.50 Subgrade washed away

Total bridge replacements costs, as in the case of Presidio Bridge 1029.00 and the potential for a new bridge at milepost 1006.50, are estimated as a single-track structure for \$7,000 per track foot, not including H&H analysis, geotechnical exploration, or environmental permitting. This approximate 950 feet of new substructure and superstructure is estimated at \$6,650,000.

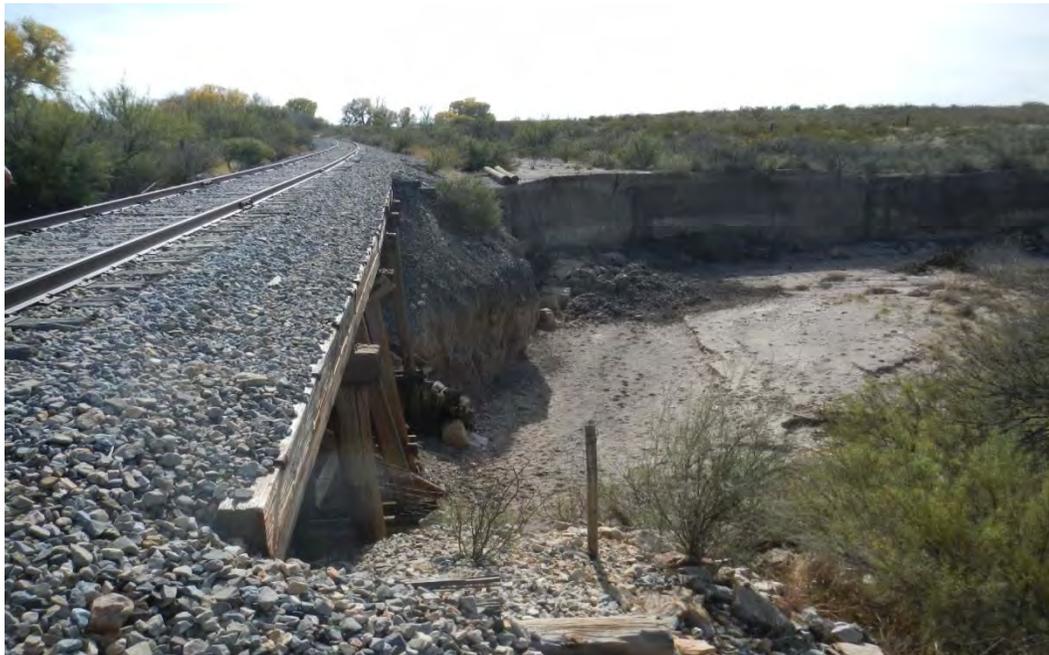
Photo 3. Bridge 985.90 (piling exposed)

It is recommended that a 'heavy' timber component replacement and streambed protection program be initiated with an annual budget based on bridge inspection record recommendations and estimated at \$750,000 per year for two years for a total of \$1,500,000

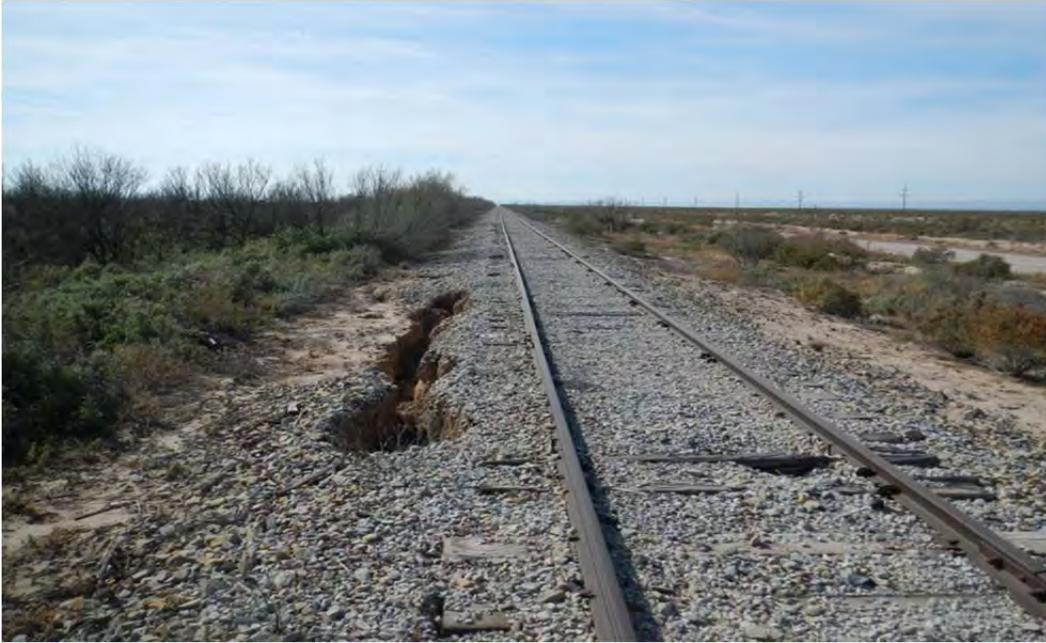
Photo 4. Milepost 906.9 and subgrade erosion

A hydraulic/hydrology analysis of the area would assist in the prioritization of the repair locations. It is estimated these drainage/erosion areas could be addressed over a two-year period with an annual expenditure of \$1,500,000 per year, totalling \$3,000,000.

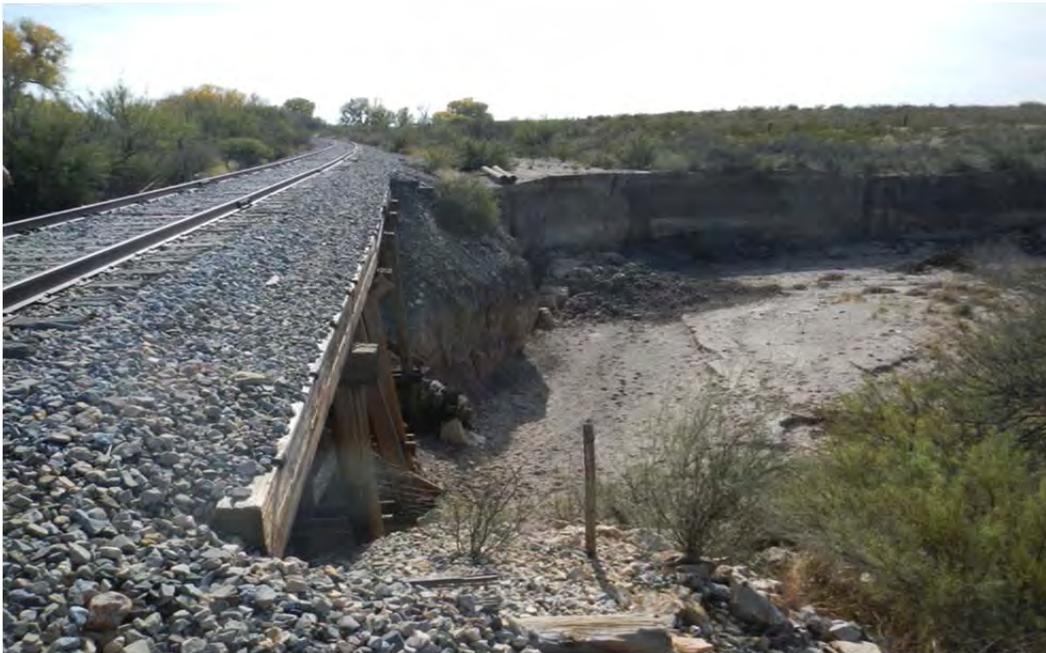
Photo 5. Bridge 985.90 and upstream bank erosion towards track structure

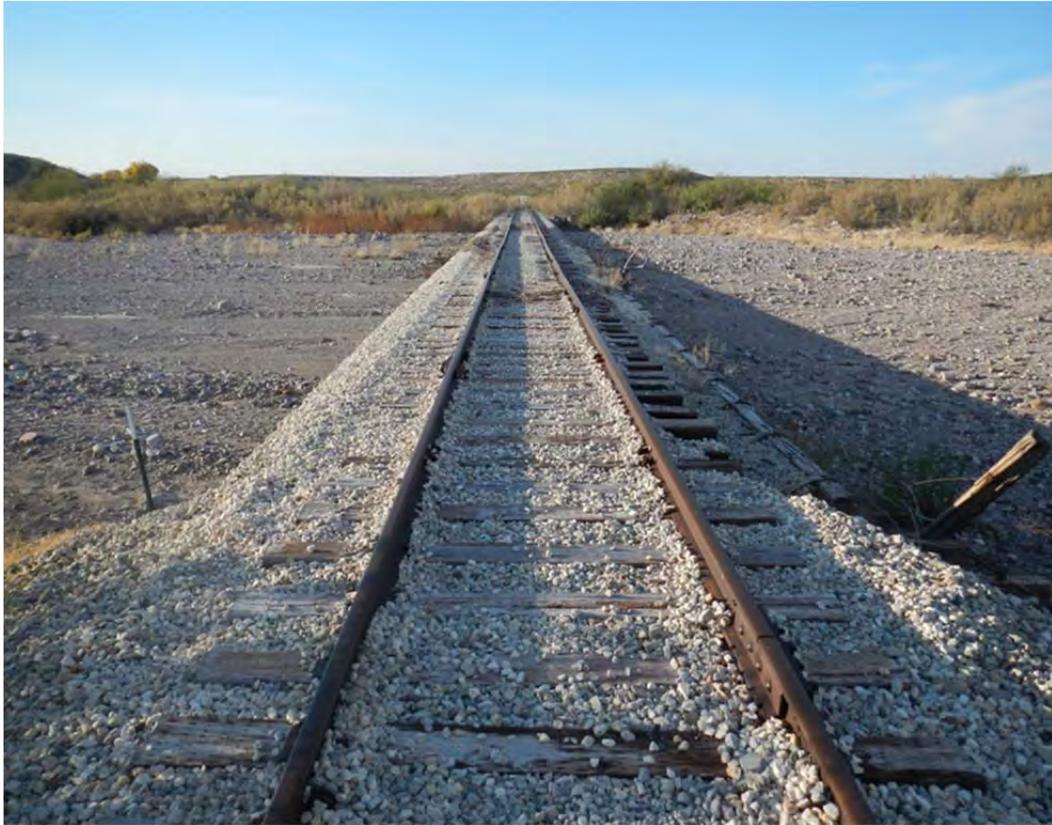
Photo 6. Bridge 1000.20 and restricted flow under structure

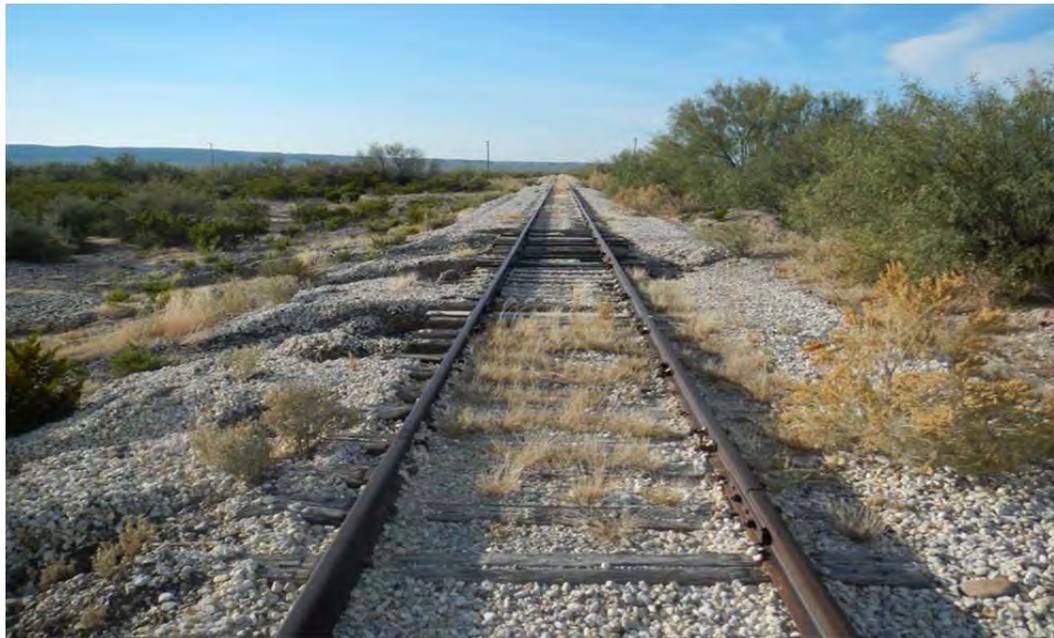
A total of 14 drainage structure observations were performed. TXPF did not provide inspection records for drainage items. These observations were made as the team hi-railed the study area. Major subgrade and subballast erosion is present throughout the area. Several areas indicate drainage occurs through the track ties, washing away the ballast between the ties and leaving the track ties unsupported. There are also areas where it appears runoff in drainages overtopped the existing structures. Embankment areas parallel to the track structure continues to erode. This is not a recent situation and has likely taken months/years to occur. Photo 4 at milepost 906.9 shows subgrade erosion, while Photo 5 at Bridge 985.90 shows upstream bank erosion. Photo 6 at Bridge 1000.20 shows limited streambed clearance to underside of structure, and Photo 7 shows surface flow through track ties, resulting in unsupported ties.

Photo 7. Drainage through tie structure
