US 67 CORRIDOR MASTER PLAN

APPENDIX K

Subject: US 67 Corridor Master Plan Pavement Evaluation Technical Memorandum

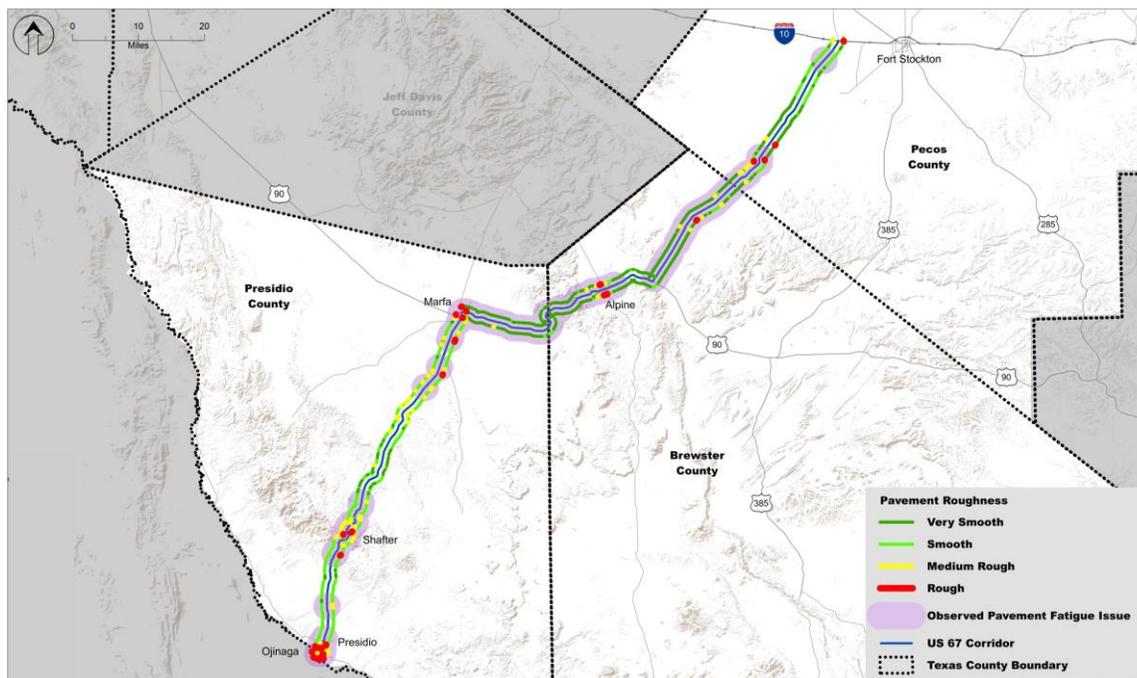
Figure 5: Observed Roughness and Early Stage Alligator Cracking

Figure 5 summarizes the locations of roughness and early stage fatigue cracking observed during the field reconnaissance. These observations are discussed for each pavement project segment.

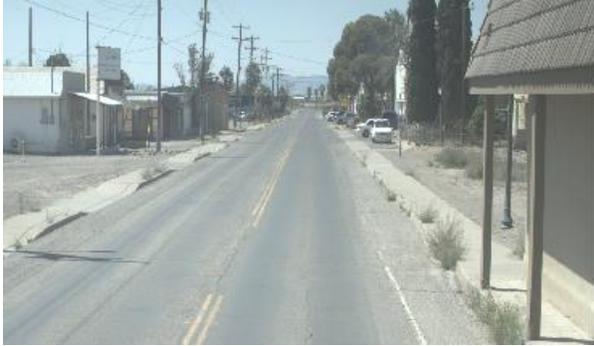
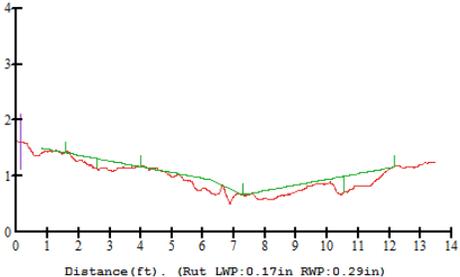
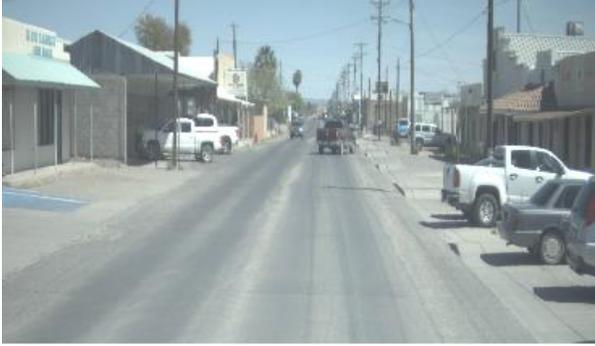
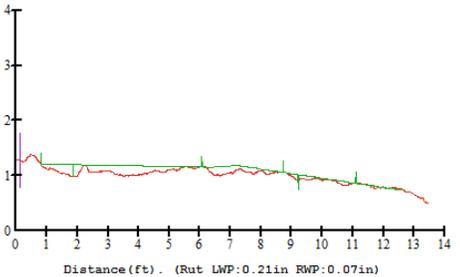
<p style="text-align: center;">Transverse Profile (y-axis, inches x-axis, feet)</p>
FY18 PMIS Scores: Not Available	
Field reconnaissance observations: Areas of alligator cracking, rutting, flushing, raveling, and longitudinal and transverse cracking were observed along the segment. Roughness was present throughout the segment as well.	
TxDOT planned maintenance and rehabilitation projects: 1) Seal coating of the north/south stretch of the segment is planned within the next 5 to 10 years. 2) No maintenance is currently planned for the southernmost east/west stretch of the segment.

Recommended projects: Prior to the planned seal coat, it is recommended that localized patching of areas exhibiting alligator cracking be performed. Due to the presence of alligator cracking and rutting, resurfacing of the southernmost east/west segment of US 67A may be considered in the future. In the long-term, the entire length of US 67A may be considered for base rehabilitation and resurfacing.

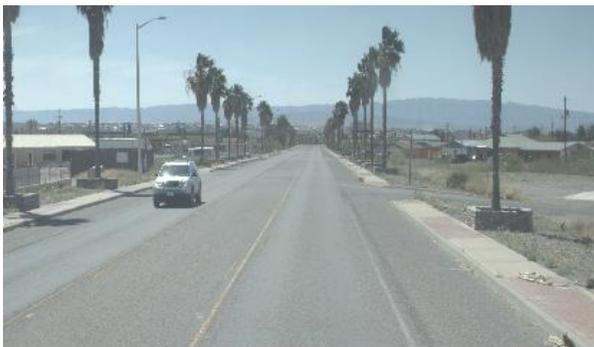
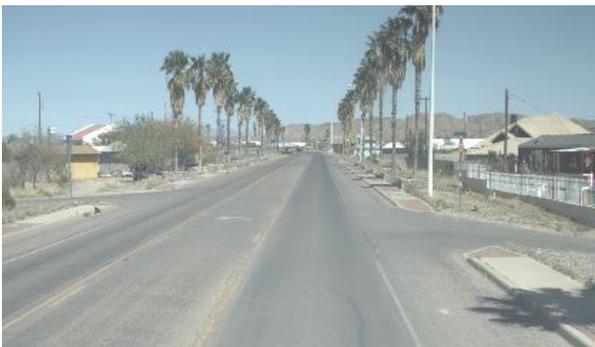
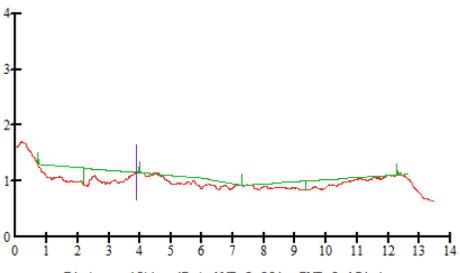
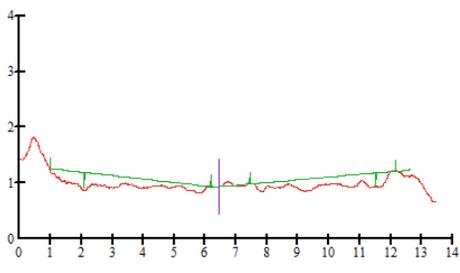
<p style="text-align: center;">Transverse Profile (y-axis, inches x-axis, feet)</p>
FY18 PMIS Scores – Condition: 85 (Good) Distress: 85 (Good) Ride: 3.8 (Smooth)		
Field reconnaissance observations: Consistent with the PMIS condition scores, the segment was found to be in overall good condition. Localized areas of early stage rutting and alligator cracking were observed along the segment. Flushing and longitudinal and transverse cracking were observed as well.

TxDOT planned maintenance and rehabilitation projects: Seal coating is planned within the next 4 years.		
Recommended projects: In the short-term, monitor the progression of rutting and early stage alligator cracking prior to the next seal coat. If these distresses progress, investigate localized patching prior to application of the next seal coat. In the long-term, continue monitoring the progression of distress. Rehabilitation of the existing base may eventually be needed. Perform a structural evaluation to assess the condition of the existing pavement structure and determine the appropriate rehabilitation activity.

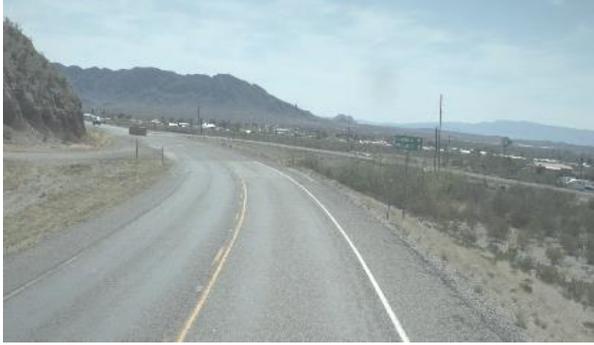
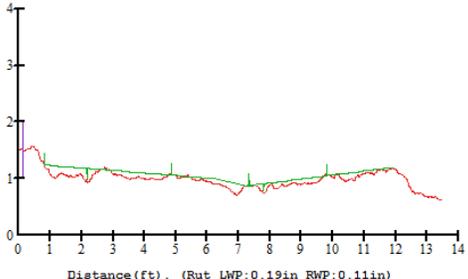
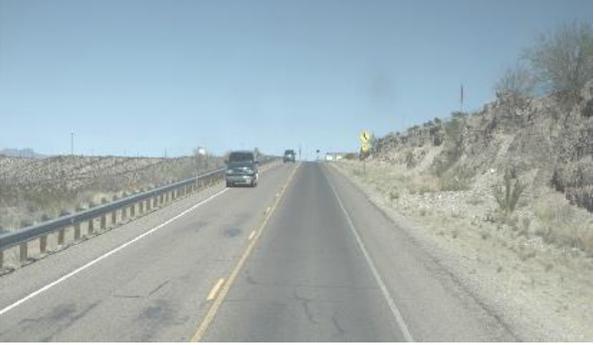
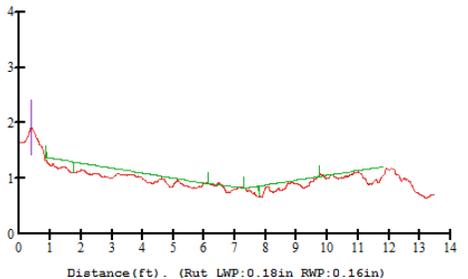
<p style="text-align: center;">Distance (ft). (Rut LWP:0.18in RWP:0.16in)</p> <p style="text-align: center;">Transverse Profile (y-axis, inches x-axis, feet)</p>
FY18 PMIS Scores – Condition: 92 (Very Good) Distress: 92 (Very Good) Ride: 3.6 (Smooth)	
Field reconnaissance observations: Localized areas of early stage alligator cracking and rutting were observed along the segment. Flushing, raveling, and longitudinal and transverse cracking were also observed.

TxDOT planned maintenance and rehabilitation projects: Seal coating is planned within the next 4 years.	
Recommended projects: In the short-term, localized patching of areas exhibiting alligator cracking is recommended prior to the next seal coat. Monitor the progression of alligator cracking and rutting. In the long-term, as freight traffic gradually increases, rehabilitation of the existing base and an overlay of this segment may eventually be needed to increase the load-carrying capacity of the pavement. Additional testing will be required to assess the condition of the pavement structure and determine the appropriate rehabilitation activity.

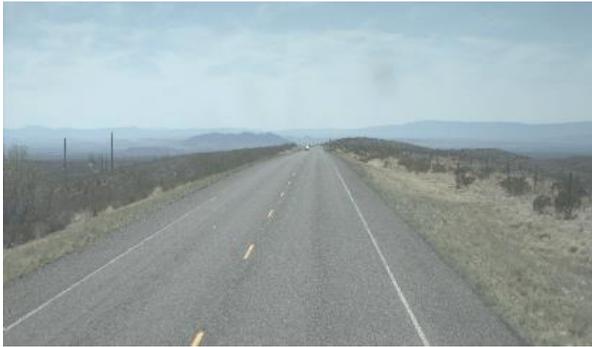
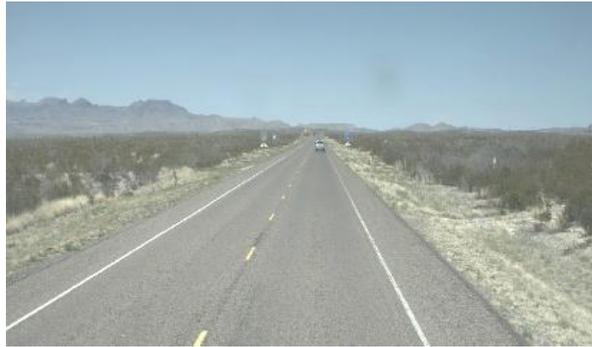
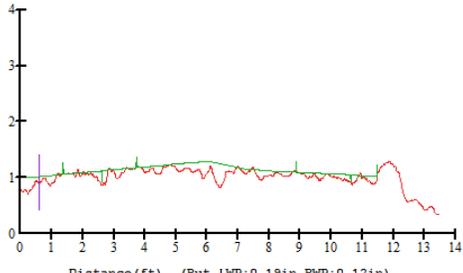
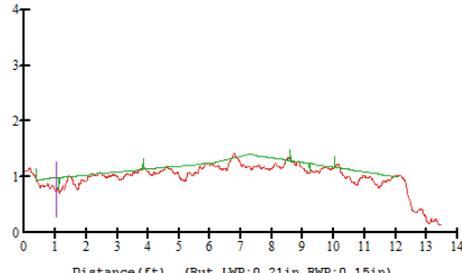
<p style="text-align: center;">Distance(ft). (Rut LWP:0.21in RWP:0.15in)</p> <p style="text-align: center;">Transverse Profile (y-axis, inches x-axis, feet)</p>
FY18 PMIS Scores – Condition: 100 (Very Good) Distress: 100 (Very Good) Ride: 3.9 (Smooth)		
Field reconnaissance observations: Consistent with the PMIS condition scores, the segment was found to be in overall very good condition. Minimal cracking was observed. Some shallow rutting and flushing were observed along the segment.

TxDOT planned maintenance and rehabilitation projects: Seal coating is planned within the next 4 years.		
Recommended projects: In the short-term, no additional projects are recommended. In the long-term, as freight traffic gradually increases, rehabilitation of the existing base and an overlay of this segment may eventually be needed to increase the load-carrying capacity of the pavement. Additional testing will be required to assess the condition of the pavement structure and determine the appropriate rehabilitation activity.

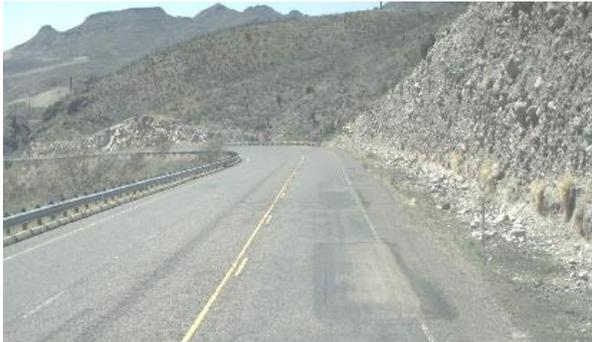
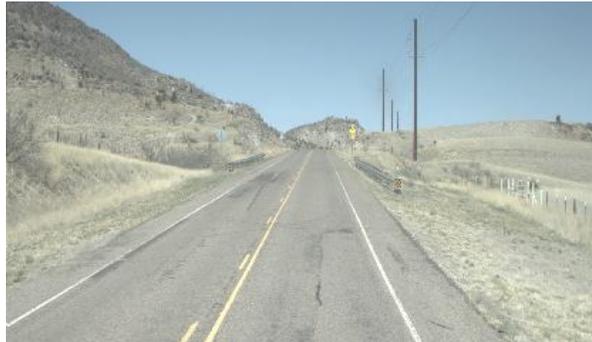
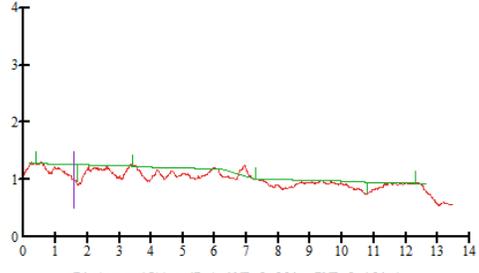
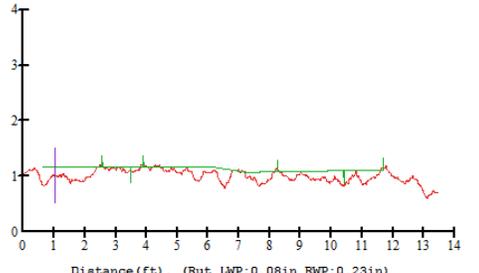
<p>Distance (ft). (Rut LWP: 0.08in RWP: 0.23in)</p> <p>Transverse Profile (y-axis, inches x-axis, feet)</p>
FY18 PMIS Scores – Condition: 93 (Very Good) Distress: 93 (Very Good) Ride: 3.4 (Smooth)		
Field reconnaissance observations: Localized areas of alligator cracking, shallow rutting, flushing, raveling, and longitudinal and transverse cracking were observed along the segment.

TxDOT planned maintenance and rehabilitation projects: Seal coating is planned along most of the segment within the next 4 years.		
Recommended projects: In the short-term, localized patching of areas exhibiting alligator cracking is recommended prior to the next seal coat. Monitor the progression of alligator cracking and rutting. In the long-term, as freight traffic gradually increases, rehabilitation of the existing base and an overlay of this segment may eventually be needed to increase the load-carrying capacity of the pavement. Additional testing will be required to assess the condition of the pavement structure and determine the appropriate rehabilitation activity.

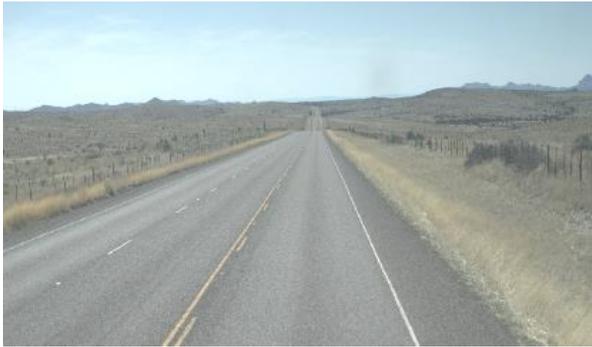
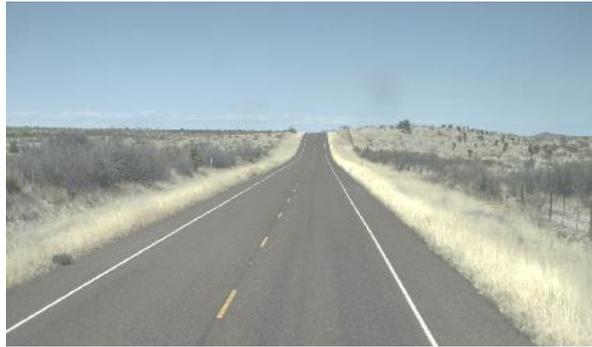
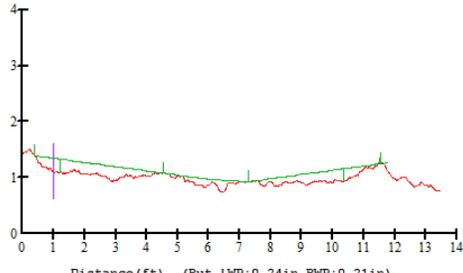
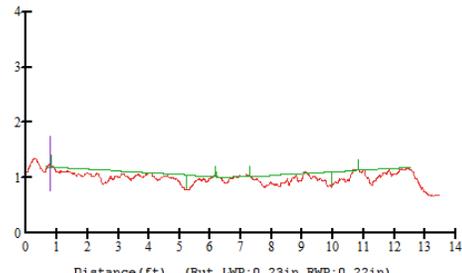
<p>Distance(ft). (Rut LWP:0.23in RMP:0.22in)</p> <p>Transverse Profile (y-axis, inches x-axis, feet)</p>
FY18 PMIS Scores – Condition: 97 (Very Good) Distress: 97 (Very Good) Ride: 4.0 (Very Smooth)		
Field reconnaissance observations: Consistent with the PMIS condition scores, the segment was found to be in overall very good condition. Minimal cracking was observed. Some shallow rutting and flushing were observed along the segment.

TxDOT planned maintenance and rehabilitation projects: Seal coating of this segment is currently underway or will begin soon. Additional seal coating is planned within the next 5 to 10 years.		
Recommended projects: In the short-term, no additional projects are recommended. In the long-term, as freight traffic gradually increases, rehabilitation of the existing base and an overlay of this segment may eventually be needed to increase the load-carrying capacity of the pavement. Additional testing will be required to assess the condition of the pavement structure and determine the appropriate rehabilitation activity.

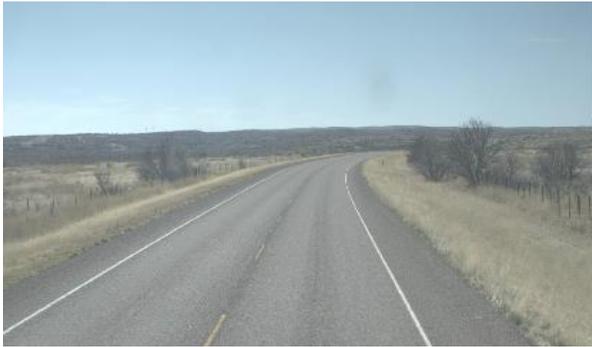
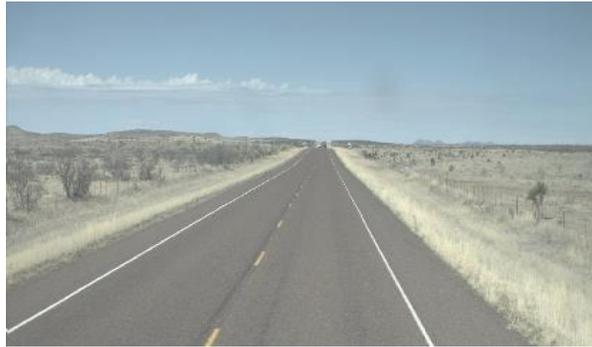
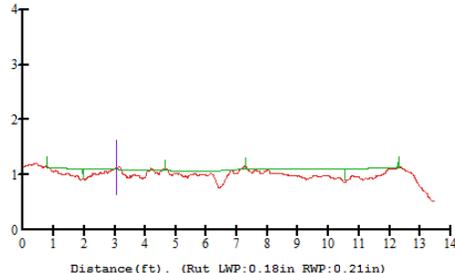
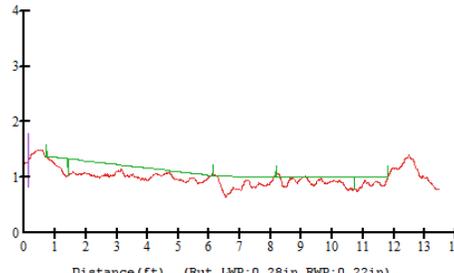
<p style="text-align: center;">Transverse Profile (y-axis, inches x-axis, feet)</p>
FY18 PMIS Scores – Condition: 92 (Very Good) Distress: 92 (Very Good) Ride: 3.7 (Smooth)		
Field reconnaissance observations: Consistent with the PMIS condition scores, the segment was found to be in overall very good condition. Minimal cracking was observed. Some shallow rutting and flushing were observed along the segment.

TxDOT planned maintenance and rehabilitation projects: Seal coating of this segment is currently underway or will begin soon.		
Recommended projects: In the short-term, no additional projects are recommended. In the long-term, as freight traffic gradually increases, rehabilitation of the existing base and an overlay of this segment may eventually be needed to increase the load-carrying capacity of the pavement. Additional testing will be required to assess the condition of the pavement structure and determine the appropriate rehabilitation activity.

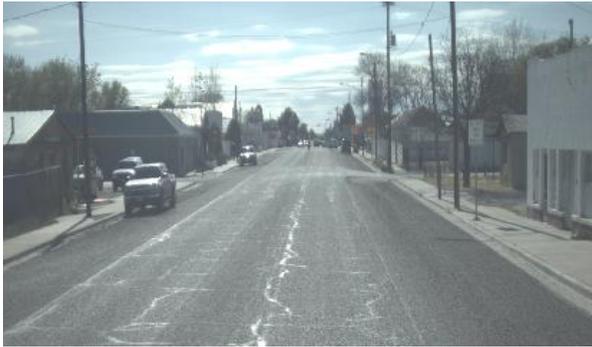
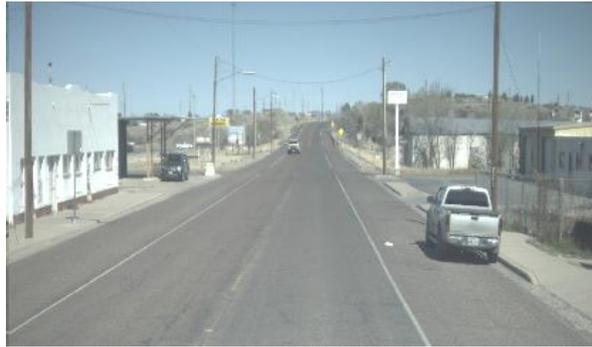
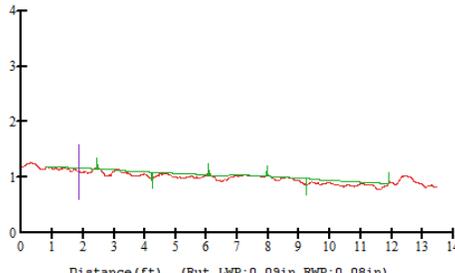
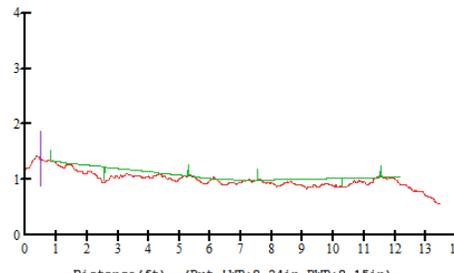
<p style="text-align: center;">Transverse Profile (y-axis, inches x-axis, feet)</p>
FY18 PMIS Scores – Condition: 96 (Very Good) Distress: 96 (Very Good) Ride: 3.6 (Smooth)		
Field reconnaissance observations: Longitudinal and transverse cracking were the predominant distress types observed. Where applied, crack seal appeared to be in overall good condition. The segment exhibited early stage alligator cracking in the wheel paths. Some shallow rutting was observed along the segment as well. These distresses should be monitored. Increasing freight traffic will likely accelerate their progression.

TxDOT planned maintenance and rehabilitation projects: Seal coating of a 0.4-mile stretch beginning at the junction of US 67/ US 90 in Marfa to 0.4 miles north is currently underway or will begin soon. Seal coating of US 67 south of the US 67/ US 90 junction to the city limits is also currently underway or will begin soon.		
Recommended projects: In the short-term, no additional projects are recommended. Monitor progression of alligator cracking and rutting. As freight gradually traffic increases, rehabilitation of the existing base and a mill and inlay of this segment may eventually be needed to increase the load-carrying capacity of the pavement.

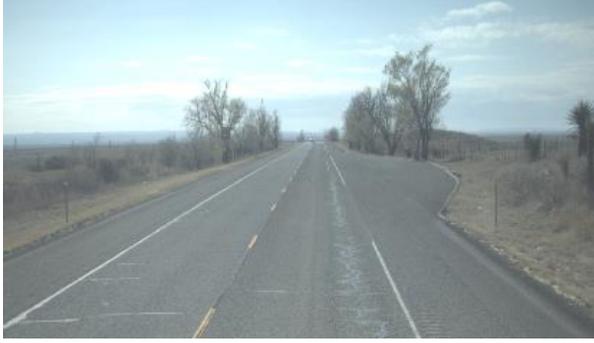
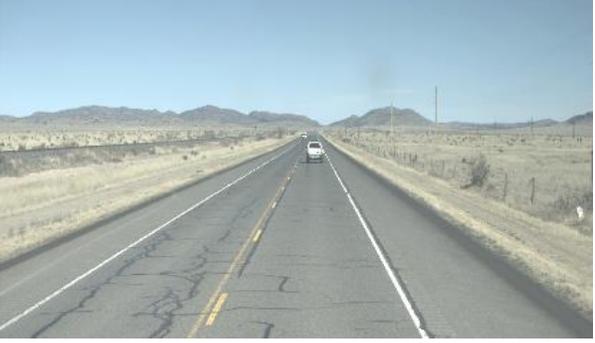
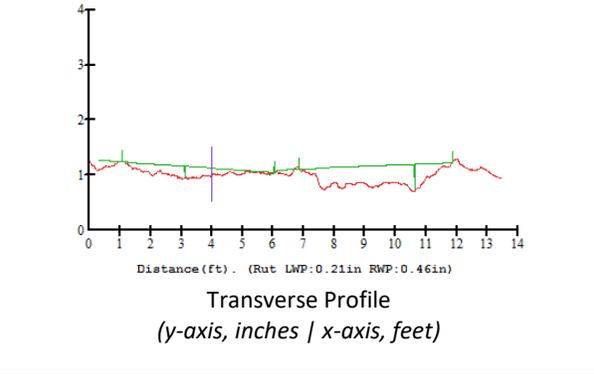
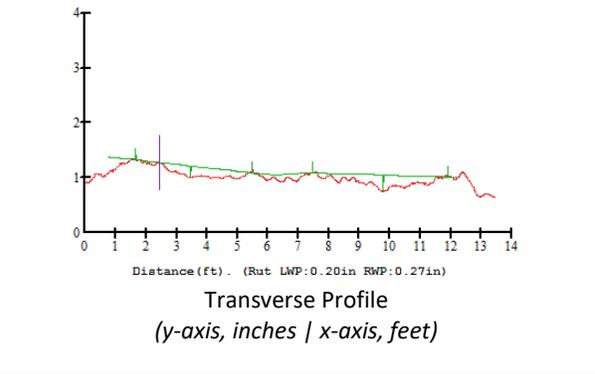
<p>Transverse Profile <i>(y-axis, inches x-axis, feet)</i></p>
<p>FY18 PMIS Scores – Condition: 99 (Very Good) Distress: 99 (Very Good) Ride: 4.5 (Very Smooth)</p>	
<p>Field reconnaissance observations: PMIS condition scores do not appear to reflect the overall condition of the pavement during field reconnaissance. The segment exhibited early stage alligator cracking in the wheel paths along the segment. Some shallow rutting was observed along the segment as well. Longitudinal and transverse cracking were the predominant distress types observed. Where applied, crack seal appeared to be in overall good condition.</p>

<p>TxDOT planned maintenance and rehabilitation projects: None.</p>	
<p>Recommended projects: Due to the presence of early stage alligator cracking and rutting along the length of this segment, it is recommended that this segment be further investigated for a potential overlay in the short-term. Additional testing is required to determine the adequacy of the pavement for projected traffic.</p>

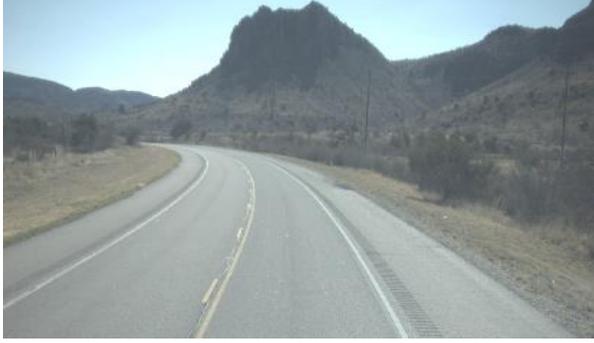
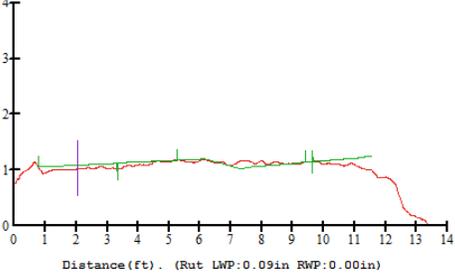
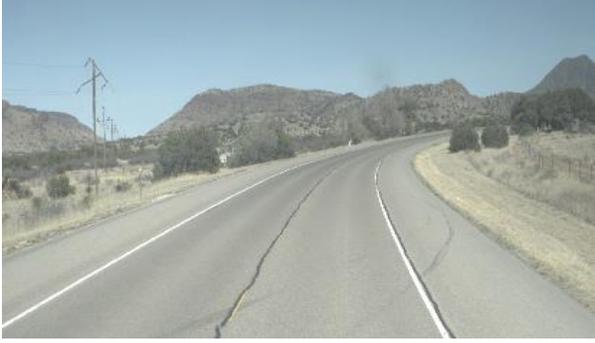
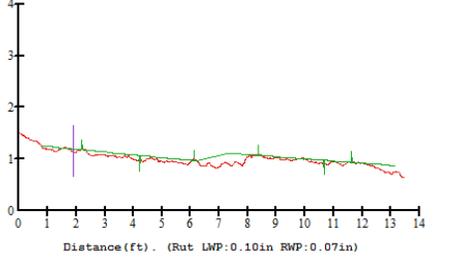
<p style="text-align: center;">Transverse Profile (y-axis, inches x-axis, feet)</p>
<p>FY18 PMIS Scores – Condition: 100 (Very Good) Distress: 100 (Very Good) Ride: 4.7 (Very Smooth)</p>	
<p>Field reconnaissance observations: Consistent with the PMIS condition scores, the segment was found to be in overall very good condition. Longitudinal and transverse cracking were the predominant distress types observed. Where applied, crack seal appeared to be in overall good condition.</p>

<p>TxDOT planned maintenance and rehabilitation projects: None.</p>	
<p>Recommended projects: In the short-term, continue the preventive maintenance crack sealing program and seal the paving joint where needed. In the long-term, as freight traffic gradually increases, rehabilitation of the existing base and an overlay of this segment may eventually be needed to increase the load-carrying capacity of the pavement. Additional testing will be required to assess the condition of the pavement structure and determine the appropriate rehabilitation activity.</p>

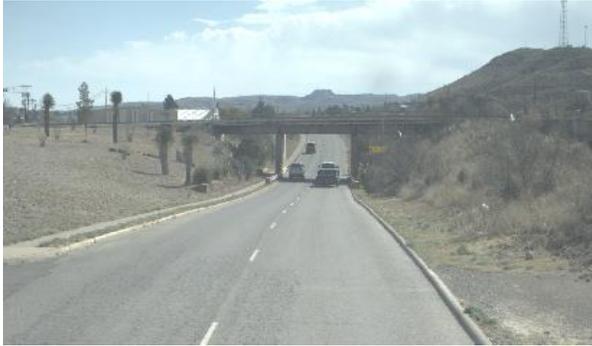
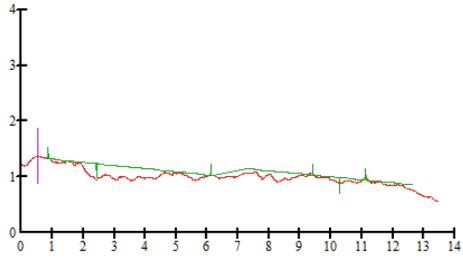
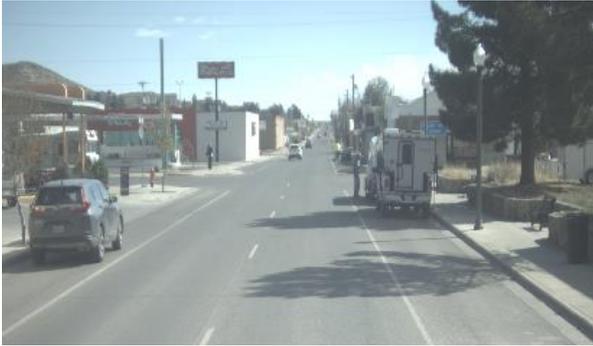
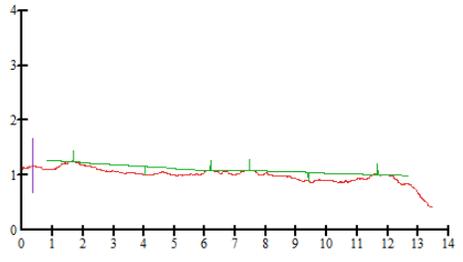
<p>FY18 PMIS Scores – Condition: 96 (Very Good) Distress: 98 (Very Good) Ride: 4.1 (Very Smooth)</p>	
<p>Field reconnaissance observations: Consistent with the PMIS condition scores, the segment was found to be in overall very good condition. Longitudinal and transverse cracking were the predominant distress types observed. Where applied, crack seal appeared to be in overall good condition. Localized areas of alligator cracking were observed along the segment, especially near the railroad bridge. Some shallow rutting was observed along the segment as well.</p>	
<p>TxDOT planned maintenance and rehabilitation projects: None.</p>	
<p>Recommended projects: In the short-term, localized patching of highly alligatorated (fatigued) areas near the railroad bridge and through the downtown corridor is recommended. As freight traffic gradually increases, the load-carrying capacity of the pavement may need to be increased. Due to the many cross-sections making-up this segment, additional testing and analysis should be performed to determine appropriate rehabilitation strategies.</p>

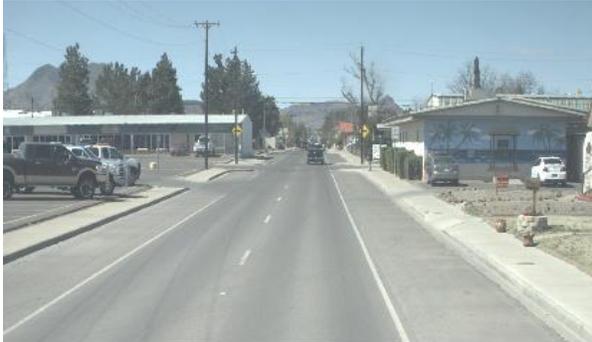
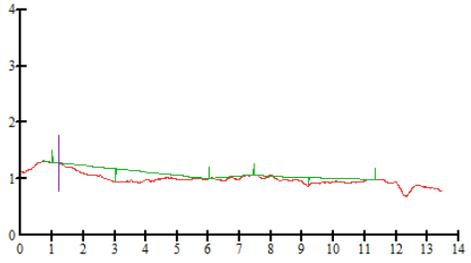
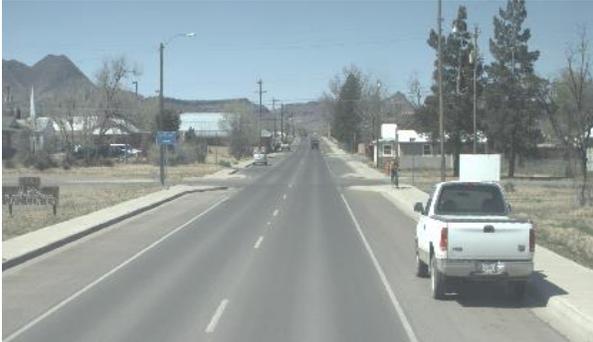
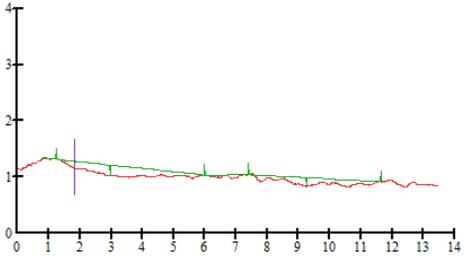
<p>FY18 PMIS Scores – Condition: 99 (Very Good) Distress: 100 (Very Good) Ride: 4.2 (Very Smooth)</p>	
<p>Field reconnaissance observations: Consistent with the PMIS condition scores, the segment was found to be in overall very good condition. Longitudinal and transverse cracking were the predominant distress types observed. Where applied, crack seal appeared to be in overall good condition. Localized areas of alligator cracking were observed along the segment, especially near intersections in the downtown area. Some shallow rutting was also observed in the segment.</p>	
<p>TxDOT planned maintenance and rehabilitation projects: None.</p>	
<p>Recommended projects: In the short-term, localized patching of fatigued areas near intersections in the downtown area is recommended. Eventually, the load-carrying capacity of the pavement may need to be increased. Due to the many cross-sections making-up this segment, additional testing and analysis should be performed to determine appropriate rehabilitation strategies.</p>

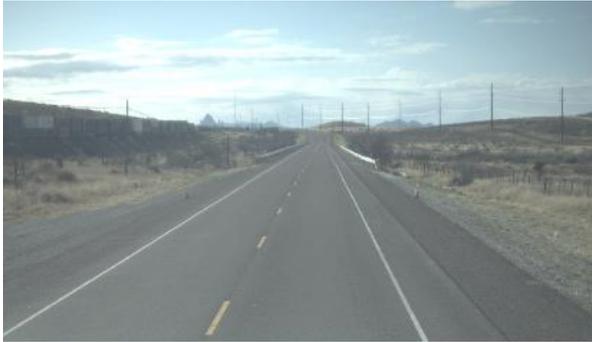
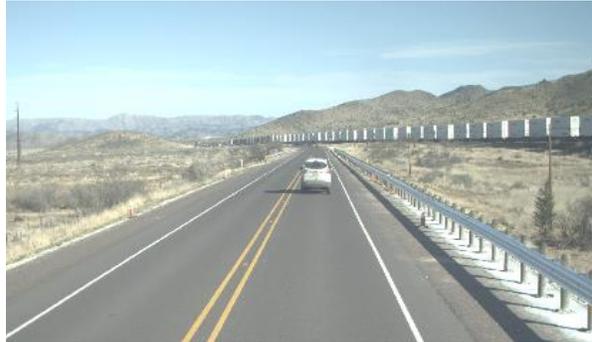
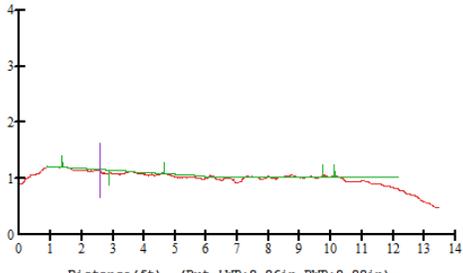
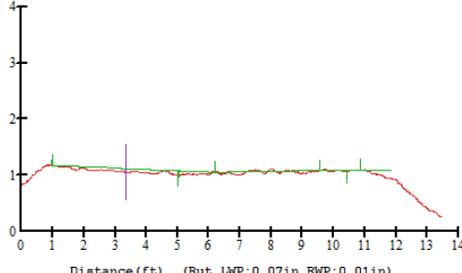
<p>Distance(ft). (Rut LWP:0.07in RWP:0.01in)</p> <p>Transverse Profile (y-axis, inches x-axis, feet)</p>
FY18 PMIS Scores – Condition: 100 (Very Good) Distress: 100 (Very Good) Ride: 3.4 (Smooth)	
Field reconnaissance observations: Consistent with the PMIS condition scores, the segment was found to be in overall very good condition. The pavement was recently overlaid and no distress was observed.

TxDOT planned maintenance and rehabilitation projects: None.	
Recommended projects: In the short-term, begin a crack sealing program. This segment was recently overlaid and appears to be performing well. Eventually, the load-carrying capacity of the pavement may need to be increased.

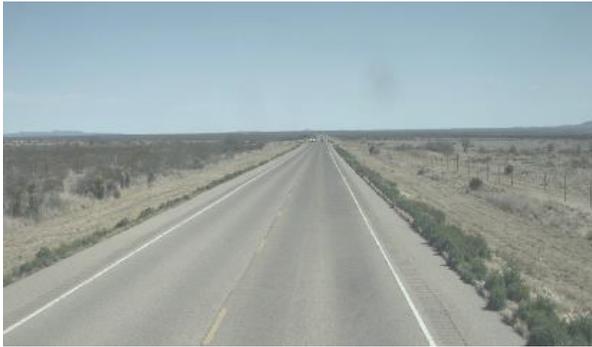
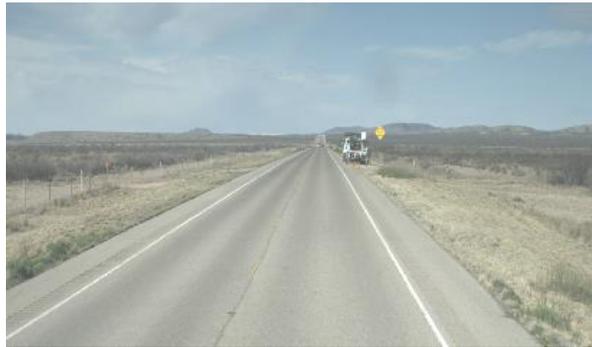
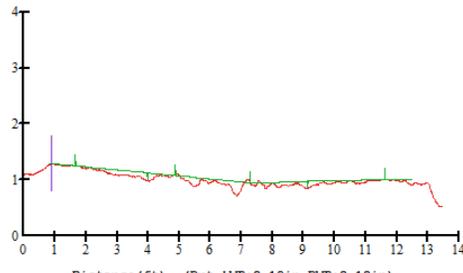
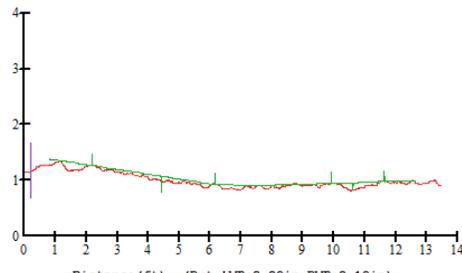
Field reconnaissance observations: Consistent with the PMIS condition scores, the segment was found to be in overall very good condition. Longitudinal and transverse cracking were the predominant distress types observed. Where applied, crack seal appeared to be in overall good condition. Some small areas of flushing were observed as well. Localized areas of early stage alligator cracking were observed along the segment. Shallow rutting was observed along the segment as well. These distresses should be monitored. Increasing freight traffic will likely accelerate their progression.			
TxDOT planned maintenance and rehabilitation projects: Seal coating is planned within the next 4 years.			
Recommended projects: In the short-term, continue crack sealing program and seal the paving joint. Monitor progression of alligator cracking and rutting.

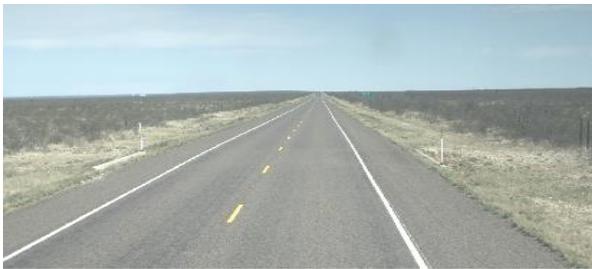
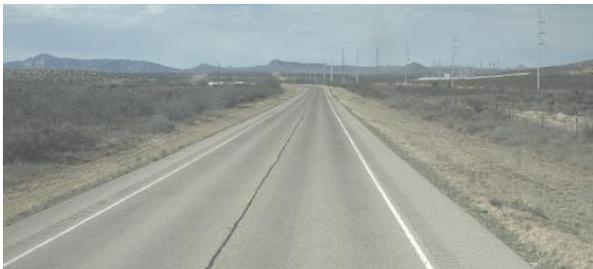
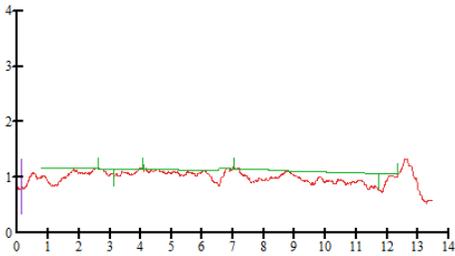
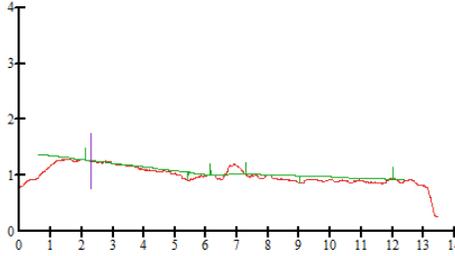
<p>FY17 PMIS Scores – Condition: 98 (Very Good) Distress: 98 (Very Good) Ride: 4.1 (Very Smooth)</p>		
<p>Field reconnaissance observations: Consistent with the PMIS condition scores, the segment was found to be in overall very good condition. Longitudinal and transverse cracking were the predominant distress types observed. Where applied, crack seal appeared to be in overall good condition. Areas of flushing were observed as well. Localized areas of early stage alligator cracking were observed along the segment. Shallow rutting was observed along the segment as well. These distresses should be monitored. Increasing freight traffic will likely accelerate their progression.</p>		
<p>TxDOT planned maintenance and rehabilitation projects: Widening of the roadbed and the addition of shoulders is planned within the next 4 years.</p>		
<p>Recommended projects: Continue crack sealing program and seal the paving joint. Monitor progression of alligator cracking and rutting. Based on the 2017 pavement study performed by TTI, the pavement was found to be structurally adequate, and no rehabilitation is recommended within the next ten years. If future hot mix overlays are planned, a minimum of 3.5 inches thickness is recommended based on the loading.</p>
