Appendix A

Existing Conditions Analysis

FM 76 (North Loop Drive) Feasibility Study

January 2023

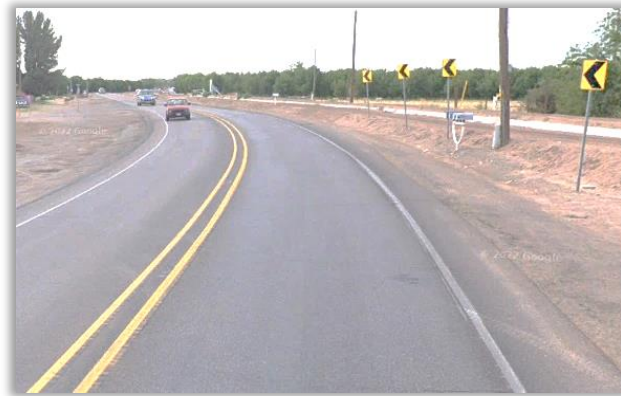
Figure 7: Curve Location near Sudan Dr along FM 76 (North Loop Dr)

The existing roadway geometry was reviewed based on the FM 76 (North Loop Dr) Plans of Existing Right-of-Way Project (in 2020) and as-builts collected during the study. It was observed that the roadway alignment is composed of straight segments and curves. Most of the curve radii adhere to TxDOT's design criteria as per the speed limits. The vertical geometry is almost flat, and no steep gradients were observed. **Figure 7** shows a curve location near Sudan Dr, along the corridor.

A summary of the corridor's curve geometry is provided in **Table 1**. Wherever the curve radius is less than the design criteria, reduced speed limit signs are available. A minimum radius of 643' should be maintained for 6% superelevation for a speed of 45 mph and 1060' for 55mph. For curve C1, the radius is 574.41' so the speed at this location is reduced to 40 mph with a speed limit sign, similar to curves C7 and C8. For small deflection angles, curves should be sufficiently long to avoid the appearance of a kink, at least 500 ft long for a central angle of 5 degrees, and the minimum length should be increased to 100 ft for each 1-degree decrease in the central angle. Curves C4, C5, C10

and C12 has deflection angle less than 5 degrees and do not satisfy the above criteria. As per AASHTO guidelines, the minimum length for horizontal curve for main highways should be fifteen times the design speed (expressed in mph). Curves C1, C2, C3, C6, C7, C8, C9 has a posted speed of 45 mph, resulting in the minimum length for horizontal curve to be 675 ft. Curve C11 have a posted speed of 55 mph, resulting in the minimum length for horizontal curve to be 825 ft. Hence, the above-mentioned curves do not satisfy this requirement.

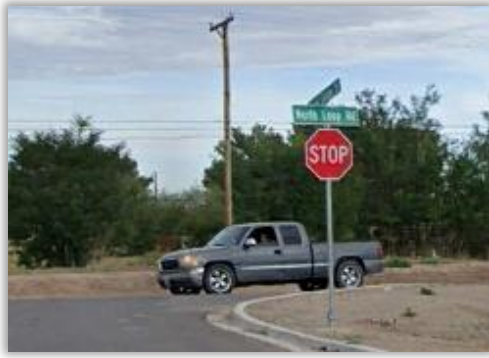
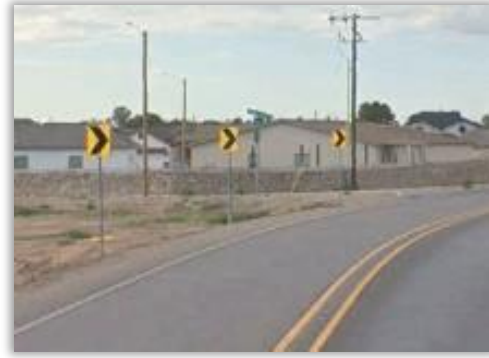
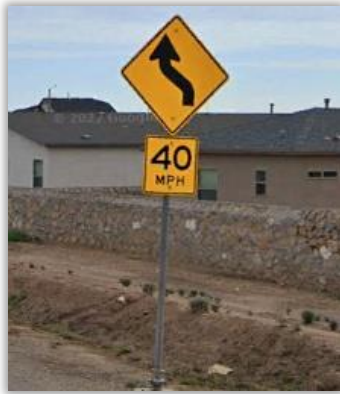
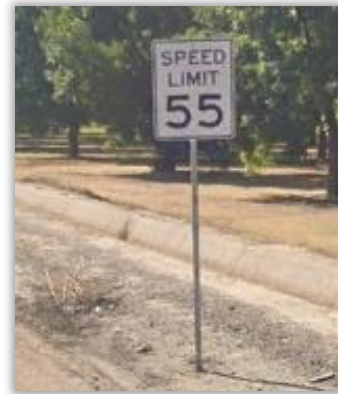
Figure 13: Signages along FM 76 (North Loop Dr)

Signs and markings are observed throughout the corridor. At few locations, the markings were not clearly visible, and signposts were slanted.

Route marker signs, speed limit signs, curve ahead signs, with speed restrictions at curves are observed along the corridor. Stop signs are observed at all the stop-controlled intersections and chevron marking signs are observed at the curve locations. Speed limit signs were observed at sections with a change in speed. **Figure 13** shows the views of signage along the corridor.

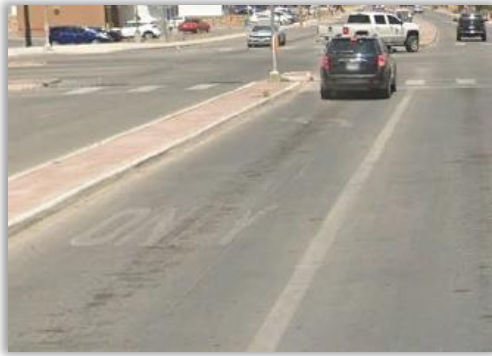
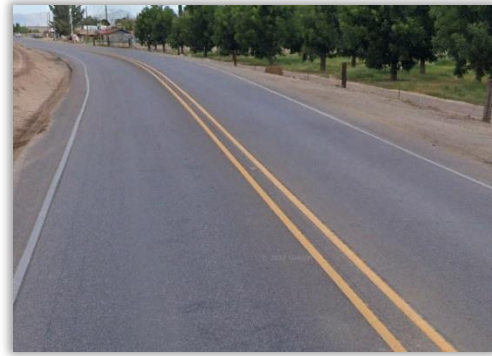
Figure 14: Striping along FM 76 (North Loop Dr)

Pavement marking at the center of the roadway is visible throughout the corridor, along with edge lines, although at some locations, the marking is faded. The center line marking is demarcated for zones of no-passing with a double yellow solid line and a one-sided yellow line at several locations. The intersections are also clearly marked with stop lines, pedestrian crossings, and yield, with arrows and left turn only markings. The dedicated turn lanes were also marked with proper arrow signs at all the required locations. Restriping of markings is required for clear visibility to the road users on both the corridor and connecting roads. **Figure 14** shows the views of striping along the corridor.

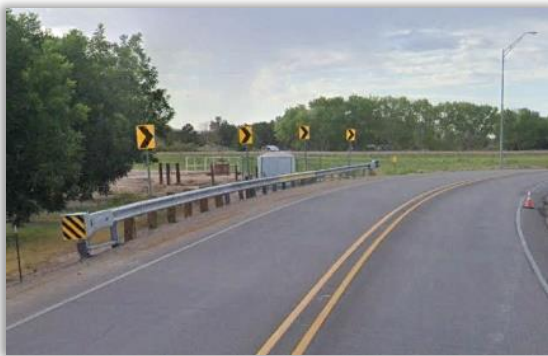
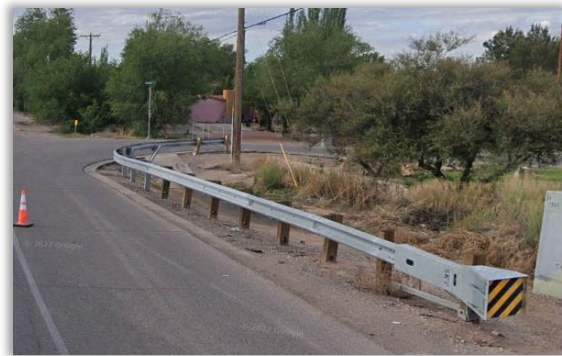
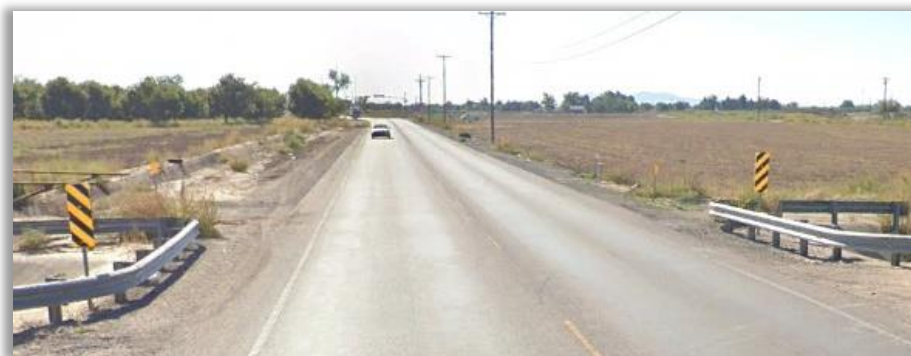
Figure 15: Safety Features along FM 76 (North Loop Dr)

Guardrails were observed at a couple of locations where embankment slopes were high, or at curve locations and canal crossing locations. Safety features along FM 76 (North Loop Dr) are shown in Figure 15.

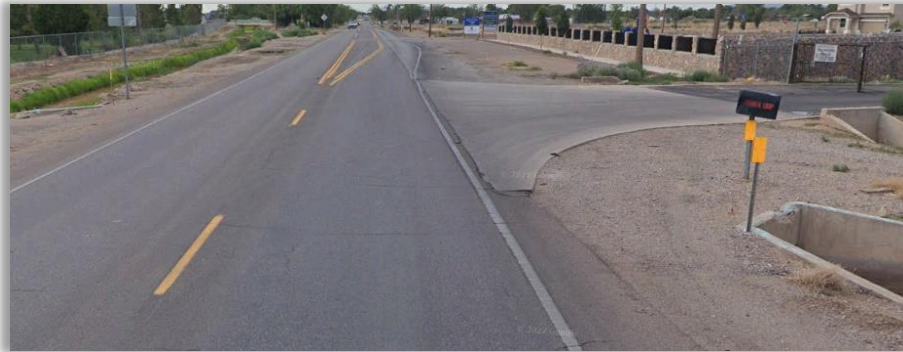
Socorro Fire Department Entrance near Bauman Rd

Figure 16: Missing Safety Features along FM 76 (North Loop Dr)

Additional safety features are required at all the locations where parapet walls/barriers are missing at canal crossings, and at locations where the canal is abutting the corridor. Typical locations where safety features are missing are shown in **Figure 16**.

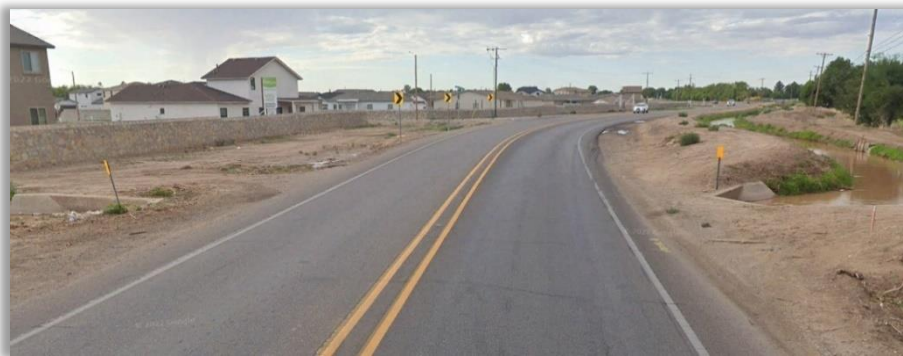
Canal crossing near Carr Rd

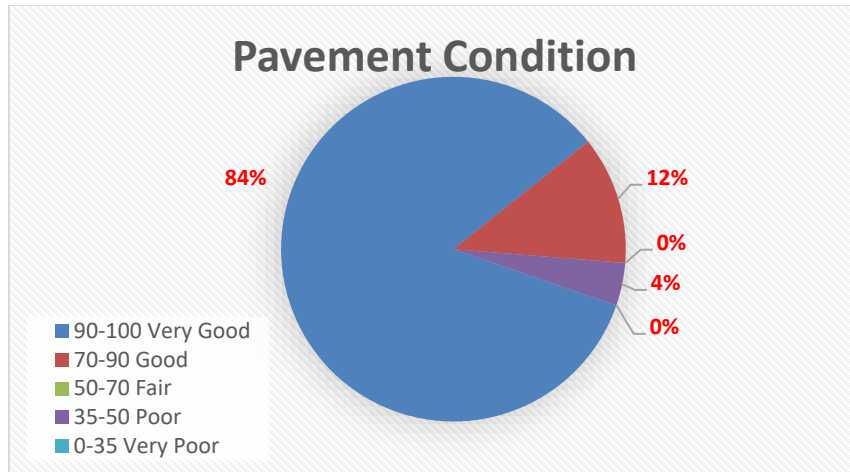
Figure 17: Pavement Condition Scores

Evaluation of TxDOT Pavement Management Information System (PMIS) data for 2022 shows that the existing pavement condition of FM 76 (North Loop Dr) between Horizon Blvd and Fabens is in good to very good condition, as 84% of the pavement has a score between 90 and 100, 12% of the pavement has a score of 70 to 90, and 4% of the pavement has a poor condition score between 35 and 50. The section that is characterized as “good” is located close to FM 1110 (Clint-San Elizario), while the section characterized as “poor” is observed in the Fabens area. Drainage issues and poor shoulder conditions were observed where the canal runs abutting the corridor. The canal banks at some locations slopes towards the existing road, causing localized water pockets along the shoulders. The pavement condition chart is shown in **Figure 17**.
