# Historic Bridge Adoption Information Packet

Bexar County

Old Seguin Rd at Salado Creek

May 6, 2019

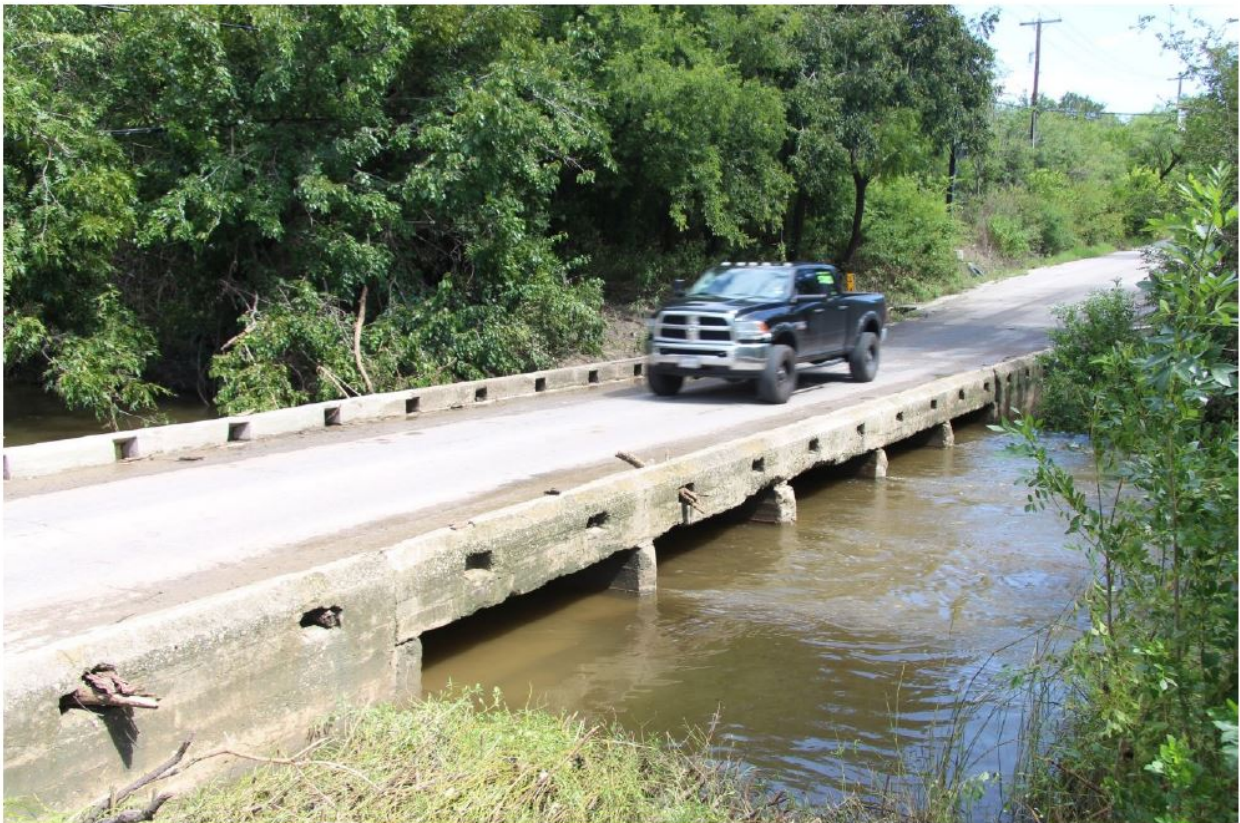
View facing north, showing narrow bridge width in relation to crossing vehicle.

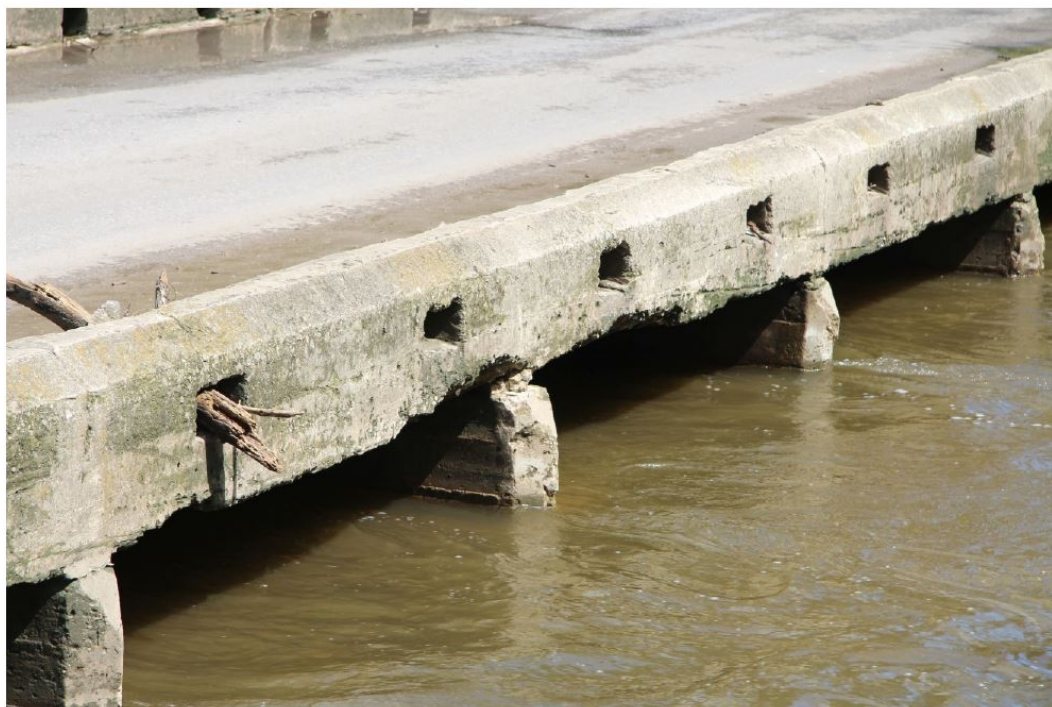
**Concrete deterioration:** The bottom slab, abutments and intermediate walls, and headwalls/wingwalls all exhibit deterioration or initial disintegration. Conditions include moderate scaling, cracking, and spalling, with exposed reinforcing steel evident in some locations. In some cases, the spalling has exposed reinforcing steel. The top slab exhibits moderate to major deterioration, with moderate scaling, spalling,

View facing north, showing concrete deterioration on southeast railing, headwall, and culvert barrels.
