Geologic Assessment

Regulated Entity Name: IH-10 Scenic Loop Road to Fair Oaks Parkway

GEOLOGY NARRATIVE

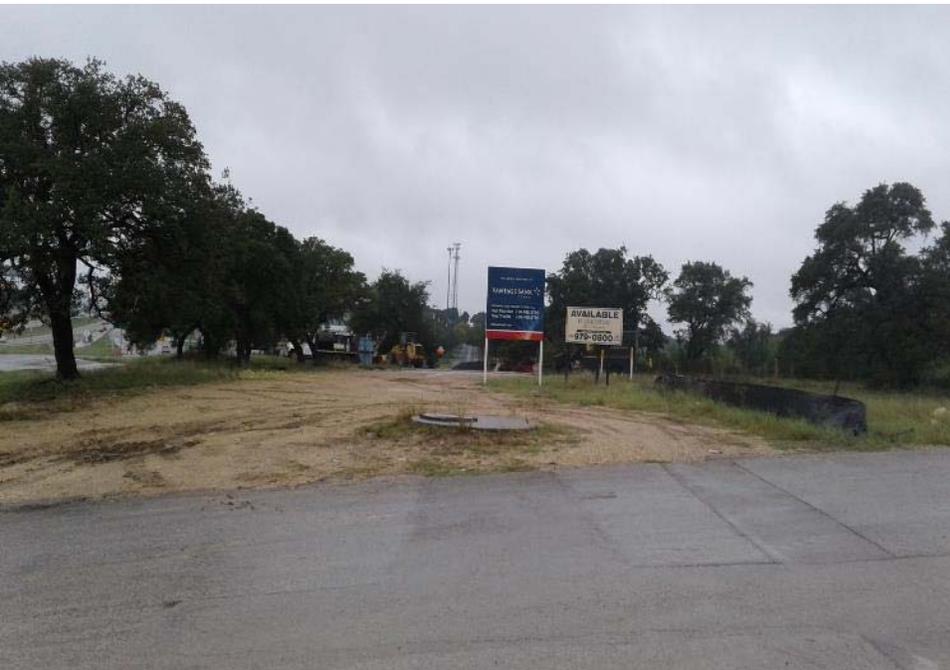
Location

Photograph 4. View facing northwest at driveway to CVS on the northside of IH-10. A sewer manhole is evident near the driveway and Old Fredericksburg Road is visible in the background (S-1).

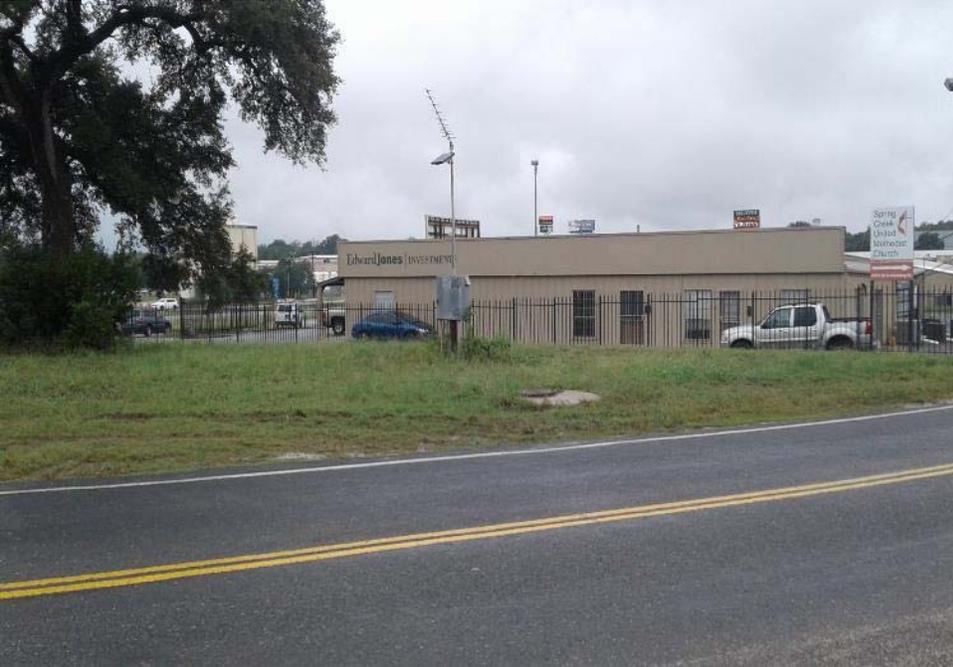
Location

Photograph 5. View facing southwest on Old Fredericksburg towards sewer manhole, utility pole, and strip mall evident in the background (S-2).

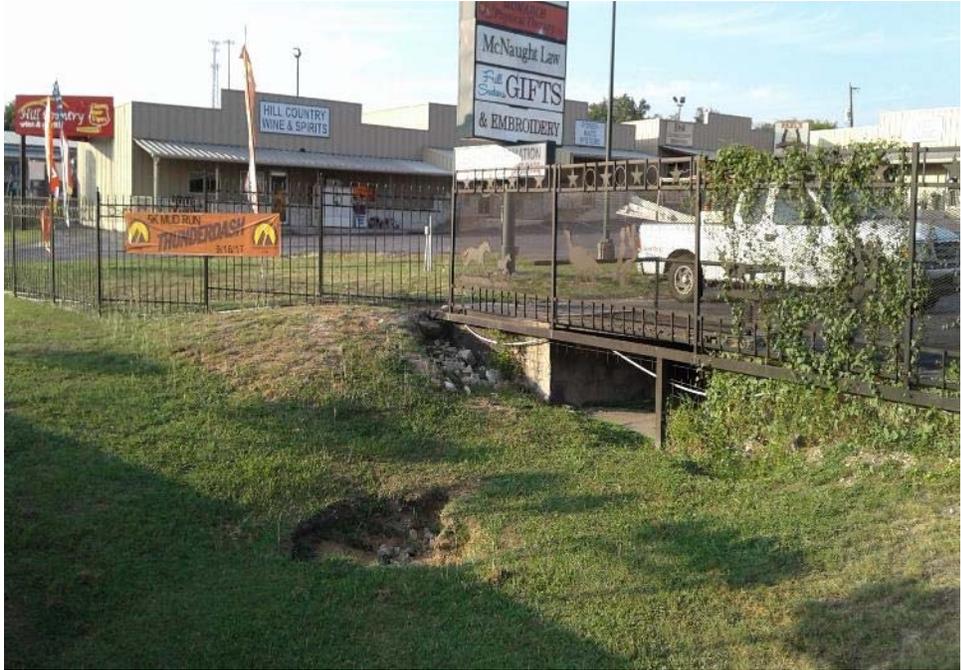
Location

Photograph 8. View facing northwest showing a culvert and associated scour within the ROW along the Frontage Road of the west bound lane of IH-10 (S-3).

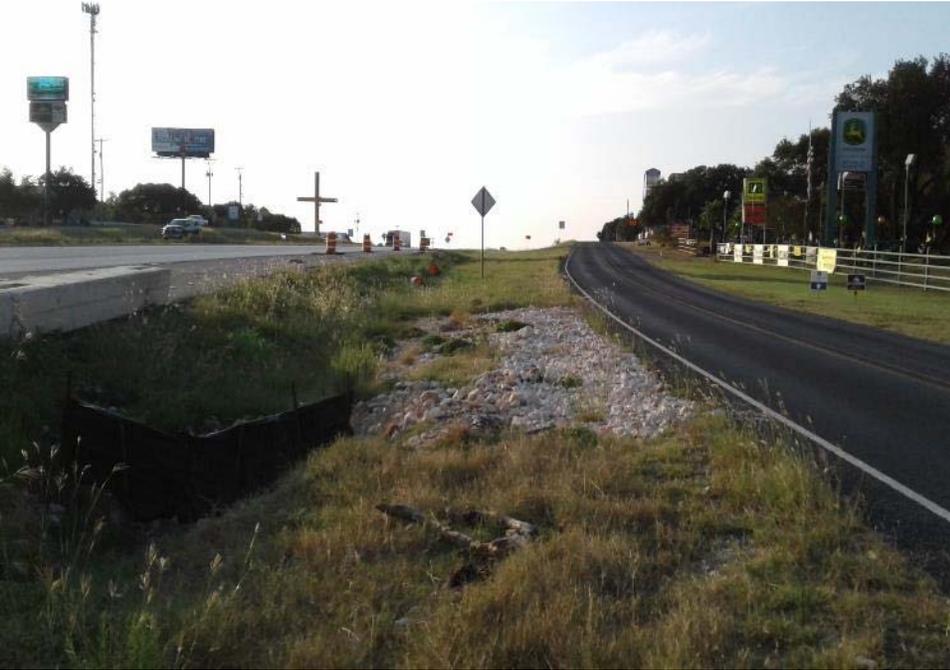
Location

Photograph 9. View of a BMP utilized between the Frontage Road and west bound lanes of IH-10 west of Fair Oaks Pkwy (S-4).

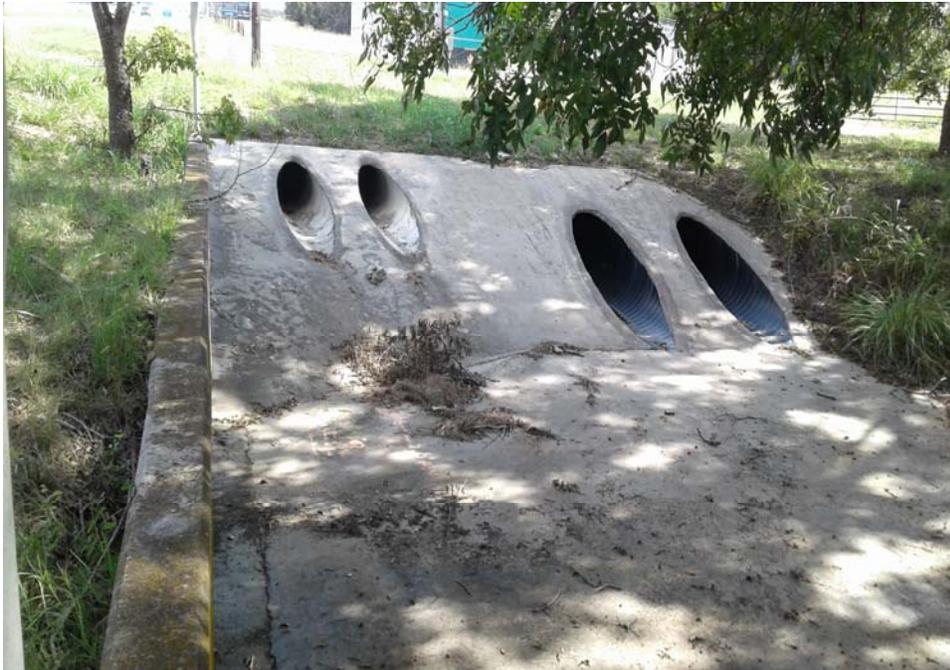
Location

Photograph 19. View facing southeast of culvert (S-5) located in the ROW west of the east bound lane of IH-10 and Frontage Road.

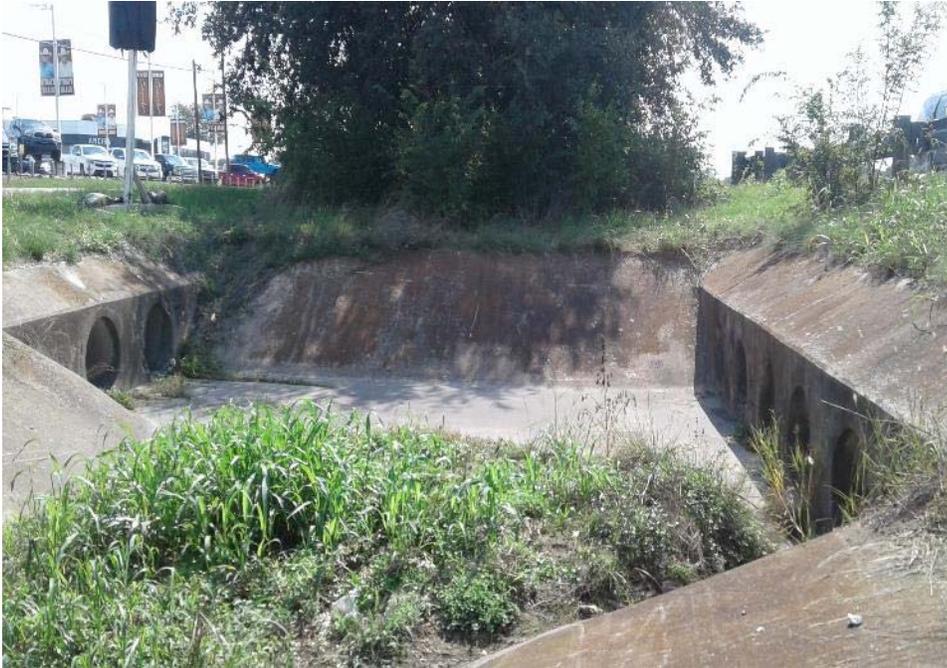
Location

Photograph 3. View facing southeast showing a boxed culvert within the ROW (S-6). A commercial business is in the background.

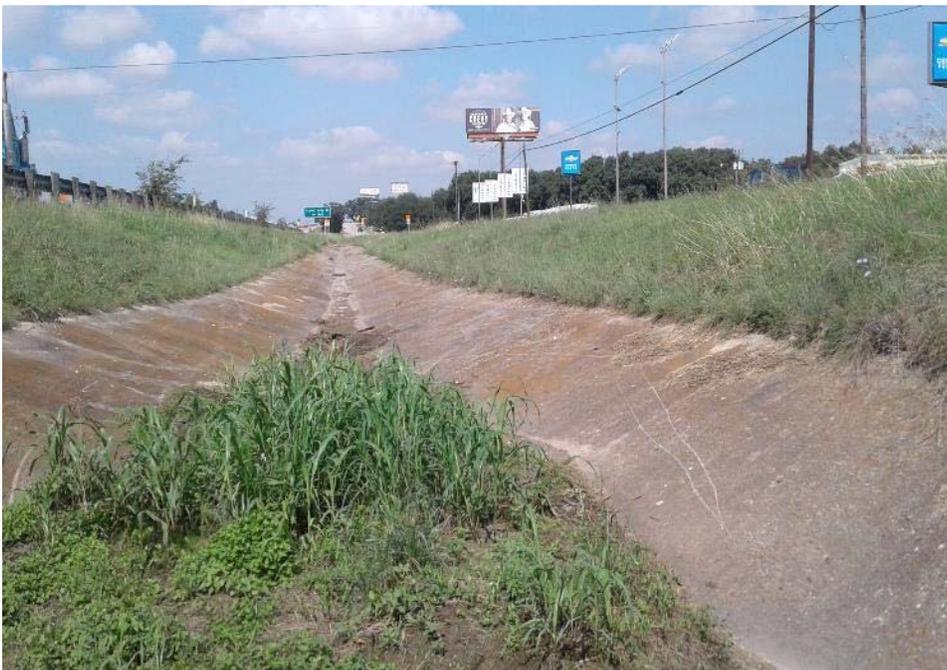
Location

Photograph 4. View facing northwest of cement drainage associated with the boxed culvert (S-6; photograph 3). Businesses and utilities present in the background.
