Draft Historic Resources  
Survey Report  
for the Oak Hill Parkway Project

U.S. Highway 290 (US 290) / State Highway (SH)  
71 West from State Loop 1 (Mopac) to  
Ranch-to-Market (RM) 1826 and SH 71 to  
Silvermine Drive  
Travis County, Texas  
CSJ # 0113-08-060 and 0700-03-077  
October 2017

# Report for Historical Studies Survey

CSJs 0113-08-060 and 0700-03-077;  
Oak Hill Parkway Project: US 290 from  
Loop 1 (Mopac) to RM 1826 and SH  
71 from US 290 to Silvermine Drive  
Travis County, Austin District

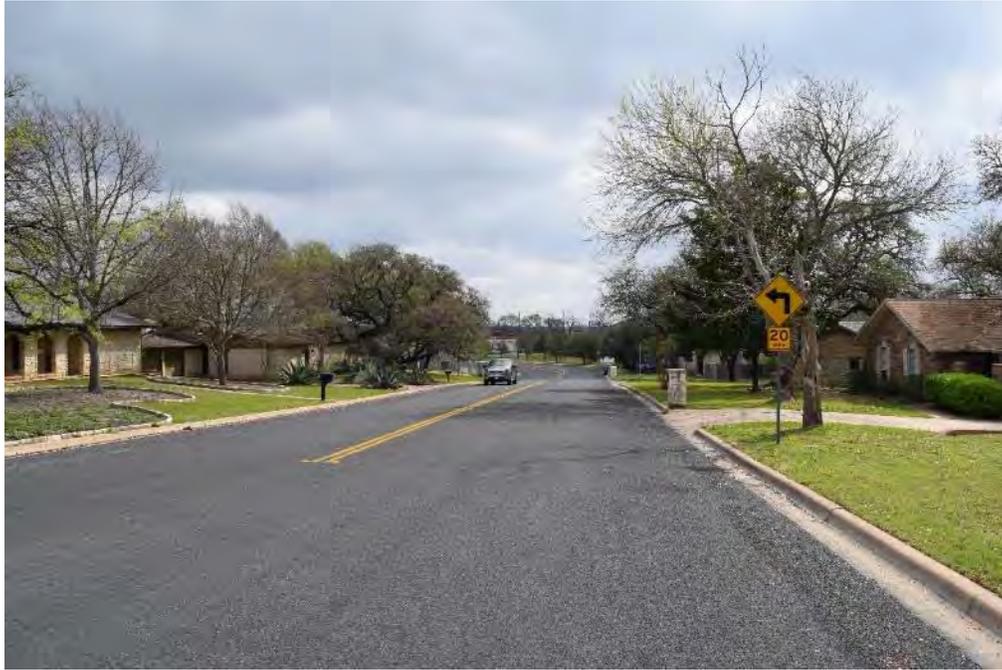
Photo 1: Scenic Brook Drive showing width of street and uniform setbacks; view facing east.

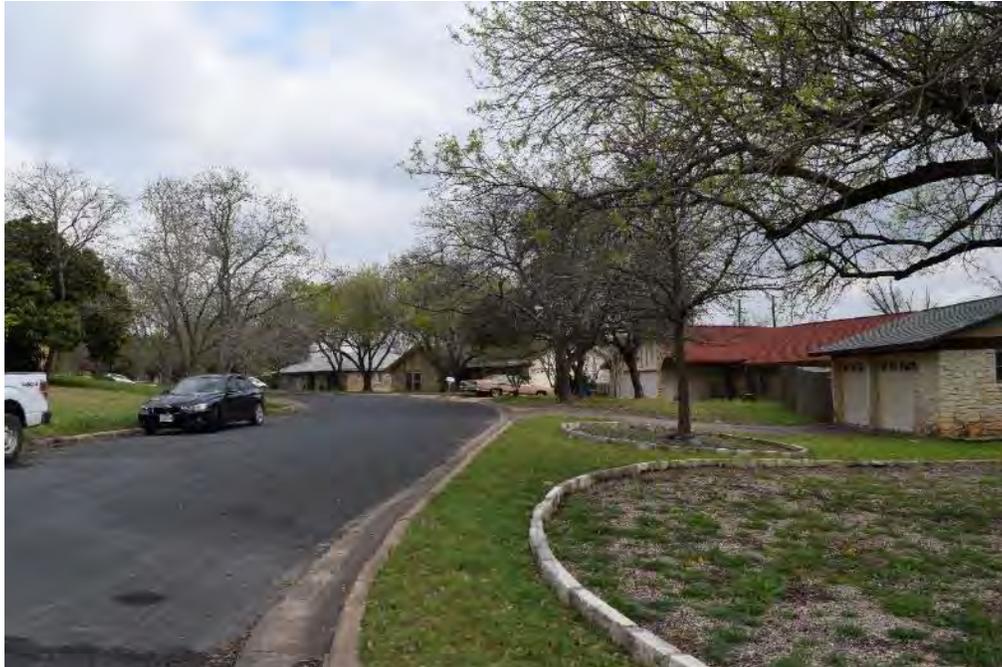
Photo 2: Grove Crest Drive at Scenic Brook Drive; view facing north.

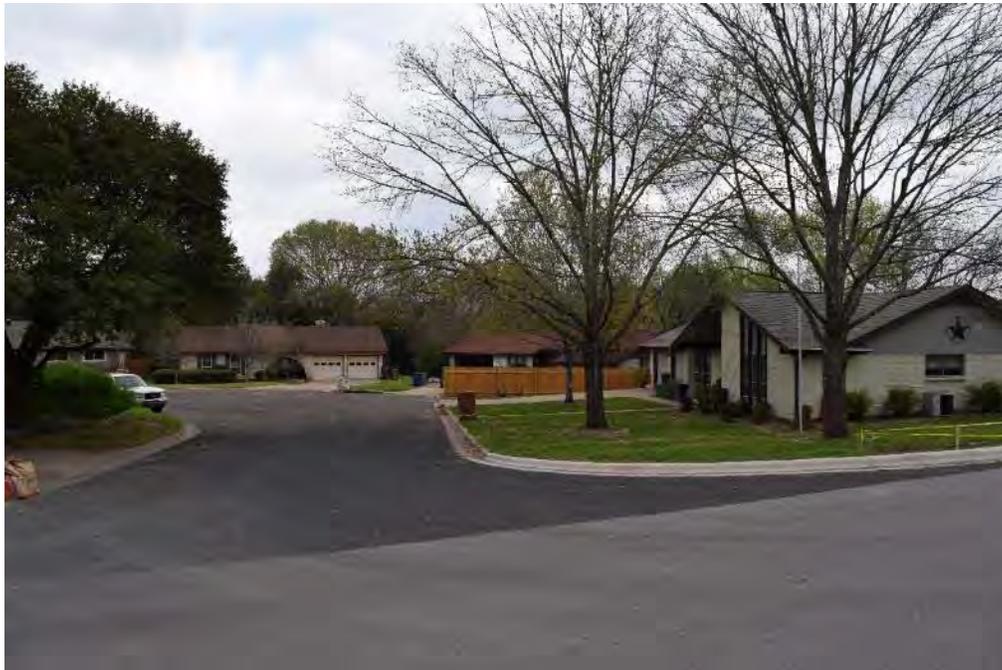
Photo 3: Silver Dale Circle (cul-de-sac) and Oak Meadow Circle; view facing north.

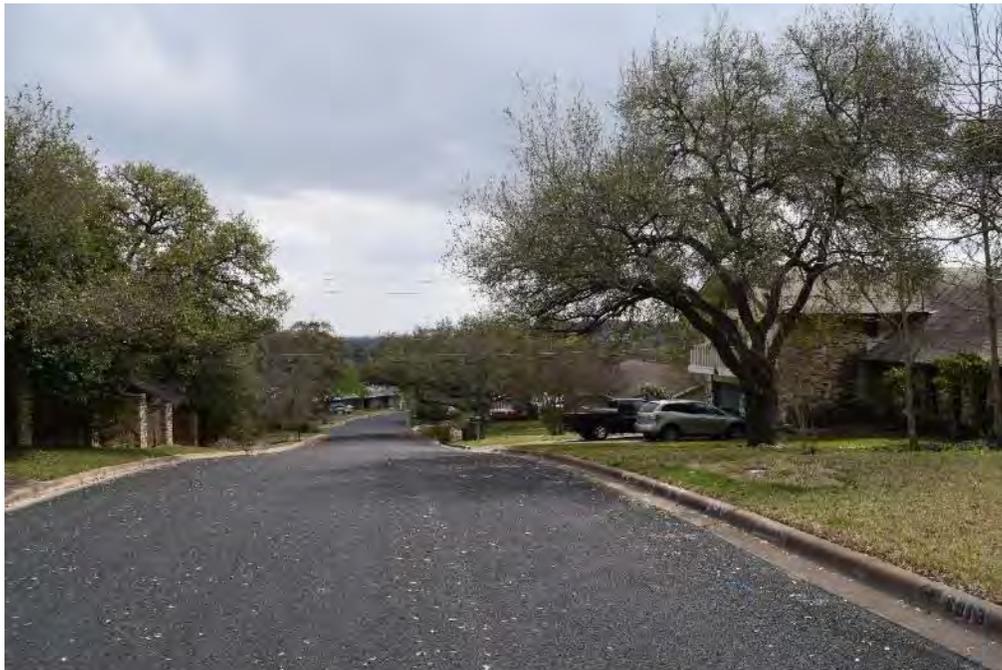
Photo 4: View of Grove Crest Drive near Dawn Hill Circle; view facing east.

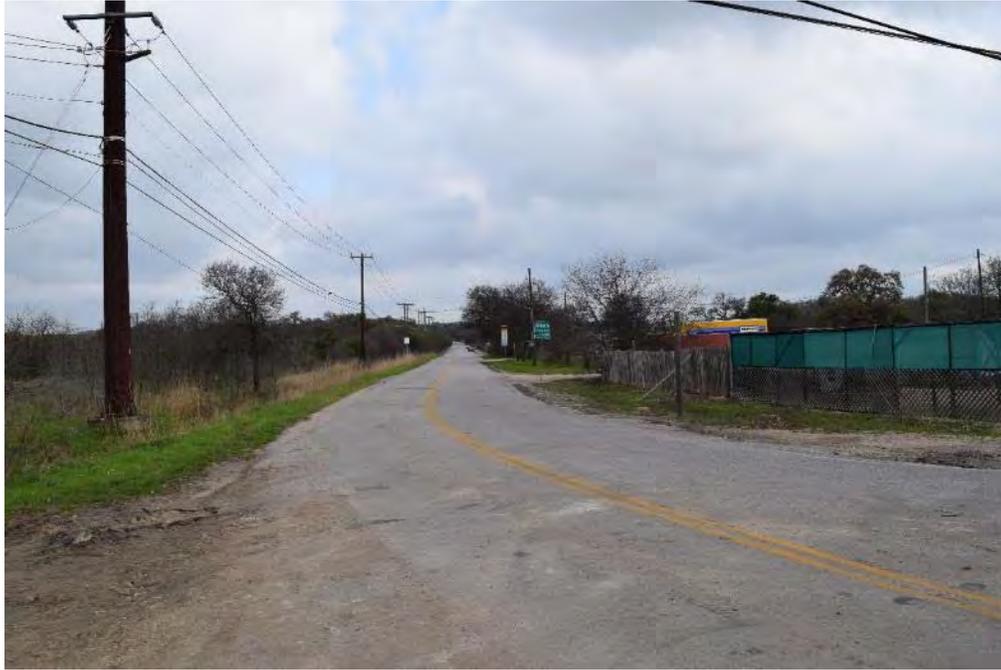
Photo 5: View from corner of U.S. 290 and Patton Ranch Road toward Resources 33a-c, which are not visible from the proposed project area; view facing north.

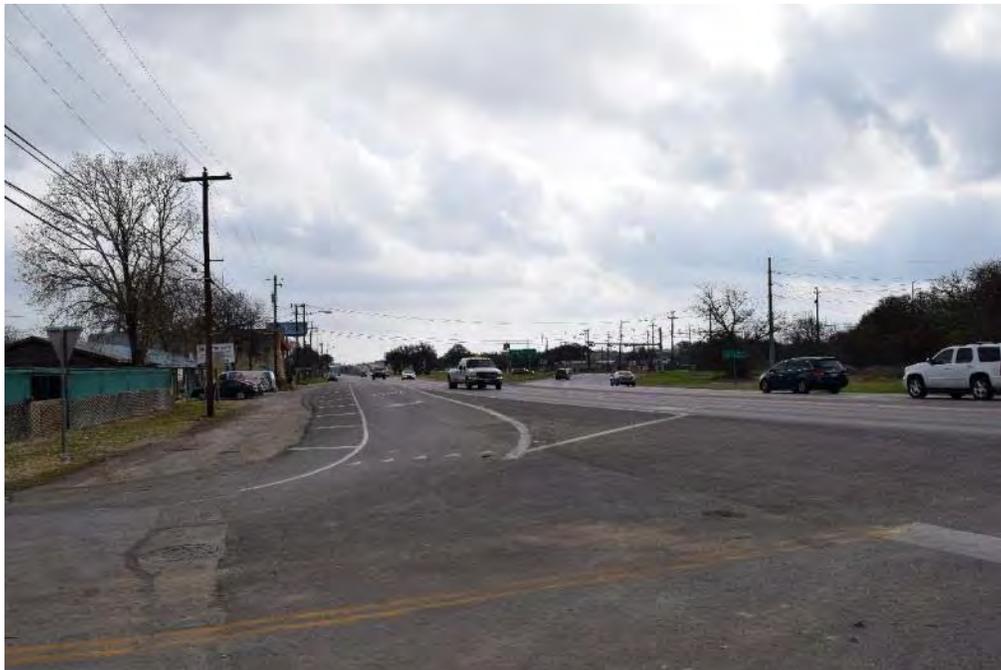
Photo 6: View from corner of U.S. 290 and Patton Ranch Road toward Resource 35a (left side of photo); view facing east.

CMEC historians considered indirect visual effects for Resources 35a, 36a, and 37a individually and as a historic district, in accordance with TxDOT’s *Standard Operating Procedure for Visual Impacts Assessment*. See Photos 6 to 13 in the General Photographs section and Figures 4a and 4b. The setting and feeling of Resources 35a, 36a, and 37a, individually and as a historic district of late nineteenth and early twentieth century buildings reflecting Oak Hill’s earliest periods, has been substantially altered over time due to the development of the project area in the second half of the twentieth century. The proposed project would not introduce any new elements to the landscape. Potential visual impacts are for Resources 35a, 36a, and 37a, and the historic district are discussed for Alternative A, followed by Alternative C.

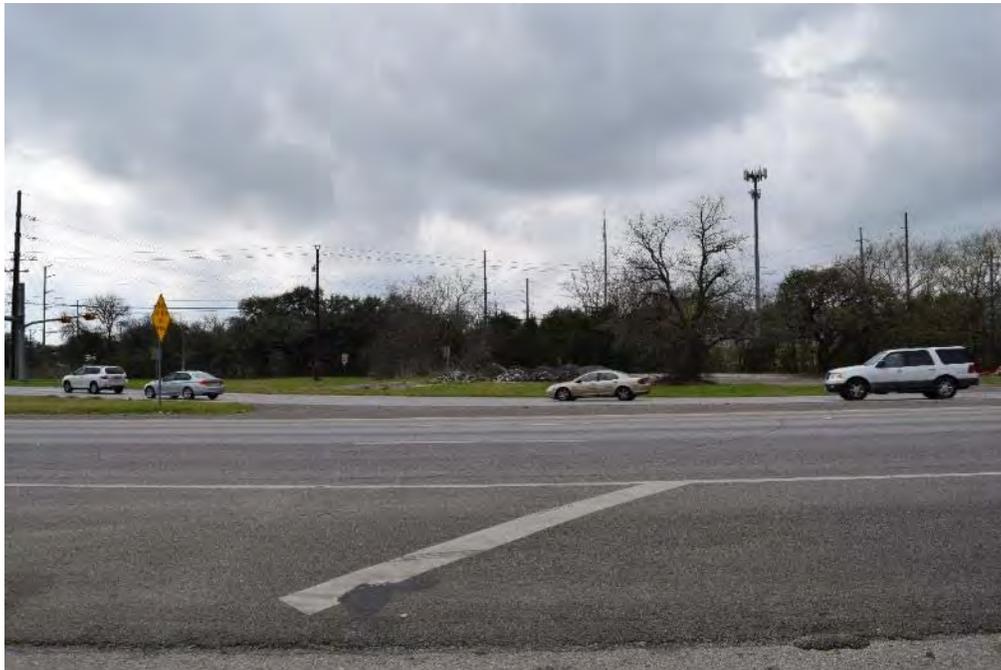
Photo 7: Viewshed from Resource 35a; view facing south.

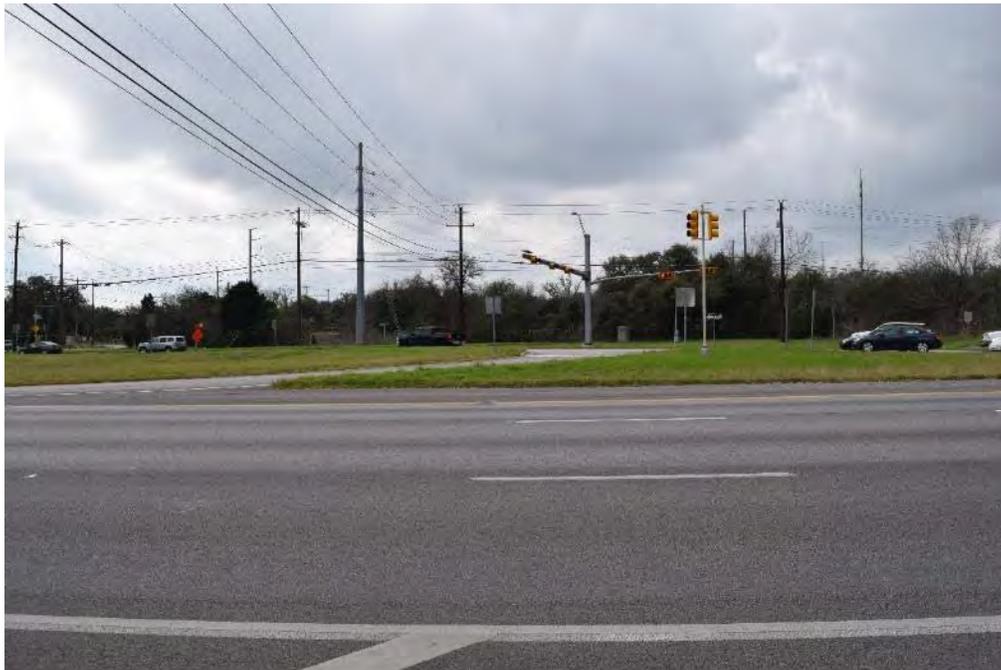
Photo 8: Viewshed from Resource 36a; view facing south.

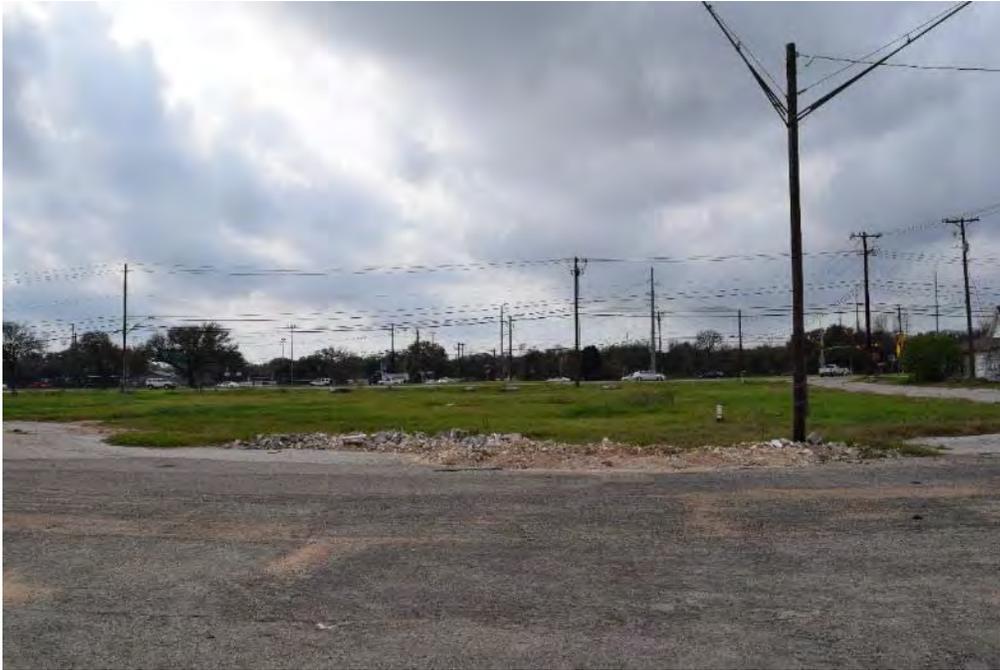
Photo 9: Viewshed from Resource 37a toward U.S. 290; view facing south.

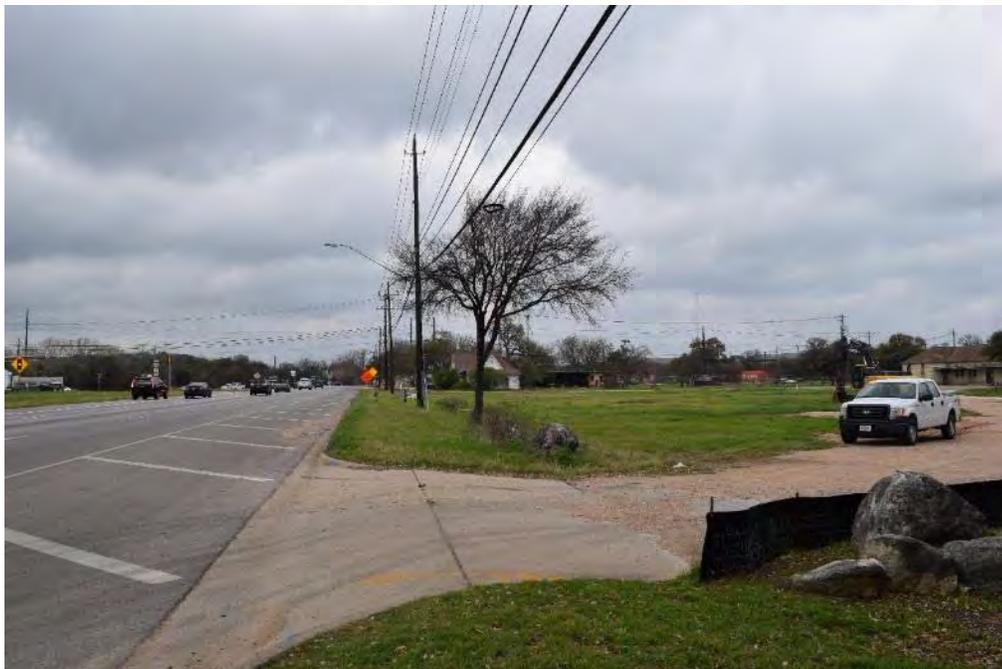
Photo 10: View along U.S. 290 from southeast corner of parcel associated with Resource 37a (visible at right edge of photo), showing distance of setback from roadway; Resource 36a visible at center of photo; view facing west.

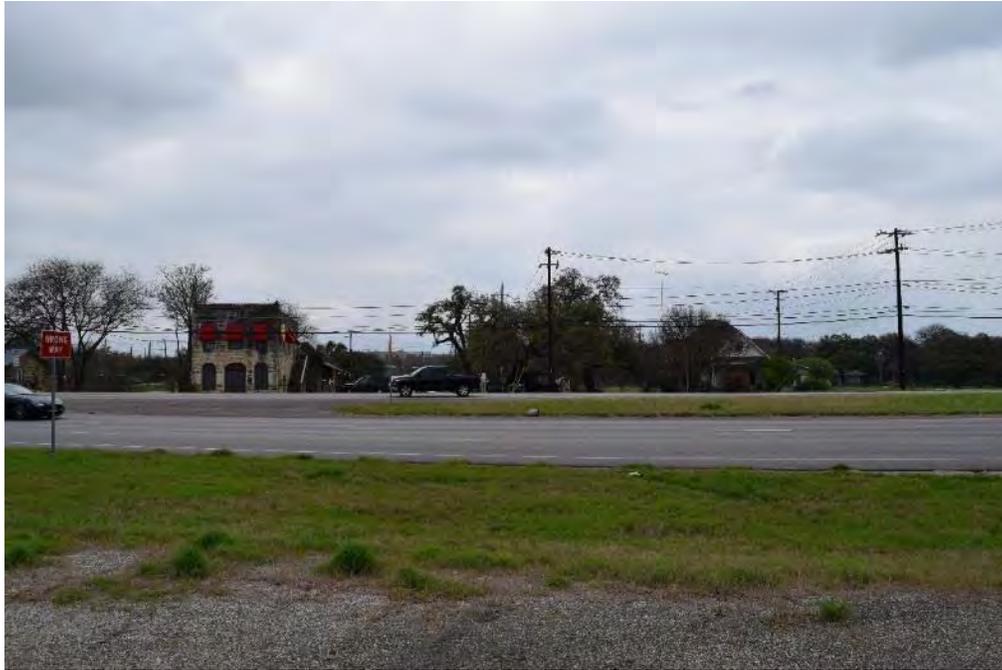
Photo 11: Viewshed toward Resources 35a and 36a from south side of U.S. 290; view facing north.

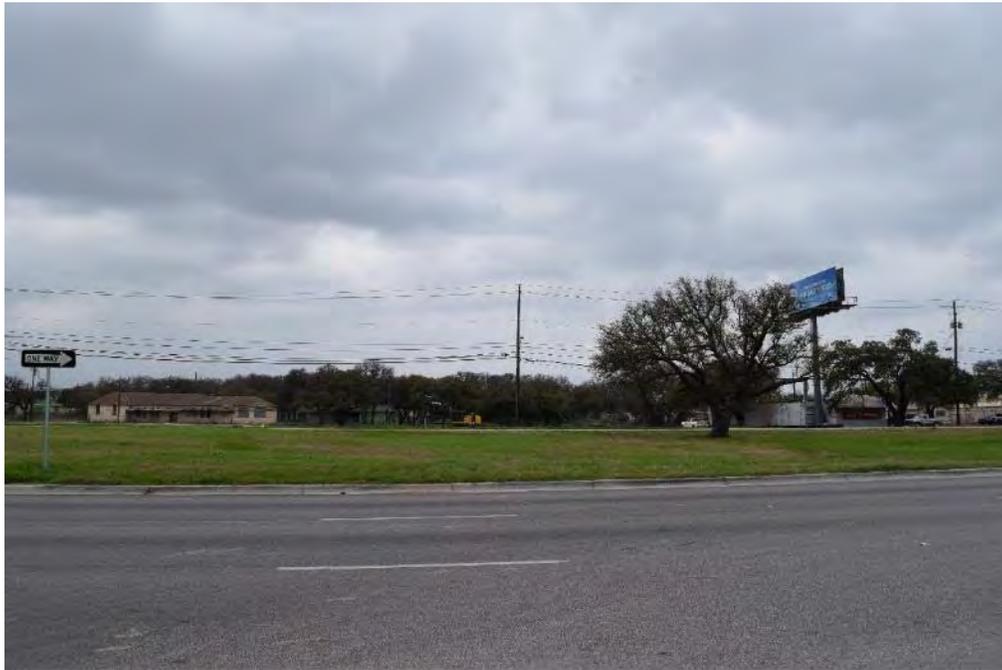
Photo 12: Viewshed toward Resources 37a and 37b from south side of U.S. 290; view facing north.

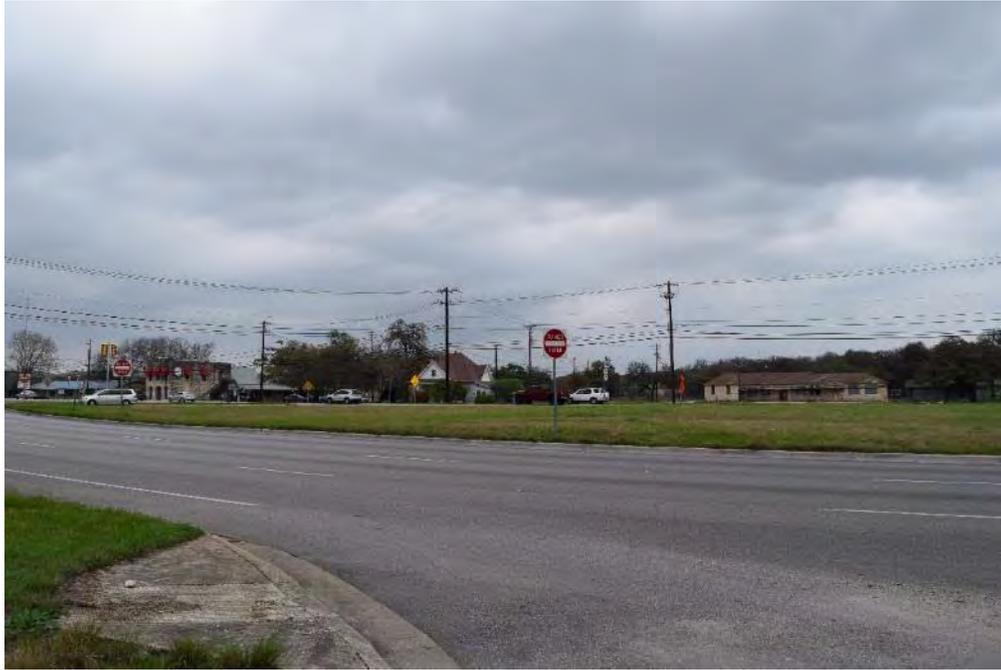
Photo 13: Overview of viewshed toward Resources 35 to 37 from south side of U.S. 290; view facing north.

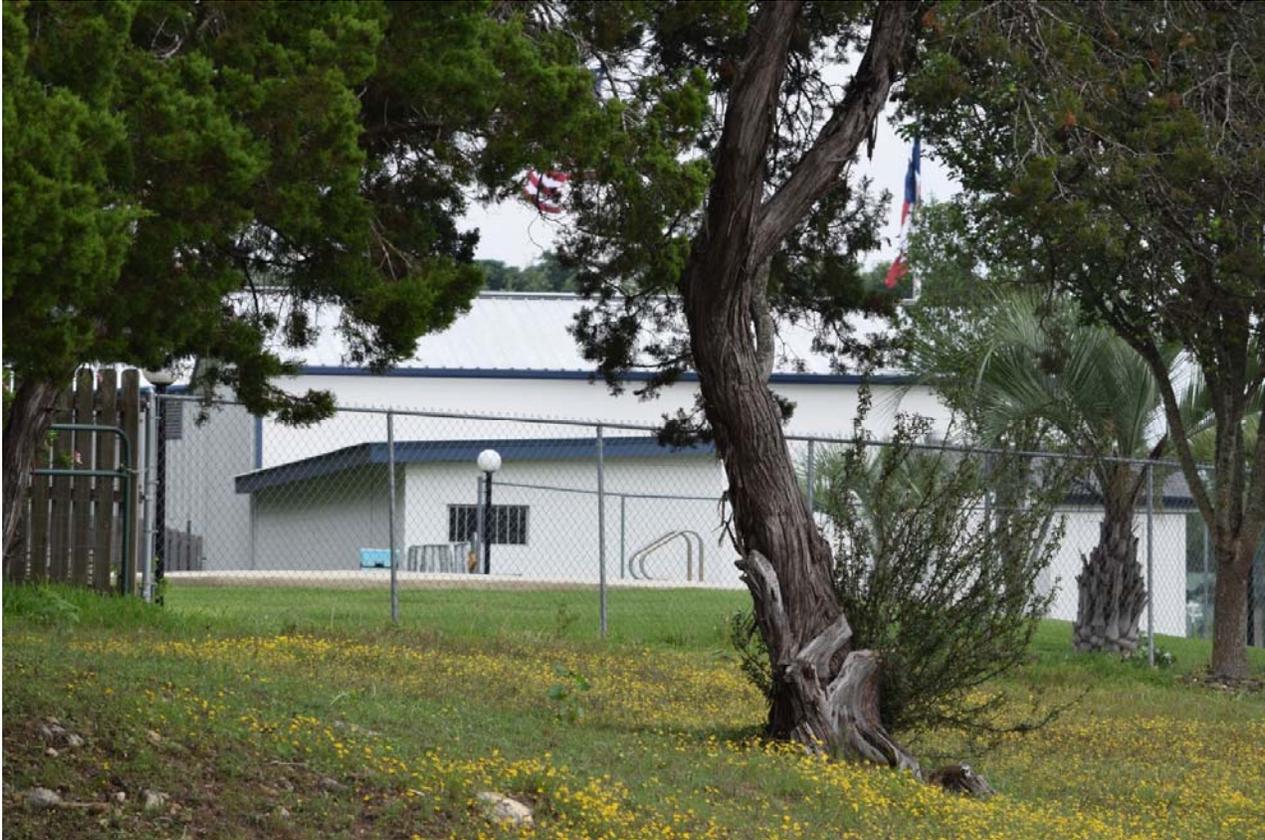
View facing southwest.

**NRHP Justification:** This resource is a non-historic-age secondary building on the same parcel as historic-age resources. The resource is less than 50 years old and was not found to possess exceptional significance under Criterion Consideration G. As a result, it is recommended not eligible for the NRHP under Criterion A, B, C, or D.

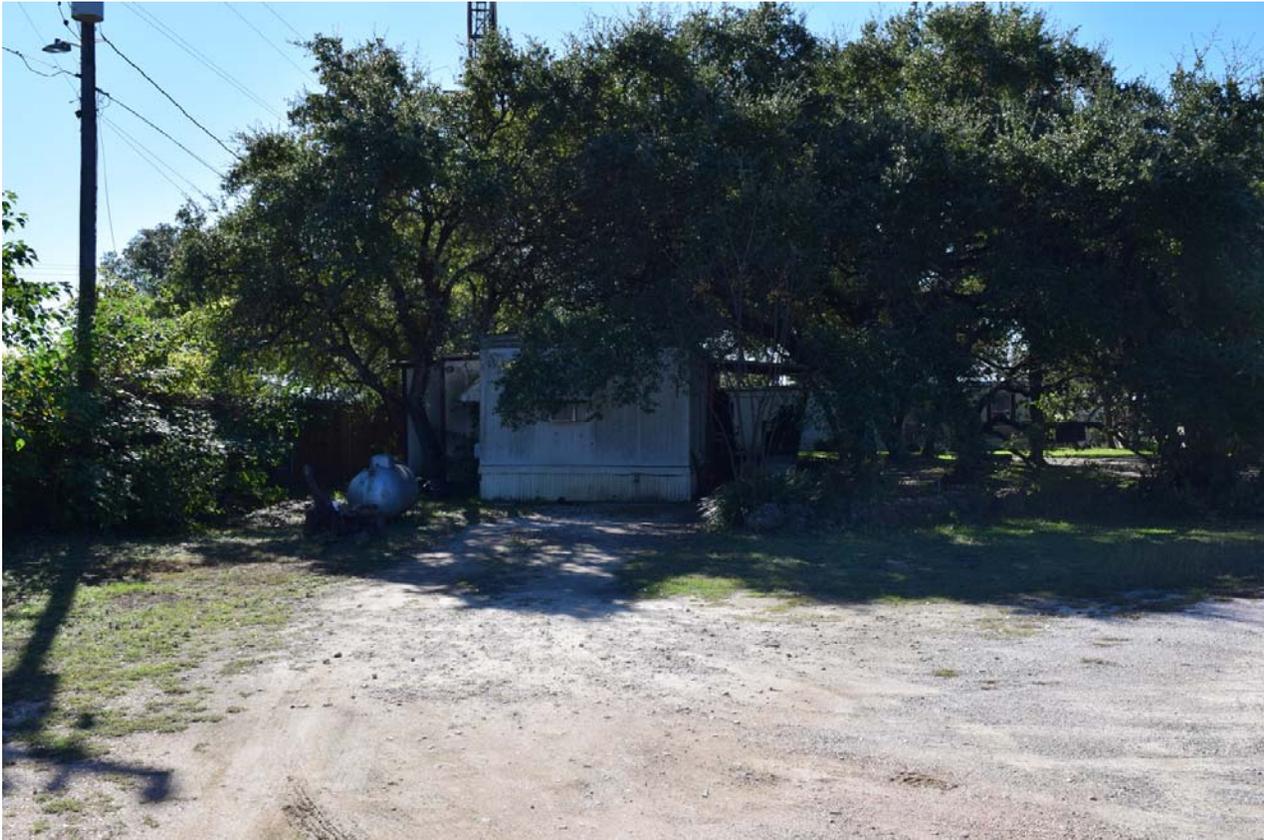
Northern elevation; view facing south  
 Photo 1 date taken: 11/15/2016

**Description:** This is a one-story mobile home with a side-gabled roof. It has vertical siding, metal windows, and a partial-width entry porch with a shed roof. An addition at the rear gives the building an irregular plan. A secondary door has been enclosed and latticework has been added to the porch.

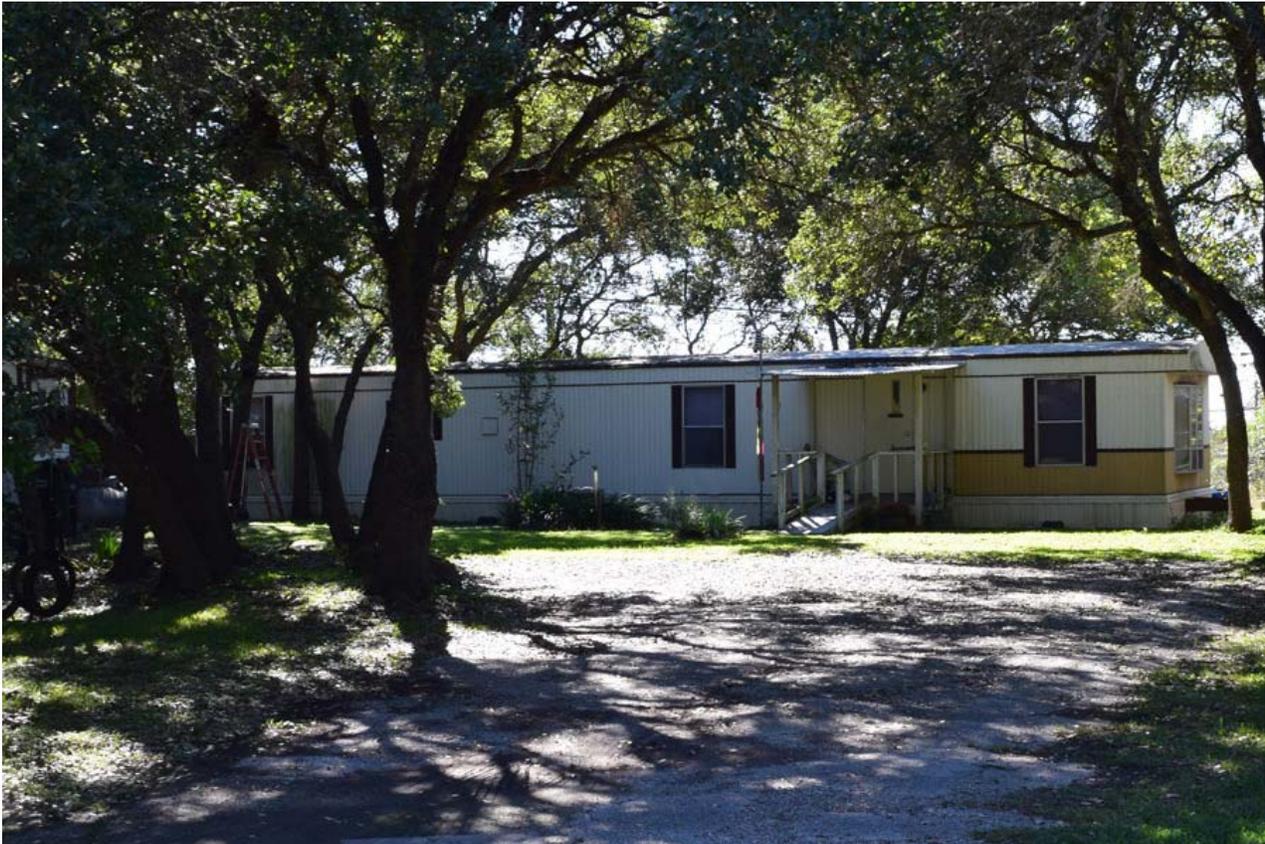
Primary elevation; view facing south  
 Photo 1 date taken: 11/15/2016

**NRHP Justification:** This resource is a non-historic-age building on the same parcel as an historic-age resource. The resource is less than 50 years old and was not found to possess exceptional significance under Criterion Consideration G. As a result, it is recommended not eligible for the NRHP under Criterion A, B, C, or D.

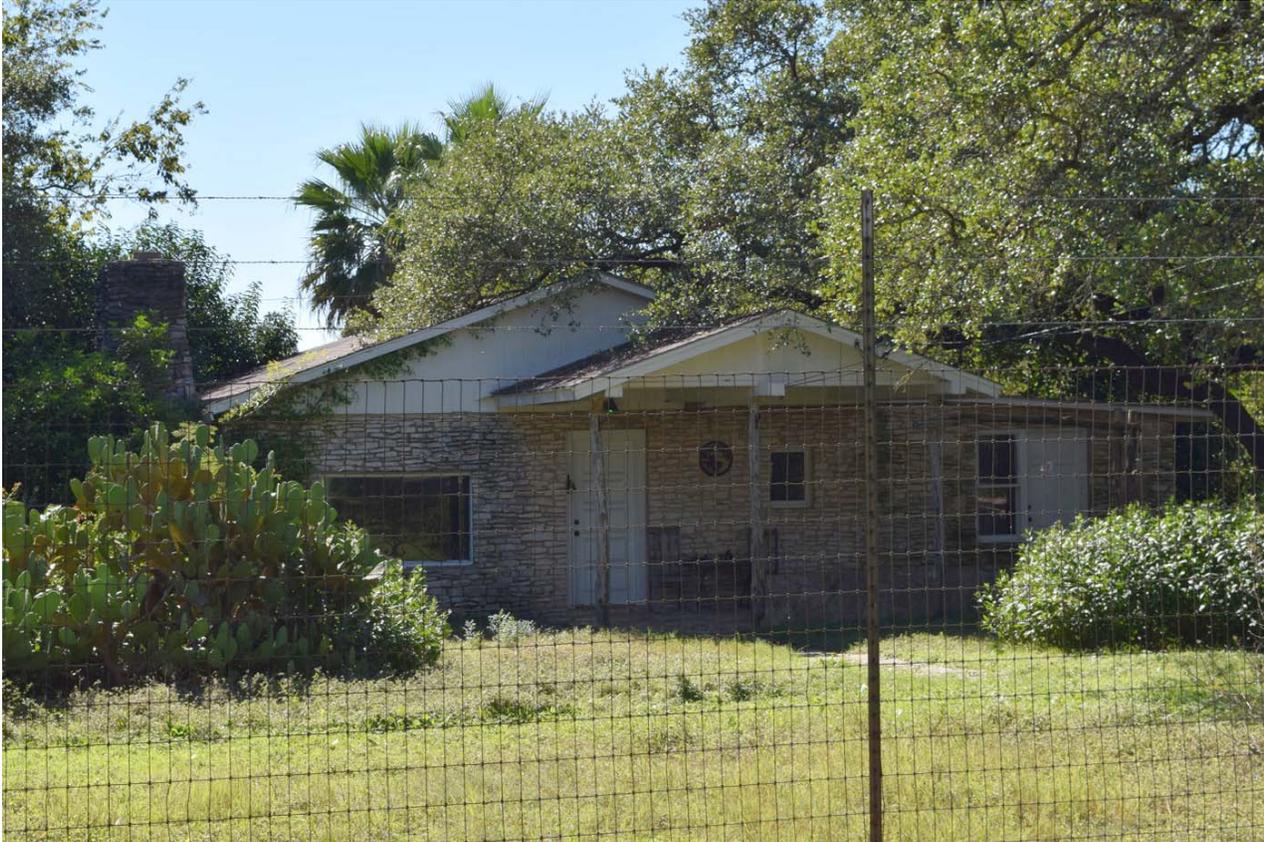
Primary elevation; view facing southwest

**Description:** This is a one-story, Ranch style, single-family home. It has a front-gabled roof with a shed roof volume on the western elevation, which appears to be an early addition. The cladding is stacked stone with vertical wood board in the gables. It has a single front door below a partial-width, projecting porch with a front-gabled roof with exposed purlins. There is a secondary door within the addition and an exterior stone chimney on the eastern elevation. Non-historic age alterations include: windows replaced, porch supports replaced, and low wall added to porch. In c.1990 an aviary operation was developed on this parcel, however, it appears this building was always residential in use.

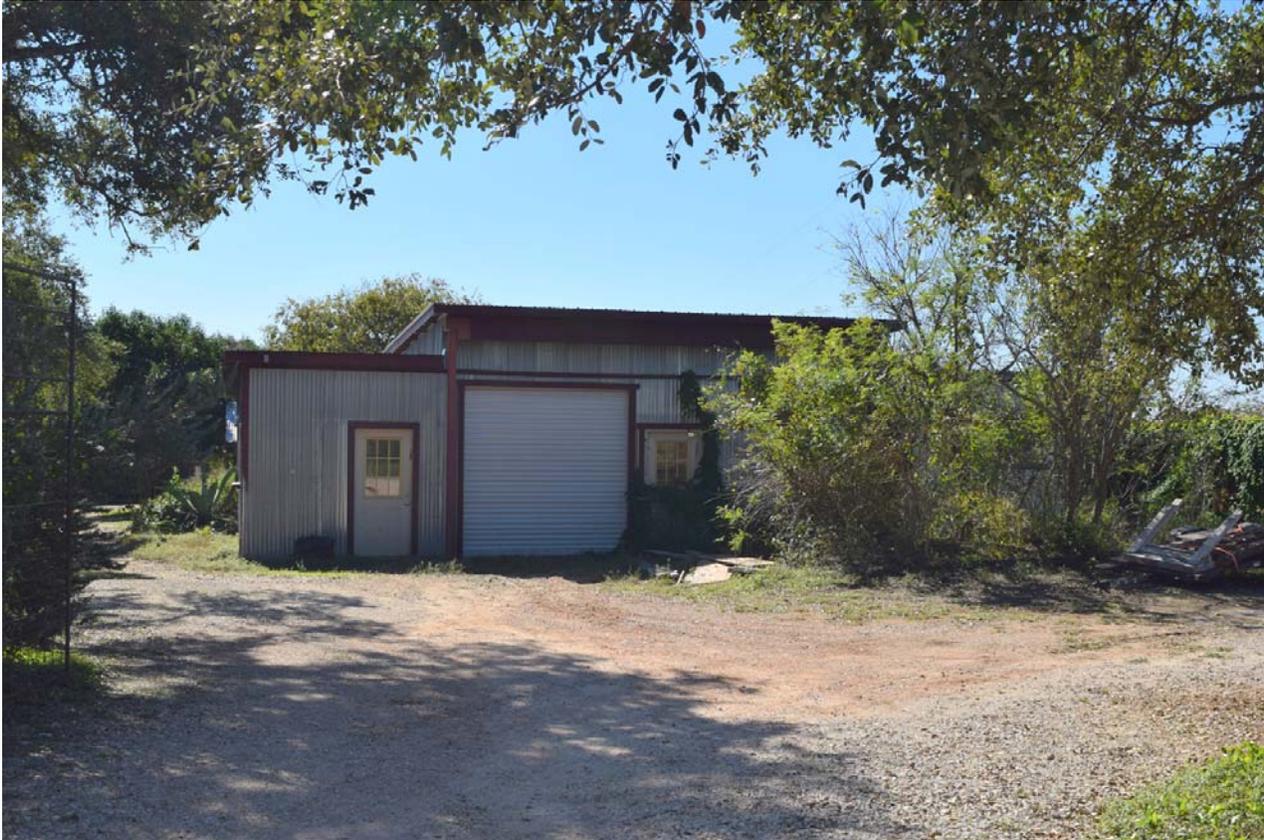
Primary elevation; view facing southwest  
 Photo 1 date taken: 11/15/2016

**NRHP Justification:** This resource is a non-historic-age secondary building on the same parcel as historic-age resources. The resource is less than 50 years old and was not found to possess exceptional significance under Criterion Consideration G. As a result, it is recommended not eligible for the NRHP under Criterion A, B, C, or D.

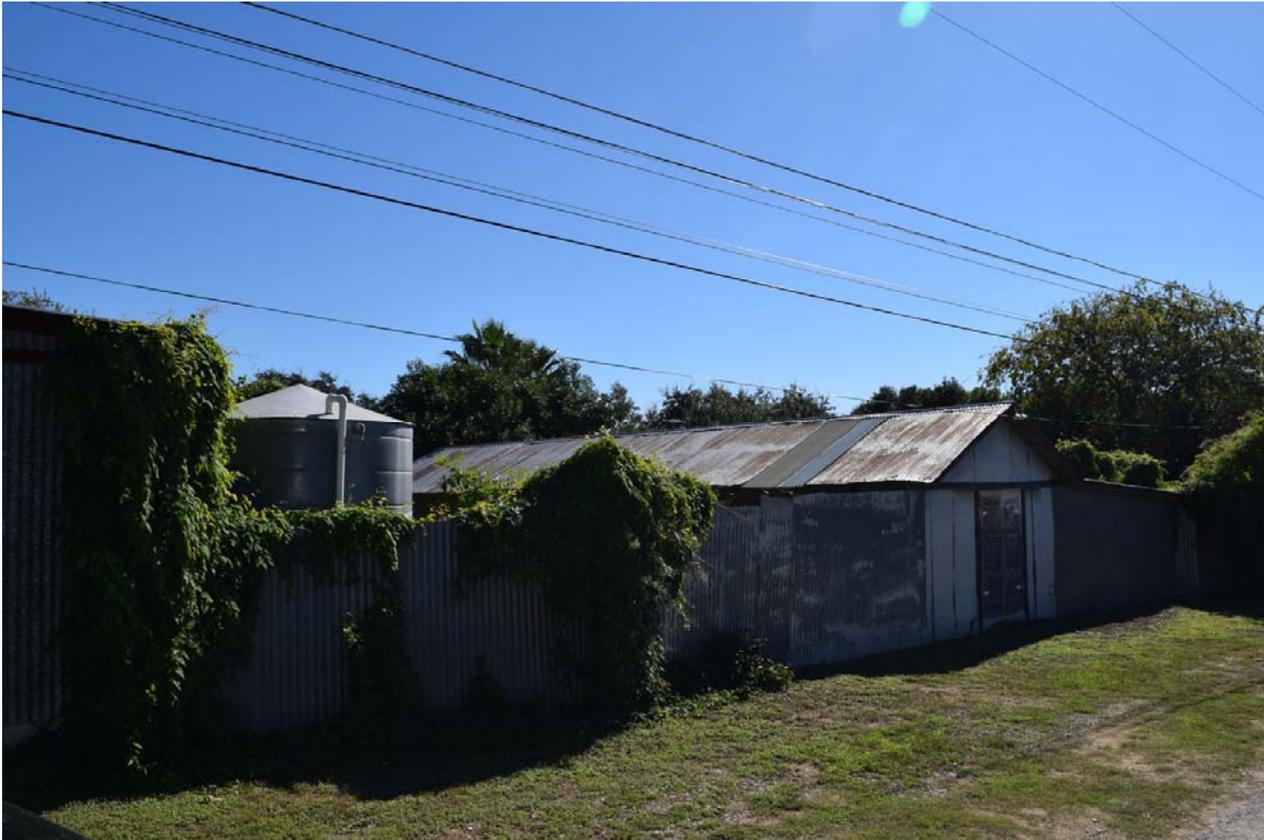
View facing southwest

**NRHP Justification:** This resource is utilitarian in nature. It was not found to embody distinctive characteristics of a type, period, or method of construction, represent the work of a master, or possess high artistic value. Additionally, no associations were identified linking it to events or persons of historic importance, and it does not have potential to reveal important information. Therefore, it is recommended not eligible for listing in the NRHP under Criterion A, B, C, or D.

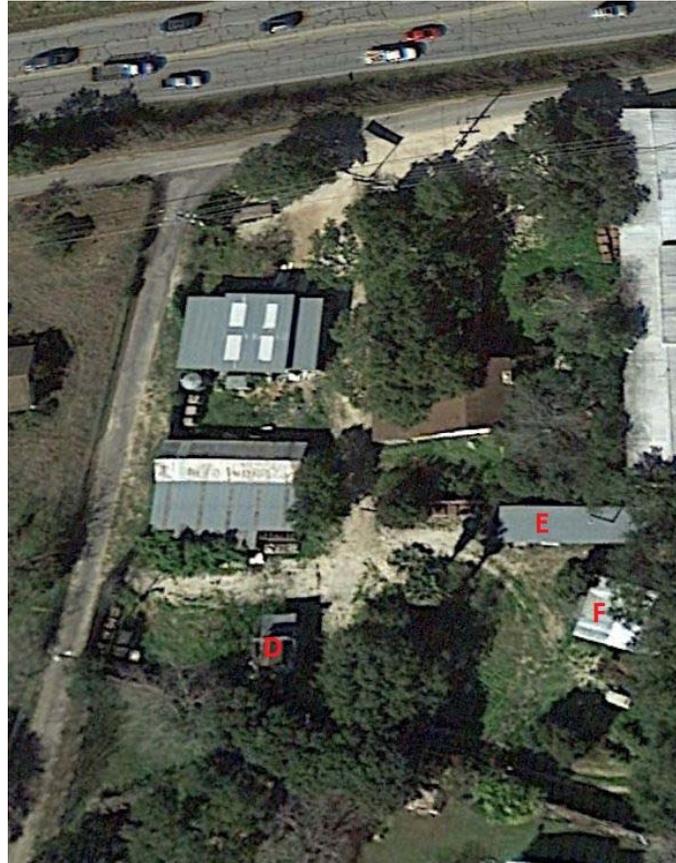
Aerial image courtesy of Google Earth. Resources D-F labeled in red are not visible from the right-of-way.  
 Photo 1 date taken: 2/3/2016 Google Earth

**Description:** Resources D-F are not visible from the right-of-way, but based on aerial imagery, they are non-historic age, utilitarian buildings associated with the former aviary which operated from c.1990 to c.2013. The buildings' current uses are unknown.

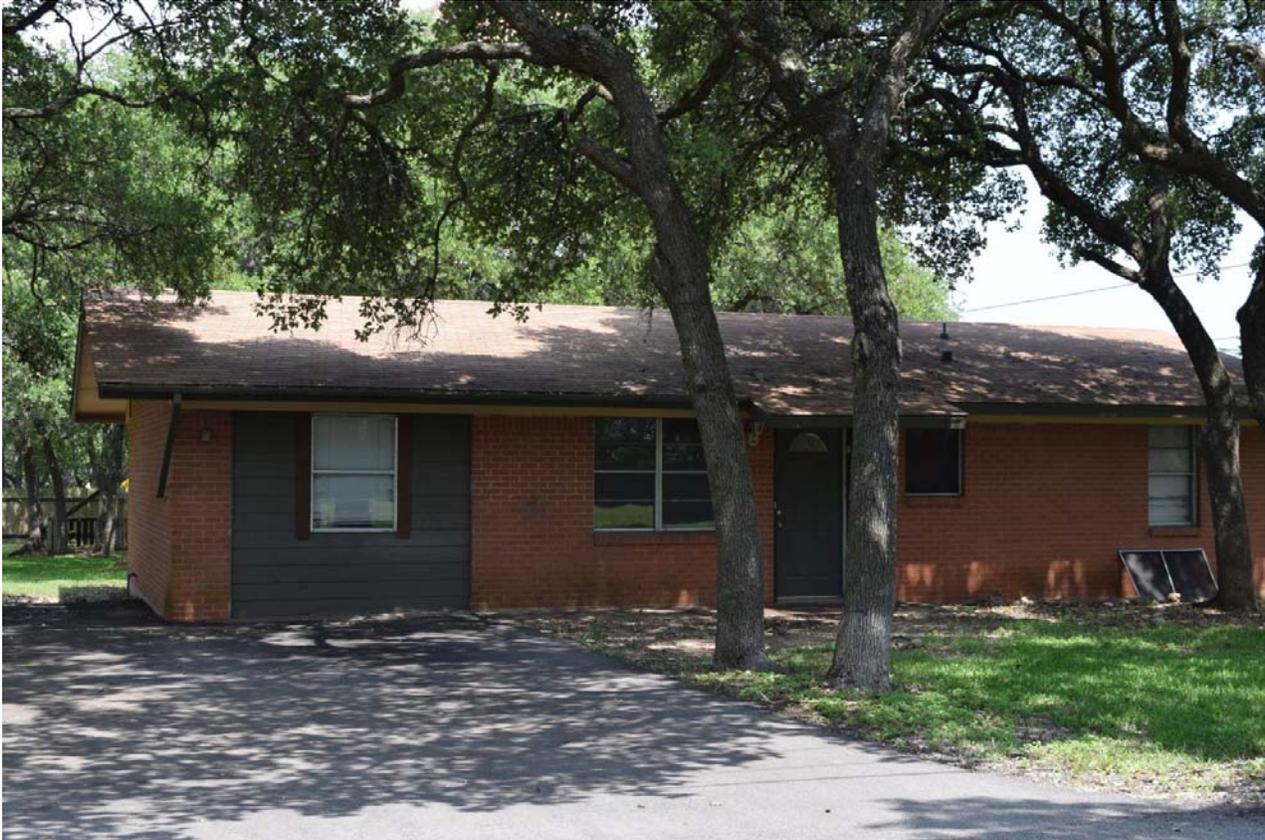
View facing east.  
 Photo 1 date taken: 5/26-28/16

**Description:** This is a one-story rectangular plan brick structure with a composition shingle gabled-roof. The windows are aluminum sashes and the former enclosed garage has been turned into a permanent conditioned space with vinyl siding and a vinyl window. The porch is inset, although the roofline extends beyond that of the rest of the house. It is supported by wood brackets and a metal support at the end of the building.

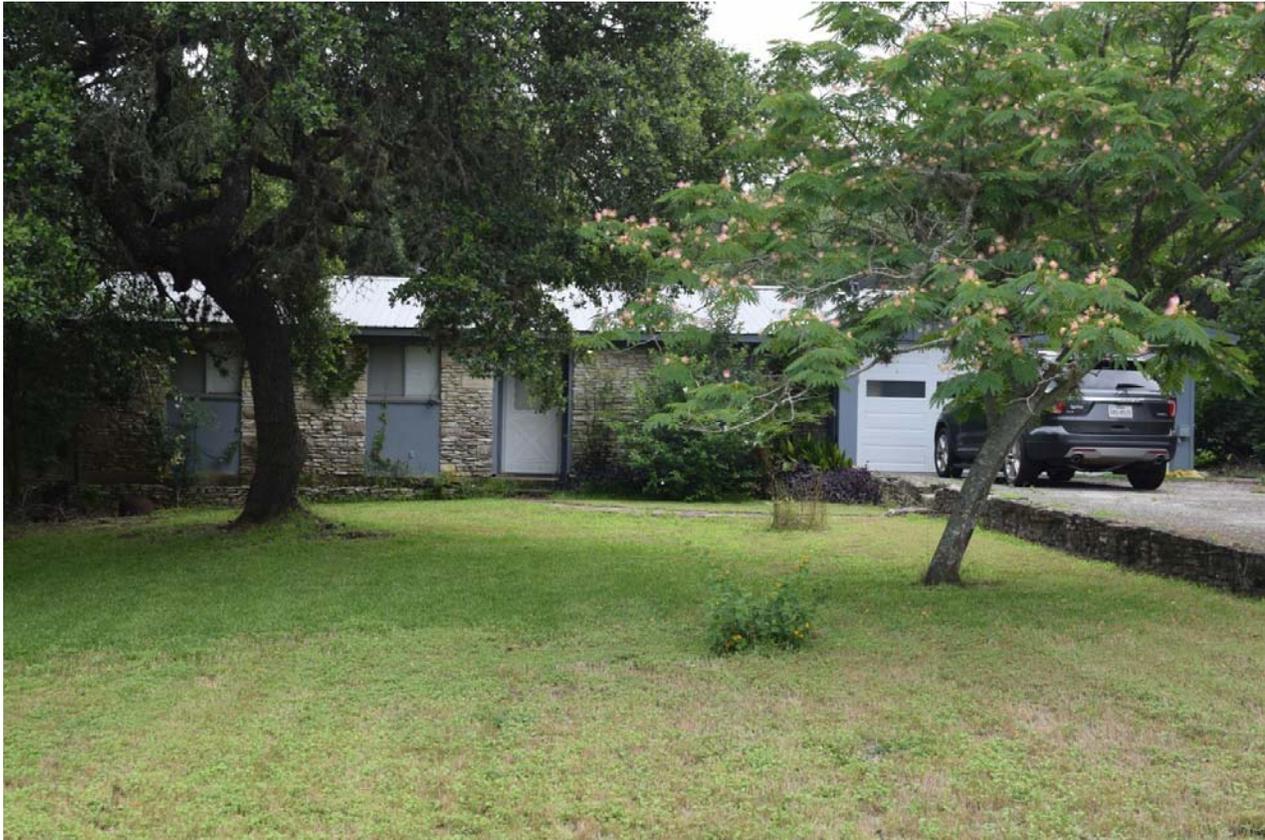
View facing south.  
 Photo 1 date taken: 5/26-28/16

**Description:** This is a one-story rectangular, Ranch style residence with stone and wood siding and a metal gabled roof. The windows are sliding metal sashes, and there is no porch over the single entry door. The house has an integrated double car garage. There is an RV parked on the east side of the property.

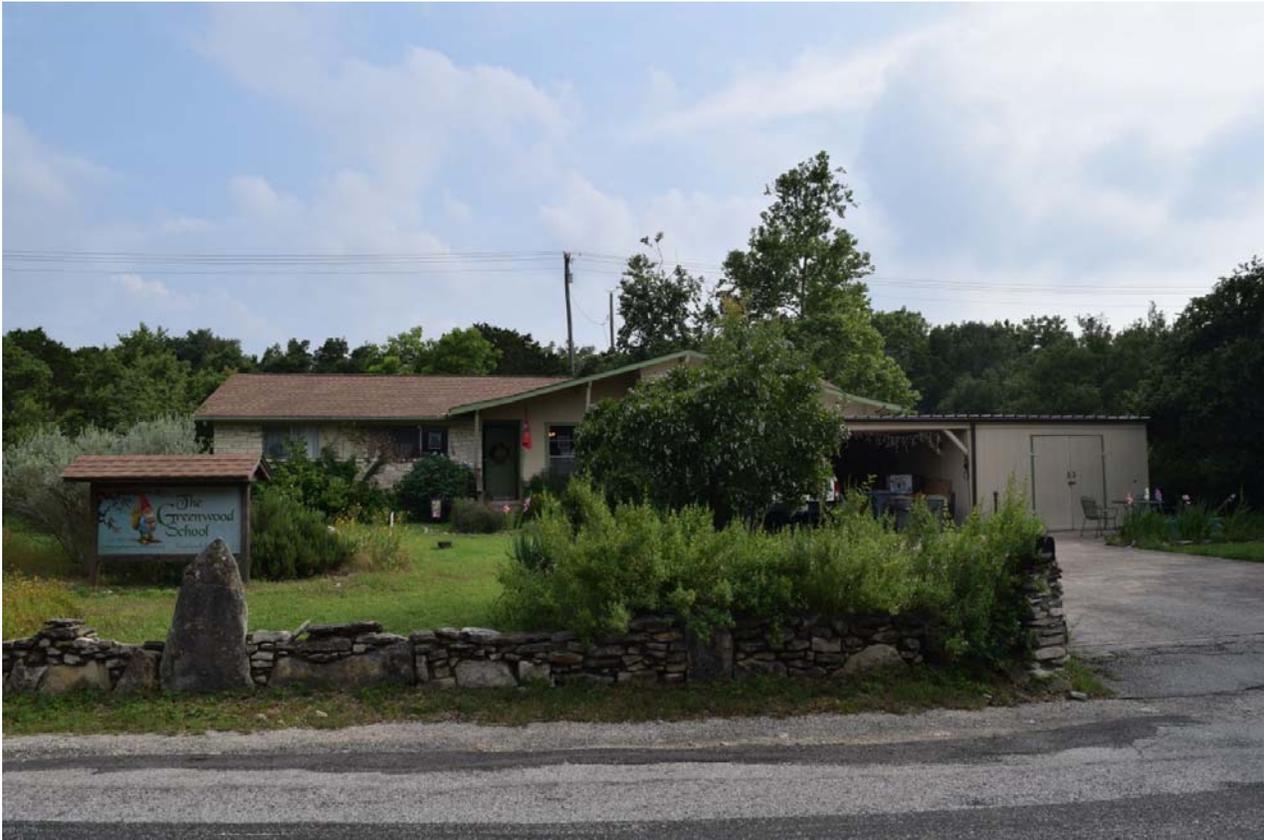
View facing south.

**Description:** This is a one-story Ranch house with stone and wood siding, and a composition shingle gable roof. The building has metal and vinyl windows. The porch is inset and has wooden supports. The garage has been converted to permanent conditioned space, and a carport and storage unit have been added to the primary elevation. The house has been converted to a school.

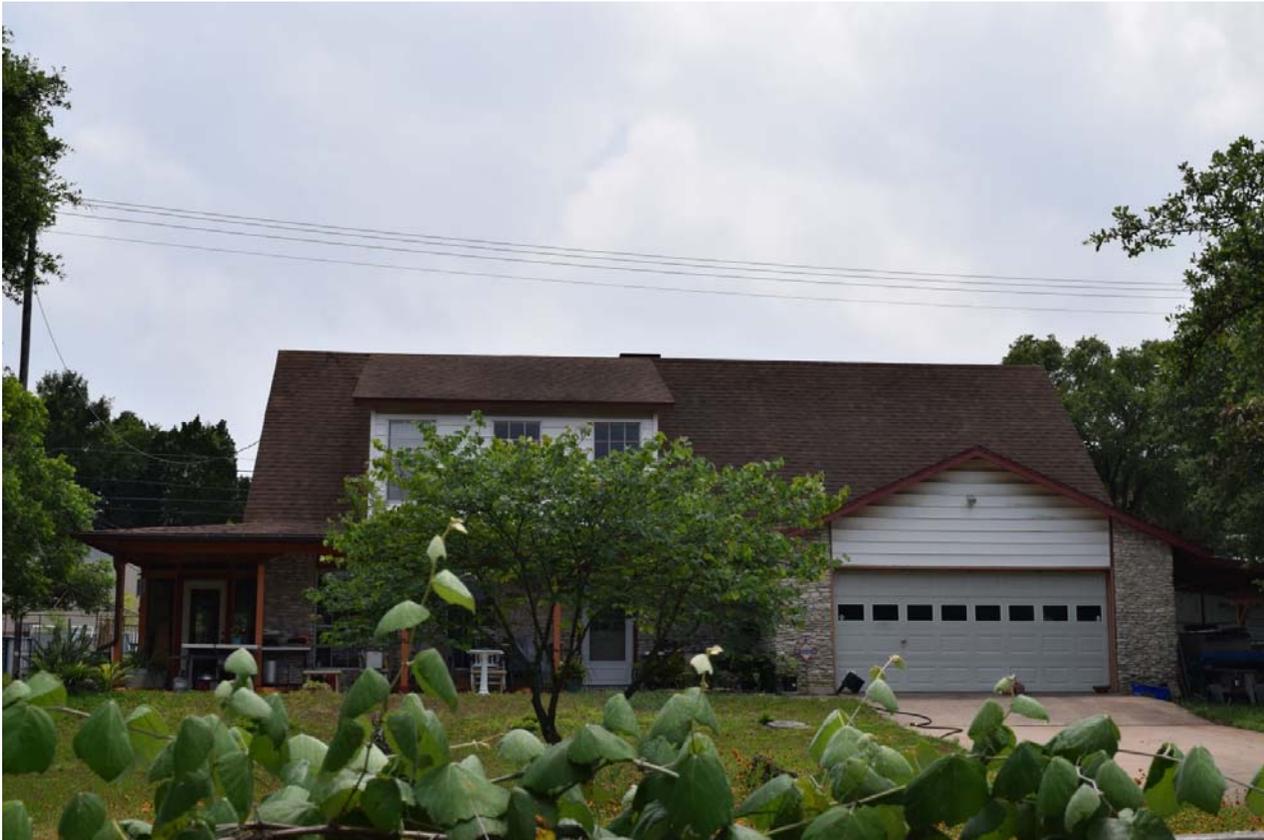
View facing south.

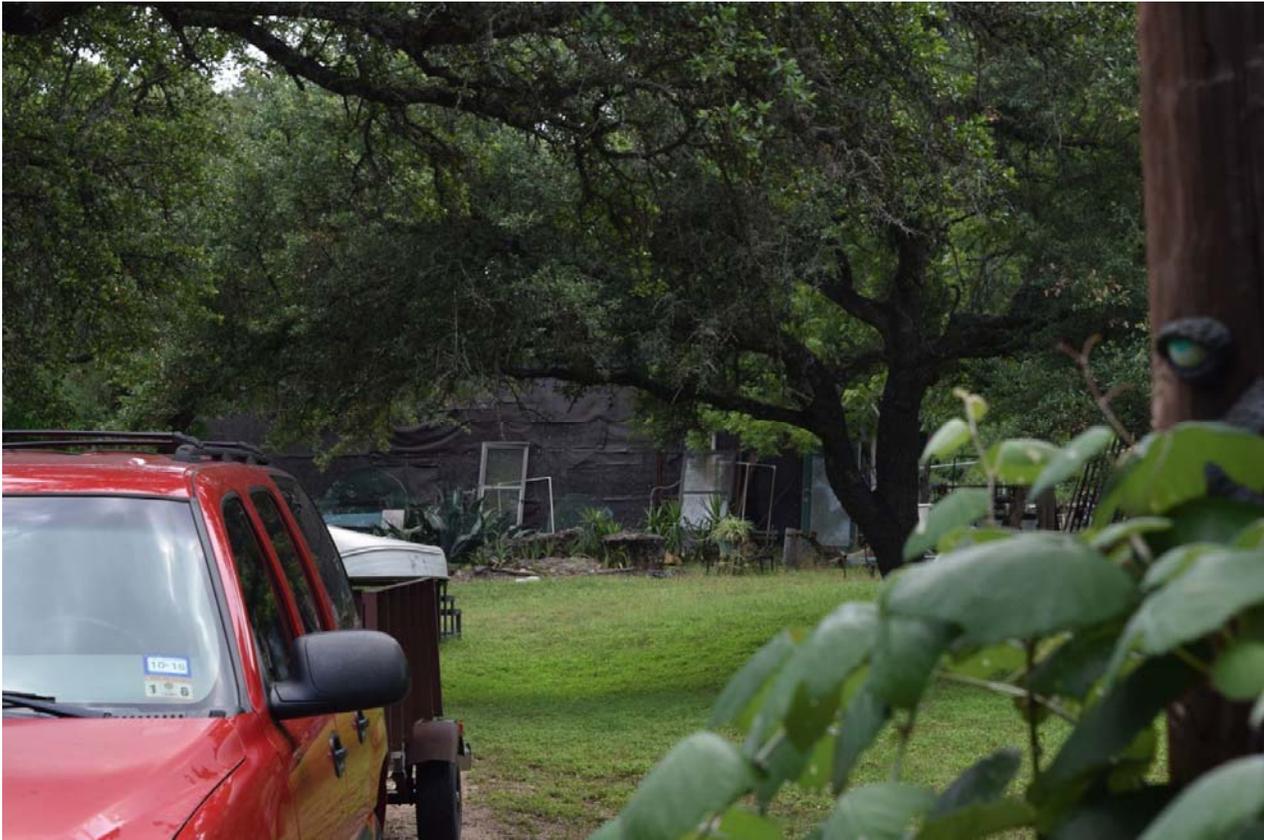
View facing southeast.

**NRHP Justification:** This resource is a non-historic-age secondary building on the same parcel as historic-age resources. The resource is less than 50 years old and was not found to possess exceptional significance under Criterion Consideration G. As a result, it is recommended not eligible for the NRHP under Criterion A, B, C, or D.
