Draft Historic Resources  
Survey Report  
for the Oak Hill Parkway Project

U.S. Highway 290 (US 290) / State Highway (SH)  
71 West from State Loop 1 (Mopac) to  
Ranch-to-Market (RM) 1826 and SH 71 to  
Silvermine Drive  
Travis County, Texas  
CSJ # 0113-08-060 and 0700-03-077  
October 2017

# Report for Historical Studies Survey

CSJs 0113-08-060 and 0700-03-077;  
Oak Hill Parkway Project: US 290 from  
Loop 1 (Mopac) to RM 1826 and SH  
71 from US 290 to Silvermine Drive  
Travis County, Austin District

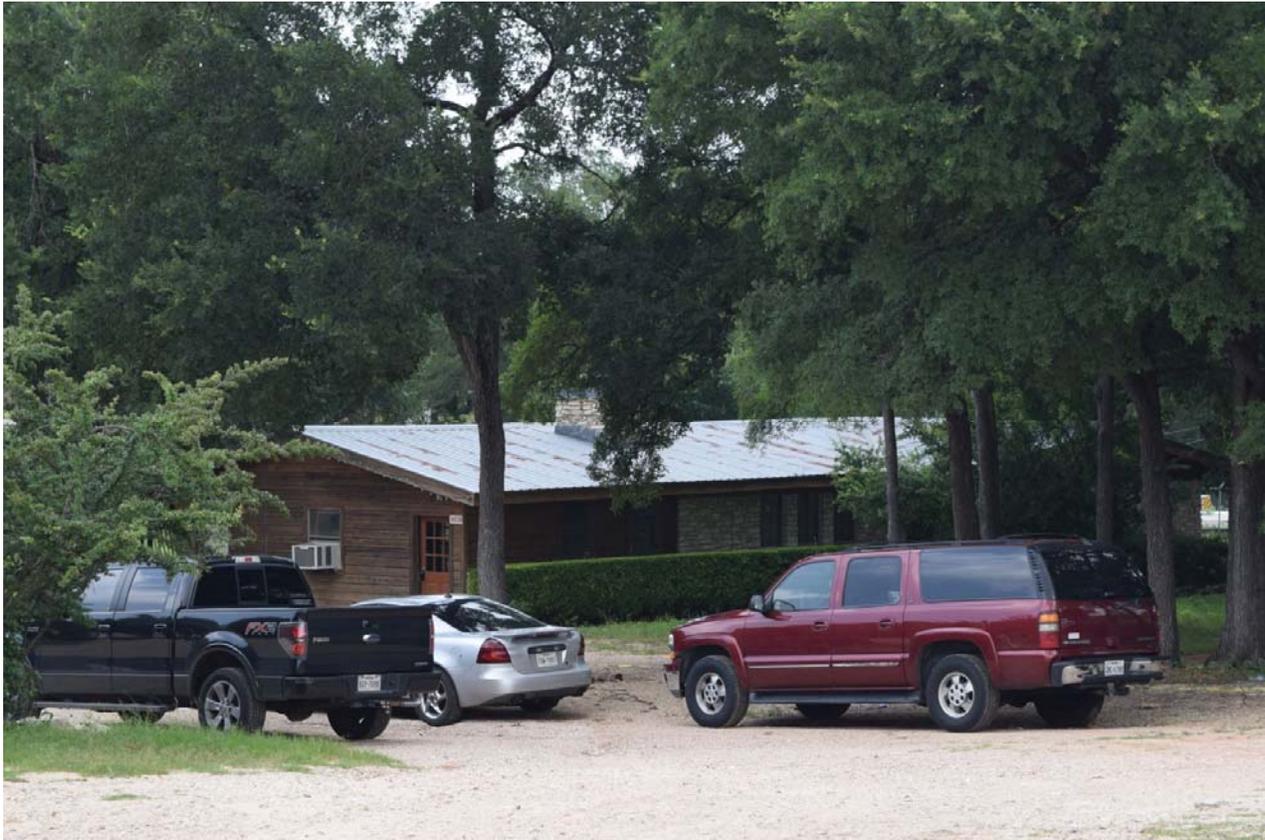
View facing northeast.  
 Photo 1 date taken: 5/26-28/16

**Description:** This is a one-story ranch-style residence with wood siding and stone construction and a metal gable roof. The windows are a variety of fixed vinyl windows and metal sash windows. There is no entry porch but there is a large back porch which opens onto the garden.

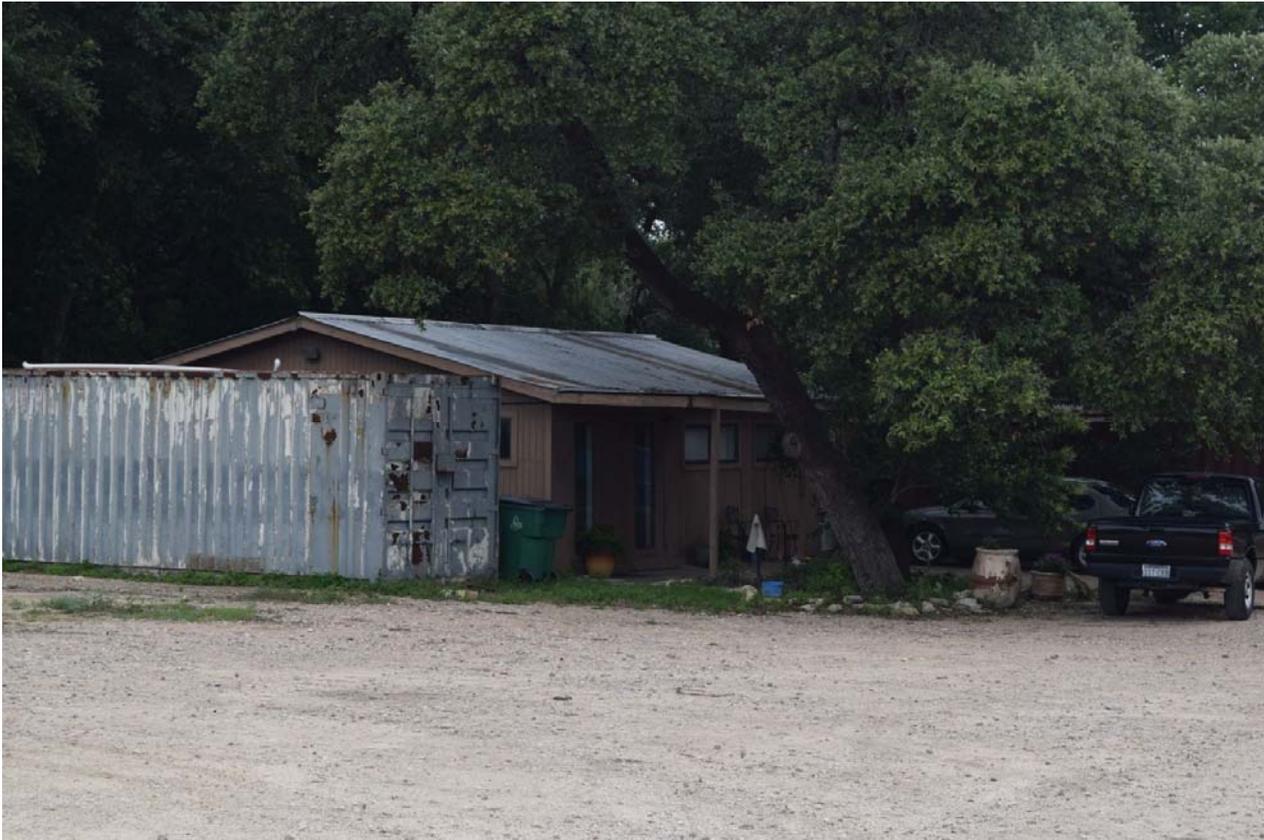
View facing northeast.

**NRHP Justification:** This resource is utilitarian in nature. It was not found to embody distinctive characteristics of a type, period, or method of construction, represent the work of a master, or possess high artistic value. Additionally, no associations were identified linking it to events or persons of historic importance, and it does not have potential to reveal important information. Therefore, it is recommended not eligible for listing in the NRHP under Criterion A, B, C, or D.

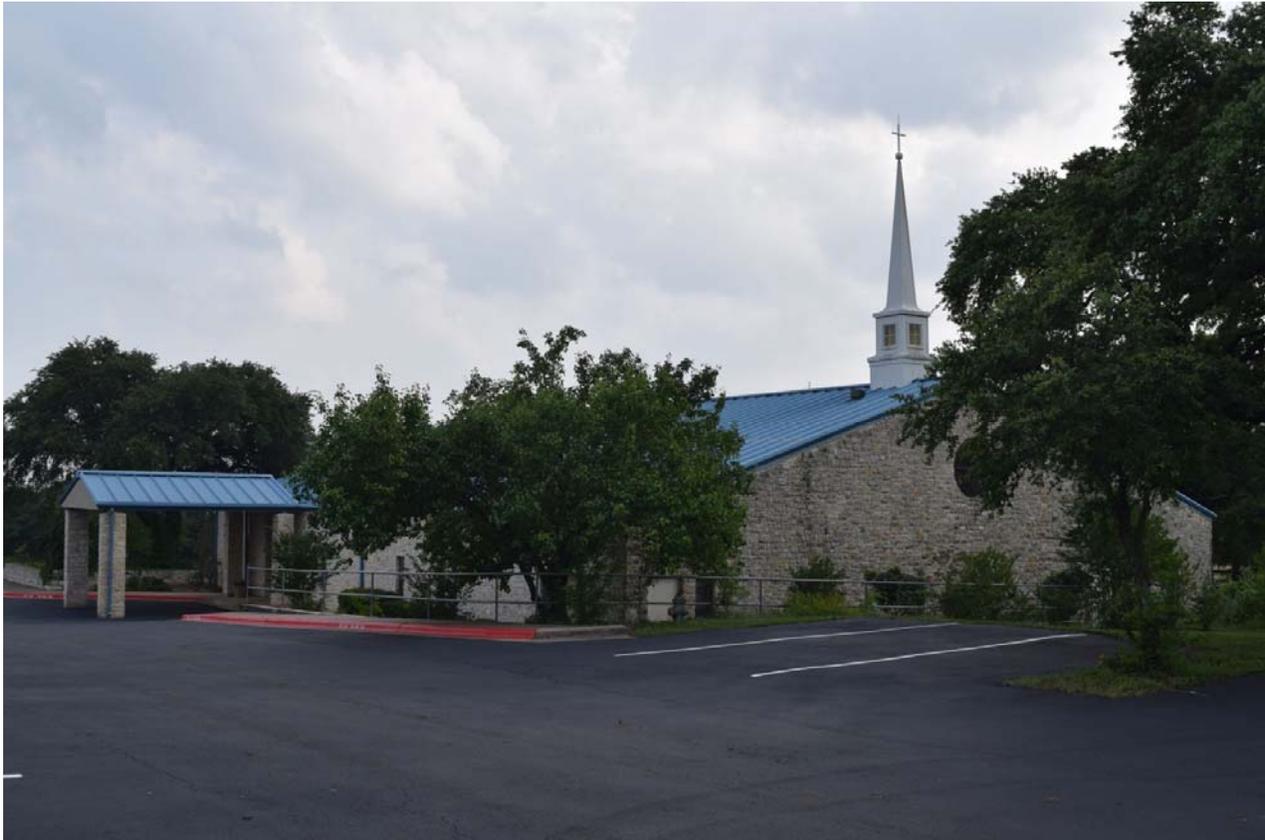
View facing southwest.

**Description:** This is a one-story church with stone cladding and a metal gable roof. The entrance walkway is covered by a gable roof supported by stone columns. The north end of the building has a white spire. The only visible windows are small vinyl windows on the south side of the building, between conditioning ducts.

**NRHP Justification:** This resource is a non-historic-age secondary building on the same parcel as an historic-age resource. It is less than 50 years old and was not found to possess exceptional significance under Criterion Consideration G. As a result, it is recommended not eligible for the NRHP under Criterion A, B, C, or D.

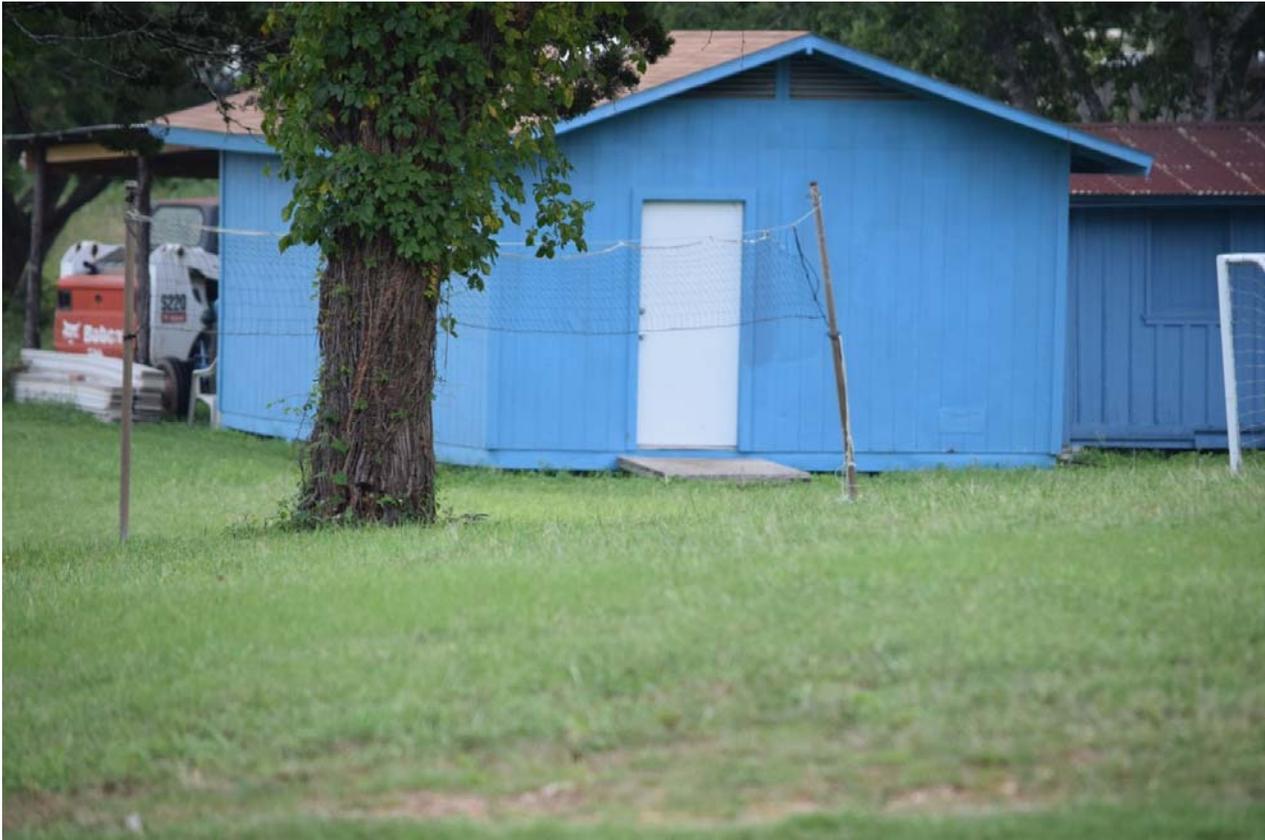
View facing northwest.  
 Photo 1 date taken: 5/26-28/16

**Description:** This building is a rectangular shed with wood siding and a composition shingle gable roof. The building has no windows; however, it has a single entry door with a small ramp attached.

**NRHP Justification:** This resource is a non-historic-age secondary building on the same parcel as an historic-age resource. It is less than 50 years old and was not found to possess exceptional significance under Criterion Consideration G. As a result, it is recommended not eligible for the NRHP under Criterion A, B, C, or D.

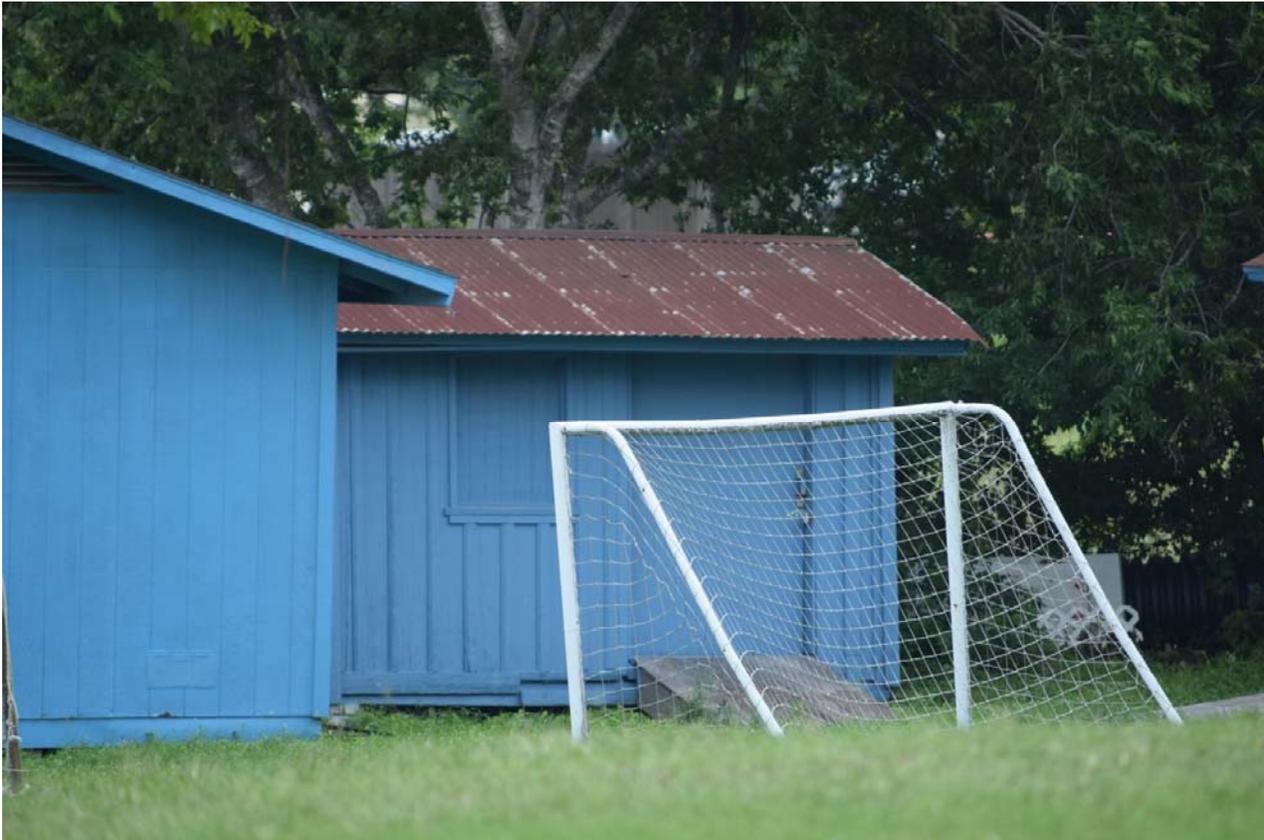
View facing northwest.

**NRHP Justification:** This resource is a non-historic-age secondary building on the same parcel as an historic-age resource. It is less than 50 years old and was not found to possess exceptional significance under Criterion Consideration G. As a result, it is recommended not eligible for the NRHP under Criterion A, B, C, or D.

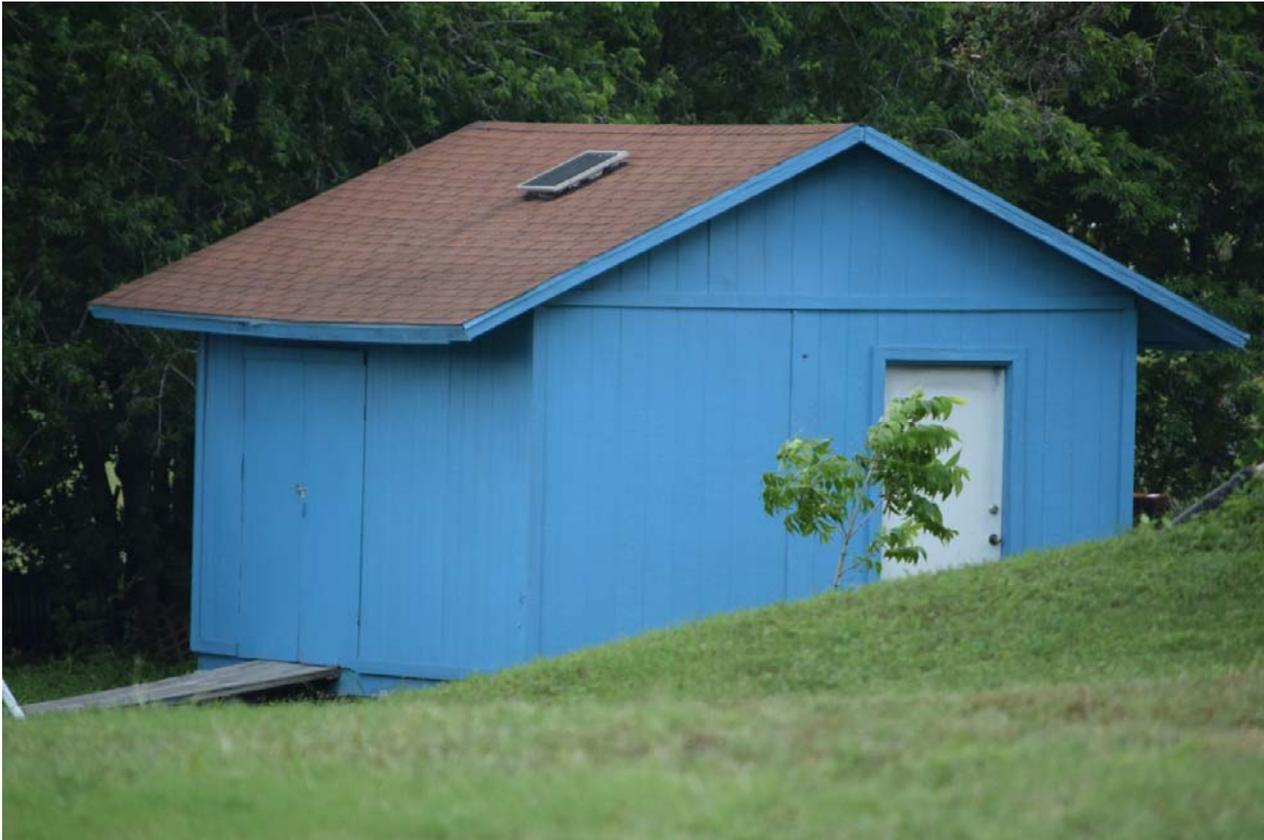
View facing northwest.

**NRHP Justification:** This resource is a non-historic-age secondary building on the same parcel as an historic-age resource. It is less than 50 years old and was not found to possess exceptional significance under Criterion Consideration G. As a result, it is recommended not eligible for the NRHP under Criterion A, B, C, or D.

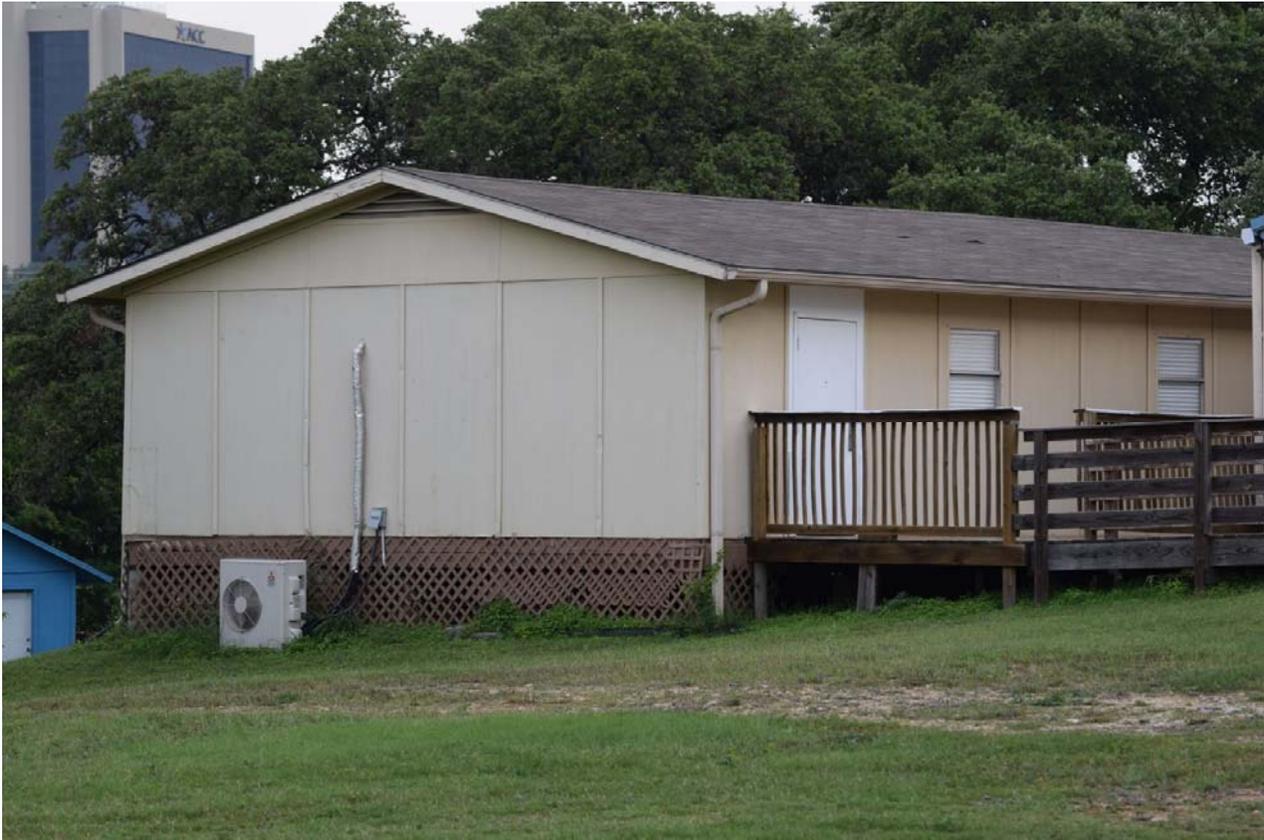
View facing northwest.

**NRHP Justification:** This resource is a non-historic-age secondary building on the same parcel as an historic-age resource. It is less than 50 years old and was not found to possess exceptional significance under Criterion Consideration G. As a result, it is recommended not eligible for the NRHP under Criterion A, B, C, or D.

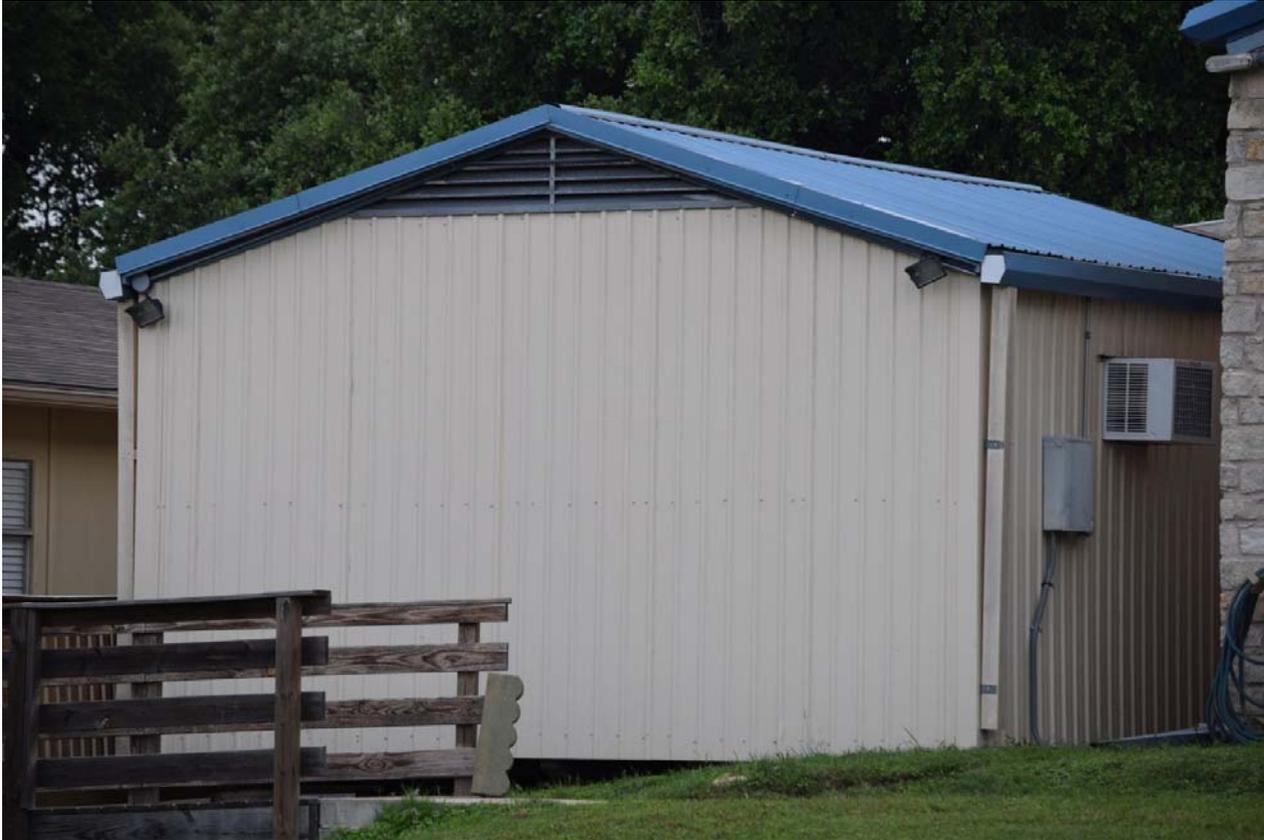
View facing northwest.

**NRHP Justification:** This resource is a non-historic-age secondary building on the same parcel as an historic-age resource. It is less than 50 years old and was not found to possess exceptional significance under Criterion Consideration G. As a result, it is recommended not eligible for the NRHP under Criterion A, B, C, or D.

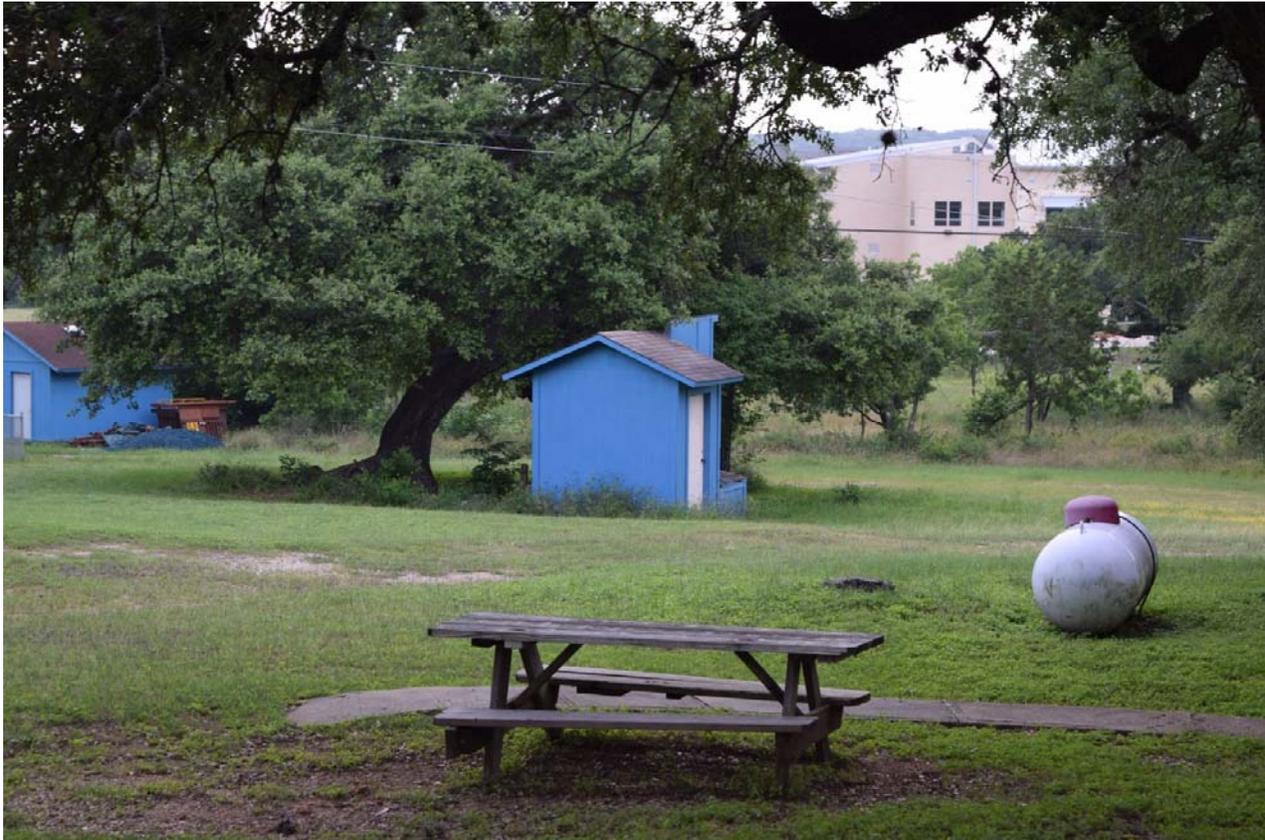
View facing southwest.  
 Photo 1 date taken: 5/26-28/16

**Description:** This is a one-story shed with wood siding and a composition shingle gable roof. There appears to be a decorative addition on the west side. The building has no windows but a single entry door is visible.

**NRHP Justification:** This resource is a non-historic-age secondary building on the same parcel as an historic-age resource. It is less than 50 years old and was not found to possess exceptional significance under Criterion Consideration G. As a result, it is recommended not eligible for the NRHP under Criterion A, B, C, or D.

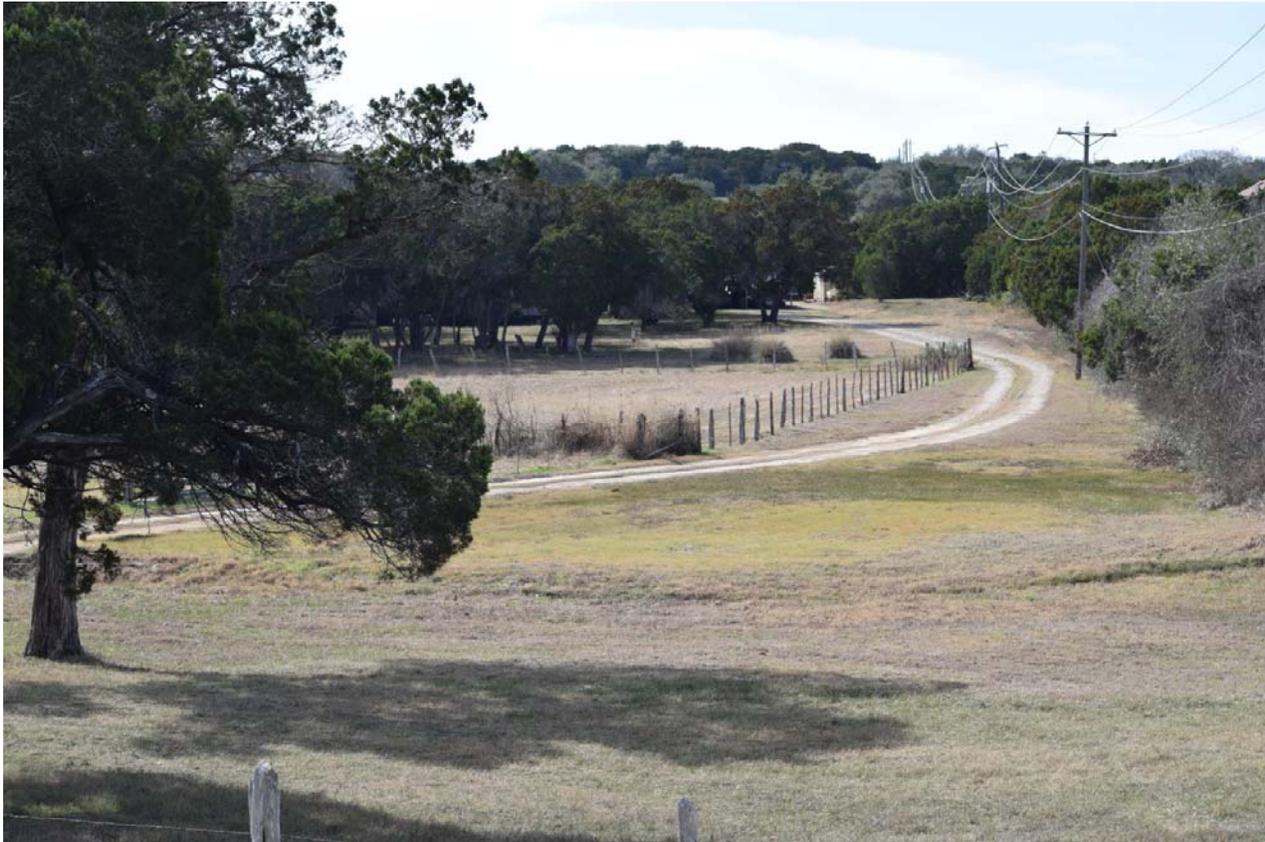
Overview of property; house located among cluster of trees near center of photo; view facing southwest.  
 Photo 1 date taken: 1/10/17

**Description:** Resource 14a is a cross-gabled house constructed in ca. 1980 based on aerial photo review. There is a two-bay, front gabled carport to the northwest side of the house. The house is obscured from the public right-of-way by trees and other vegetation and few details are visible.

**NRHP Justification:** This resource is a non-historic-age residence. The resource is less than 50 years old and was not found to possess exceptional significance under Criterion Consideration G. As a result, it is recommended not eligible for the NRHP under Criterion A, B, C, or D.

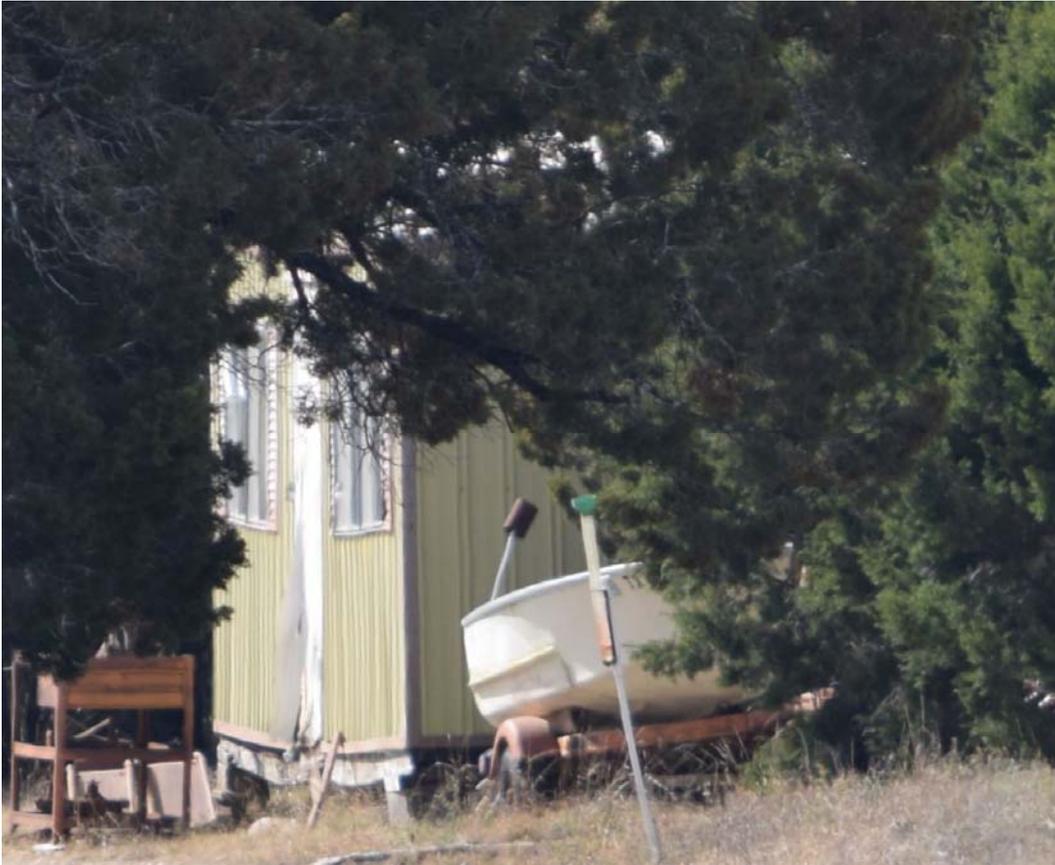
View facing southwest.

**NRHP Justification:** This resource is utilitarian in nature. It was not found to embody distinctive characteristics of a type, period, or method of construction, represent the work of a master, or possess high artistic value. Additionally, no associations were identified linking it to events or persons of historic importance, and it does not have potential to reveal important information. Therefore, it is recommended not eligible for listing in the NRHP under Criterion A, B, C, or D.

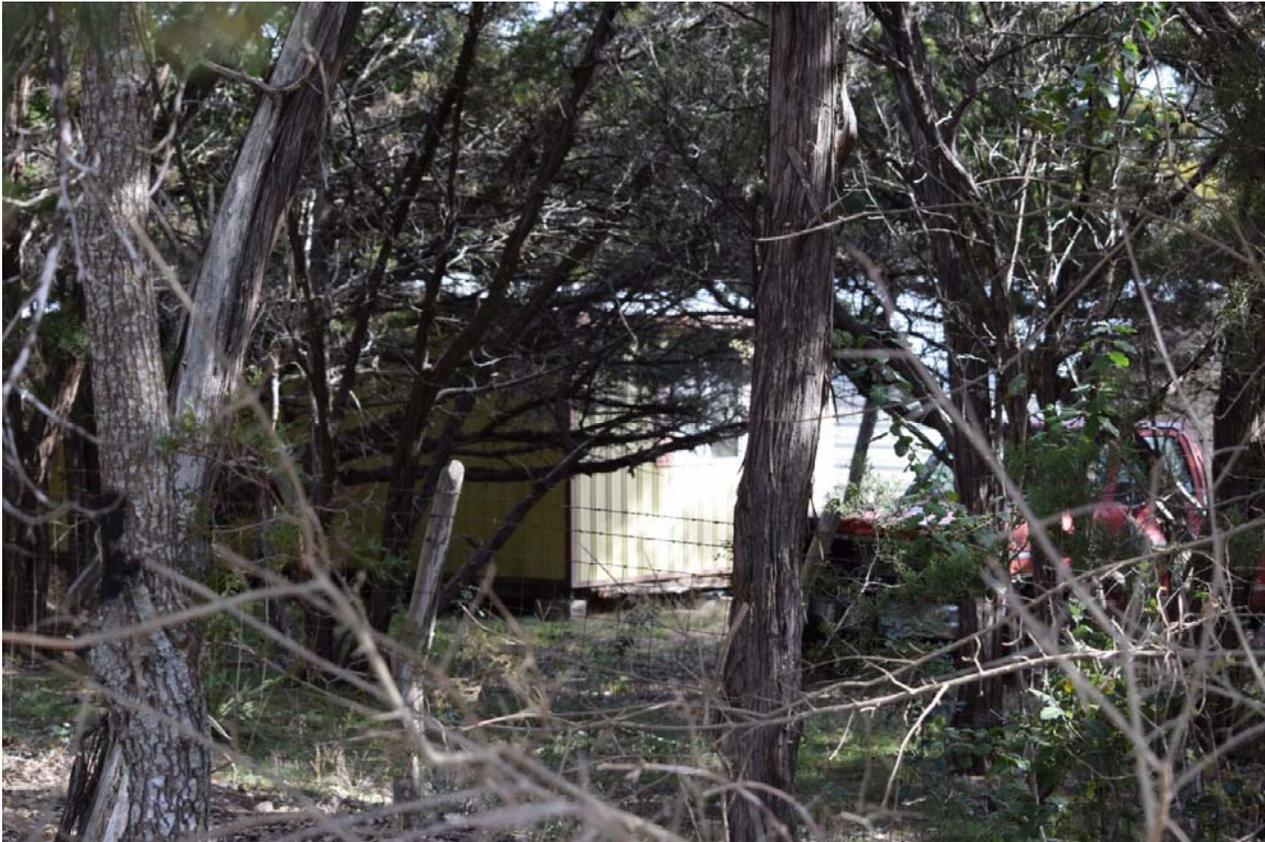
View facing northeast.  
 Photo 1 date taken: 1/10/17

**Description:** Resource 14c is a utilitarian building clad in corrugated metal. Substantial vegetation surrounding the building made it difficult to take photographs and to obtain information about the building.

**NRHP Justification:** This resource is a non-historic-age residence. The resource is less than 50 years old and was not found to possess exceptional significance under Criterion Consideration G. As a result, it is recommended not eligible for the NRHP under Criterion A, B, C, or D.

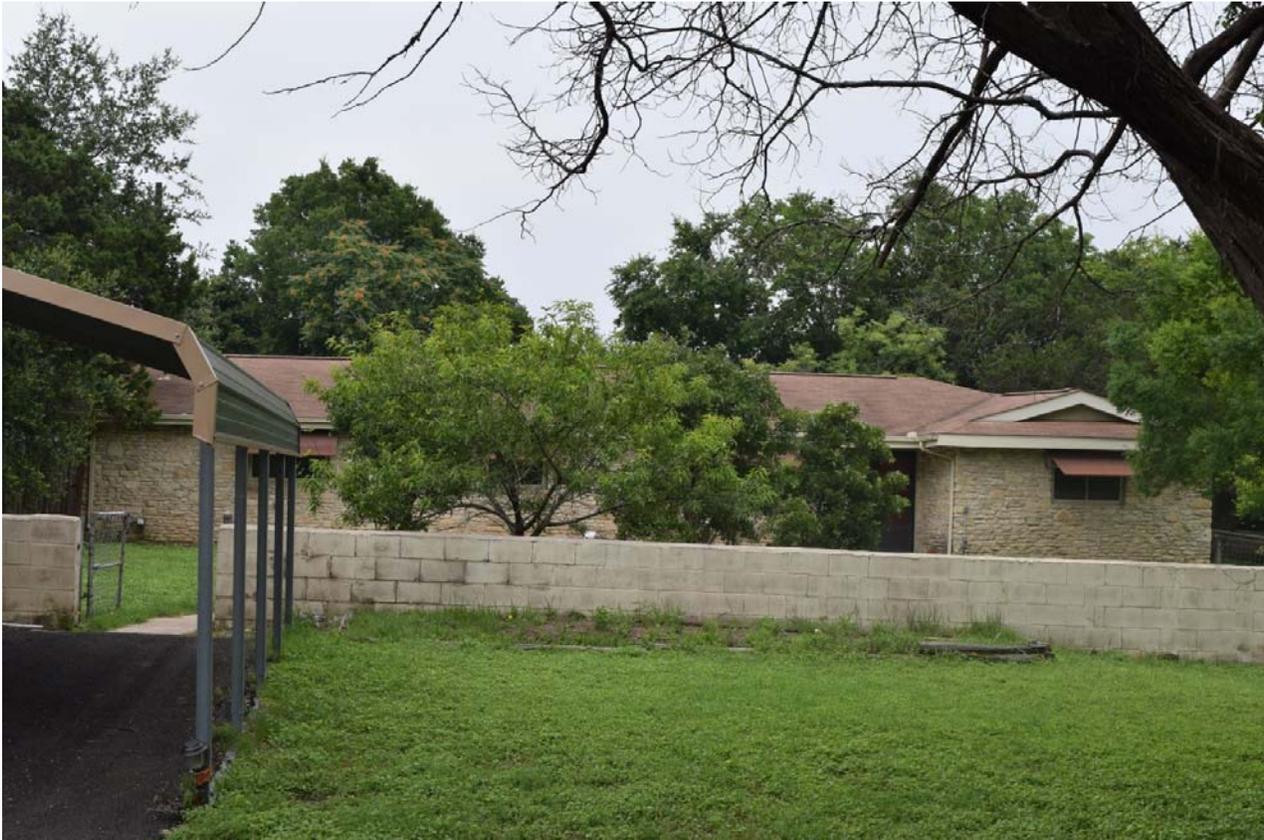
Photo 1 date taken: 5/26-28/16

<b>Resource ID</b> 15a	<b>Name:</b> None	<b>Year Built:</b> 1966	<b>Source:</b> TCAD
	<b>Address:</b> 8637 MOUNTAIN CREST DR	Austin Travis County	Texas
<b>Parcel ID</b> 101507	<b>Lat:</b> 30.254715	<b>Long:</b> -97.891507	
	<b>Type:</b> Building	<b>Style:</b> Ranch	<b>Form:</b> L-plan
<b>Historic Function/ Subcategory:</b>	Domestic/ Single Dwelling	<b>Indiv. NRHP Eligible?</b> No	<b>Effect:</b> N/A
<b>Current Function/Subcategory:</b>	Domestic/ Single Dwelling	<b>Contributing to District?</b> N/A

View facing southeast.

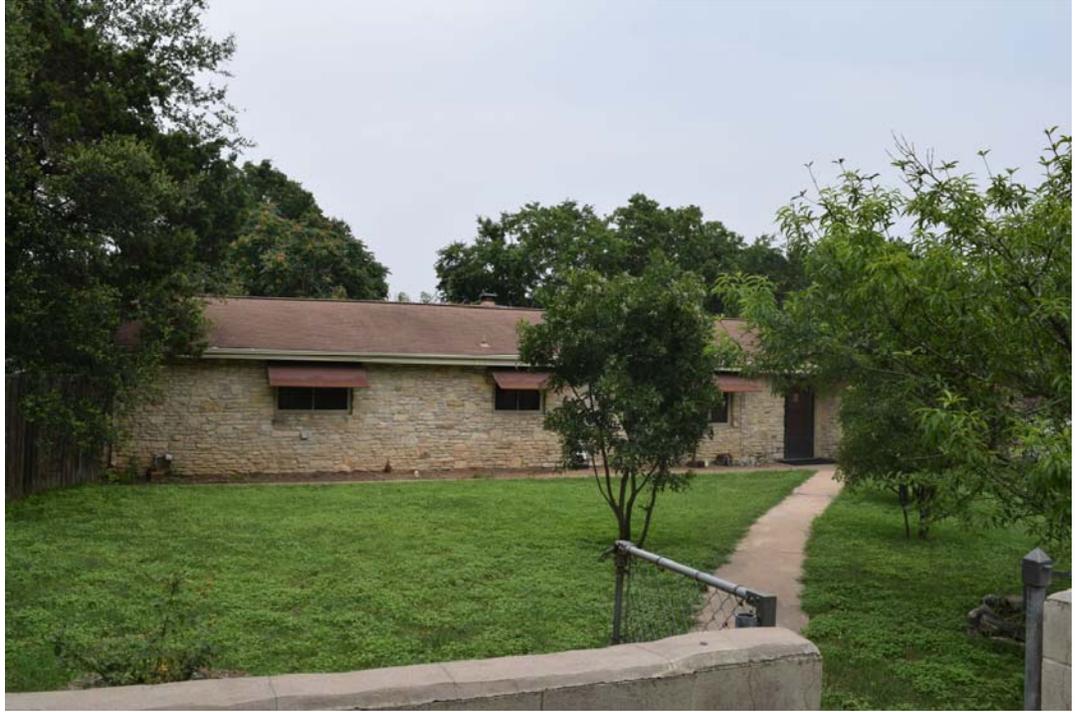
Photo 2 date taken:  
5/26-28/16

View facing southwest.

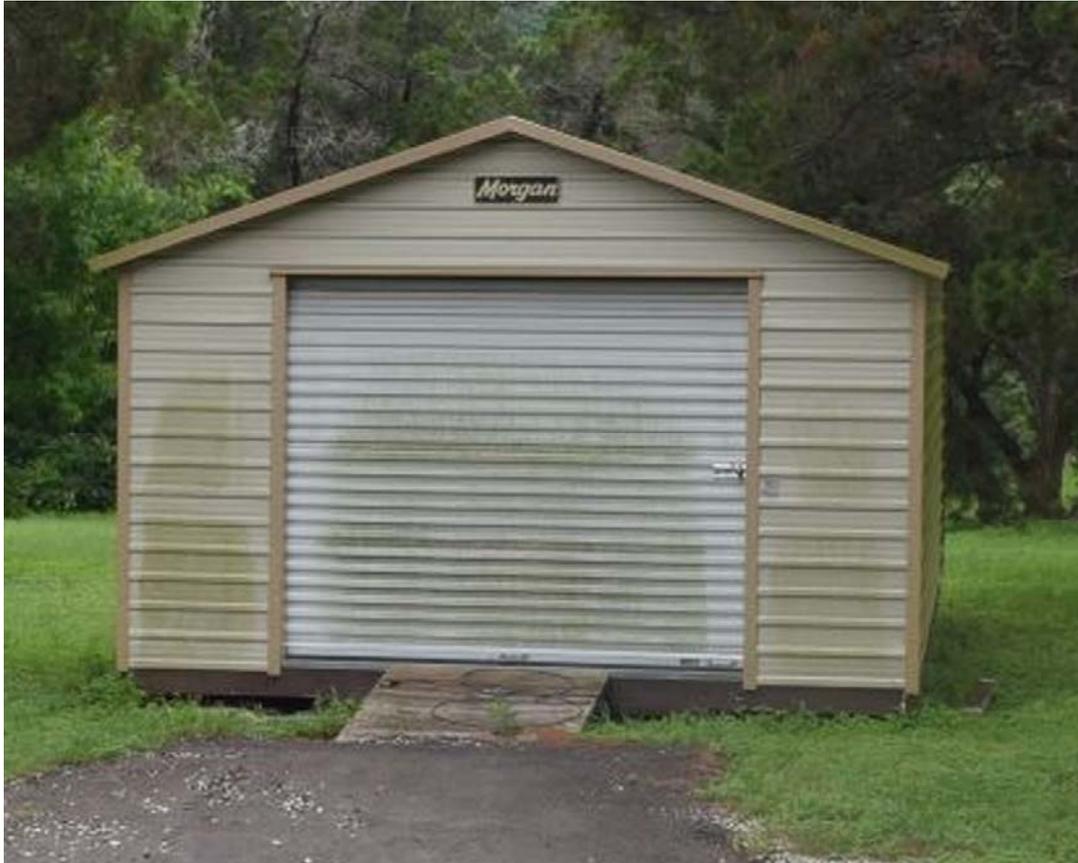
Photo 1 date taken: 5/26-28/16

Resource ID 15b      Name: None      Year Built: ca. 1980      Source: field survey  
 Address: 8637 MOUNTAIN CREST DR      Austin      Travis County      Texas  
 Parcel 101507      Lat: 30.254829      Long: -97.891915  
 ID      Type: Building      Style: None      Form: Rectangular  
 Historic Function/ Subcategory: Domestic/ Secondary Structure      Individ. NRHP Eligible? No      Effect: N/A  
 Current Function/Subcategory: Domestic/ Secondary Structure      Contributing to District? N/A

View facing southwest.

**NRHP Justification:** This resource is a non-historic-age secondary building on the same parcel as an historic-age resource. The resource is less than 50 years old and was not found to possess exceptional significance under Criterion Consideration G. As a result, it is recommended not eligible for the NRHP under Criterion A, B, C, or D.

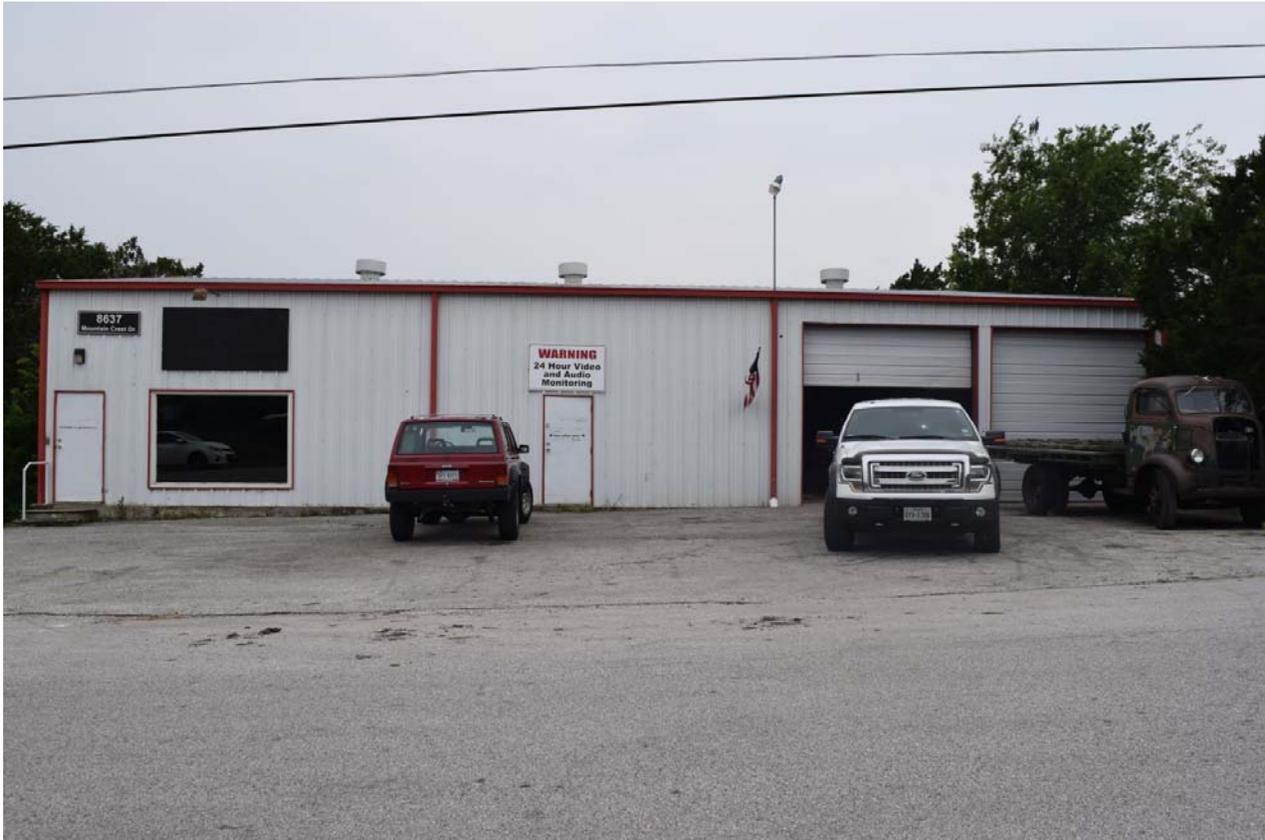
Photo 1 date taken: 5/26-28/16

Resource ID 15c      Name: None identified      Year Built: ca. 1990      Source: aerial photos  
 Address: 8637 MOUNTAIN CREST DR      Austin      Travis County      Texas  
 Parcel 101507      Lat: 30.25513      Long: -97.892075  
 ID      Type: Building      Style: None      Form: Rectangular  
 Historic Function/ Subcategory: Commerce/ Business      Individ. NRHP Eligible? No      Effect: N/A  
 Current Function/Subcategory: Commerce/ Business      Contributing to District? N/A

View facing southwest.

**NRHP Justification:** This resource is a non-historic-age secondary building on the same parcel as an historic-age resource. The resource is less than 50 years old and was not found to possess exceptional significance under Criterion Consideration G. As a result, it is recommended not eligible for the NRHP under Criterion A, B, C, or D.

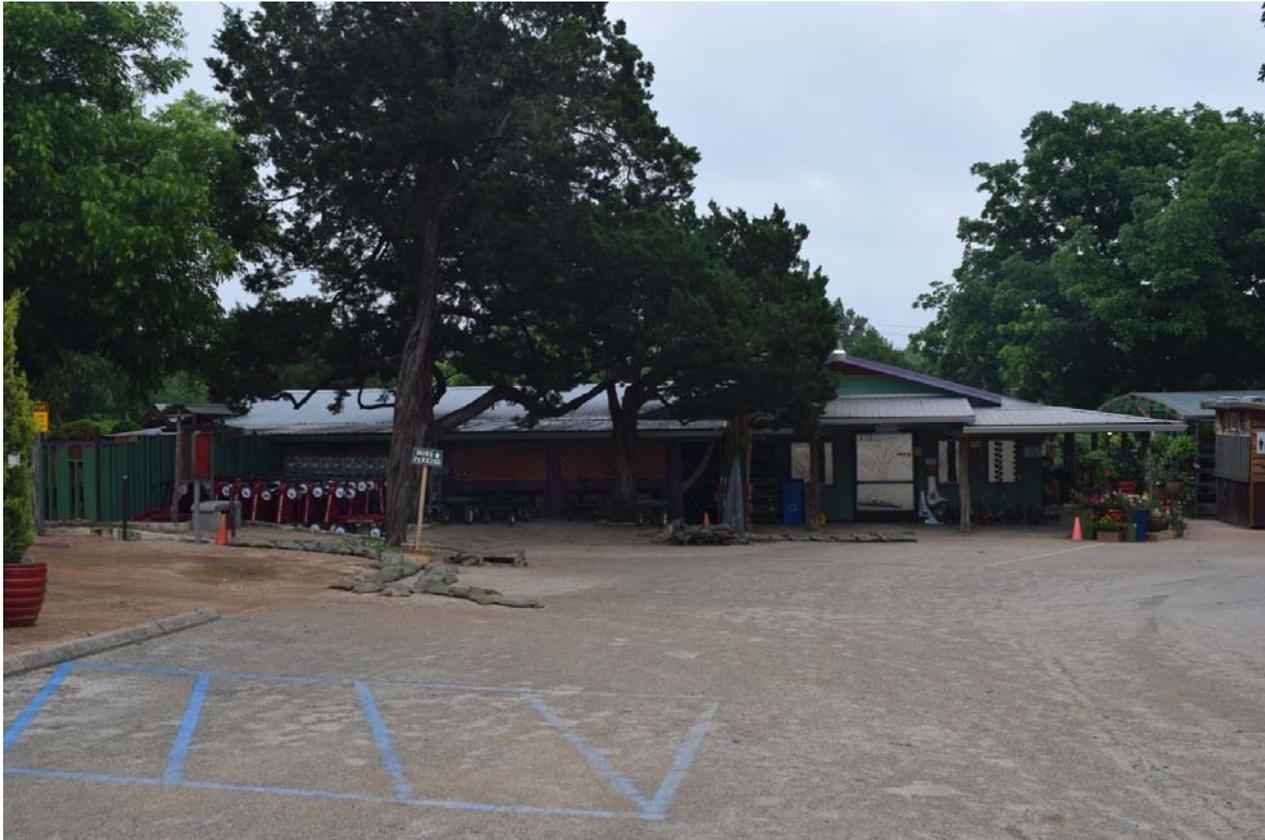
Photo 1 date taken: 5/26-28/16

Resource ID 16a      Name: The Natural Gardener      Year Built: 1966      Source: TCAD  
 Address: 8648 OLD BEE CAVES RD      Austin      Travis County      Texas  
 Parcel 101525      Lat: 30.256687      Long: -97.890951  
 ID      Type: Building      Style: None      Form: Irregular  
 Historic Function/ Subcategory: Domestic/ Single Dwelling      Individ. NRHP Eligible? No      Effect: N/A  
 Current Function/Subcategory: Commerce/ Business      Contributing to District? N/A

View facing east.

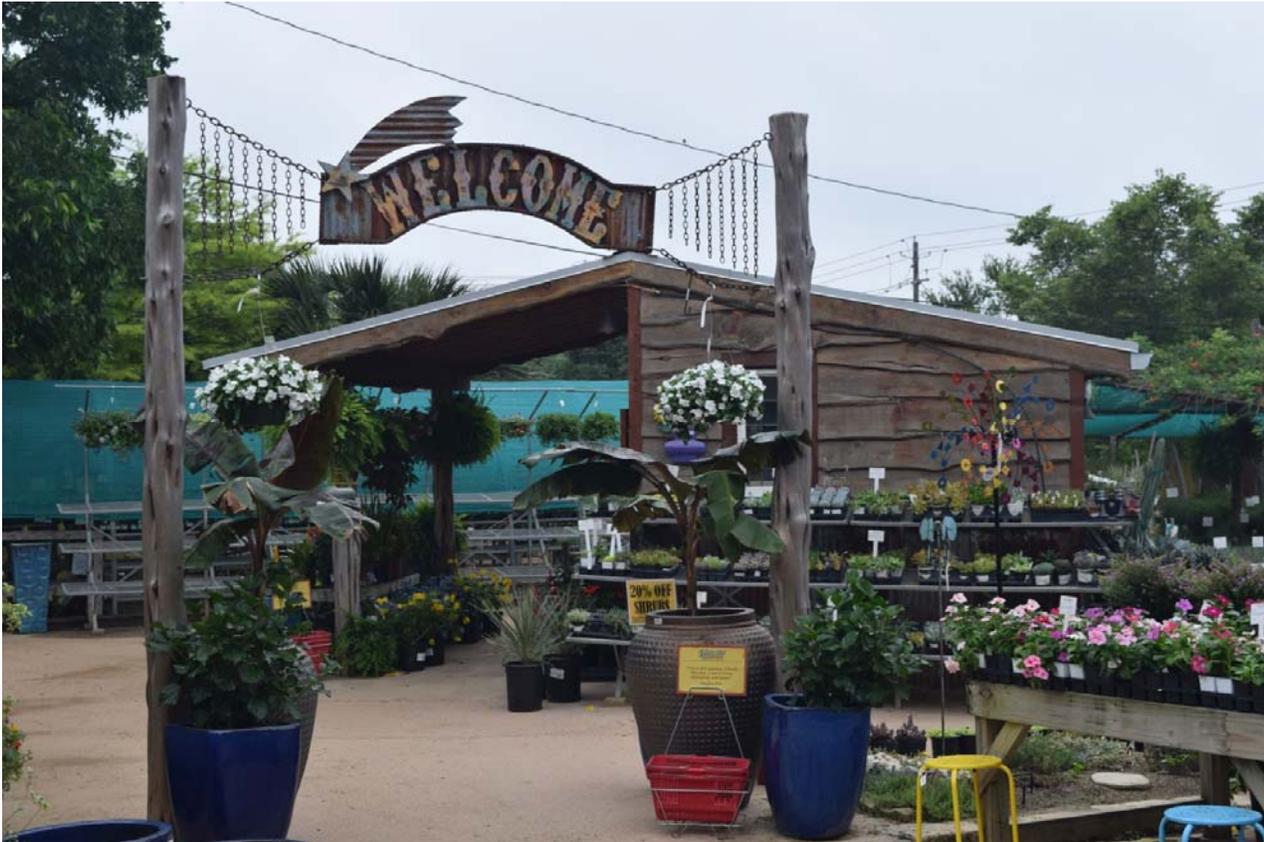
Photo 1 date taken: 5/26-28/16

Resource ID 16b      Name: The Natural Gardener      Year Built: ca. 2000      Source: field survey  
 Address: 8648 OLD BEE CAVES RD      Austin      Travis County      Texas  
 Parcel 101525      Lat: 30.256439      Long: -97.890932  
 ID      Type: Building      Style: None      Form: Rectangular  
 Historic Function/ Subcategory: Commerce/ Business      Individ. NRHP Eligible? No      Effect: N/A  
 Current Function/Subcategory: Commerce/ Business      Contributing to District? N/A

View facing east.

**NRHP Justification:** This resource is a non-historic-age secondary building on the same parcel as an historic-age resource. It is less than 50 years old and was not found to possess exceptional significance under Criterion Consideration G. As a result, it is recommended not eligible for the NRHP under Criterion A, B, C, or D.

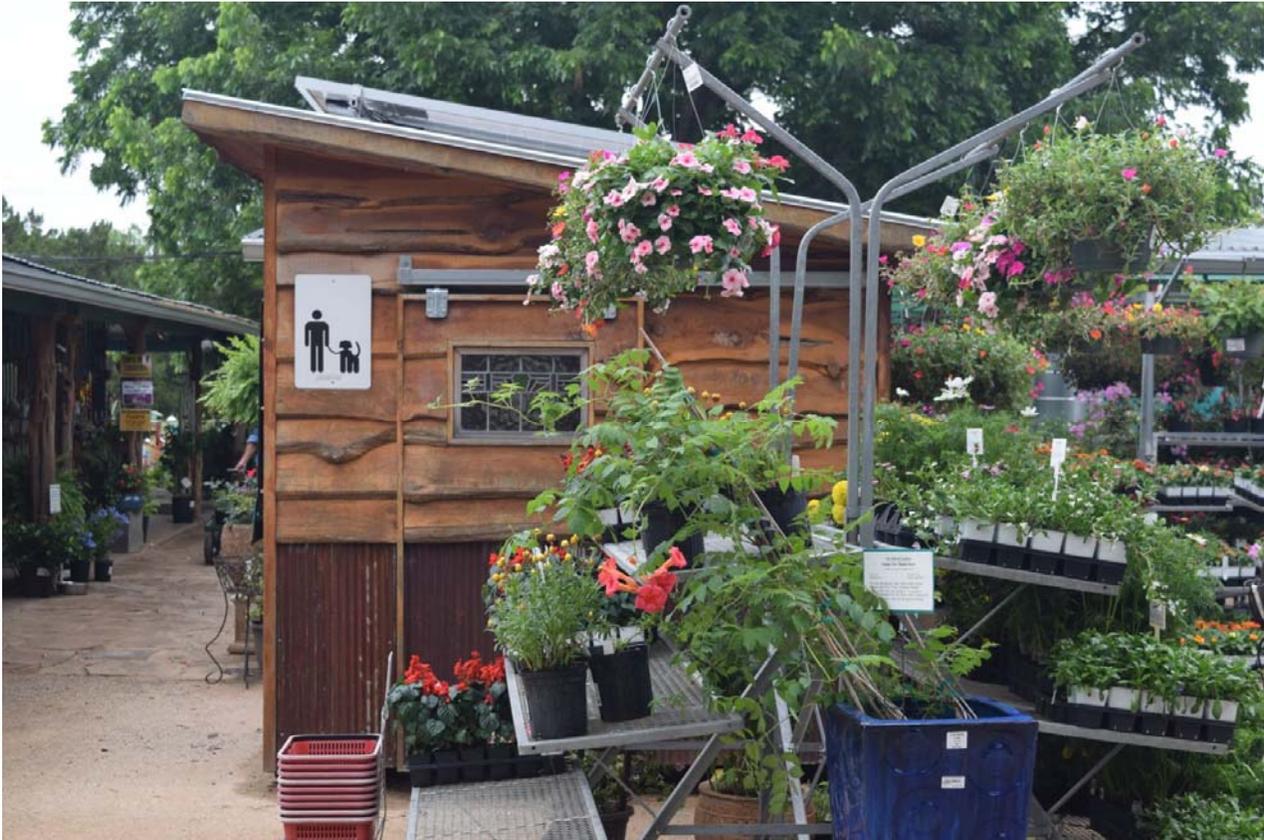
Photo 1 date taken: 5/26-28/16

**Resource ID** 16c      **Name:** The Natural Gardener      **Year Built:** ca. 2000      **Source:** field survey  
**Address:** 8648 OLD BEE CAVES RD      Austin      Travis County      Texas  
**Parcel ID** 101525      **Lat:** 30.256481      **Long:** -97.891027  
**Type:** Building      **Style:** None      **Form:** Rectangular  
**Historic Function/ Subcategory:** Commerce/ Business      **Indiv. NRHP Eligible?** No      **Effect:** N/A  
**Current Function/Subcategory:** Commerce/ Business      **Contributing to District?** N/A

View facing east.

**Description:** This is a one-story bathroom structure with a metal shed roof and rough-hewn wood siding. It has one stained glass window in the single sliding barn door and no other windows.

**NRHP Justification:** This resource is a non-historic-age secondary building on the same parcel as an historic-age resource. It is less than 50 years old and was not found to possess exceptional significance under Criterion Consideration G. As a result, it is recommended not eligible for the NRHP under Criterion A, B, C, or D.
