Draft Historic Resources  
Survey Report  
for the Oak Hill Parkway Project

U.S. Highway 290 (US 290) / State Highway (SH)  
71 West from State Loop 1 (Mopac) to  
Ranch-to-Market (RM) 1826 and SH 71 to  
Silvermine Drive  
Travis County, Texas  
CSJ # 0113-08-060 and 0700-03-077  
October 2017

# Report for Historical Studies Survey

CSJs 0113-08-060 and 0700-03-077;  
Oak Hill Parkway Project: US 290 from  
Loop 1 (Mopac) to RM 1826 and SH  
71 from US 290 to Silvermine Drive  
Travis County, Austin District

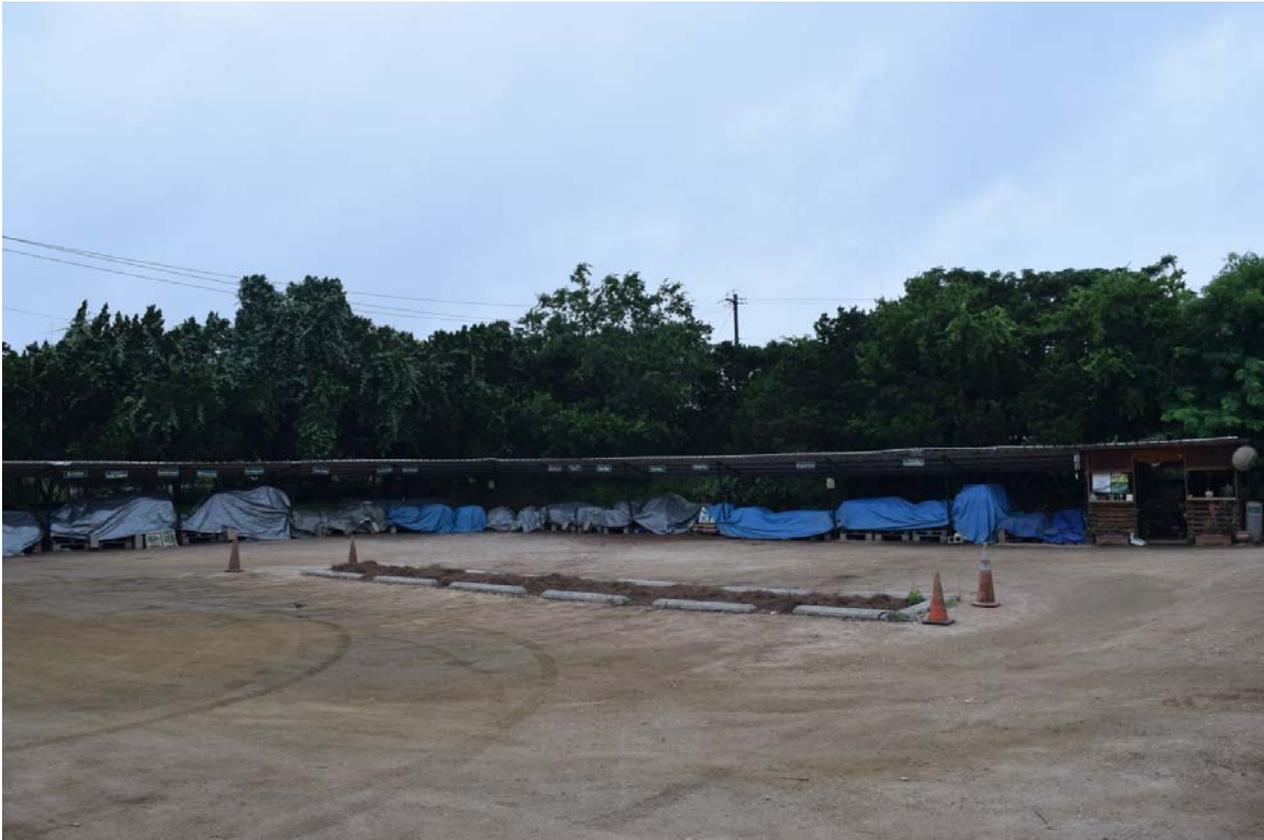
Photo 1 date taken: 5/26-28/16

Resource ID 16d      Name: The Natural Gardener      Year Built: 1980      Source: TCAD  
 Address: 8648 OLD BEE CAVES RD      Austin      Travis County      Texas  
 Parcel 101525      Lat: 30.256544      Long: -97.891431  
 ID      Type: Building      Style: None      Form: U-plan  
 Historic Function/ Subcategory: Commerce/ Business      Individ. NRHP Eligible? No      Effect: N/A  
 Current Function/Subcategory: Commerce/ Business      Contributing to District? N/A

View facing southwest.

**NRHP Justification:** This resource is a non-historic-age secondary building on the same parcel as historic-age resources. The resource is less than 50 years old and was not found to possess exceptional significance under Criterion Consideration G. As a result, it is recommended not eligible for the NRHP under Criterion A, B, C, or D.

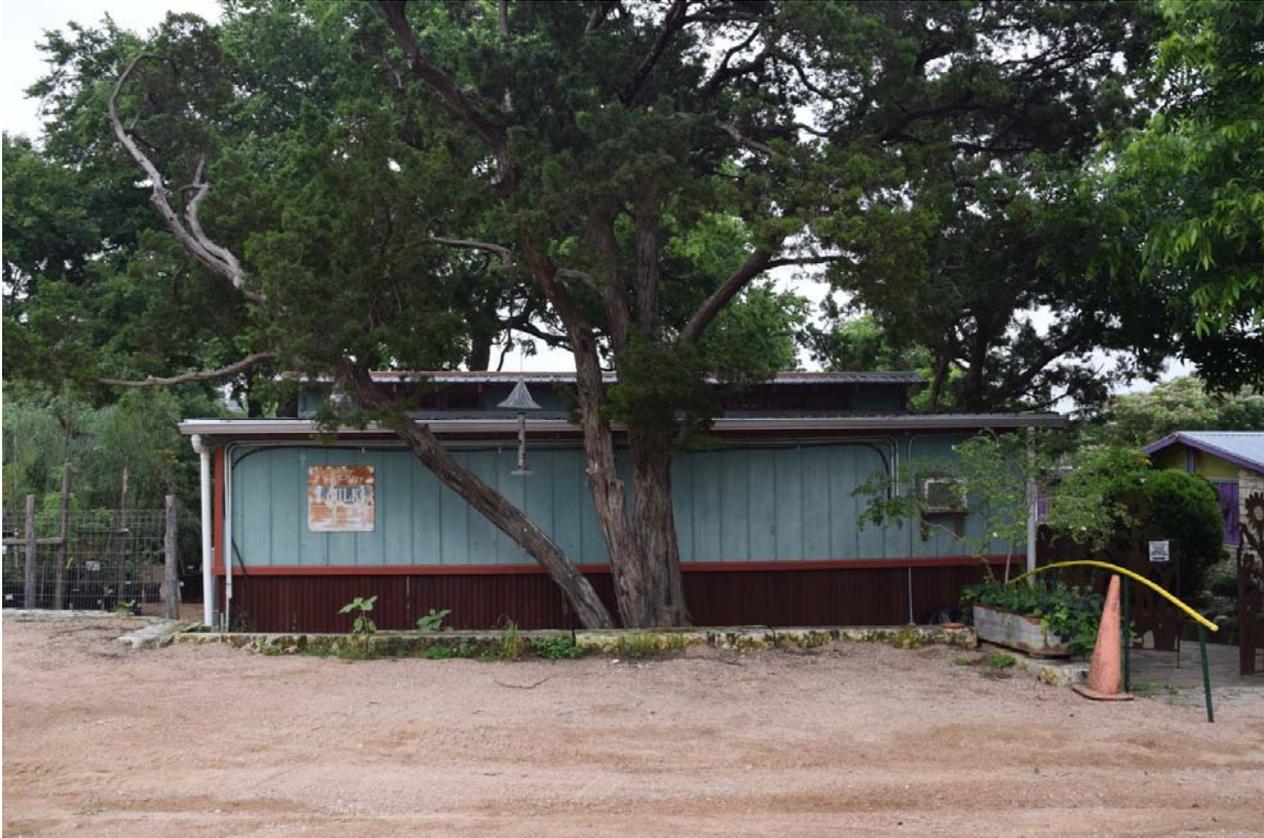
Photo 1 date taken: 5/26-28/16

Resource ID 16e      Name: The Natural Gardener      Year Built: 1980      Source: TCAD  
 Address: 8648 OLD BEE CAVES RD      Austin      Travis County      Texas  
 Parcel 101525      Lat: 30.256935      Long: -97.890841  
 ID      Type: Building      Style: None      Form: Rectangular  
 Historic Function/ Subcategory: Commerce/ Business      Individ. NRHP Eligible? No      Effect: N/A  
 Current Function/Subcategory: Commerce/ Business      Contributing to District? N/A

View facing east.

**NRHP Justification:** This resource is a non-historic-age secondary building on the same parcel as an historic-age resource. It is less than 50 years old and was not found to possess exceptional significance under Criterion Consideration G. As a result, it is recommended not eligible for the NRHP under Criterion A, B, C, or D.

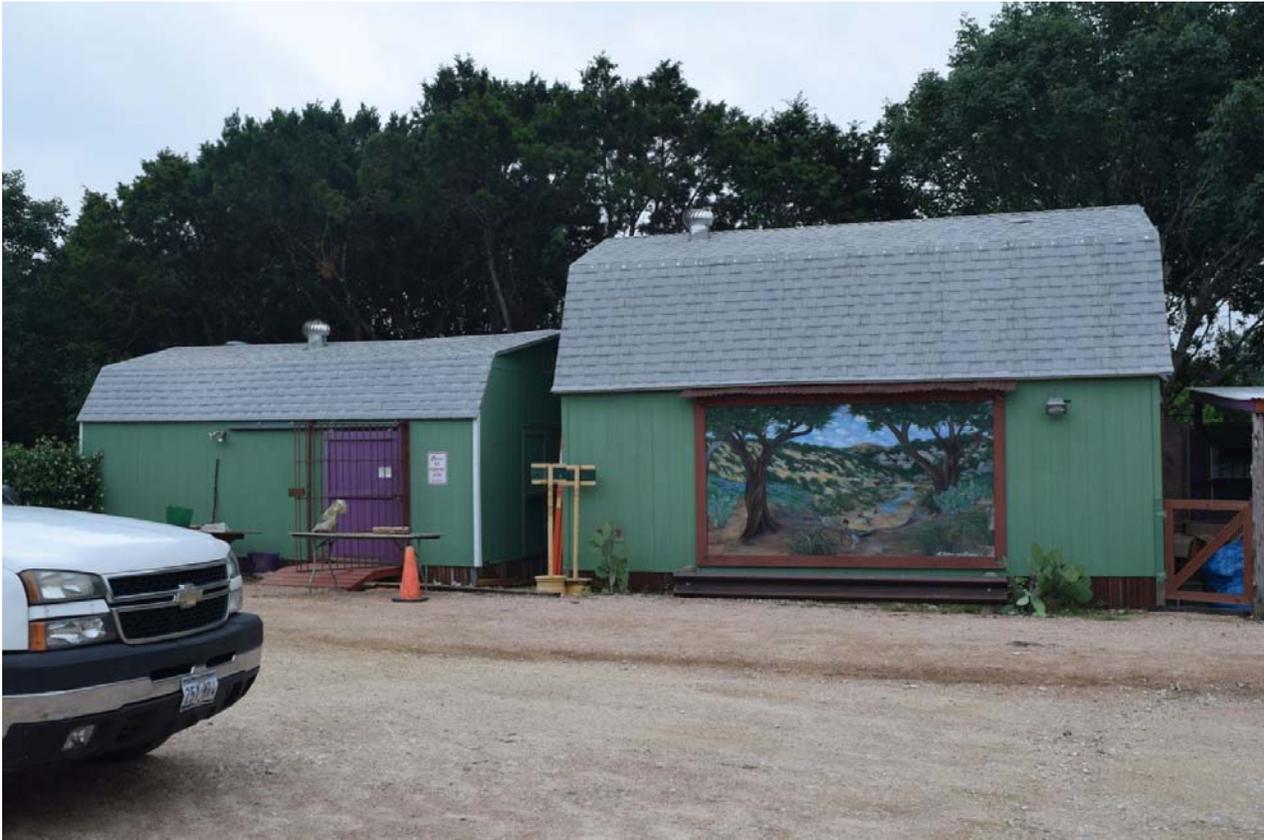
Photo 1 date taken: 5/26-28/16

<b>Resource ID</b> 16f	<b>Name:</b> The Natural Gardener	<b>Year Built:</b> ca. 2000	<b>Source:</b> field survey
	<b>Address:</b> 8648 OLD BEE CAVES RD	Austin Travis County	Texas
Parcel ID 101525	<b>Lat:</b> 30.257106	<b>Long:</b> -97.89078	
	<b>Type:</b> Building	<b>Style:</b> None	<b>Form:</b> Rectangular
<b>Historic Function/ Subcategory:</b>	Commerce/ Business	<b>Indiv. NRHP Eligible?</b> No	<b>Effect:</b> N/A
<b>Current Function/Subcategory:</b>	Commerce/ Business	<b>Contributing to District?</b> N/A

View facing east.

**NRHP Justification:** This resource is a non-historic-age secondary building on the same parcel as an historic-age resource. It is less than 50 years old and was not found to possess exceptional significance under Criterion Consideration G. As a result, it is recommended not eligible for the NRHP under Criterion A, B, C, or D.

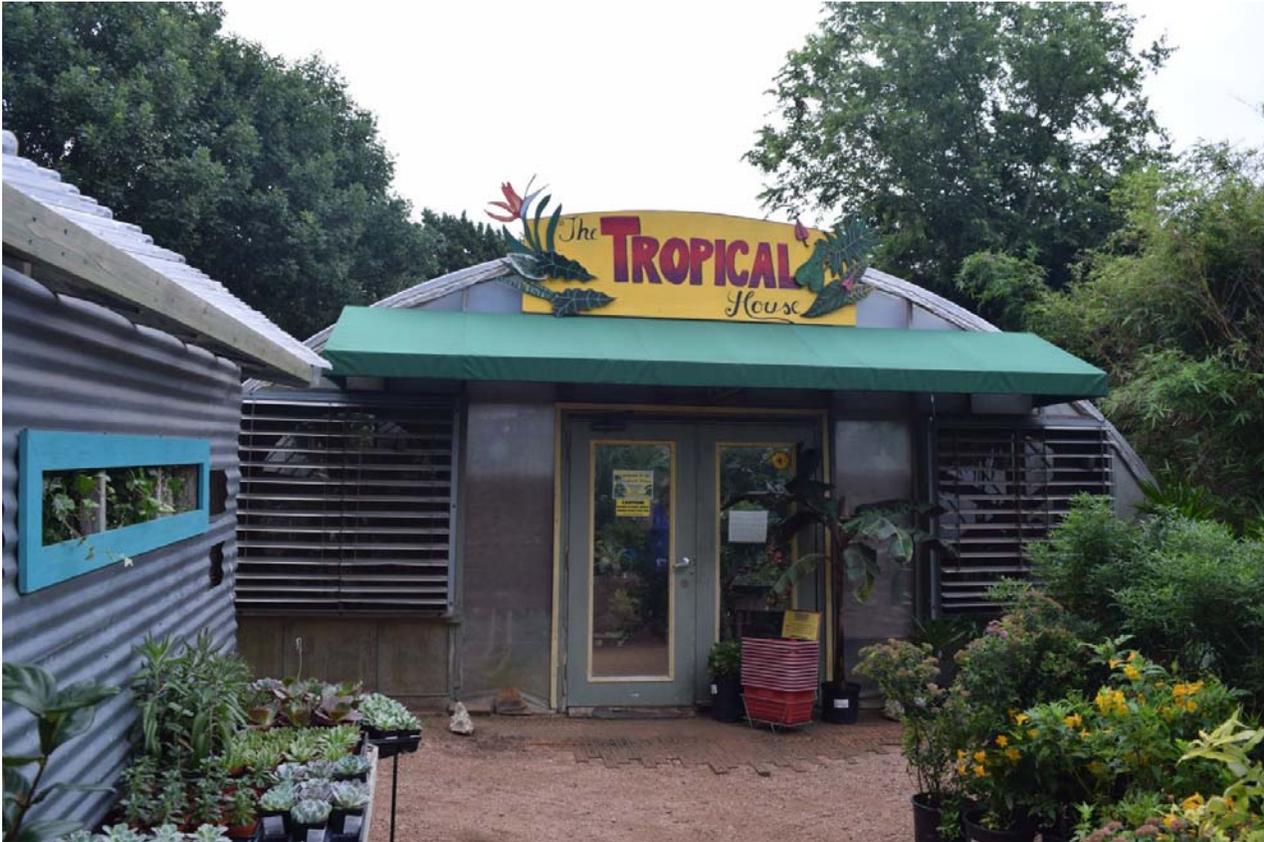
Photo 1 date taken: 5/26-28/16

Resource ID 16g      Name: The Natural Gardener      Year Built: ca. 2000      Source: field survey  
 Address: 8648 OLD BEE CAVES RD      Austin      Travis County      Texas  
 Parcel 101525      Lat: 30.257125      Long: -97.890524  
 ID      Type: Building      Style: None      Form: Rectangular  
 Historic Function/ Subcategory: Commerce/ Business      Individ. NRHP Eligible? No      Effect: N/A  
 Current Function/Subcategory: Commerce/ Business      Contributing to District? N/A

View facing north.

**NRHP Justification:** This resource is a non-historic-age secondary building on the same parcel as an historic-age resource. It is less than 50 years old and was not found to possess exceptional significance under Criterion Consideration G. As a result, it is recommended not eligible for the NRHP under Criterion A, B, C, or D.

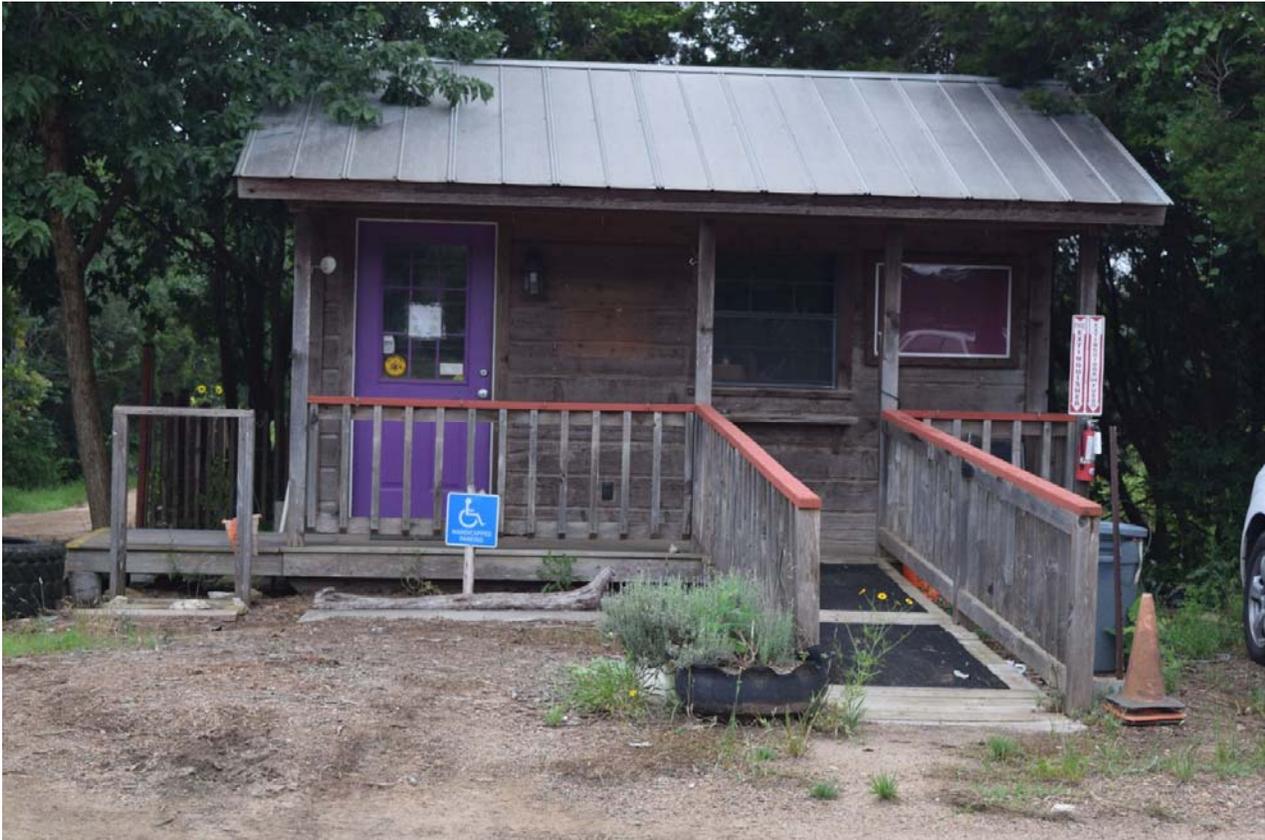
Photo 1 date taken: 5/26-28/16

Resource ID 16h      Name: The Natural Gardener      Year Built: ca. 2000      Source: field survey  
 Address: 8648 OLD BEE CAVES RD      Austin      Travis County      Texas  
 Parcel 101525      Lat: 30.25774      Long: -97.890479  
 ID      Type: Building      Style: None      Form: Rectangular  
 Historic Function/ Subcategory: Commerce/ Business      Individ. NRHP Eligible? No      Effect: N/A  
 Current Function/Subcategory: Commerce/ Business      Contributing to District? N/A

View facing south.

**NRHP Justification:** This resource is a non-historic-age secondary building on the same parcel as an historic-age resource. It is less than 50 years old and was not found to possess exceptional significance under Criterion Consideration G. As a result, it is recommended not eligible for the NRHP under Criterion A, B, C, or D.

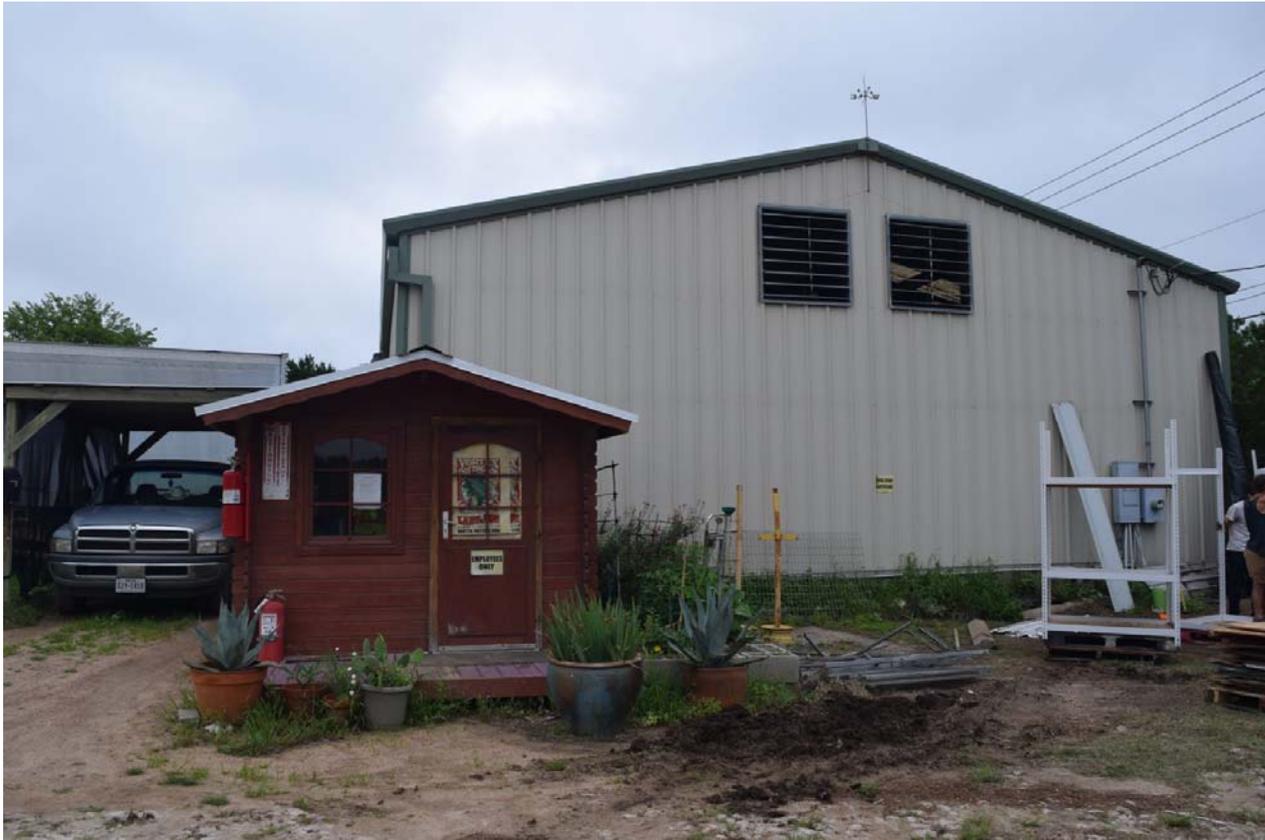
Resource ID 16i      Name: The Natural Gardener      Year Built: 2000      Source: TCAD  
 Address: 8648 OLD BEE CAVES RD      Austin      Travis County      Texas  
 Parcel 101525      Lat: 30.257581      Long: -97.889448  
 ID      Type: Building      Style: None      Form: Rectangular  
 Historic Function/ Subcategory: Commerce/ Business      Individ. NRHP Eligible? No      Effect: N/A  
 Current Function/Subcategory: Commerce/ Business      Contributing to District? N/A

View facing north.  
 Photo 1 date taken: 5/26-28/16

**Description:** This is a one-story commercial warehouse with a rectangular floorplan, metal siding, and a metal side-gabled roof. The building has a roll up door on the west side and no windows, although there are two vents in the south wall.

**NRHP Justification:** This resource is a non-historic-age secondary building on the same parcel as an historic-age resource. It is less than 50 years old and was not found to possess exceptional significance under Criterion Consideration G. As a result, it is recommended not eligible for the NRHP under Criterion A, B, C, or D.

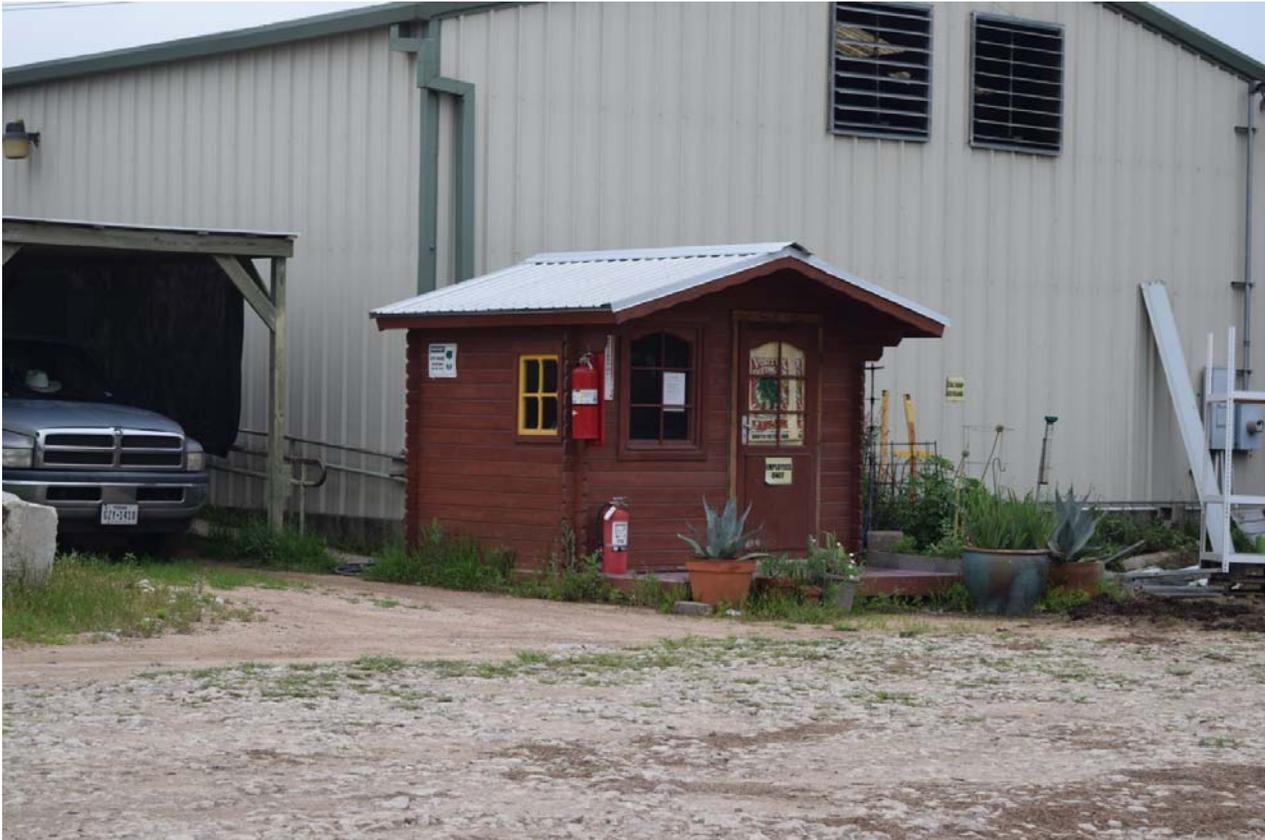
Resource ID 16j      Name: The Natural Gardener      Year Built: ca. 2000      Source: field survey  
 Address: 8648 OLD BEE CAVES RD      Austin      Travis County      Texas  
 Parcel 101525      Lat: 30.257505      Long: -97.889625  
 ID      Type: Building      Style: None      Form: Rectangular  
 Historic Function/ Subcategory: Commerce/ Business      Individ. NRHP Eligible? No      Effect: N/A  
 Current Function/Subcategory: Commerce/ Business      Contributing to District? N/A

View facing northeast.  
 Photo 1 date taken: 5/26-28/16

**Description:** This is a pre-fabricated one-story shed with a metal front-gabled roof. The windows are fixed wood frames.

**NRHP Justification:** This resource is a non-historic-age secondary building on the same parcel as an historic-age resource. It is less than 50 years old and was not found to possess exceptional significance under Criterion Consideration G. As a result, it is recommended not eligible for the NRHP under Criterion A, B, C, or D.

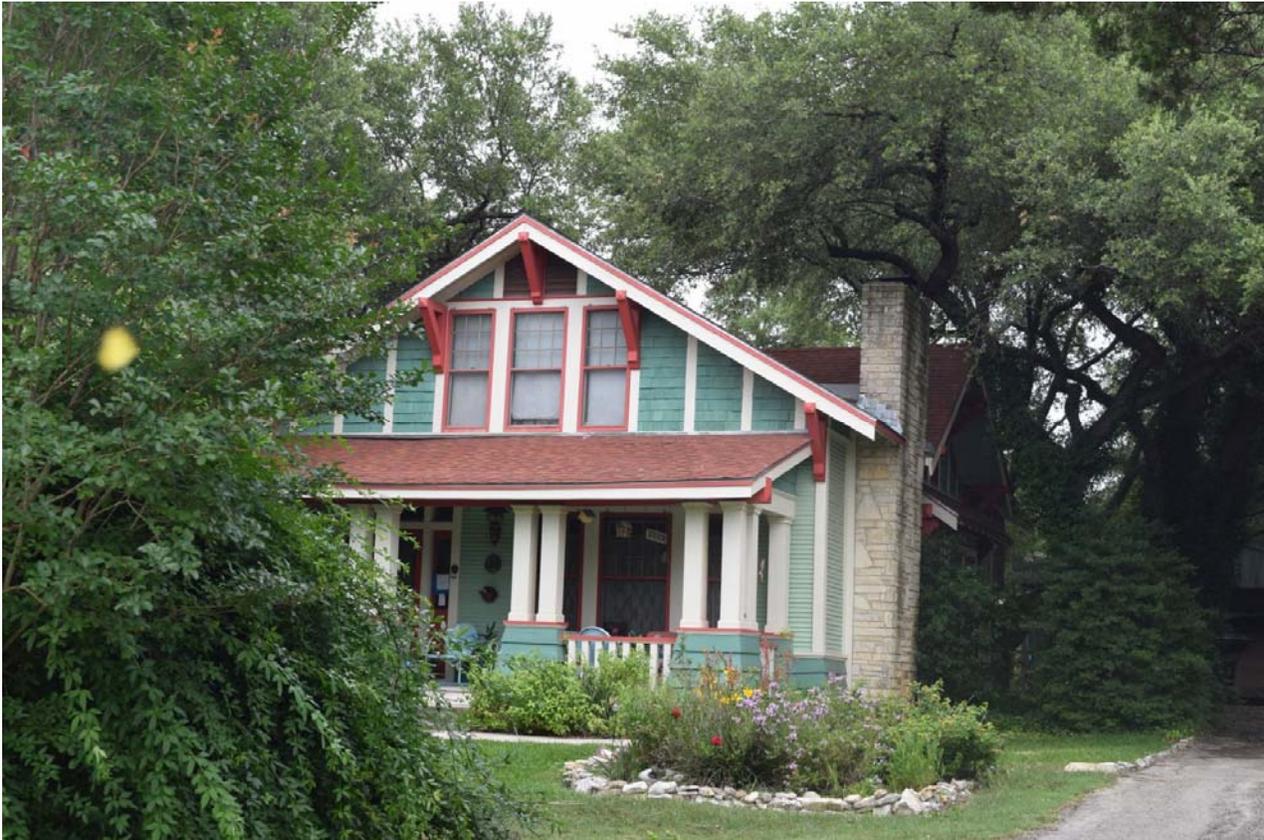
Photo 1 date taken: 5/26-28/16

Resource ID 17a      Name: None      Year Built: ca. 1970      Source: aerial photos  
 Address: 8624 OLD BEE CAVES RD      Austin      Travis County      Texas  
 Parcel ID 101516      Lat: 30.255591      Long: -97.889541  
 Type: Building      Style: Craftsman      Form: Rectangular  
 Historic Function/ Subcategory: Domestic/ Single Dwelling      Individ. NRHP Eligible? No      Effect: N/A  
 Current Function/Subcategory: Domestic/ Single Dwelling      Contributing to District? N/A

View facing northwest.

**NRHP Justification:** Review of aerial photographs indicate this house was not in this location prior to 1973 and research did not reveal whether it had been moved to this location or if it was built to reflect the Craftsman bungalow style and form. If the latter, it is not associated with the appropriate context to convey architectural significance. No associations were identified linking it to events or persons of historic importance, and it does not have potential to reveal important information. Therefore, it is recommended not eligible for listing in the NRHP under Criterion A, B, C, or D. Should further research reveal the house does date to the early twentieth century and was moved to this location, it should be reevaluated for eligibility for NRHP listing.

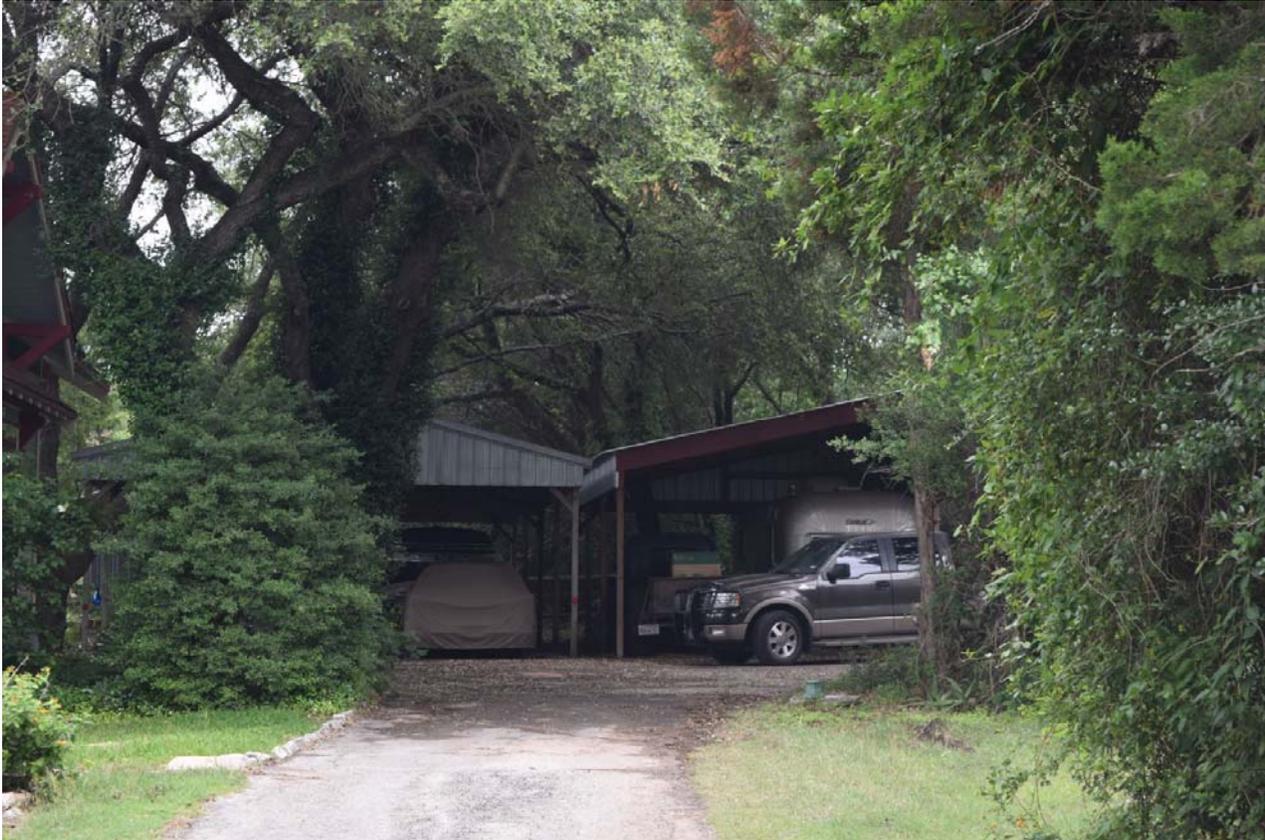
Resource ID 17b      Name: None      Year Built: ca. 1980      Source: field survey  
 Address: 8624 OLD BEE CAVES RD      Austin      Travis County      Texas  
 Parcel 101516      Lat: 30.25572      Long: -97.889339  
 ID      Type: Building      Style: None      Form: Rectangular  
 Historic Function/ Subcategory: Domestic/ Secondary Structure      Individ. NRHP Eligible? No      Effect: N/A  
 Current Function/Subcategory: Domestic/ Secondary Structure      Contributing to District? N/A

View facing northeast.  
 Photo 1 date taken: 5/26-28/16

**Description:** Resource 17b consists of two, open frame carports connected at the northeast side.

**NRHP Justification:** This resource is a non-historic-age secondary building on the same parcel as historic-age resources. The resource is less than 50 years old and was not found to possess exceptional significance under Criterion Consideration G. As a result, it is recommended not eligible for the NRHP under Criterion A, B, C, or D.

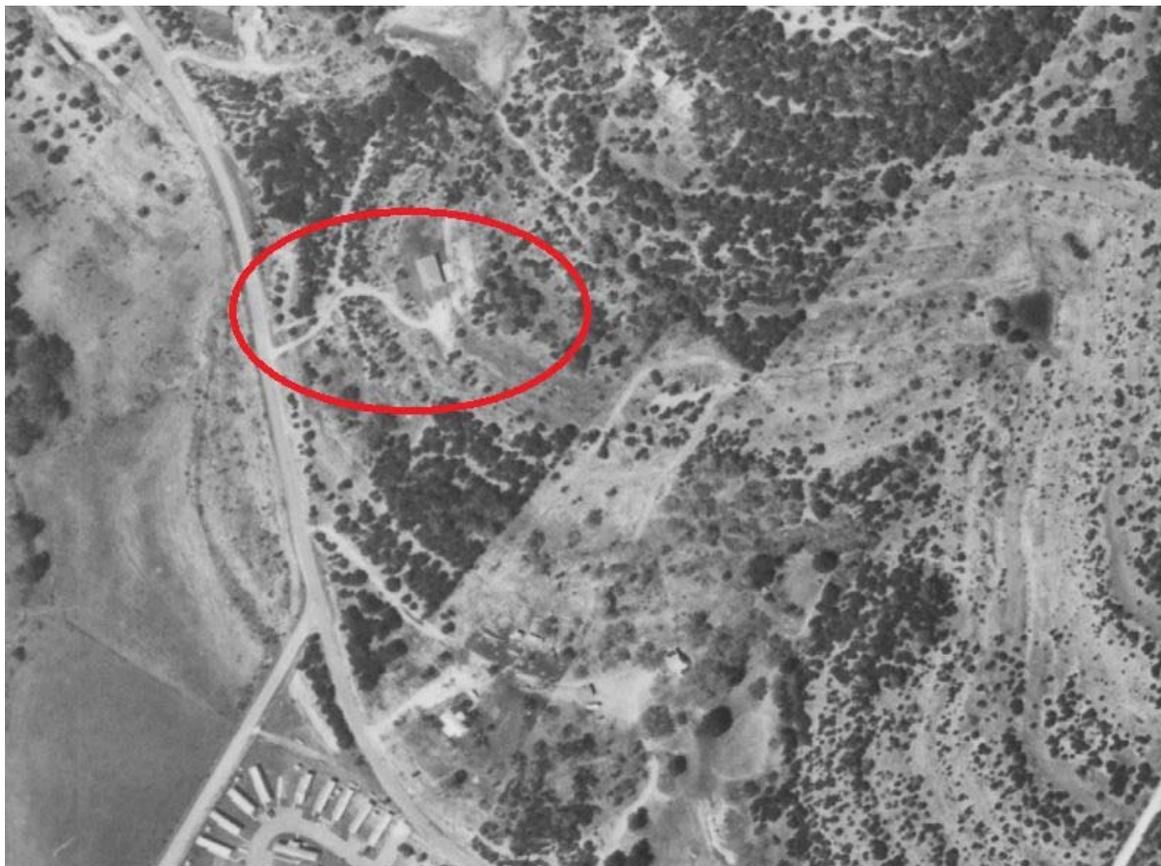
1973 aerial photograph showing Resource 18 in red circle. Image courtesy of Earth Explorer.  
 Photo 1 date taken: 1973

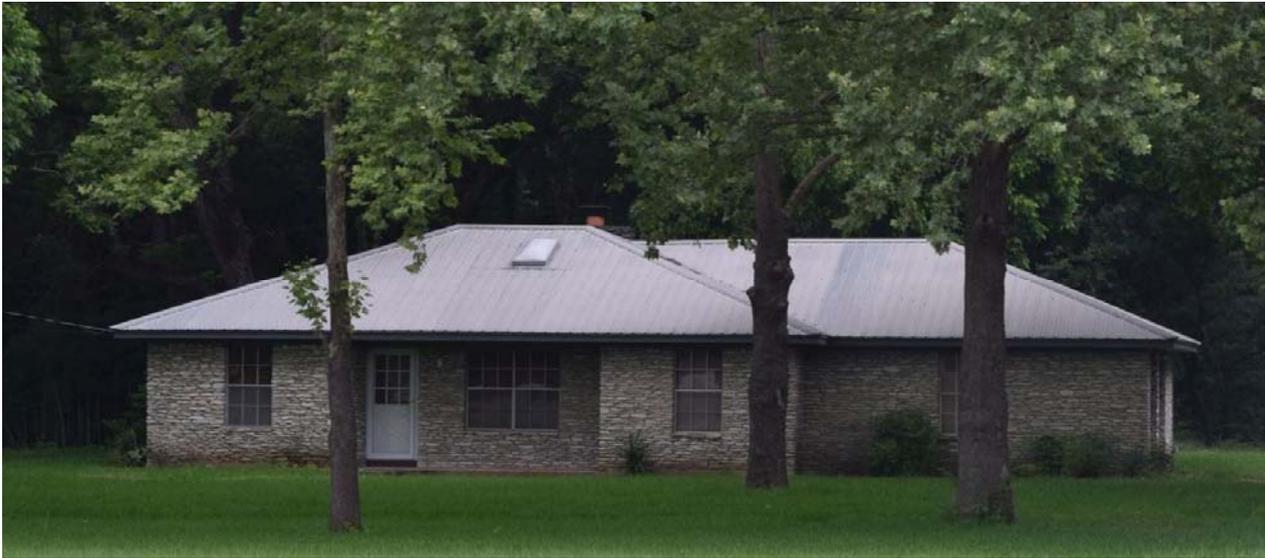
Photo 1 date taken: 5/26-28/16

<b>Resource ID</b> 19a	<b>Name:</b> None	<b>Year Built:</b> 1970	<b>Source:</b> TCAD
	<b>Address:</b> 8131 STATE HY 71	Austin Travis County	Texas
Parcel 306463 ID	<b>Lat:</b> 30.245107	<b>Long:</b> -97.886803	
	<b>Type:</b> Building	<b>Style:</b> Ranch	<b>Form:</b> Irregular
<b>Historic Function/ Subcategory:</b>	Domestic/ Single Dwelling	<b>Indiv. NRHP Eligible?</b> No	<b>Effect:</b> N/A
<b>Current Function/Subcategory:</b>	Domestic/ Single Dwelling	<b>Contributing to District?</b> N/A

View facing southwest.

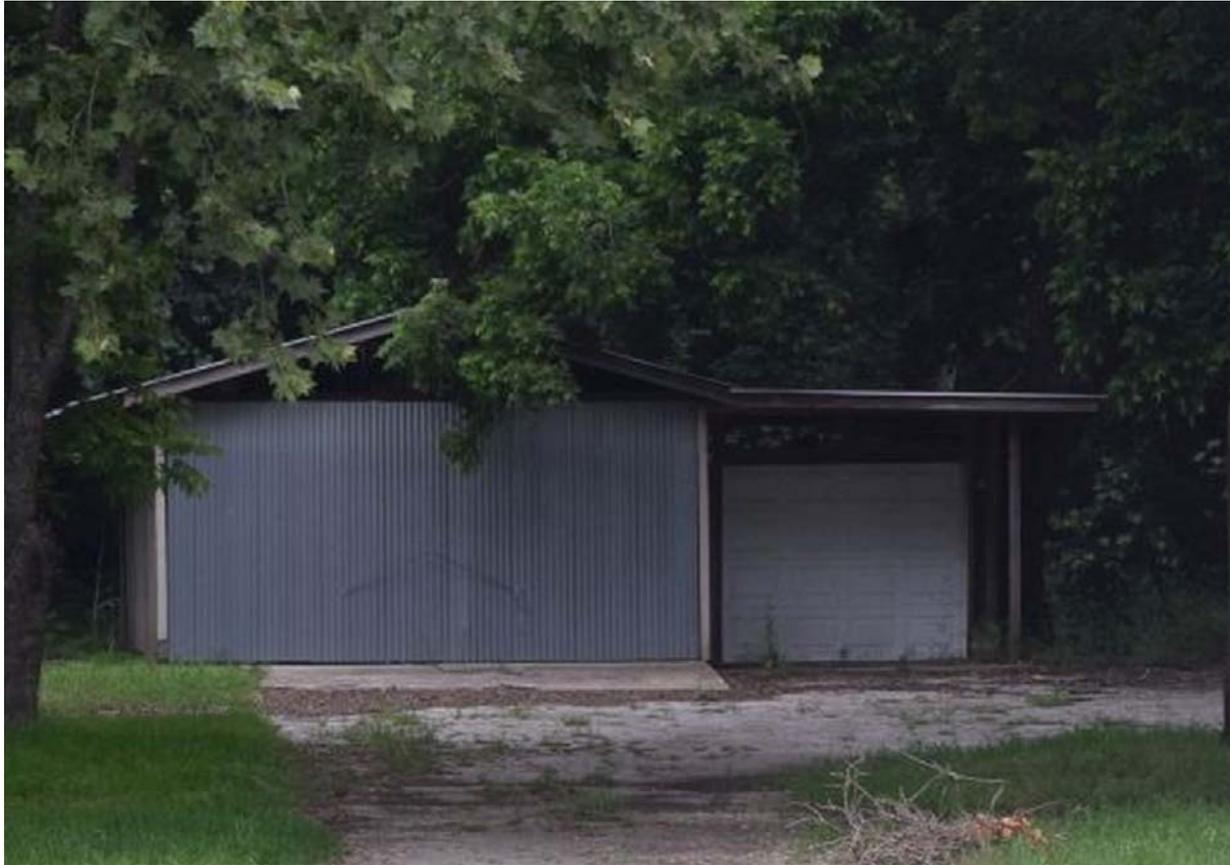
Photo 1 date taken: 5/26-28/16

Resource ID 19b      Name: None      Year Built: ca. 2000      Source: field survey  
 Address: 8131 STATE HY 71      Austin      Travis County      Texas  
 Parcel 306463      Lat: 30.245008      Long: -97.886888  
 ID      Type: Building      Style: None      Form: Rectangular  
 Historic Function/ Subcategory: Domestic/ Secondary Structure      Individ. NRHP Eligible? No      Effect: N/A  
 Current Function/Subcategory: Domestic/ Secondary Structure      Contributing to District? N/A

View facing southwest.

**NRHP Justification:** This resource is a non-historic-age secondary building on the same parcel as an historic-age resource. It is less than 50 years old and was not found to possess exceptional significance under Criterion Consideration G. As a result, it is recommended not eligible for the NRHP under Criterion A, B, C, or D.

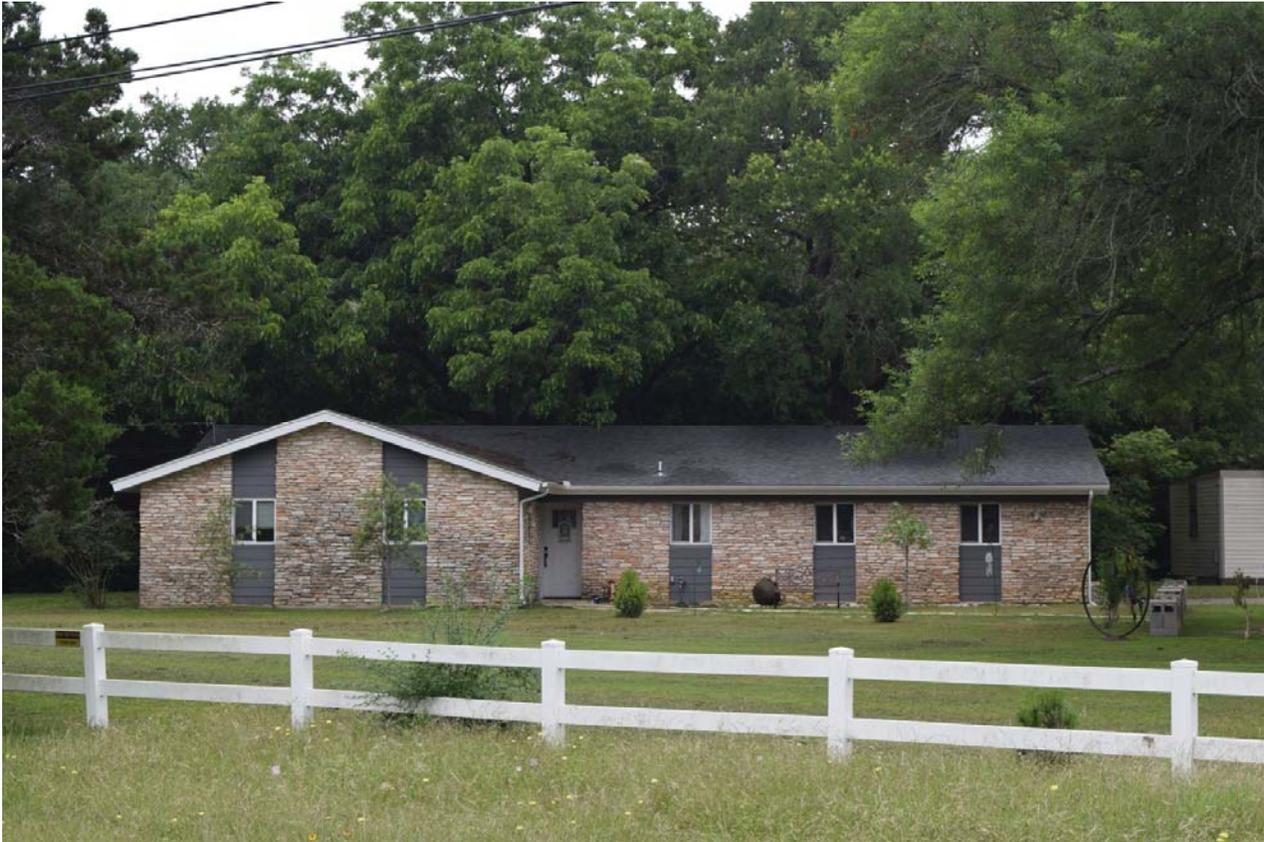
Photo 1 date taken: 5/26-28/16

<b>Resource ID</b> 20a	<b>Name:</b> None	<b>Year Built:</b> 1970	<b>Source:</b> TCAD
	<b>Address:</b> 8101 STATE HY 71	Austin Travis County	Texas
Parcel ID 306465	<b>Lat:</b> 30.244874	<b>Long:</b> -97.885758	
	<b>Type:</b> Building	<b>Style:</b> Ranch	<b>Form:</b> L-plan
<b>Historic Function/ Subcategory:</b>	Domestic/ Single Dwelling	<b>Indiv. NRHP Eligible?</b> No	<b>Effect:</b> N/A
<b>Current Function/Subcategory:</b>	Domestic/ Single Dwelling	<b>Contributing to District?</b> N/A

View facing south.

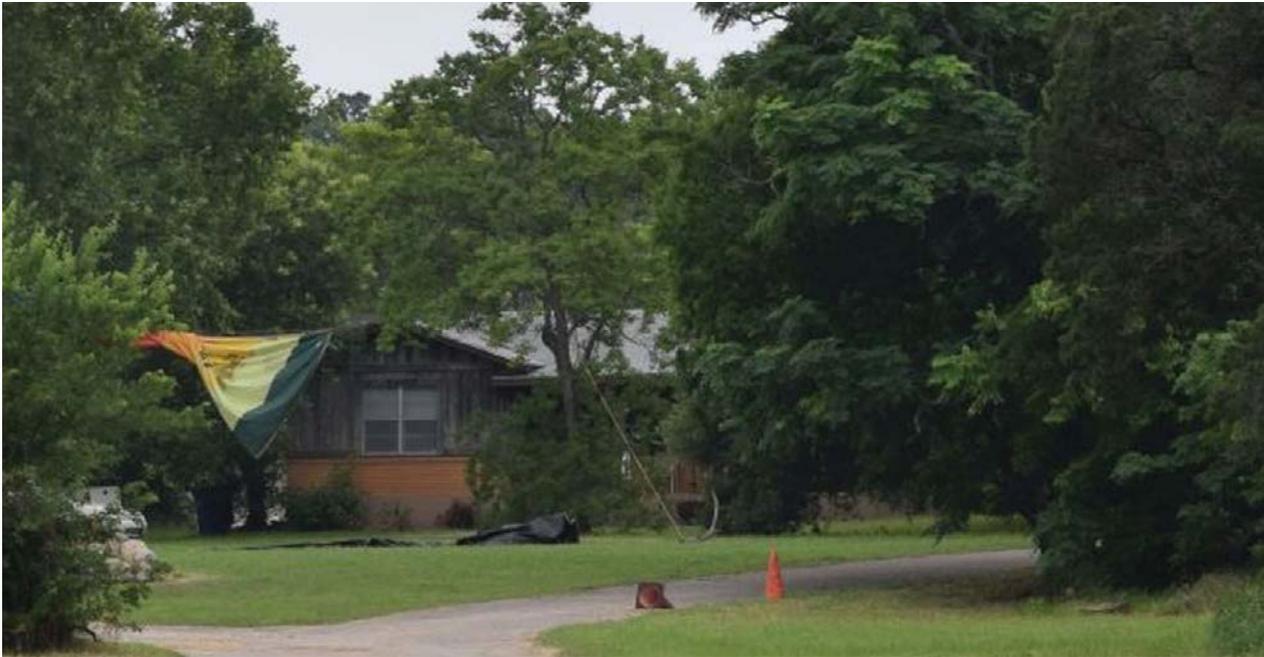
Northeast elevation. View facing southwest  
 Photo 1 date taken: 5/26-28/16

**Description:** This is a one-story ranch-style house with wood and brick siding and aluminum windows. It has a composition shingle cross-gabled roof. Due to set back from roadway and surrounding vegetation, the house is difficult to see from the public right of way.

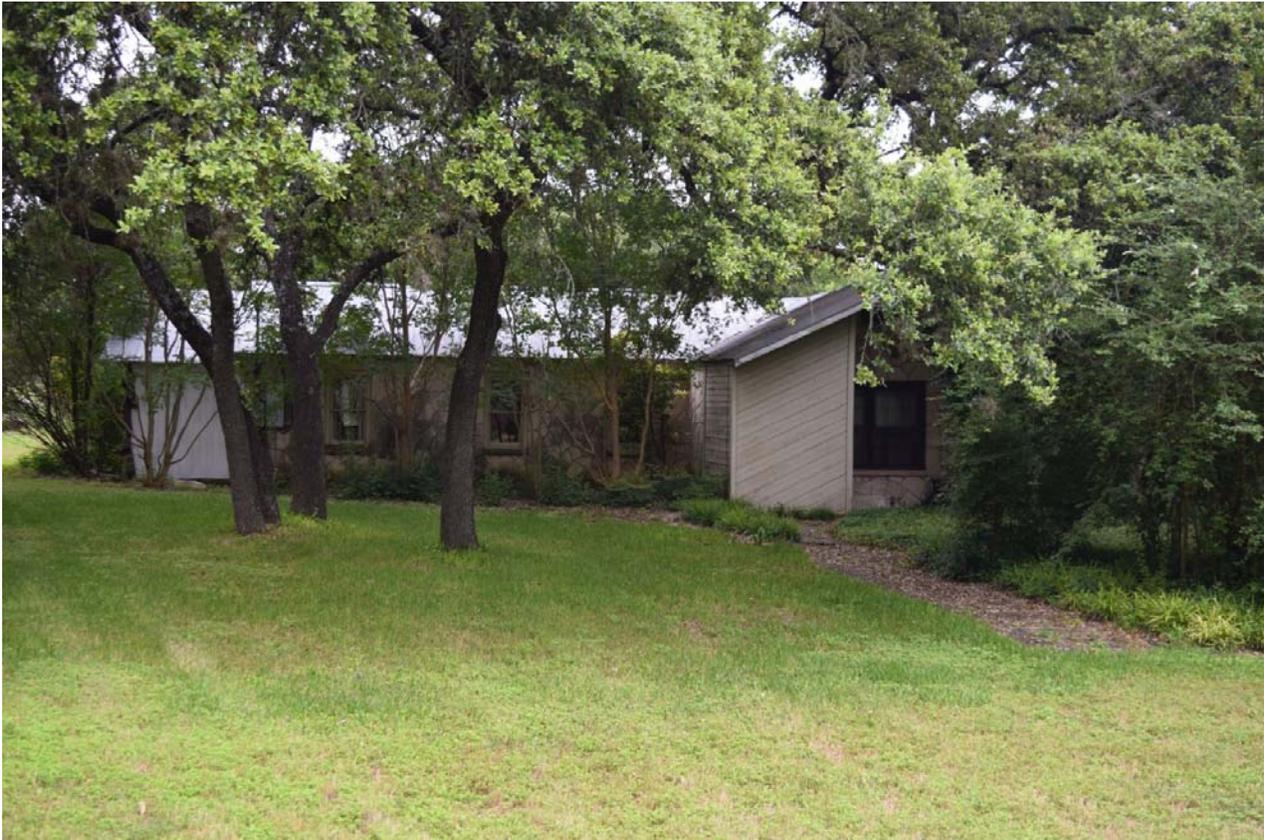
View facing east.  
 Photo 1 date taken: 5/26-28/16

**Description:** This is a one-story L-plan residence with stone and wood siding and a metal gabled roof. It has both wooden and vinyl windows. An addition to the north side and the use of diagonal wood cladding lend a mid-twentieth century aesthetic to the building. The owner confirmed the original date of construction and additions to the building.

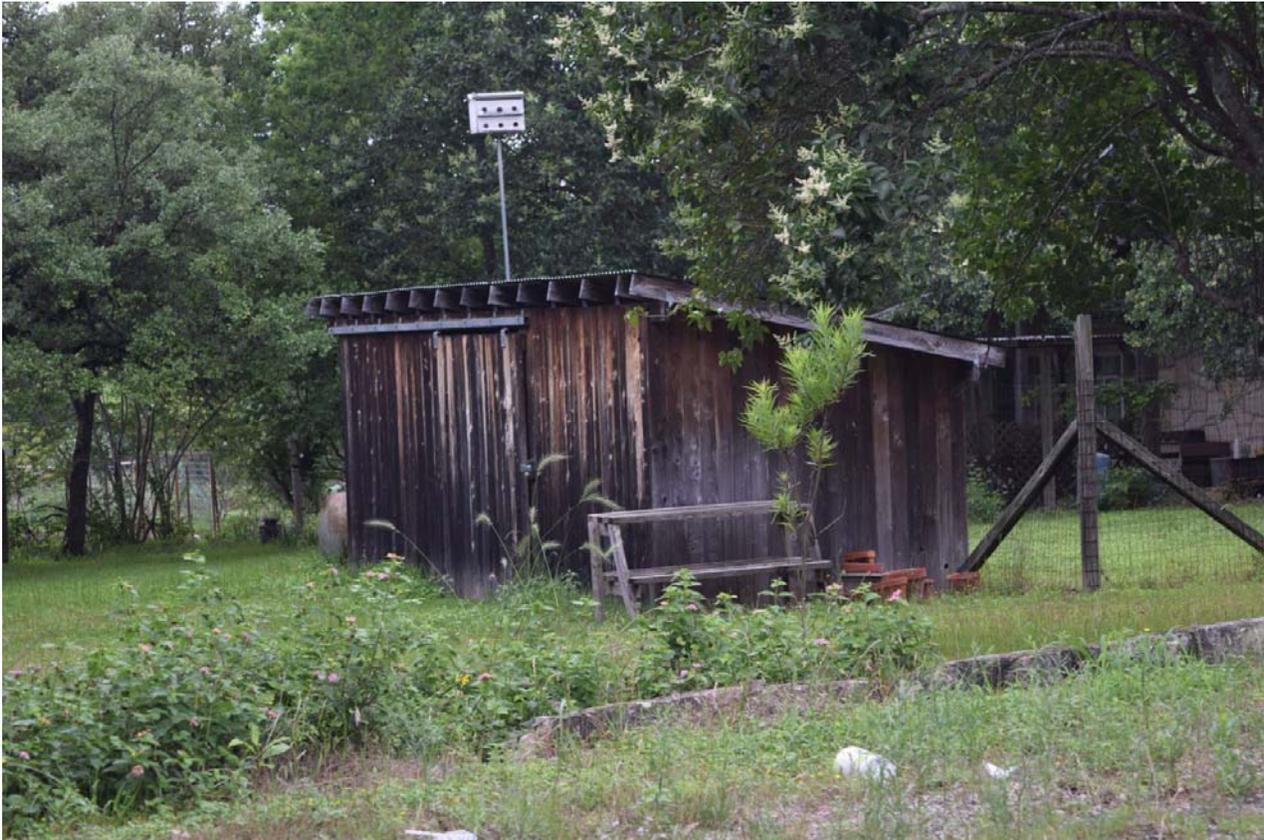
View facing southwest.

Photo 1 date taken: 5/26-28/16

**Description:** This is a one-story rustic shed with cedar siding and a metal shed roof on exposed rafters. The door is a sliding barn door.

**NRHP Justification:** This resource is a non-historic-age secondary building on the same parcel as historic-age resources. The resource is less than 50 years old and was not found to possess exceptional significance under Criterion Consideration G. As a result, it is recommended not eligible for the NRHP under Criterion A, B, C, or D.

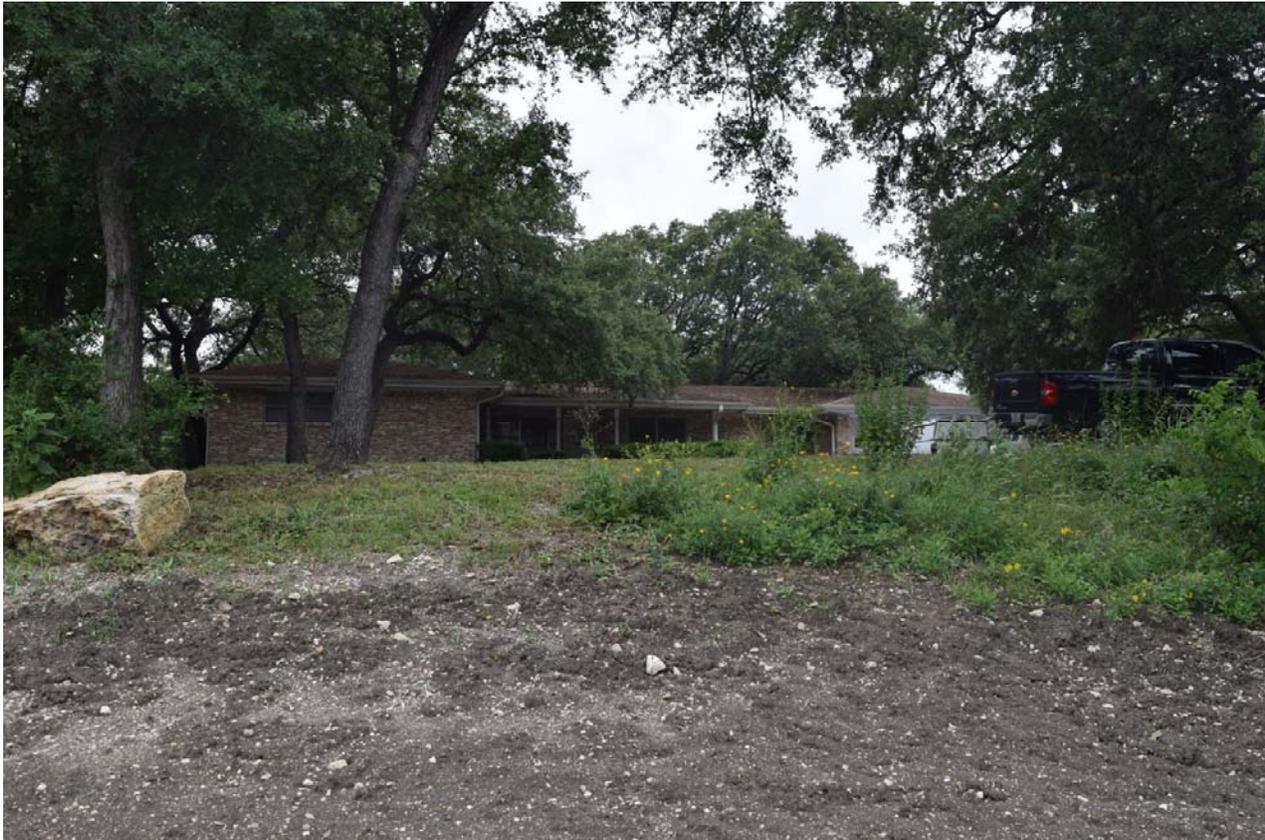
View facing west.  
 Photo 1 date taken: 5/26-28/16

**Description:** This is a one-story ranch-style house clad in stone. It has a cross-hipped roof with composition shingles. The house has a partial width, shed roof porch. Windows are small high-set metal sashes on the wings and larger sashes on the primary elevation. Due to surrounding vegetation and location on hill above SH 71, photographs from multiple perspectives were difficult to obtain.

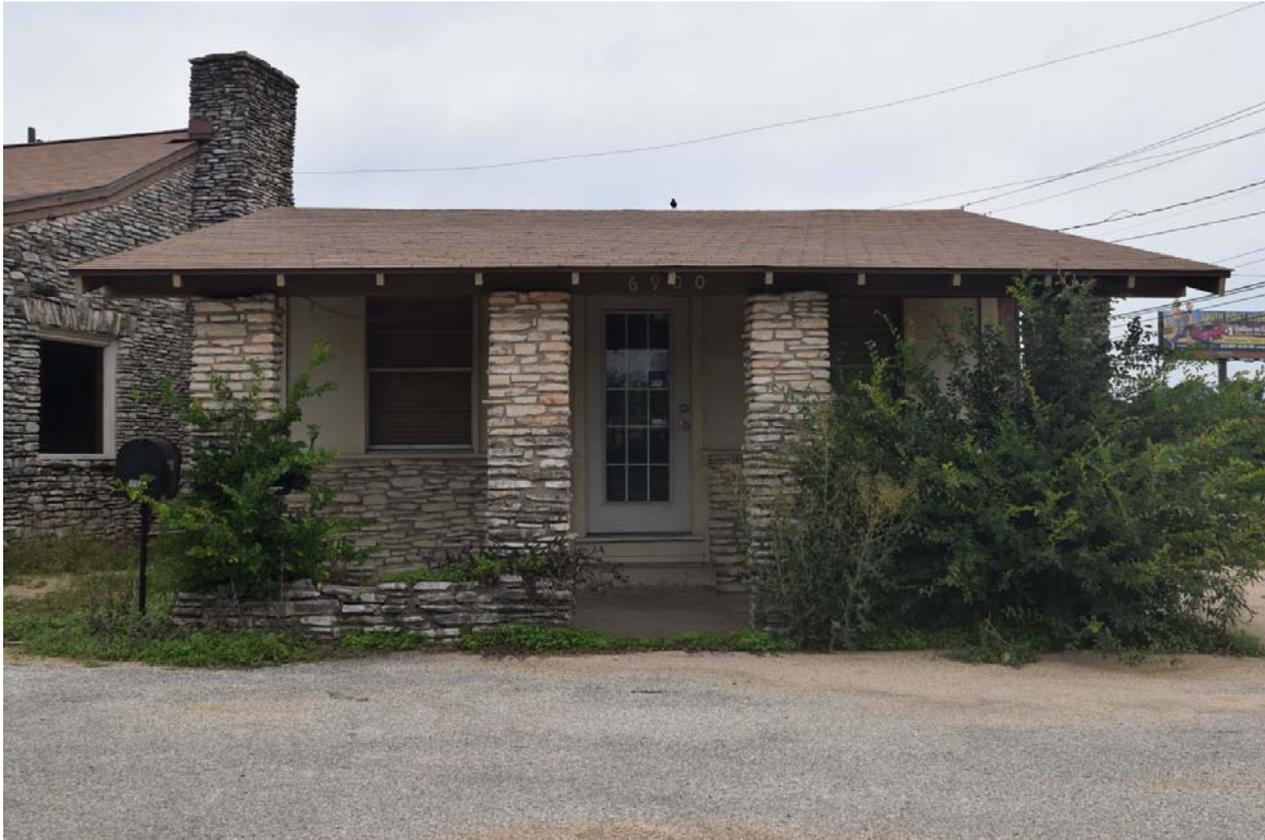
View facing north.  
 Photo 1 date taken: 5/26-28/16

**Description:** This is a one-story commercial building clad in stone and stucco. It has a side-gabled roof with full width, integrated porch supported by stone columns. The main door is a single steel door. The windows are not visible beneath metal window screens.
