Draft Historic Resources  
Survey Report  
for the Oak Hill Parkway Project

U.S. Highway 290 (US 290) / State Highway (SH)  
71 West from State Loop 1 (Mopac) to  
Ranch-to-Market (RM) 1826 and SH 71 to  
Silvermine Drive  
Travis County, Texas  
CSJ # 0113-08-060 and 0700-03-077  
October 2017

# Report for Historical Studies Survey

CSJs 0113-08-060 and 0700-03-077;  
Oak Hill Parkway Project: US 290 from  
Loop 1 (Mopac) to RM 1826 and SH  
71 from US 290 to Silvermine Drive  
Travis County, Austin District

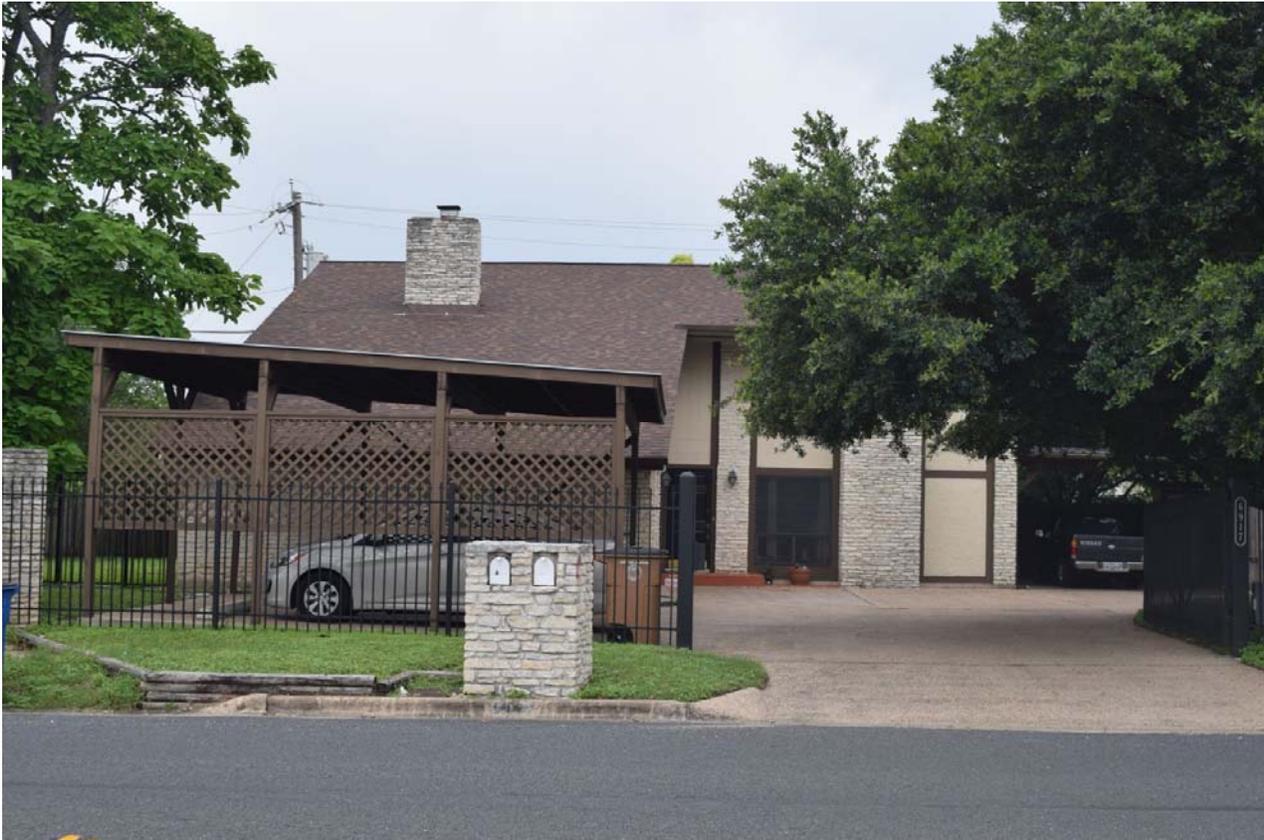
Photo 1 date taken: 5/26-28/16

Resource ID 27a Name: None Year Built: 1971 Source: TCAD  
 Address: 6917 SCENIC BROOK DR Austin Travis County Texas  
 Parcel 308759 Lat: 30.236538 Long: -97.879201  
 ID Type: Building Style: Contemporary Form: Irregular  
 Historic Function/ Subcategory: Domestic/Multiple Dwelling Individ. NRHP Eligible? No Effect: N/A  
 Current Function/Subcategory: Domestic/Multiple Dwelling Contributing to District? N/A

View facing south.

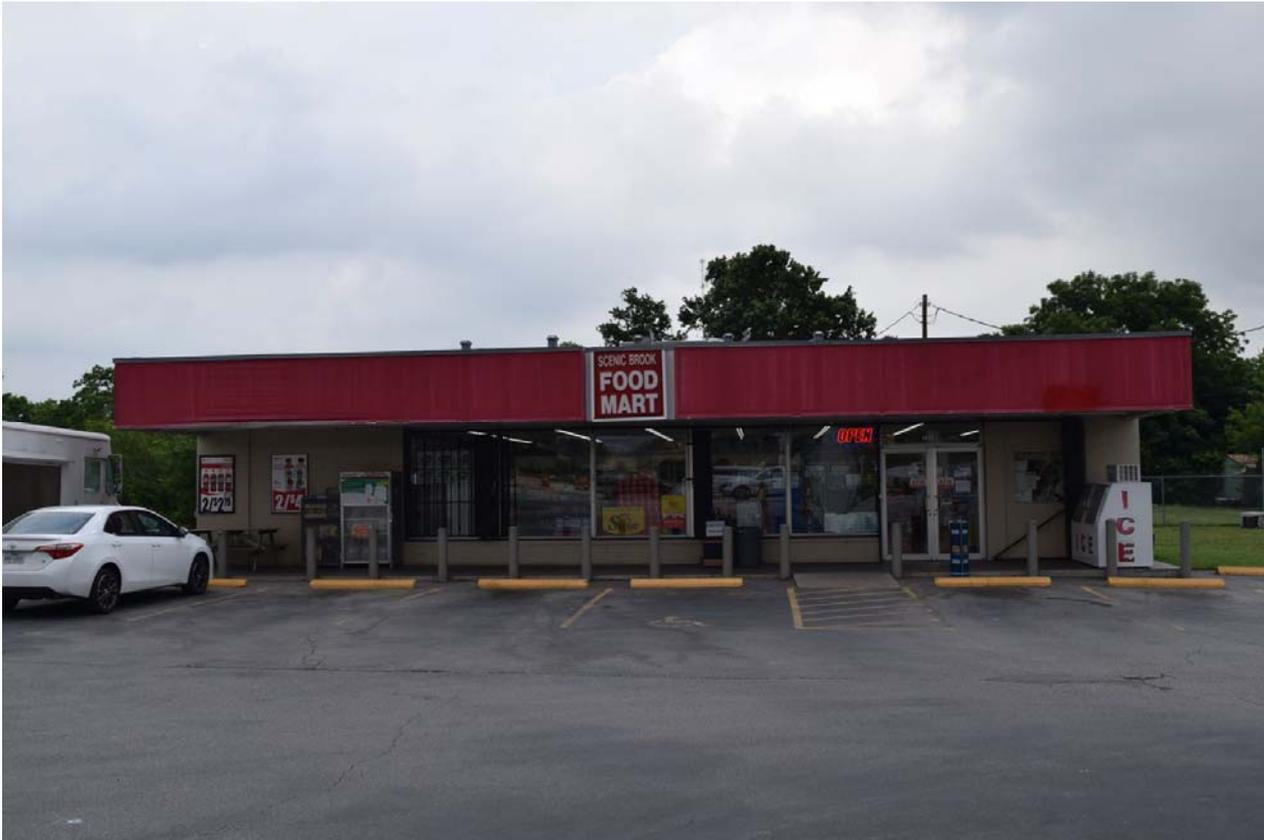
Photo 1 date taken: 5/26-28/16

Resource ID 28      Name: Scenic Brook Food Mart      Year Built: 1973      Source: TCAD  
 Address: 7216 STATE HY 71      Austin      Travis County      Texas  
 Parcel 308762      Lat: 30.236888      Long: -97.877553  
 ID      Type: Building      Style: None      Form: Rectangular  
 Historic Function/ Subcategory: Commerce/ Business      Individ. NRHP Eligible? No      Effect: N/A  
 Current Function/Subcategory: Commerce/ Business      Contributing to District? N/A

View facing east.

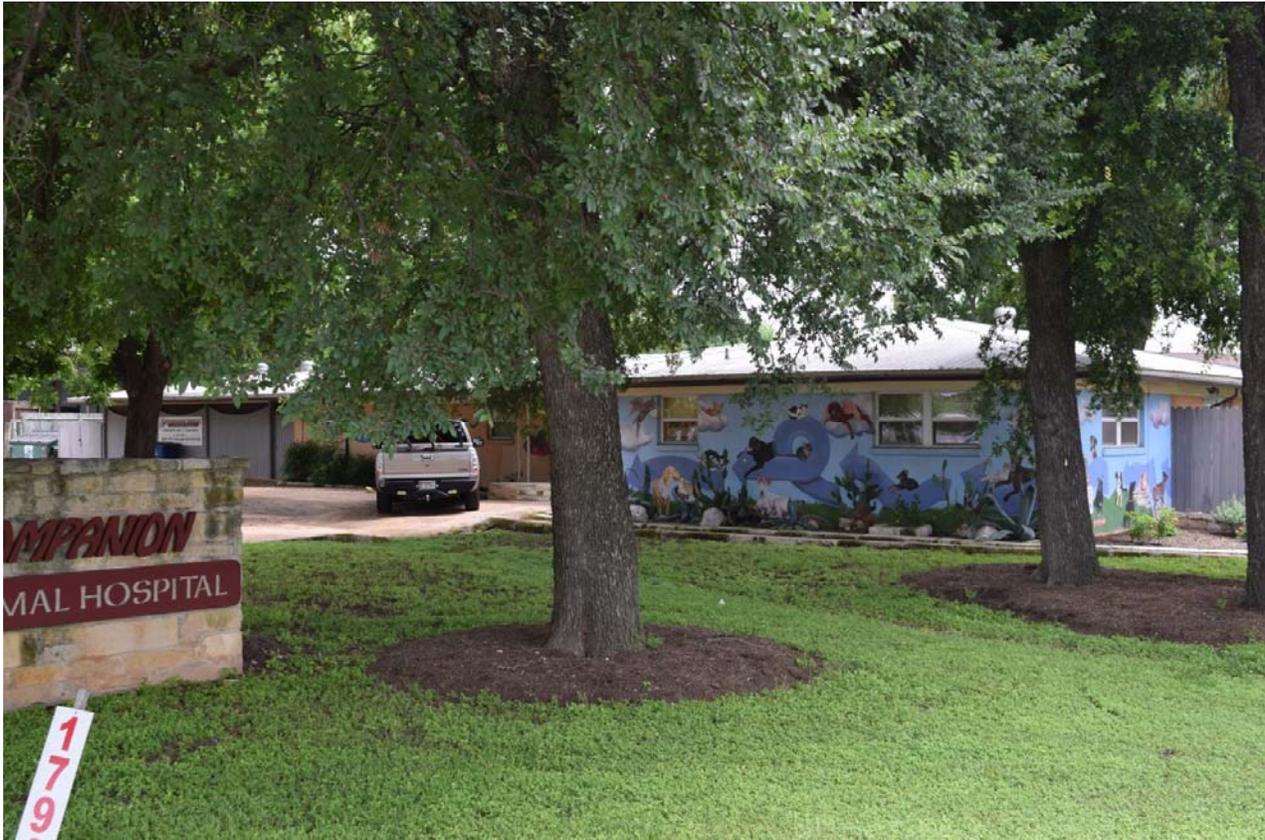
View facing north.  
 Photo 1 date taken: 5/26-28/16

Resource ID 29      Name: Companion Animal Hospital      Year Built: 1958      Source: TCAD  
 Address: 7132 STATE HY 71      Austin      Travis County      Texas  
 Parcel 311852      Lat: 30.236031      Long: -97.87685  
 ID      Type: Building      Style: Mid-century Modern      Form: Irregular  
 Historic Function/ Subcategory: Healthcare/Animal Hospital      Individ. NRHP Eligible? No      Effect: N/A  
 Current Function/Subcategory: Healthcare/Animal Hospital      Contributing to District? N/A

**Description:** This is a one-story L-plan commercial building with a composition shingle hipped roof and stucco walls. There are high-set vinyl sash windows and a single door in the inset porch, which is supported by a fabricated metal post. The building currently has a mural reflecting its function.

**NRHP Justification:** This resource is a common example of its type and has no distinguishing characteristics. No associations were identified linking this resource to persons or events of historic importance. The resource does not embody distinctive characteristics of a type, period, or method of construction when compared with other nearby gas stations/convenience stores. Also, it does not represent the work of a master or possess high artistic value, and it does not have potential to reveal important information. As a result, it is recommended not eligible for inclusion in the NRHP under Criterion A, B, C, or D.

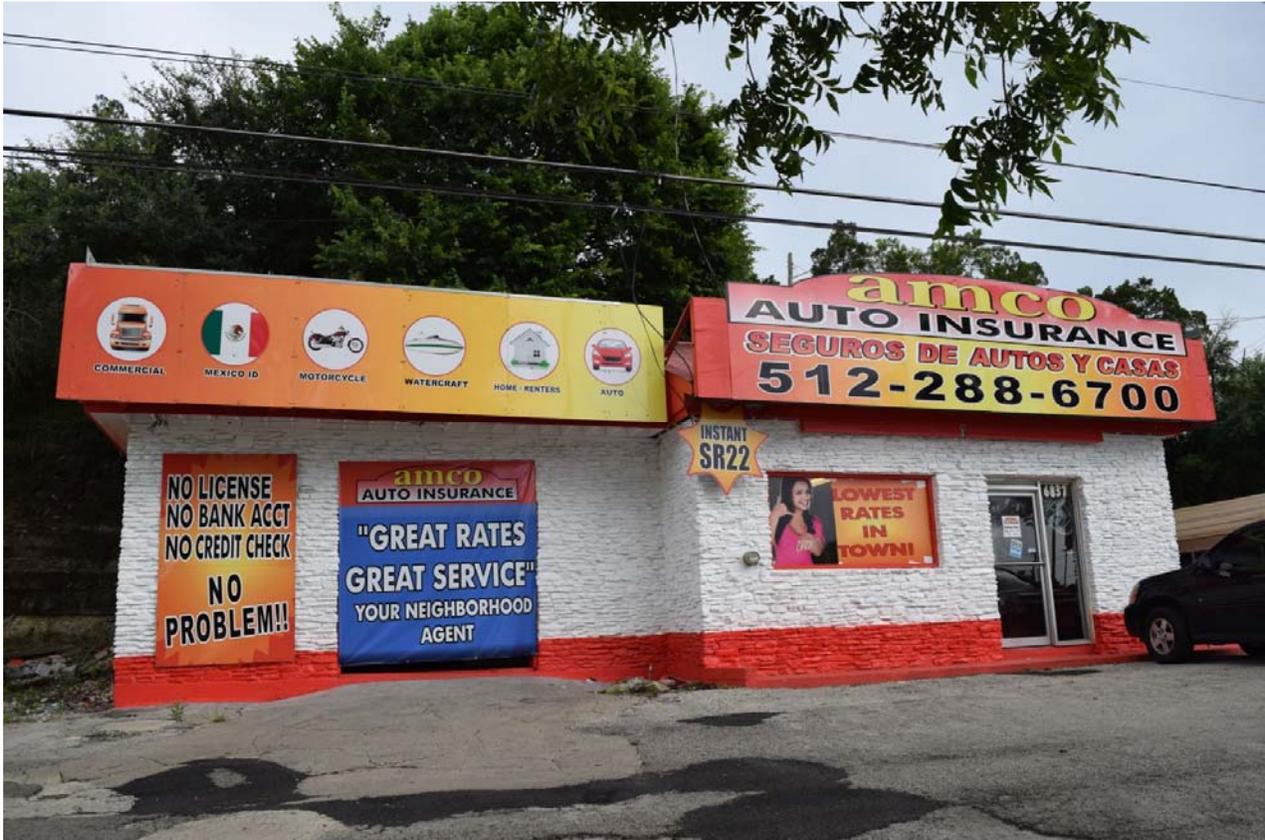
Photo 1 date taken: 5/26-28/16

Resource ID 32a Name: AMCO Auto Insurance Year Built: 1966 Source: TCAD  
 Address: 6837 U S HY 290 Austin Travis County Texas  
 Parcel 311753 Lat: 30.233688 Long: -97.871325  
 ID Type: Building Style: None Form: Irregular  
 Historic Function/ Subcategory: Commerce/ Business Individ. NRHP Eligible? No Effect: N/A  
 Current Function/Subcategory: Commerce/ Business Contributing to District? N/A

View facing south.

**NRHP Justification:** This resource is a common example of its type and has no distinguishing characteristics. No associations were identified linking this resource to persons or events of historic importance. The resource does not embody distinctive characteristics of a type, period, or method of construction. Also, it does not represent the work of a master or possess high artistic value, and it does not have potential to reveal important information. As a result, it is recommended not eligible for inclusion in the NRHP under Criterion A, B, C, or D.

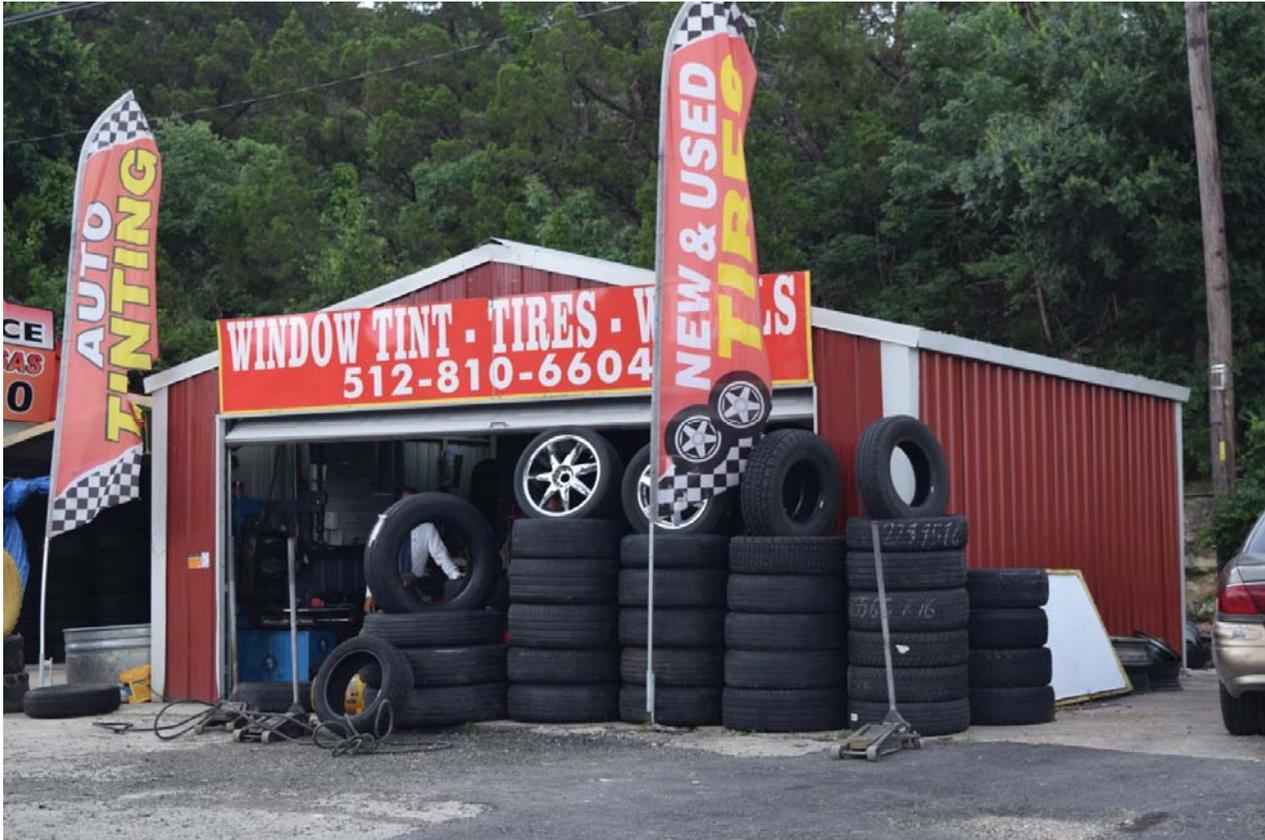
Photo 1 date taken: 5/26-28/16

Resource ID 32b Name: Window Tint-Tires-Wheels Year Built: ca. 1990 Source: field survey  
 Address: 6837 U S HY 290 Austin Travis County Texas  
 Parcel 311753 Lat: 30.233662 Long: -97.871522  
 ID Type: Building Style: None Form: Rectangular  
 Historic Function/ Subcategory: Commerce/ Business Indiv. NRHP Eligible? No Effect: N/A  
 Current Function/Subcategory: Commerce/ Business Contributing to District? N/A

View facing southeast.

**Description:** This is a one-story metal building with a front gable roof. There is an overhead garage door in the north elevation. The building is used for a tire repair business. There is a free-standing metal carport at the east side of the building.

**NRHP Justification:** This resource is a non-historic-age secondary building on the same parcel as historic-age resources. The resource is less than 50 years old and was not found to possess exceptional significance under Criterion Consideration G. As a result, it is recommended not eligible for the NRHP under Criterion A, B, C, or D.

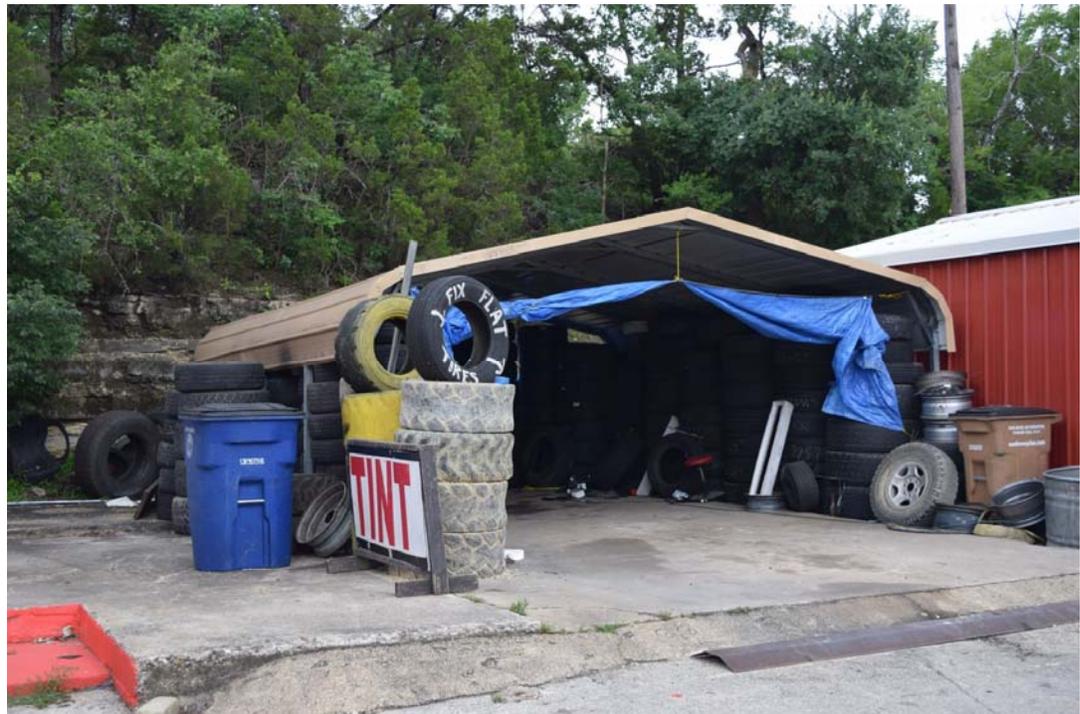
Photo 3 date taken:  
5/26-28/16

Freestanding carport east of  
Resource 32b. View facing  
southeast.

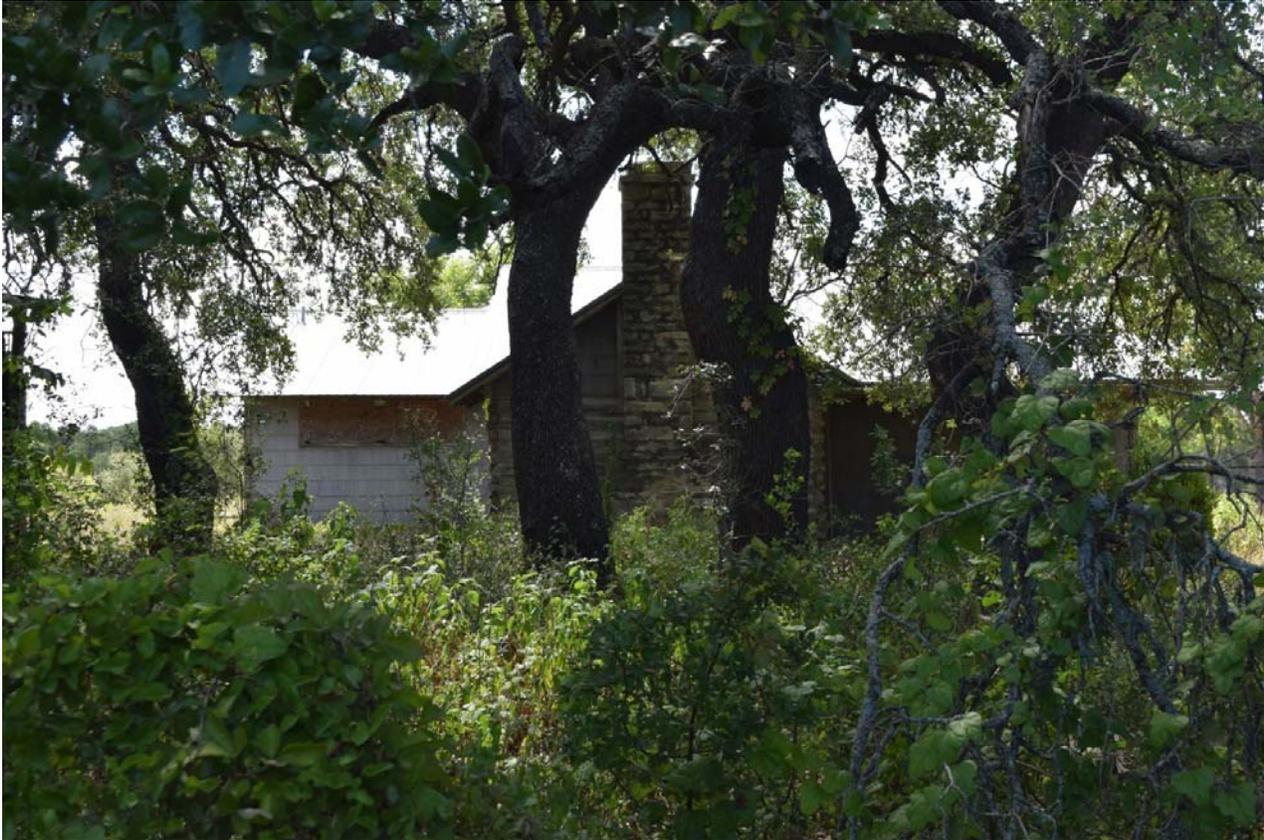
View facing east  
 Photo 1 date taken: 7/19/16

Resource ID 33a      Name: Patton Ranch      Year Built: 1870      Source: TCAD  
 Address: 5613 PATTON RANCH RD      Austin      Travis County      Texas  
 Parcel 310576      Lat: 30.242007      Long: -97.857074  
 ID      Type: Building      Style: None      Form: Irregular  
 Historic Function/ Subcategory: Domestic/ Single Dwelling      Individ. NRHP Eligible? Yes      Effect: No Effect  
 Current Function/Subcategory: Vacant/ Not in Use      Contributing to District? N/A

**Description:** This resource is a one-story house with the original front-gabled log building and additions to the north and south sides. It has a cross gable roof, irregular floor plan, exterior stone chimney, and inset porch. The additions are clad in asbestos siding. Windows are boarded over. Although the TCAD dates the building to 1935, the Travis County Historical Commission's 2015 survey indicates the log portion was constructed in 1870 by James A. Patton. The property is overgrown with heavy vegetation making photos from various perspectives difficult to take. The property is not currently in use.

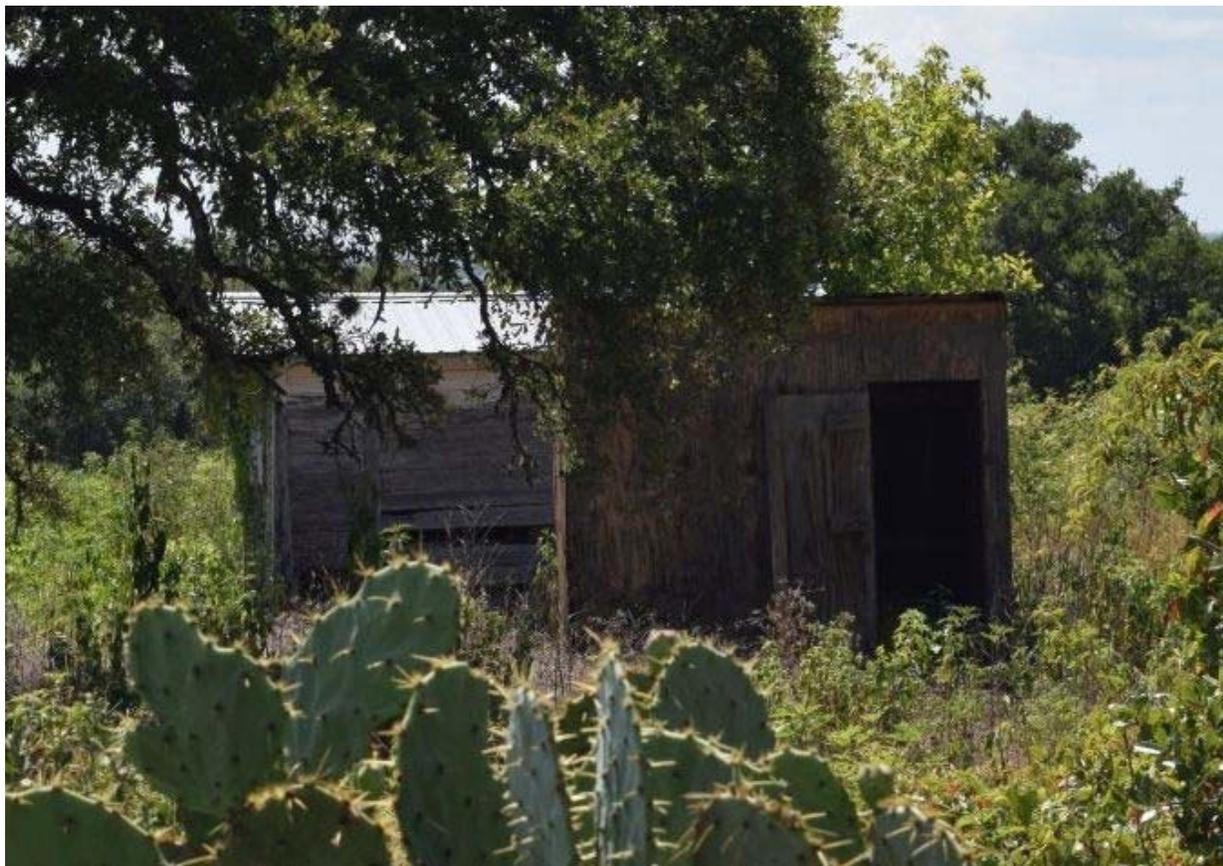
View facing east.  
 Photo 1 date taken: 7/19/16

Resource ID 33b      Name: Patton Ranch      Year Built: 1935      Source: TCAD  
 Address: 5613 PATTON RANCH RD      Austin      Travis County      Texas  
 Parcel 310576      Lat: 30.242306      Long: -97.857127  
 ID      Type: Building      Style: None      Form: Rectangular  
 Historic Function/ Subcategory: Domestic/ Secondary Structure      Individ. NRHP Eligible? No      Effect: No Effect  
 Current Function/Subcategory: Vacant/ Not in Use      Contributing to District? N/A

**Description:** This resource constitutes two outbuildings assumed to have been used to house animals or store agricultural implements. The buildings are clad in wood siding. One has a shed roof and the other one has a front gable roof.

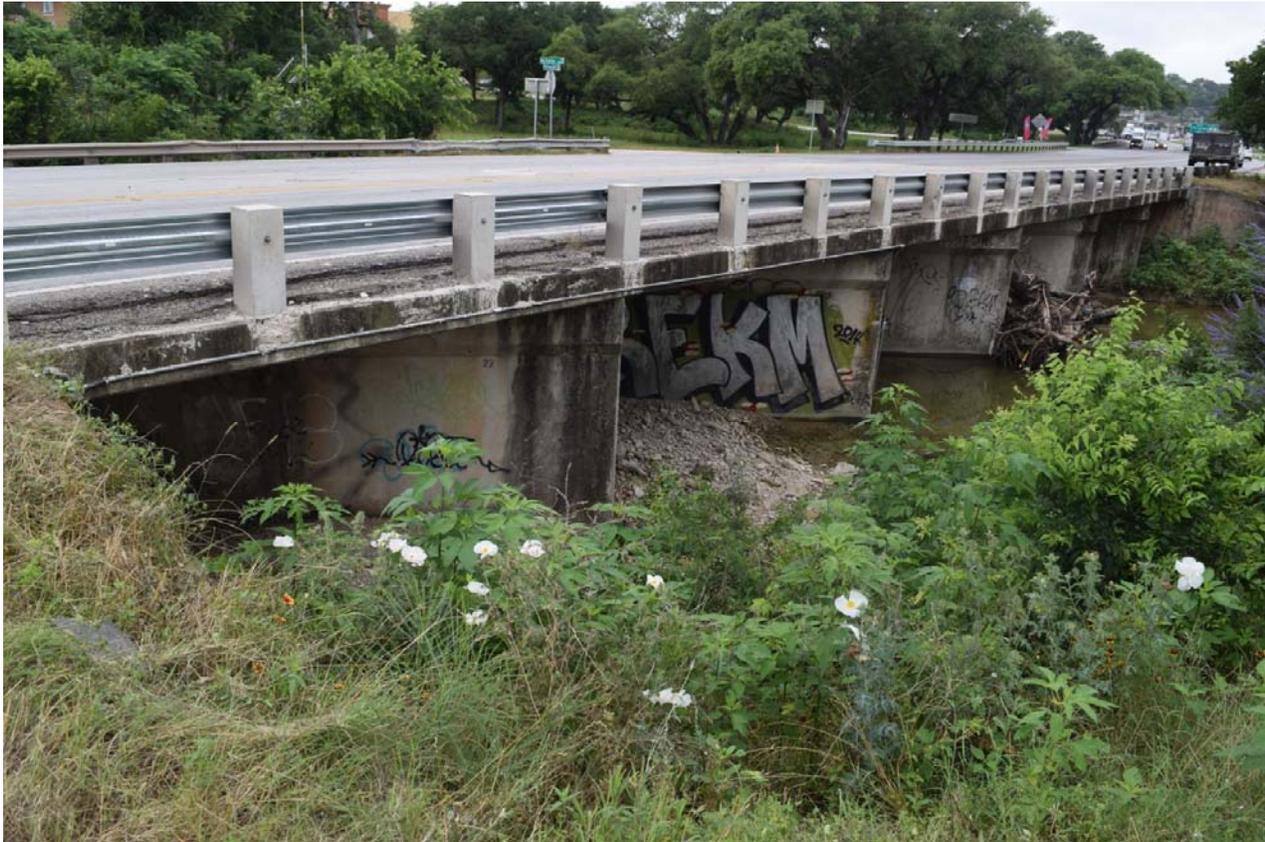
Photo 1 date taken: 5/26-28/16

<b>Resource ID</b> 34	<b>Name:</b> US 290 Bridge	<b>Year Built:</b> 1934/1963	<b>Source:</b> NBI
	<b>Address:</b> OVER WILLIAMSON CREEK	Austin Travis County	Texas
Parcel n/a ID	<b>Lat:</b> 30.235355	<b>Long:</b> -97.860195	
	<b>Type:</b> Structure	<b>Style:</b> None	<b>Form:</b> Linear
<b>Historic Function/ Subcategory:</b>	Transportation/ Road-related	<b>Indiv. NRHP Eligible?</b> No	<b>Effect:</b> N/A
<b>Current Function/Subcategory:</b>	Transportation/ Road-related	<b>Contributing to District?</b> N/A

View facing southwest.

**Description:** The NBI number for this structure is 142270011308022. Constructed in 1934, this bridge is a six span, concrete slab bridge. NBI records indicate it was reconstructed in 1963. The railing has been replaced with metal guard rail.

**NRHP Justification:** In their 2001 inventory of non-truss bridges, TxDOT determined this bridge is not eligible for listing in the NRHP. The bridge has lost integrity of materials and workmanship due to the loss of the original railing and its replacement with metal guard rail.

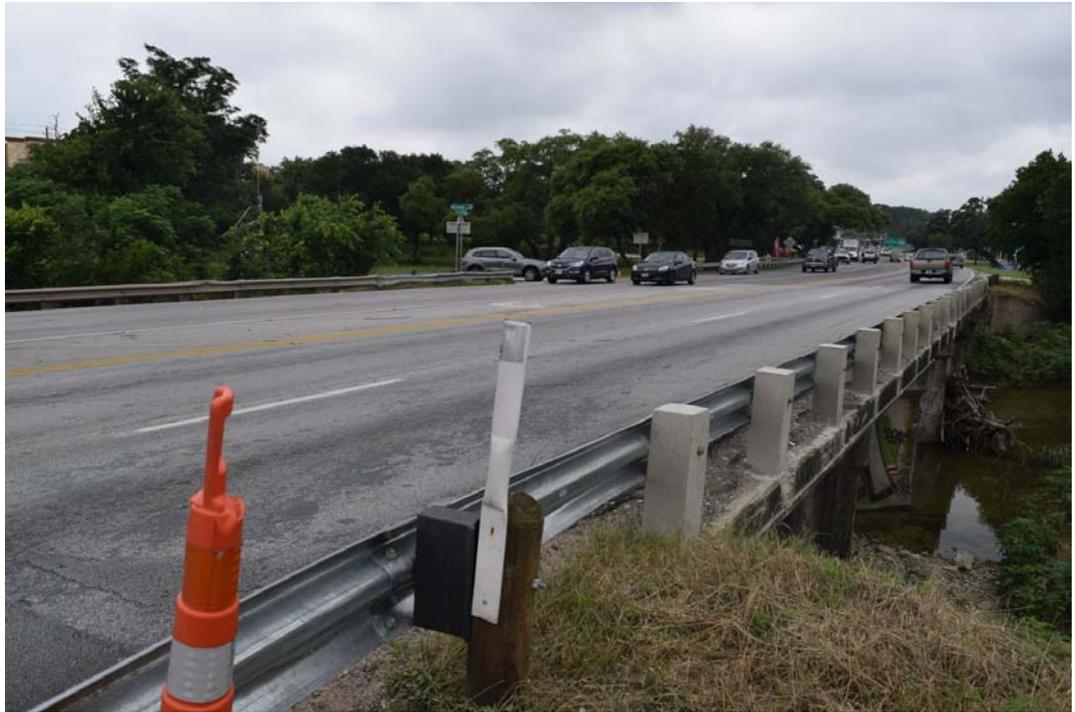
Photo 2 date taken:  
5/26-28/16

View facing southwest.

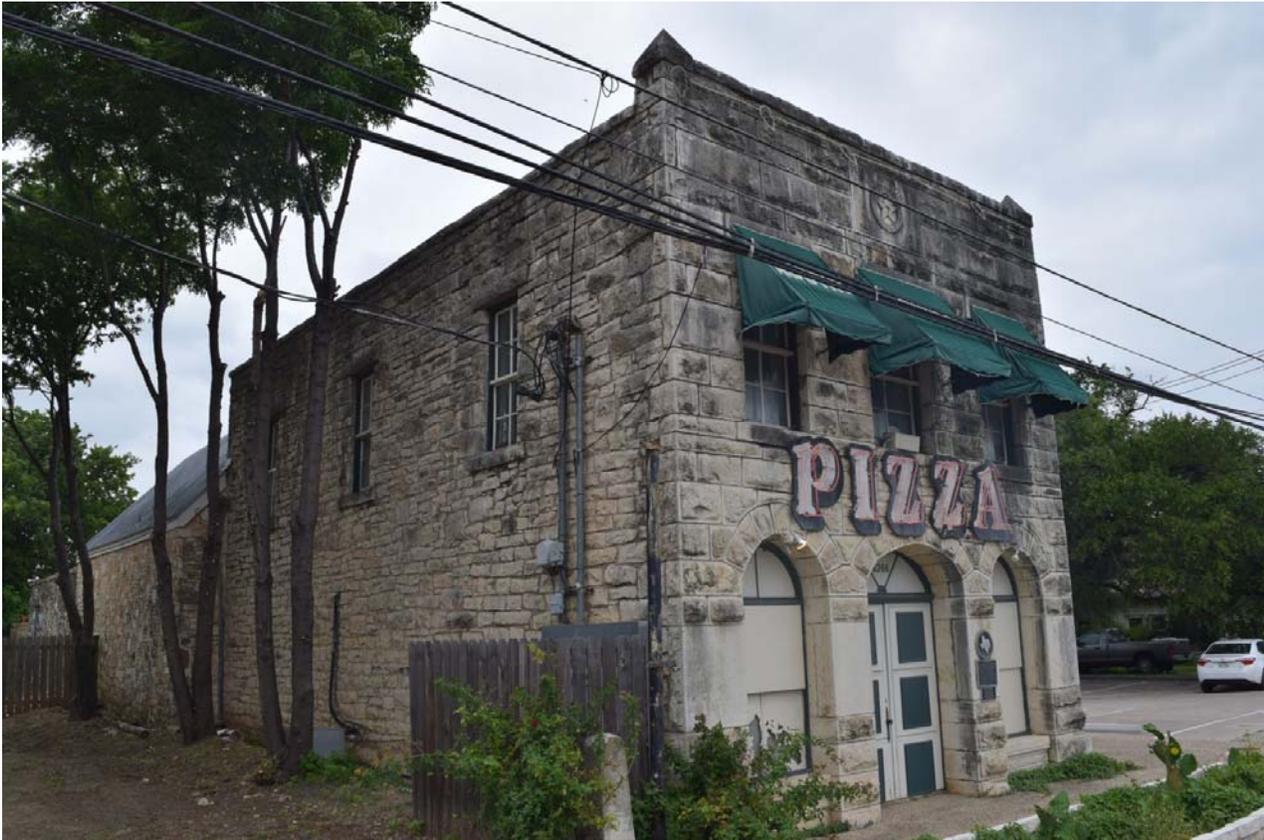
Photo 1 date taken: 5/26-28/16

<b>Resource ID</b> 35a	<b>Name:</b> Austin Pizza Garden	<b>Year Built:</b> 1898	<b>Source:</b> Plaque
	<b>Address:</b> 6266 W U S HY 290	Austin Travis County	Texas
Parcel ID 311716	<b>Lat:</b> 30.23571	<b>Long:</b> -97.859029	
	<b>Type:</b> Building	<b>Style:</b> Romanesque	<b>Form:</b> Rectangular
<b>Historic Function/ Subcategory:</b>	Commerce/ Business	<b>Indiv. NRHP Eligible?</b> Yes	<b>Effect:</b> No Adverse Effect
<b>Current Function/Subcategory:</b>	Commerce/ Restaurant	<b>Contributing to District?</b> Yes

View facing north.

**NRHP Justification:** Known as the Old Rock Store, the building is designated as a Recorded Texas Historic Landmark (1970) and City of Austin Landmark. Additionally, the resource is significant at the local level under Criterion A in the area of Commerce for its long history as a commercial building and under Criterion C in the area of Architecture as a good, local example of rustic limestone architecture from the late nineteenth century. It retains most aspects of integrity but has lost integrity of setting as the setting has been dramatically altered over time as the area developed in the second half of the twentieth century. However, the building continues to convey a strong sense of Oak Hill's history.

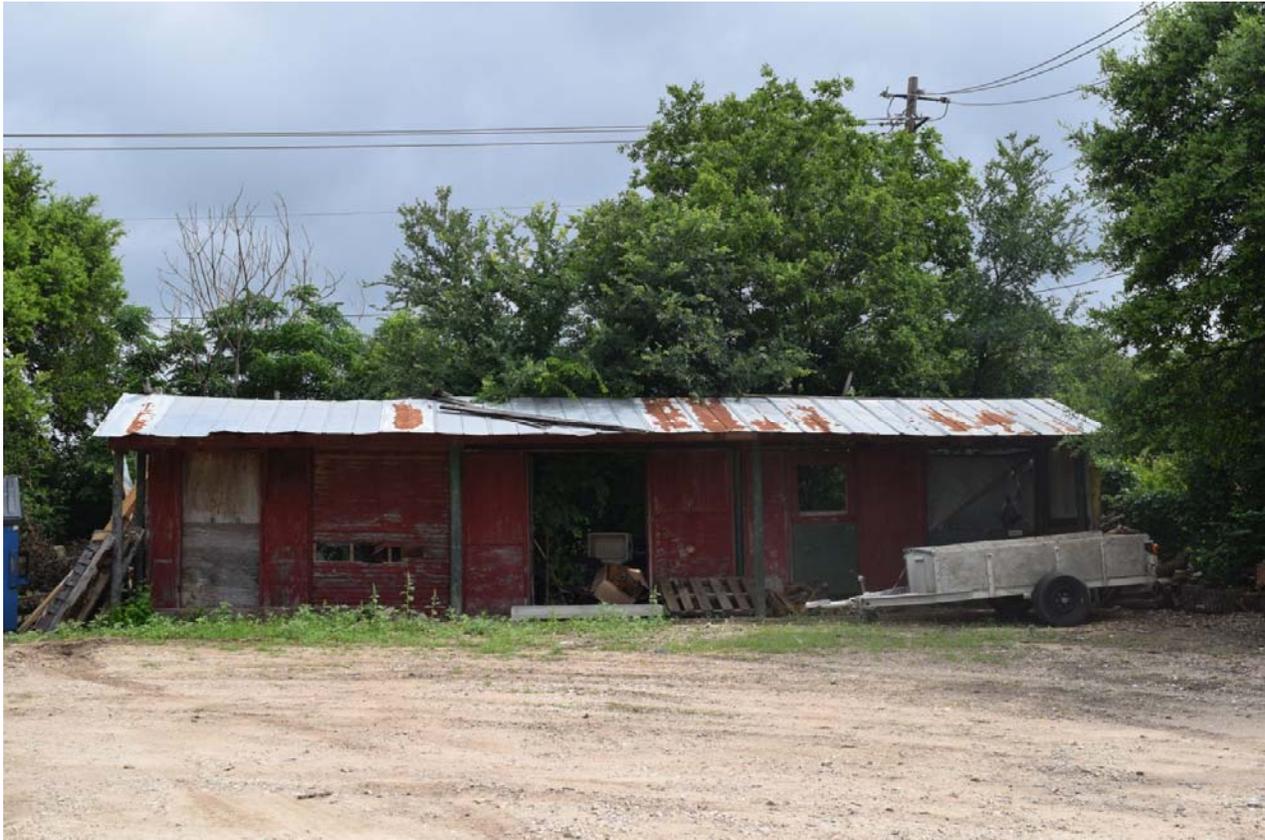
View facing north.  
 Photo 1 date taken: 5/26-28/16

<b>Resource ID</b> 35b	<b>Name:</b> Austin Garden Pizza	<b>Year Built:</b> ca. 1975	<b>Source:</b> aerial photos
	<b>Address:</b> 6240 W US HY 290	Austin Travis County	Texas
Parcel ID 311716	<b>Lat:</b> 30.236716	<b>Long:</b> -97.858878	
	<b>Type:</b> Building	<b>Style:</b> None	<b>Form:</b> Rectangular
<b>Historic Function/ Subcategory:</b>	Commerce/ Business	<b>Indiv. NRHP Eligible?</b> No	<b>Effect:</b> N/A
<b>Current Function/Subcategory:</b>	Commerce/ Restaurant	<b>Contributing to District?</b> No

**Description:** This building is an ancillary building with multiple doors of varied sizes. It appears to be used for storage. It is assumed to have been constructed when The Natural Gardener (Resource 16a-j) occupied this property.

**NRHP Justification:** Resource 35b is a non-historic-age ancillary building at the rear of the property. The resource is less than 50 years old and was not found to possess exceptional significance under Criterion Consideration G. As a result, it is recommended not eligible for the NRHP under Criterion A, B, C, or D. It is considered non-contributing to the NRHP eligible Resource 35a.

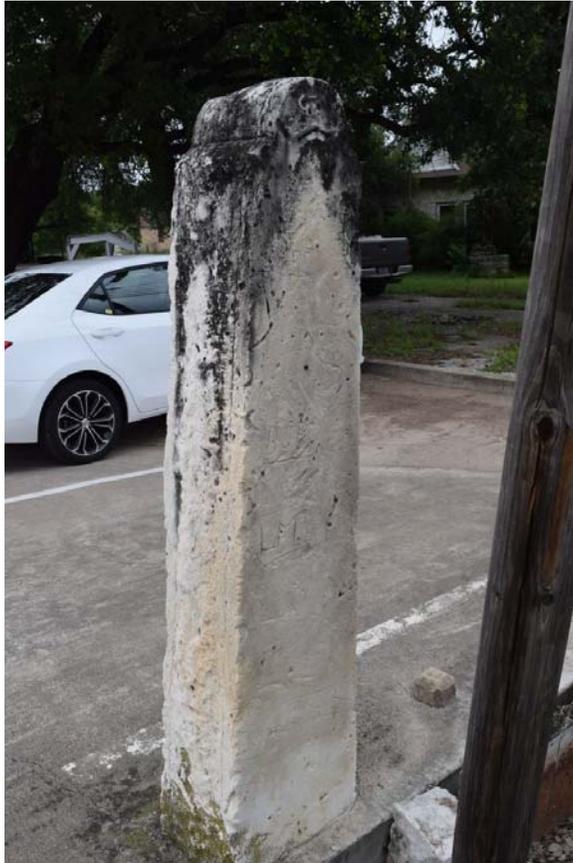
Photo 1 date taken: 5/26-28/16

<b>Resource ID</b> 35c	<b>Name:</b> None	<b>Year Built:</b> ca. 1900	<b>Source:</b> field survey
	<b>Address:</b> 6266 W US HWY 290	Austin Travis County	Texas
Parcel ID 311716	<b>Lat:</b> 30.235631	<b>Long:</b> -97.858816	
	<b>Type:</b> Object	<b>Style:</b> None	<b>Form:</b> Obelisk
<b>Historic Function/ Subcategory:</b>	Transportation/ Road-related	<b>Indiv. NRHP Eligible?</b> No	<b>Effect:</b> No Effect
<b>Current Function/Subcategory:</b>	Transportation/ Road-related	<b>Contributing to District?</b> No

**Description:** This is an obelisk located at edge of right-of-way and the parking lot of the Austin Pizza Garden/Old Rock Store. It is assumed to be a right-of-way marker. However, the text and other markings are no longer visible due to deterioration.

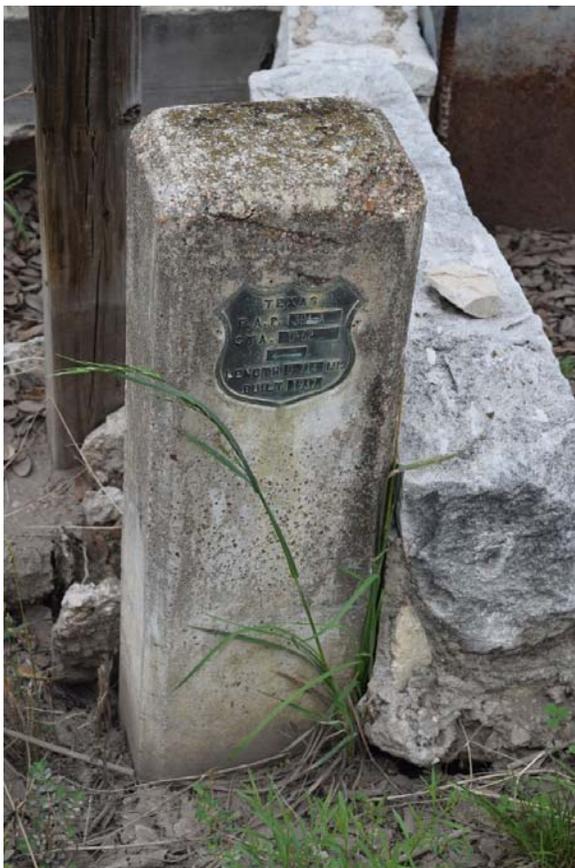
Photo 1 date taken: 5/26-28/16

Resource ID 35d      Name: State Highway Marker      Year Built: 1937      Source: Plaque  
 Address: 6266 W US HWY 290      Austin      Travis County      Texas  
 Parcel ID 311716      Lat: 30.235608      Long: -97.858815  
 ID      Type: Object      Style: None      Form: Obelisk  
 Historic Function/ Subcategory: Transportation/ Road-related      Individ. NRHP Eligible? No      Effect: N/A  
 Current Function/Subcategory: Transportation/ Road-related      Contributing to District? No

View facing north.

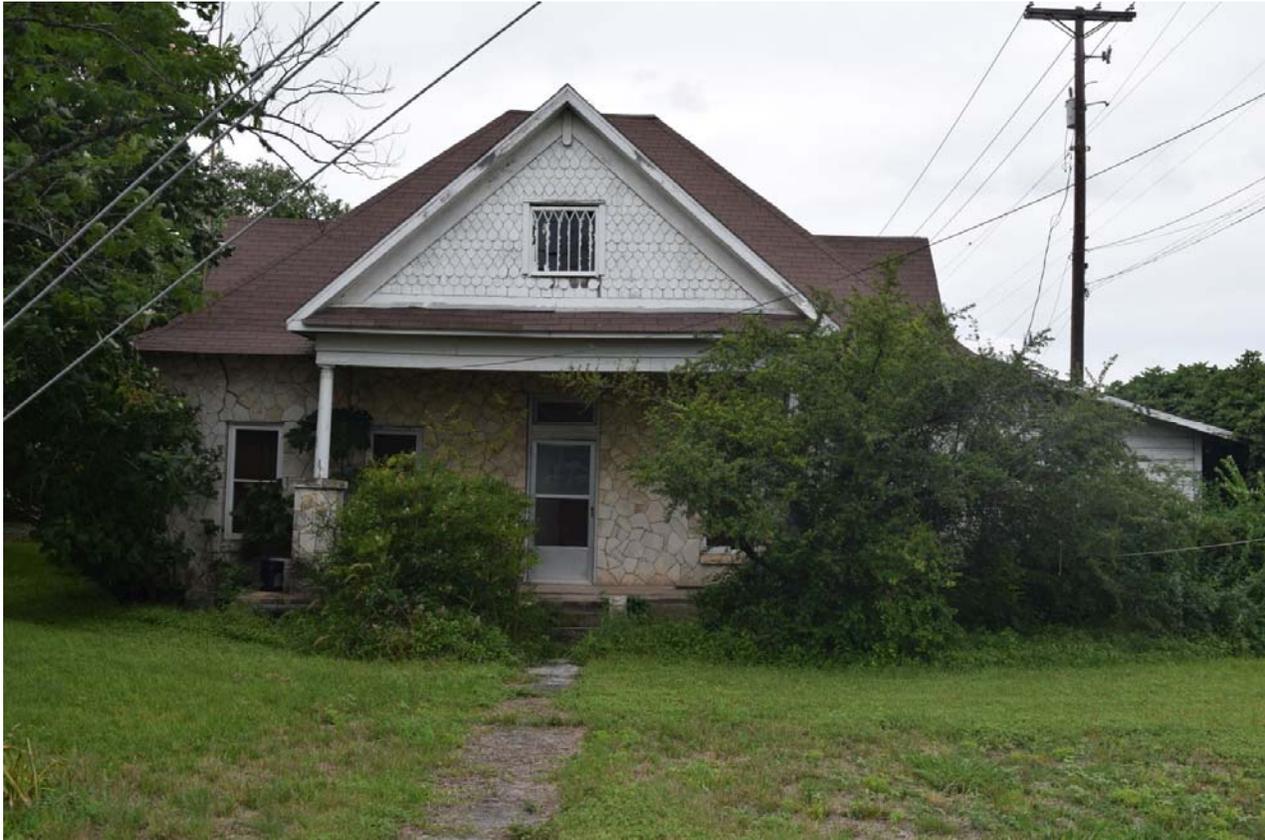
View facing north.  
 Photo 1 date taken: 5/26-28/16

**Description:** This building is a single-story Free Classic style, as described in Travis County Historical Commission's 2015 survey, residence with a steeply pitched composition shingle roof. The original cladding was wood board, which is still visible in several locations. Stone veneer has been added to most of the house below the eave line. Windows are double hung wood sashes although the original single door has been replaced. The porch is supported by stone piers and wooden posts, and the gable end has a fishscale shingle detail. There is a shed roof addition to the east side. The Travis County Appraisal District dates the house at 1925; however the Travis County Historical Commission's 2015 survey dates it to ca. 1895.

**NRHP Justification:** This resource was identified as a high priority resource in the Travis County Historical Commission's 2015 survey as a rare and no unique example of its architectural style in Oak Hill and for its association with the pioneering Patton and Enochs families in the area. Although research did not indicate the house rises to the level necessary to be NRHP eligible under Criterion B, it is recommended eligible under Criterion C in the area of architecture at the local level. The alterations only slightly diminish integrity of design, materials, and workmanship, but they were completed in the historic period. The setting has been dramatically altered over time as the area developed in the second half of the twentieth century.

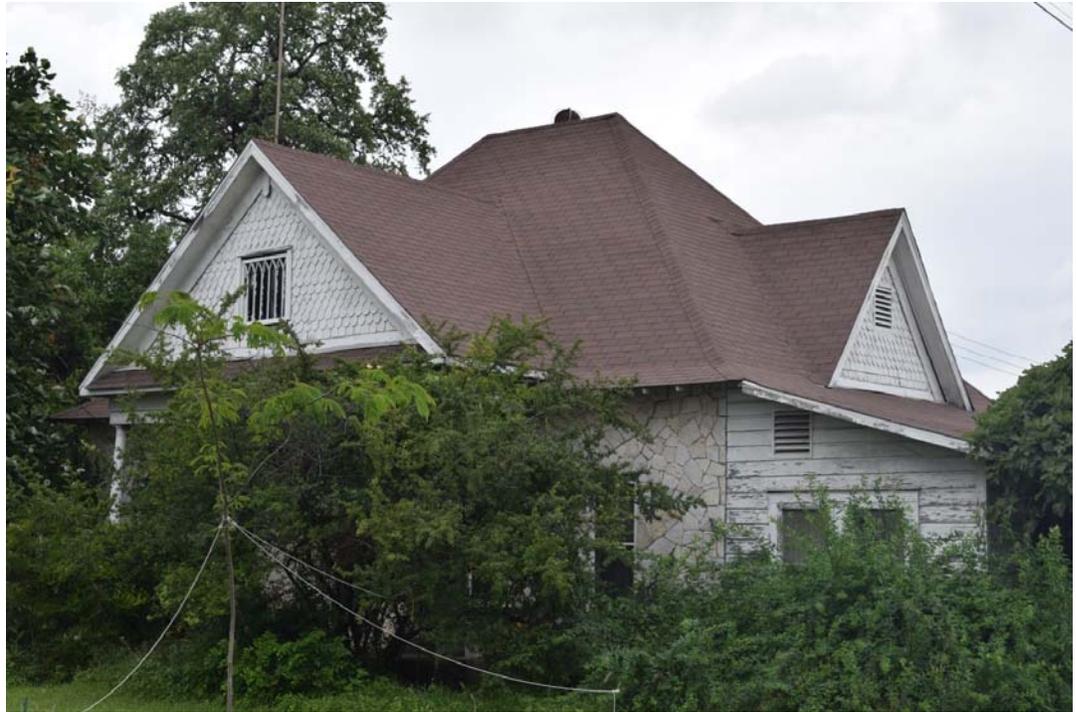
Photo 2 date taken:  
5/26-28/16

View facing northwest.

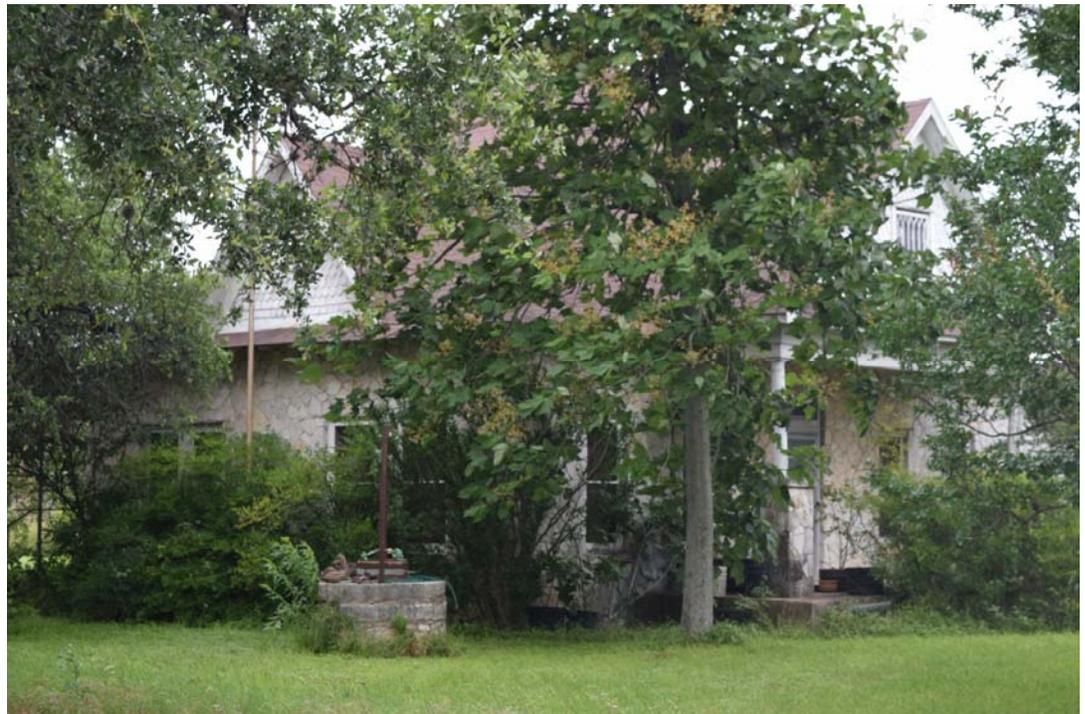
Photo 3 date taken:  
5/26-28/16

View facing northeast including well.

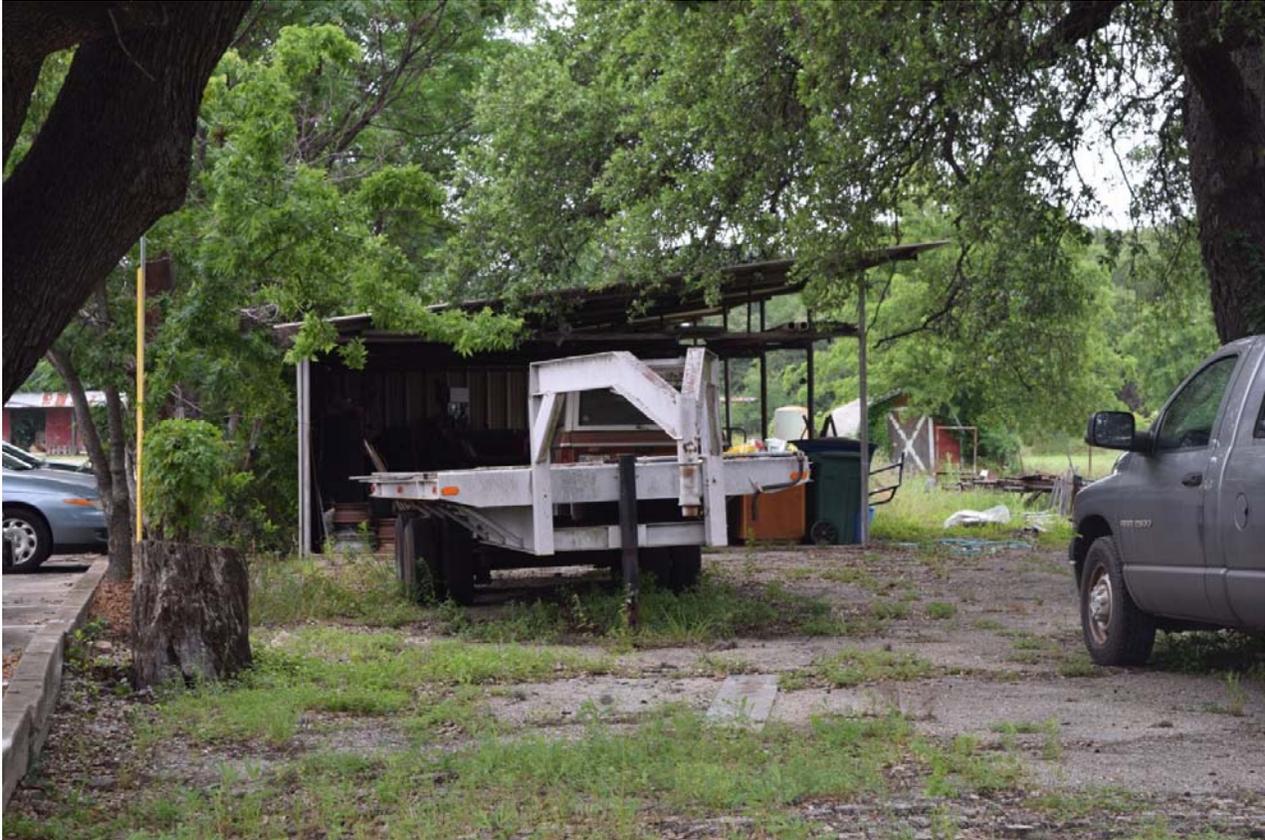
View facing north.  
 Photo 1 date taken: 5/26-28/16

**Description:** This structure is a garage carport with a shed roof supported by metal posts. It has an enclosed space in the rear.

**NRHP Justification:** This resource is a non-historic-age secondary building on the same parcel as historic-age resources. The resource is less than 50 years old and was not found to possess exceptional significance under Criterion Consideration G. As a result, it is recommended not eligible individually for the NRHP under Criterion A, B, C, or D. It is also considered non-contributing to the NRHP eligible Resource 36a.

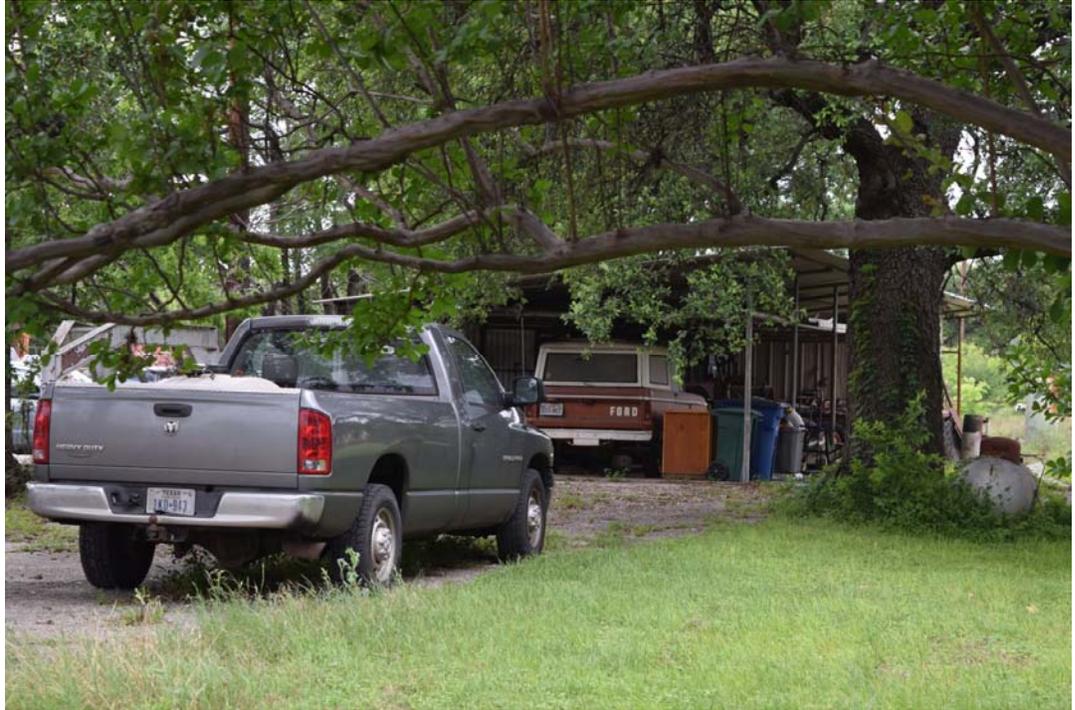
Photo 2 date taken:  
5/26-28/16

View facing northwest.
