Draft Historic Resources  
Survey Report  
for the Oak Hill Parkway Project

U.S. Highway 290 (US 290) / State Highway (SH)  
71 West from State Loop 1 (Mopac) to  
Ranch-to-Market (RM) 1826 and SH 71 to  
Silvermine Drive  
Travis County, Texas  
CSJ # 0113-08-060 and 0700-03-077  
October 2017

# Report for Historical Studies Survey

CSJs 0113-08-060 and 0700-03-077;  
Oak Hill Parkway Project: US 290 from  
Loop 1 (Mopac) to RM 1826 and SH  
71 from US 290 to Silvermine Drive  
Travis County, Austin District

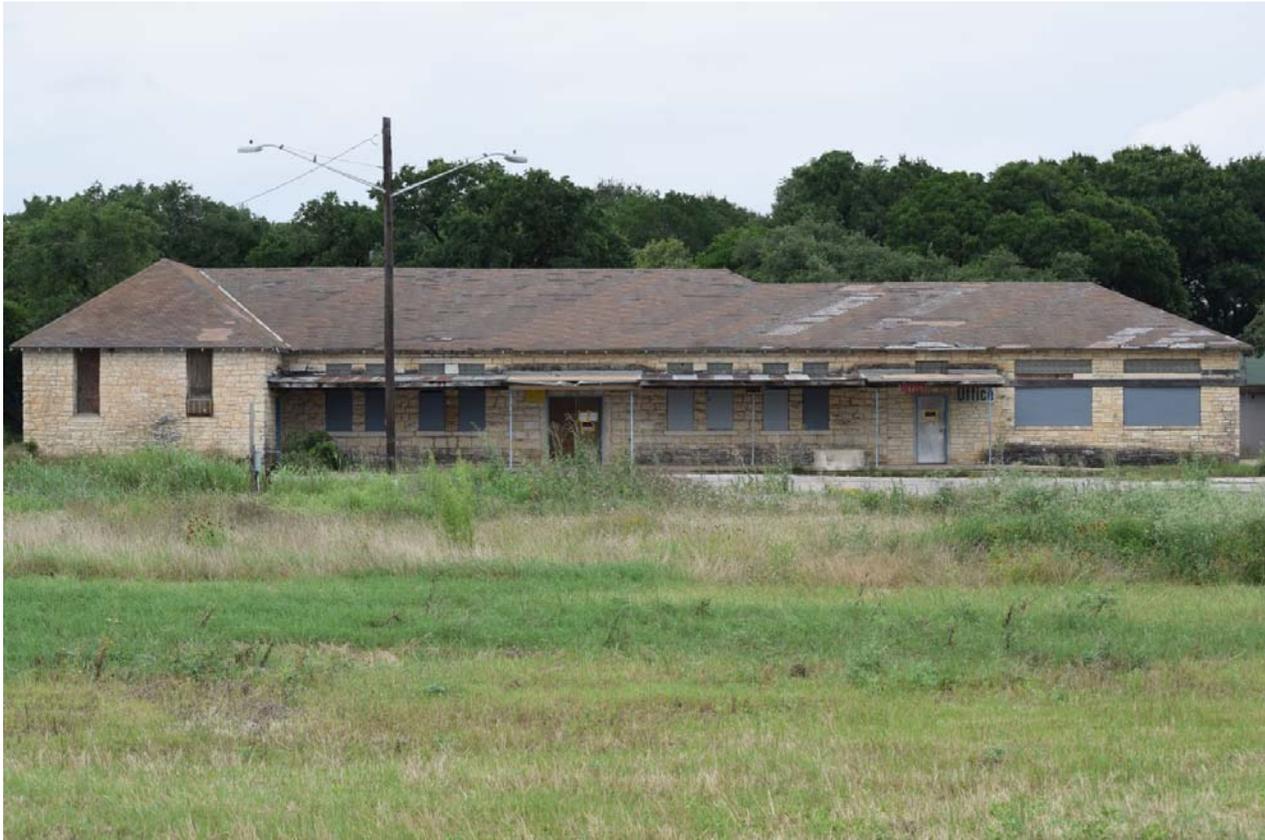
View facing north.  
 Photo 1 date taken: 5/26-28/16

**Description:** The building is a one-story stone building with a hipped composition shingle roof. The windows appear to have been wooden double hung sashes; however many are boarded up. The building has a partial-width awning supported by metal posts that covers the upper portion of the windows, creating transoms. The building was the original Oak Hill School and was enlarged with an addition to the east end. A secondary building (Resource 37b) is located to the northeast of this building.

**NRHP Justification:** The former Oak Hill School is designated a City of Austin Landmark. Additionally, it was identified as a high preservation priority in the Travis County Historical Commission's 2015 survey. Although its integrity of setting is diminished due to the rapid development of the area in the second half of the twentieth century and its integrity of association is diminished due to it being vacant and no longer in use as a school, the building is recommended eligible for NRHP listing under Criterion A at the local level in the area of Education as an example of a rural, early twentieth century school.

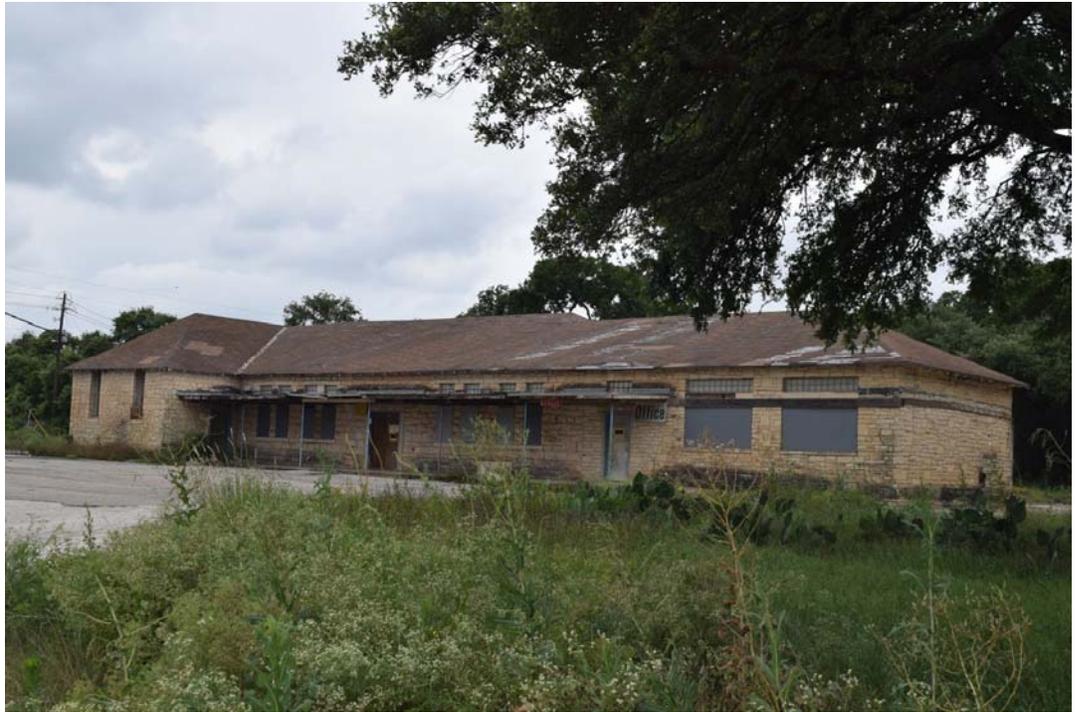
Photo 2 date taken:  
5/26-28/16

View facing northwest.

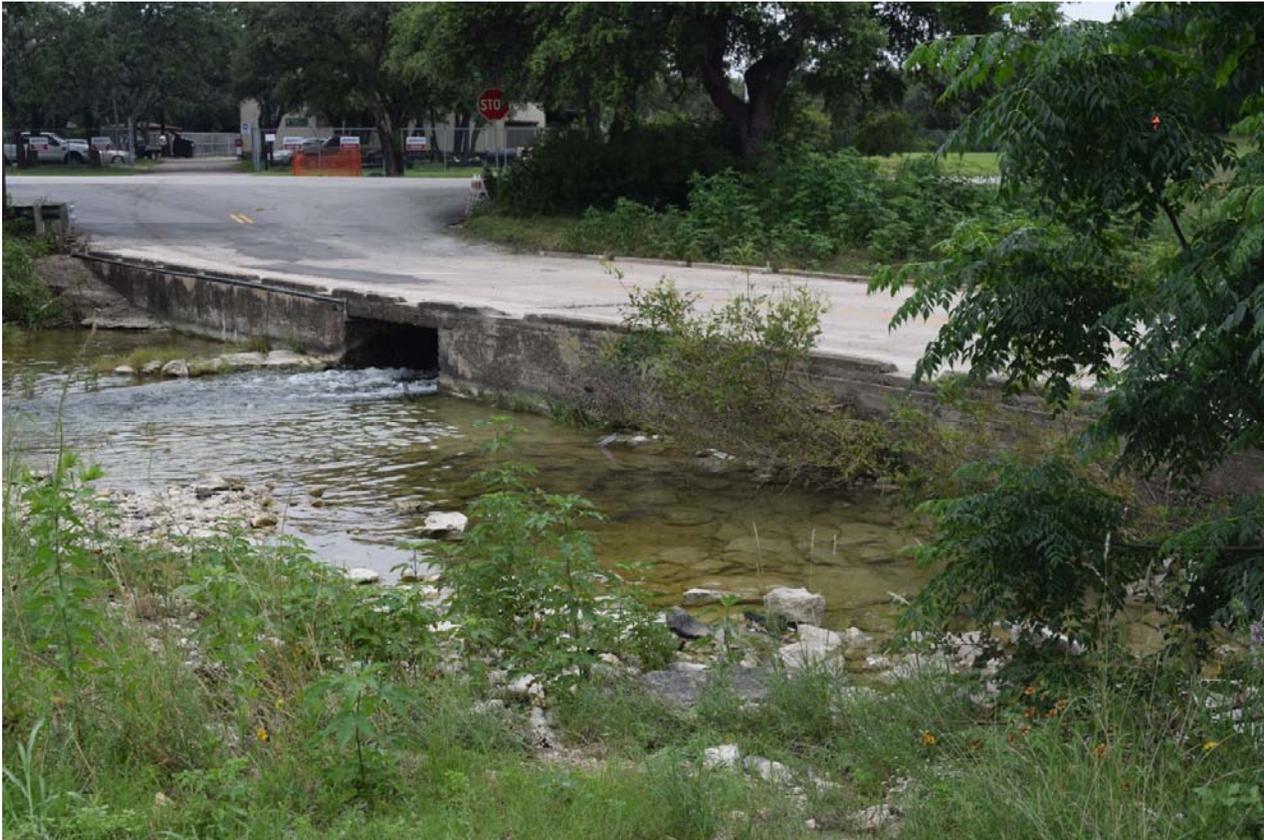
View facing southwest.  
 Photo 1 date taken: 5/26-28/16

**Description:** The structure that carries Joe Tanner Lane over Williamson Creek is a concrete culvert. Constructed ca. 1960 based on review of aerial photographs, the structure has a small hydraulic opening and is lined with intermittent curbing, rather than railing, to accommodate being over topped during high water events. The structure is small enough that it is not classified as a bridge and is not assigned a National Bridge Inventory number.

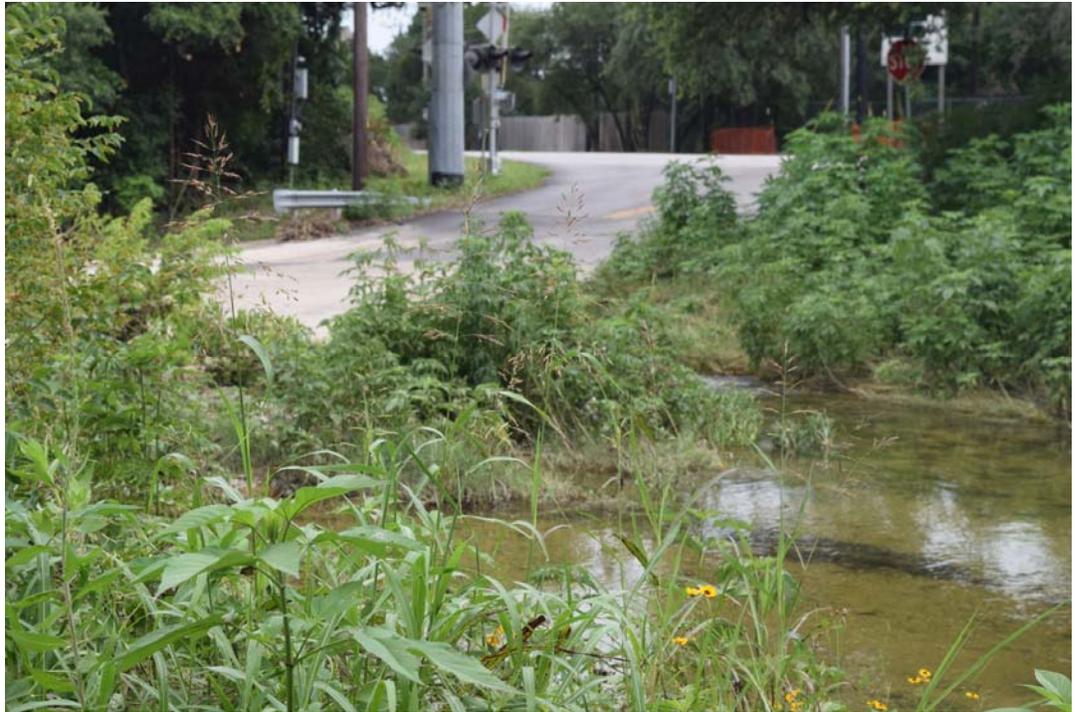
Photo 2 date taken:  
5/26-28/16

View facing southeast.

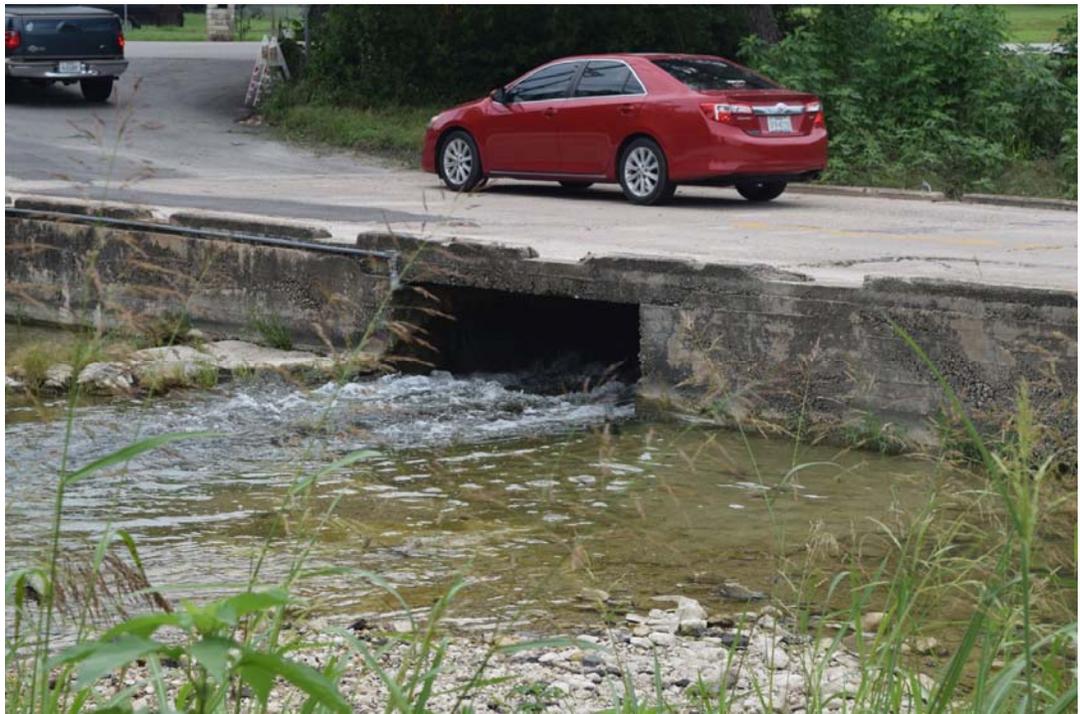
Photo 3 date taken:  
5/26-28/16

View facing southwest.
