# Wetlands/Waters of the U.S. Delineation Report

US Highway 79 from Interstate Highway 35 to  
Farm-to-Market Road 1460

Round Rock, Williamson County, Texas

September 2018

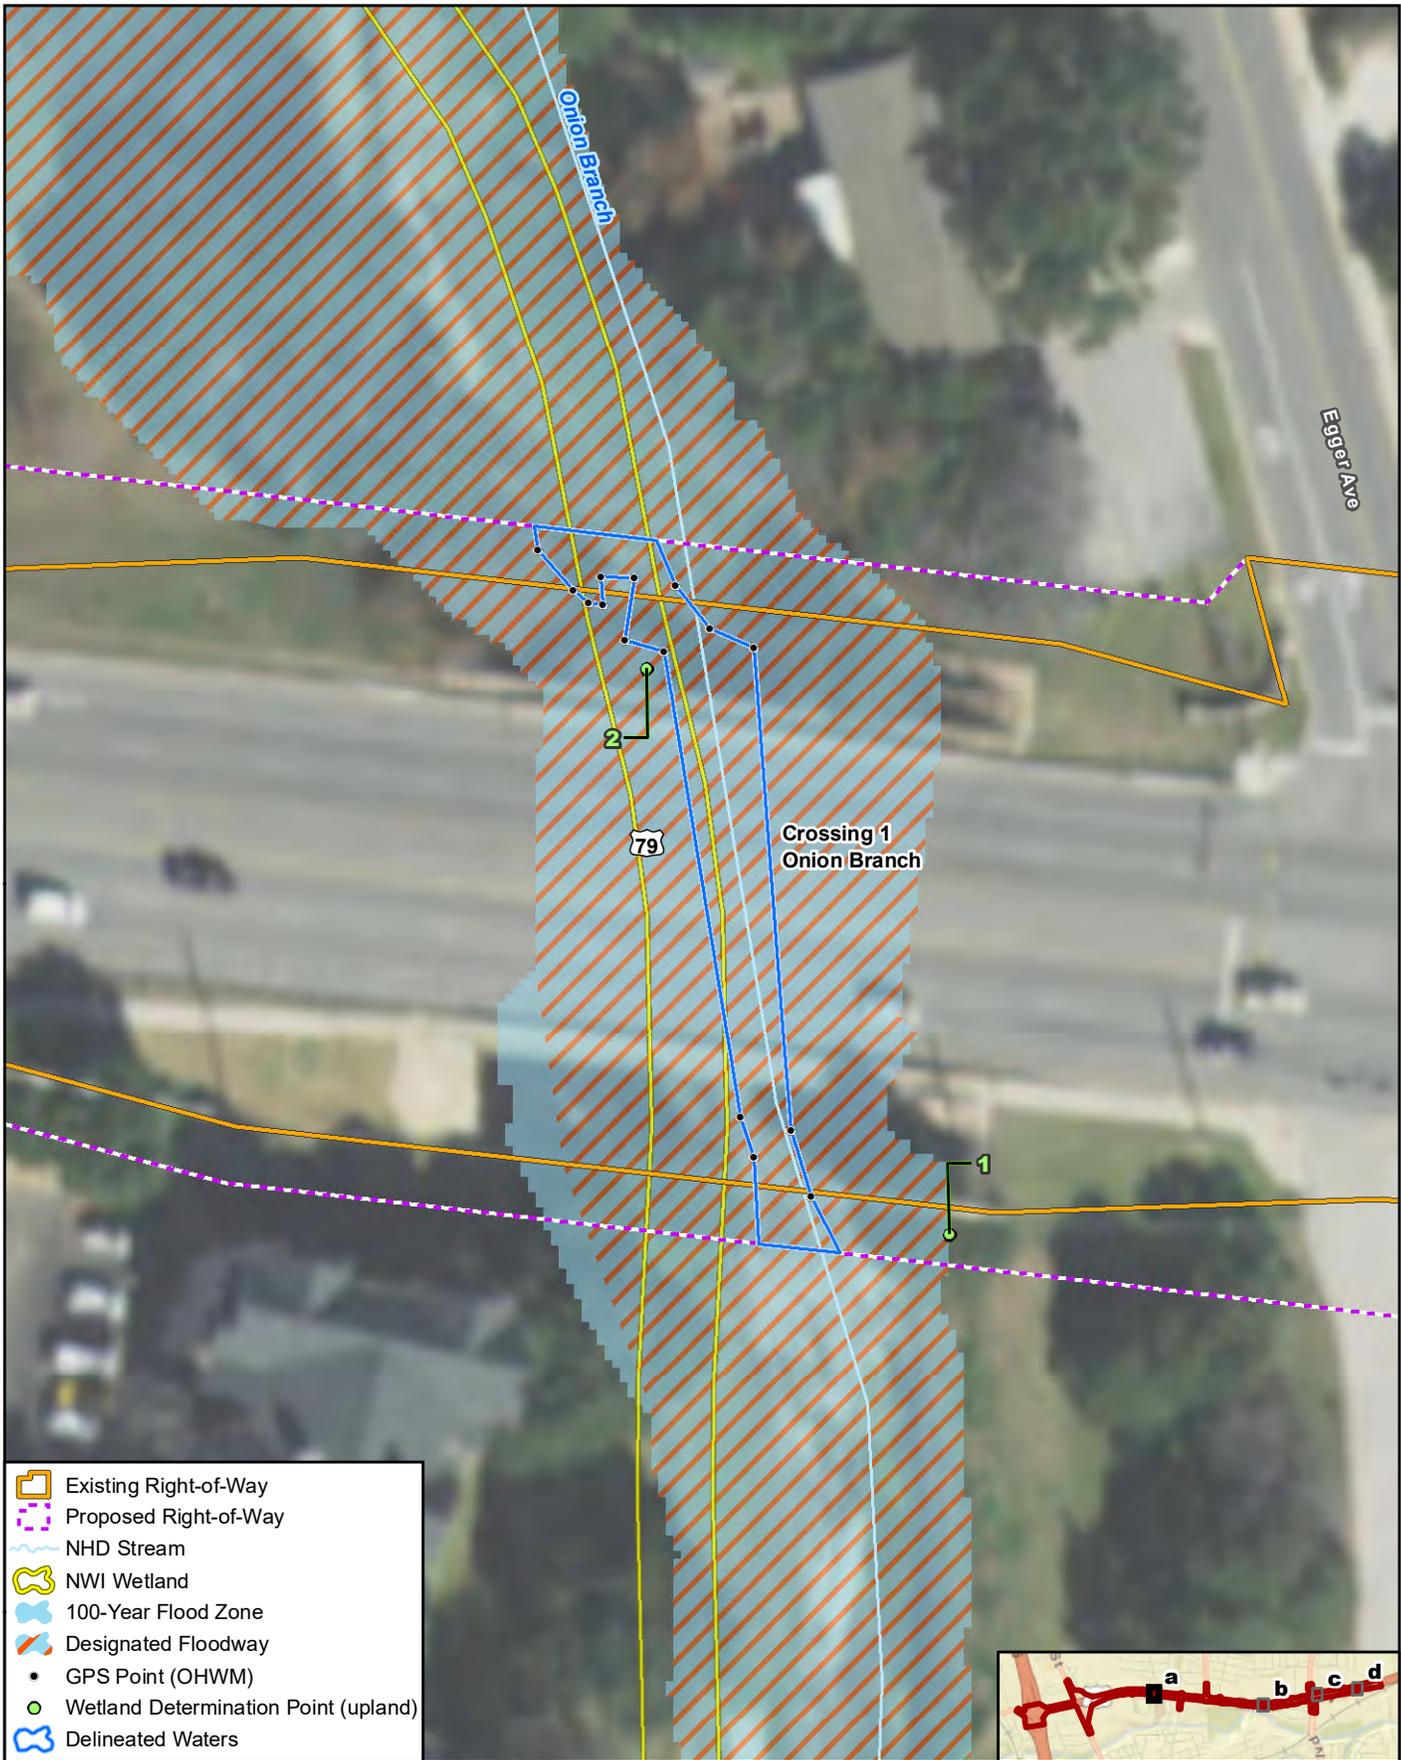
**Figure 6a**  
**Potential Waters of the U.S.**  
**US 79 from I-35 to FM 1460**

Vegetation adjacent to the stream was sparse due to the prevalence of scoured limestone bedrock. Green ash (*Fraxinus pennsylvanica*) was the dominant woody species adjacent to the stream. Live oak (*Quercus fusiformis*) and cedar elm (*Ulmus crassifolia*) were prevalent on the bluffs above the stream. Green ash comprised the scant sapling/shrub layer. Purple love grass (*Eragrostis pectinacea*), giant ragweed (*Ambrosia trifida*), and straggler daisy (*Calyptracarpus vialis*) were among the herbaceous species observed. Greenbriar (*Smilax bona-nox*) was the dominant woody vine in the area. See **Figure 5**, **Figure 6a**, and **Photos 1 – 11**.

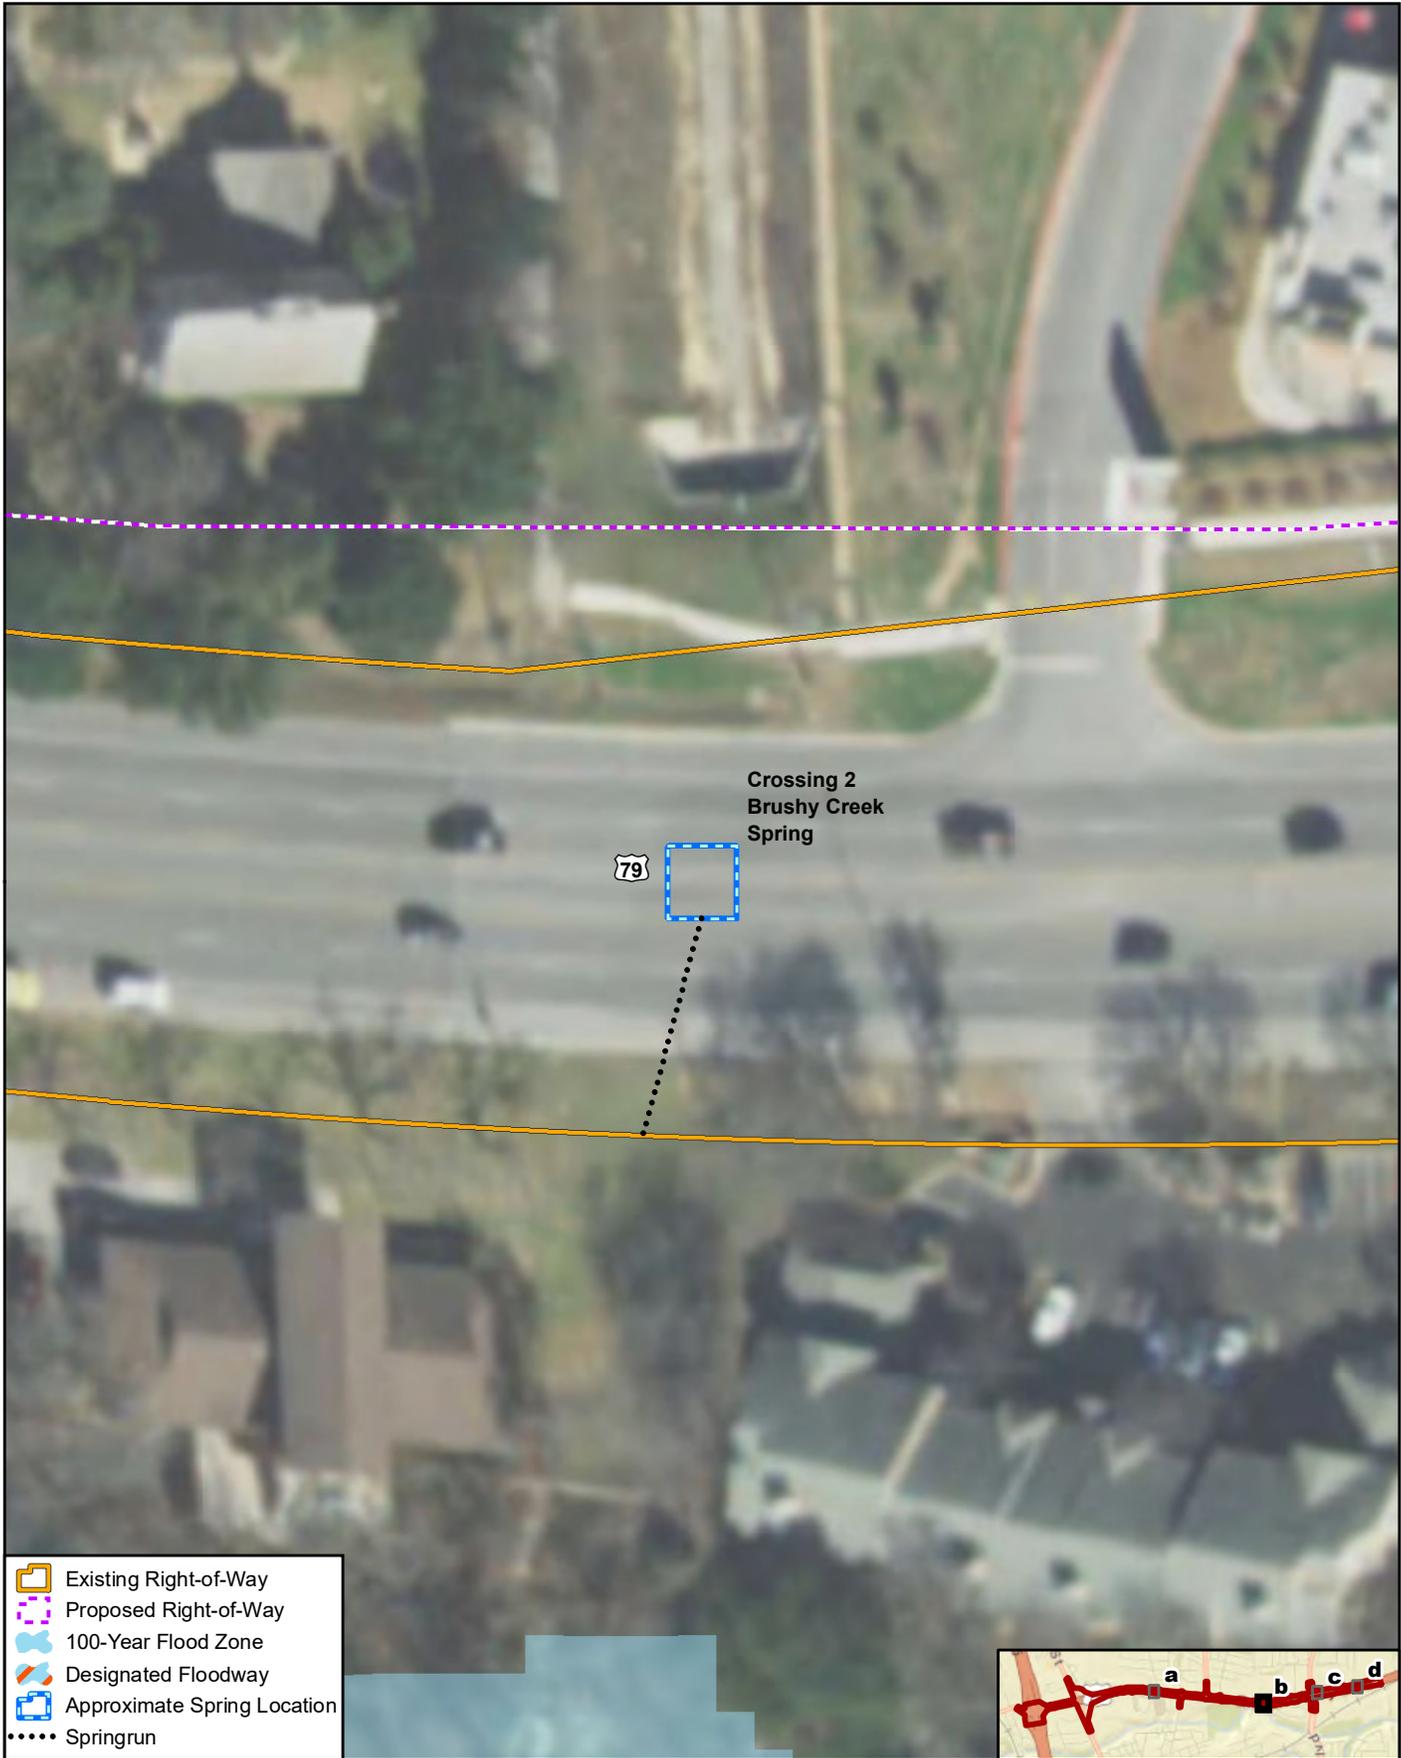
Data Sources: NHD (2018), NWI (2018),  
 FEMA NFHL (2018), CMEC (2018)  
 Aerial Source: ESRI (2017)

Following the completion of preliminary data gathering and synthesis, the routine method of wetland determination was used to identify potentially jurisdictional areas within the existing ROW. Potential waters of the U.S. were evaluated in the field and localized hydrologic characteristics and the dominant vegetative species observed at the site were described. Locations where wetland determination data forms were completed are shown in **Figures 6a–6d**.

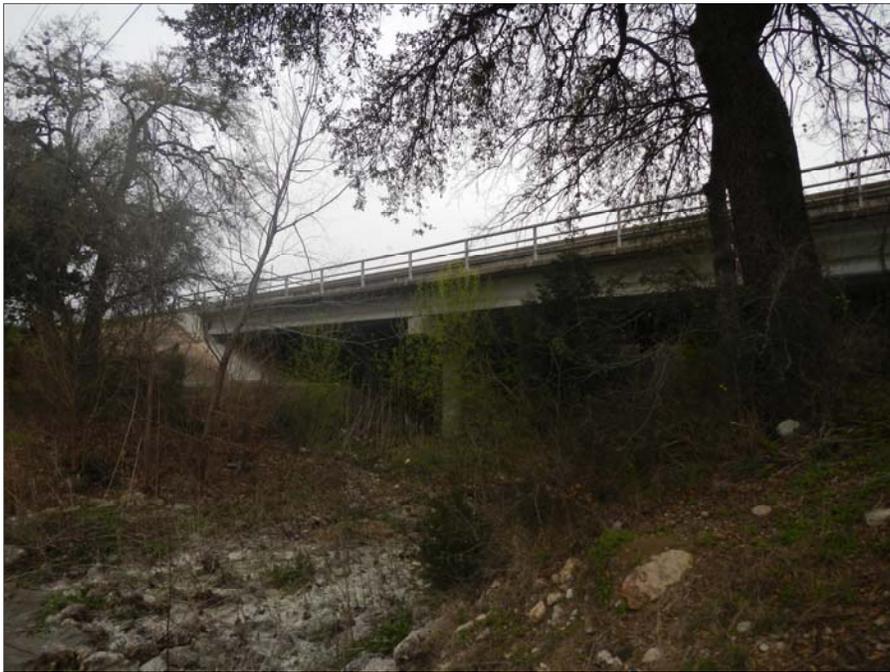
Photo 1: Crossing 1 - Onion Branch, viewing northwest.

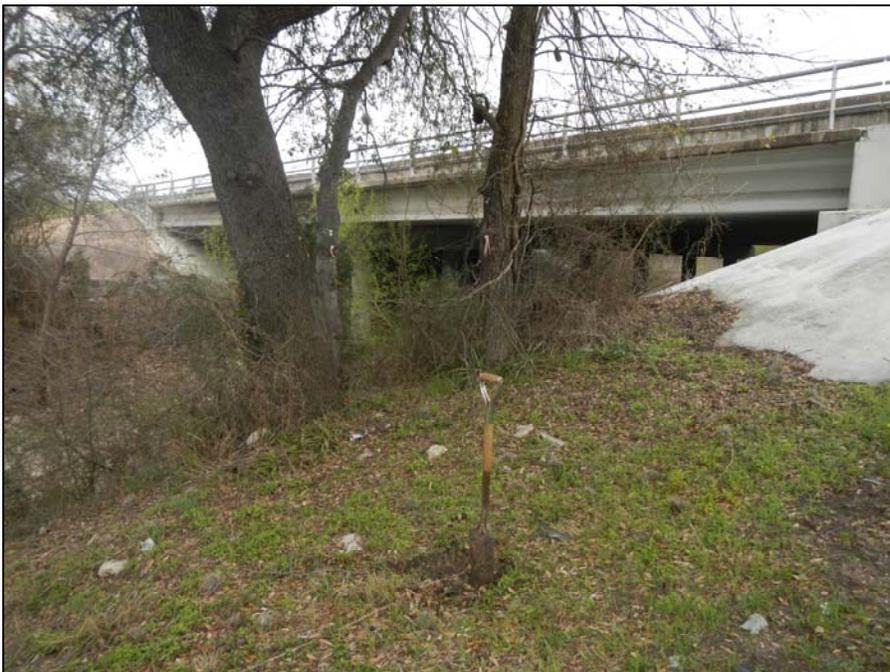
Photo 2: Crossing 1 - Wetland Determination Point 1, viewing northwest.

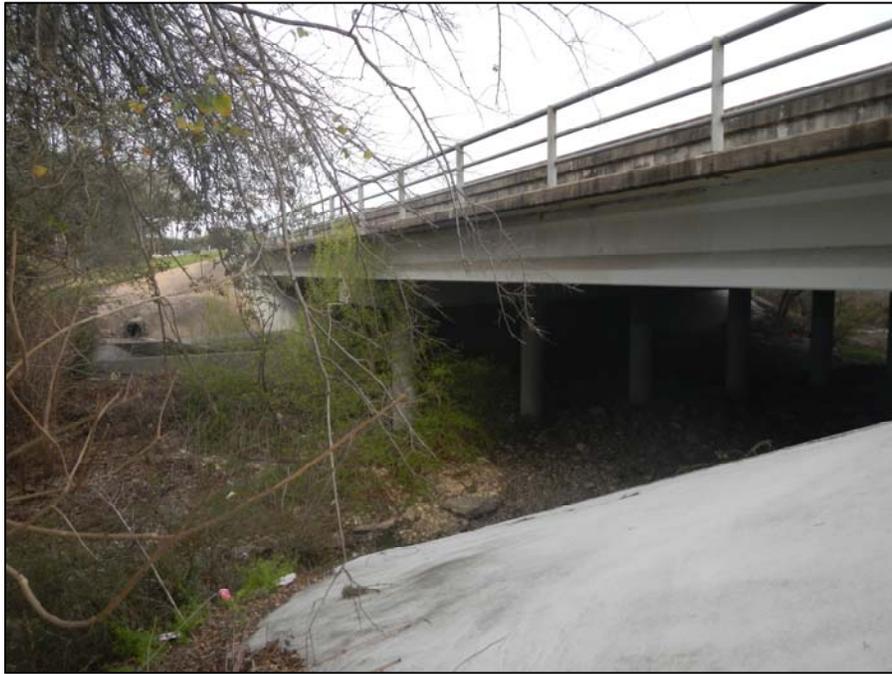
Photo 3: Crossing 1 - Bridge at Onion Branch, viewing west.

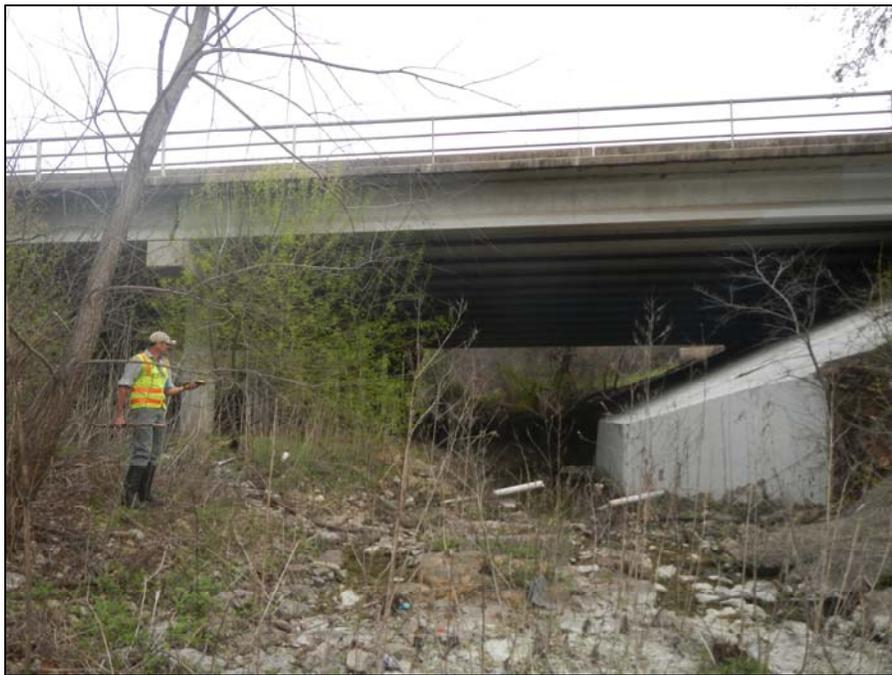
Photo 4: Crossing 1 - Upstream at Onion Branch, viewing north. Note exposed bedrock streambed and minimal surface flow.

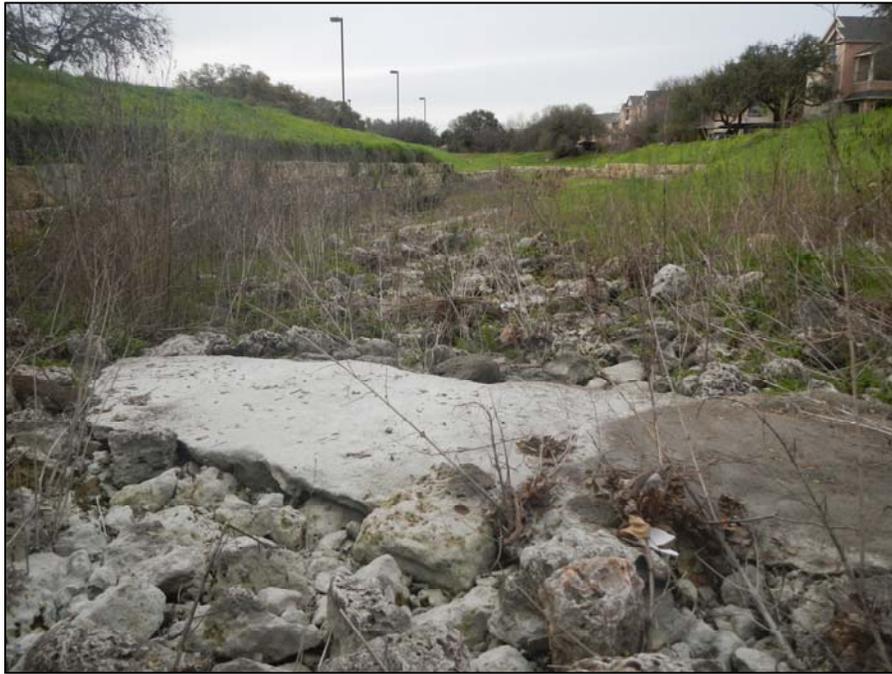
Photo 5: Crossing 1 - Concrete slab and rubble downstream of US 79 in Onion Branch, viewing south.

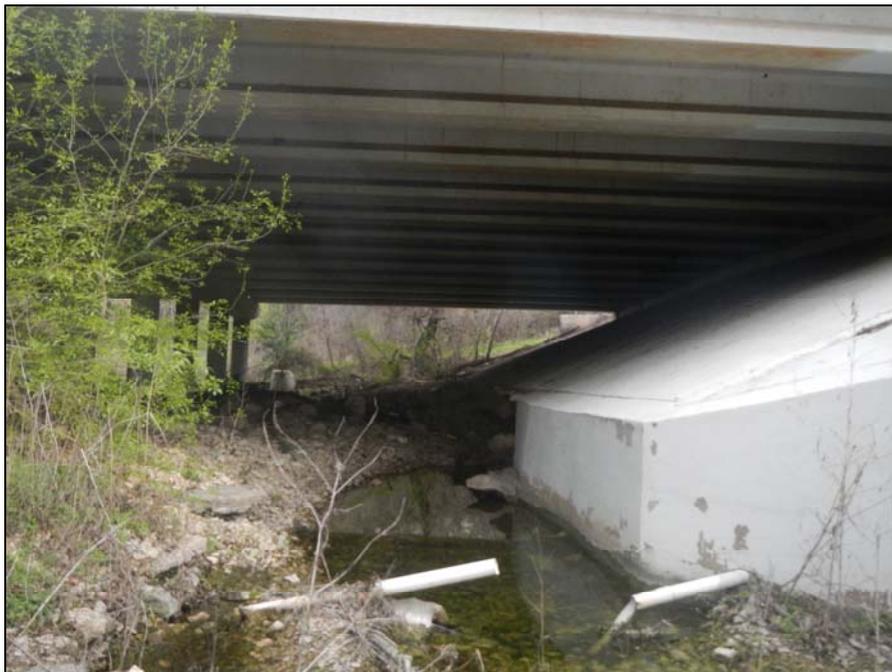
Photo 6: Crossing 1 - Scour pool under the existing US 79 Bridge, viewing north (upstream).

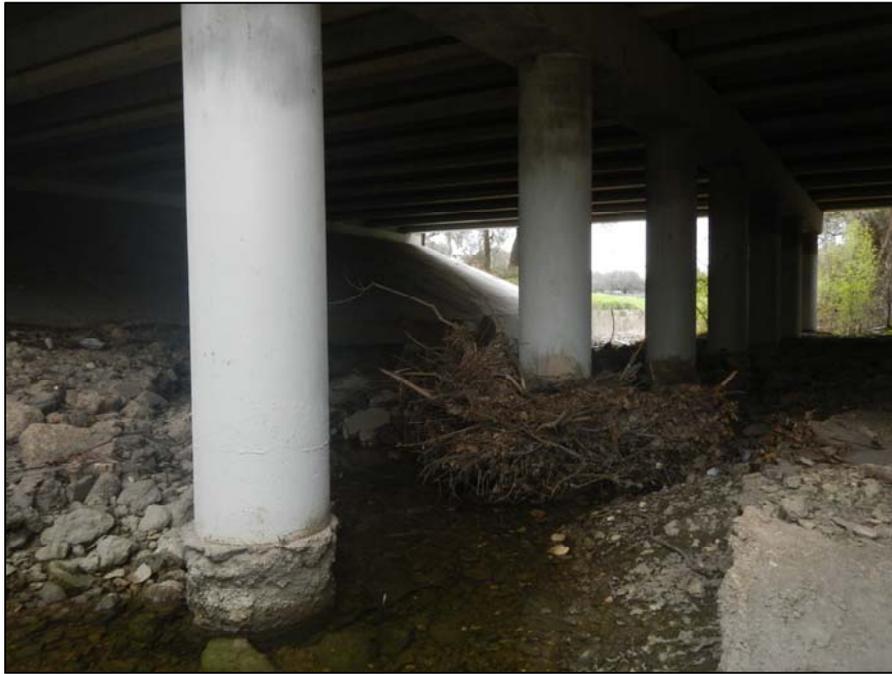
Photo 7: Crossing 1 - Scoured areas and flood debris associated with existing bridge piers.

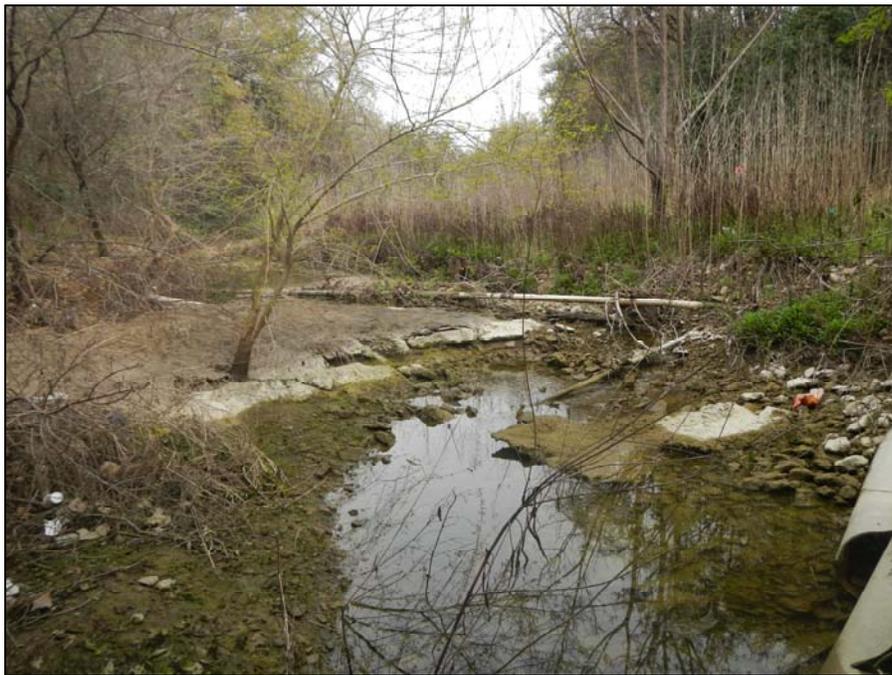
Flowing water was observed in Onion Branch at the time of the field visit; however, the water was principally in pools (1-14 inches deep) and the flow between the pools was almost imperceptible. Hardened underground utility infrastructure (e.g., concrete-encased wastewater pipes) formed the majority of the pools by impounding flow in Onion Branch. Other pools were apparently the result of scour, especially in the vicinity of existing bridge piers. Exposed bedrock constituted the majority of the stream bottom with adjacent low terraces of sand and gravel. Wetland Determination Data Form 1 and 2 were completed adjacent to the stream (**Attachment C**).

Photo 8: Crossing 1 - Onion Branch, north of US 79, viewing north. Note concrete slab and underground utilities.

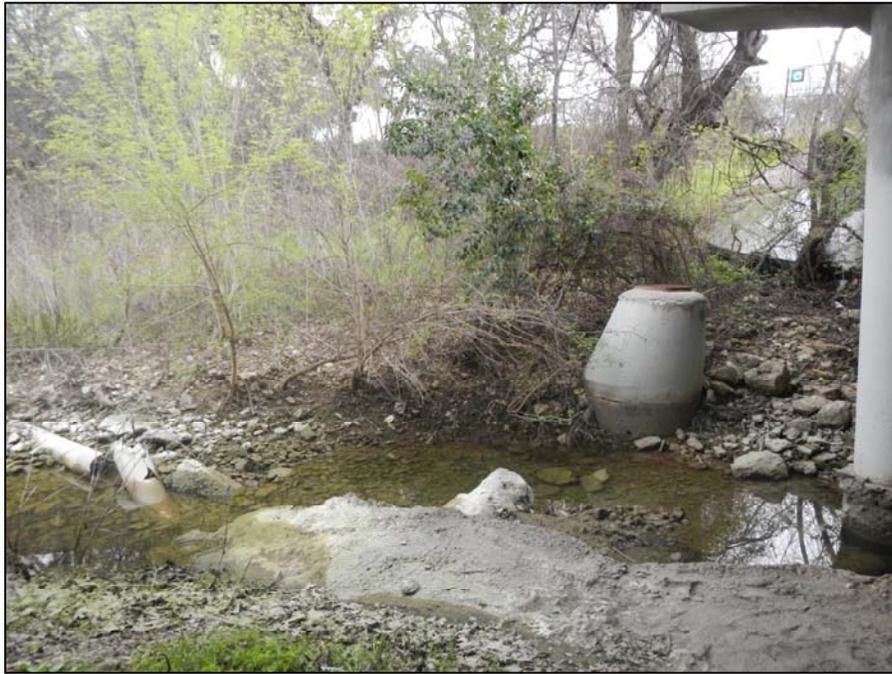
Photo 9: Crossing 1 - Onion Branch. Flow is left to right. The concrete slab encased the (broken) pipe that intersects the stream.

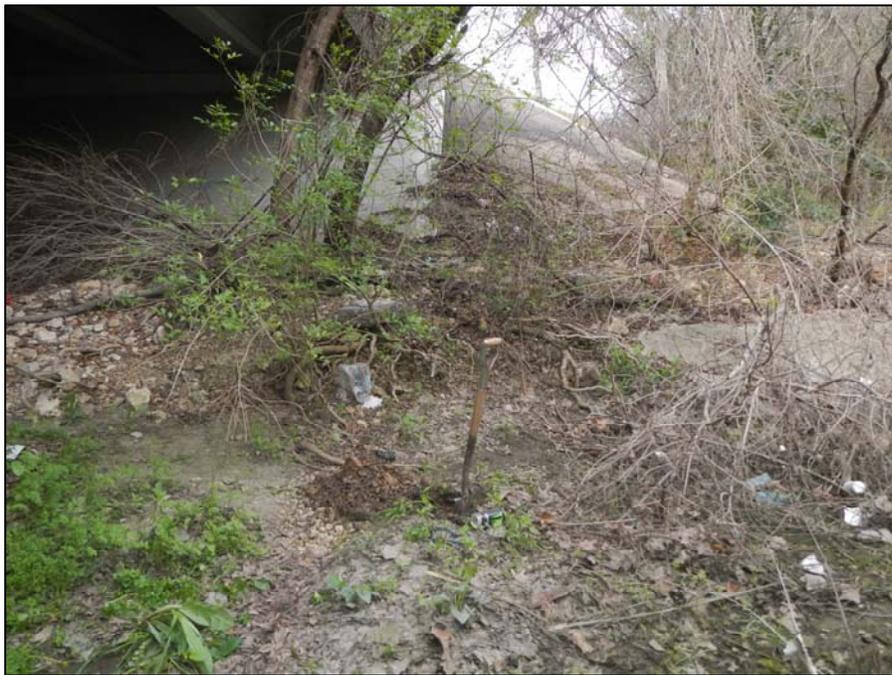
Photo 10: Crossing 1 - Wetland Determination Point 2, viewing west.

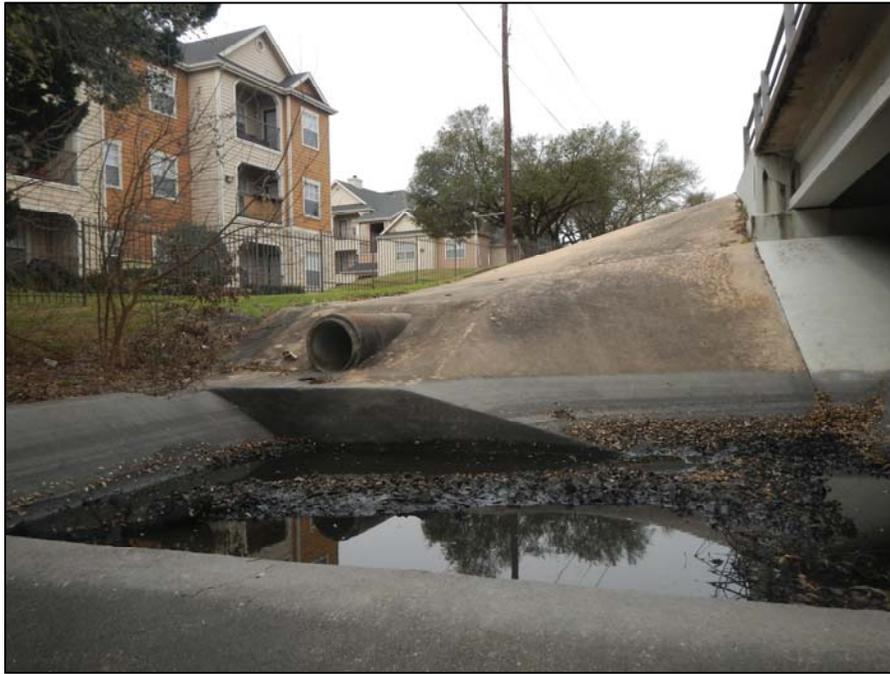
Photo 11: Crossing 1 - Concrete-lined water quality pond adjacent to the right bank of Onion Branch south (downstream) of the US 79 bridge, viewing southwest.

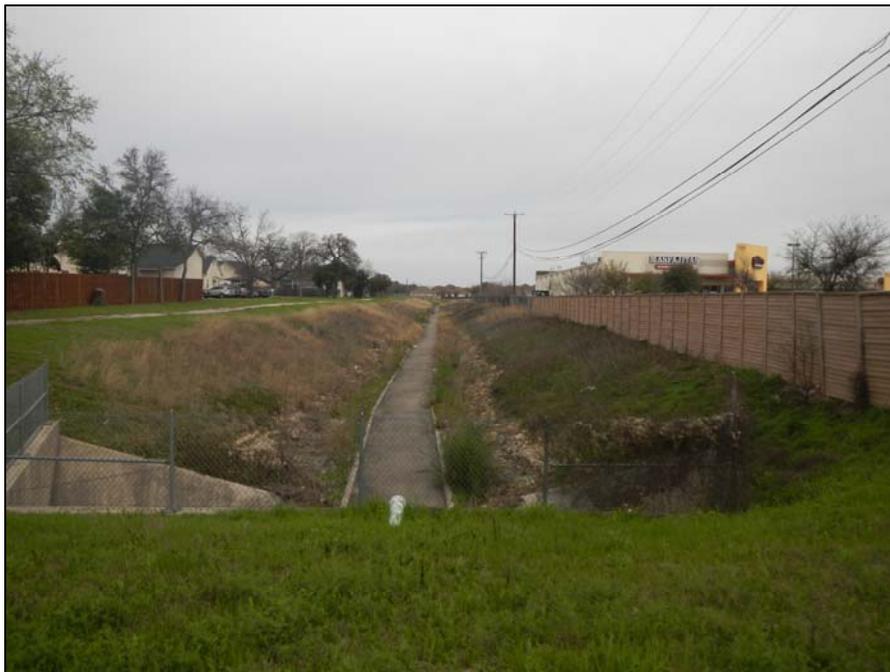
Photo 12: Crossing 2 - Pilot channel for stormwater infrastructure connected to the culvert where Brushy Creek Spring emanates. Flow is toward the photo point. US 79 is behind the photo point. Note the small (~4-inch) pipe above the headwall of the culvert's inlet.

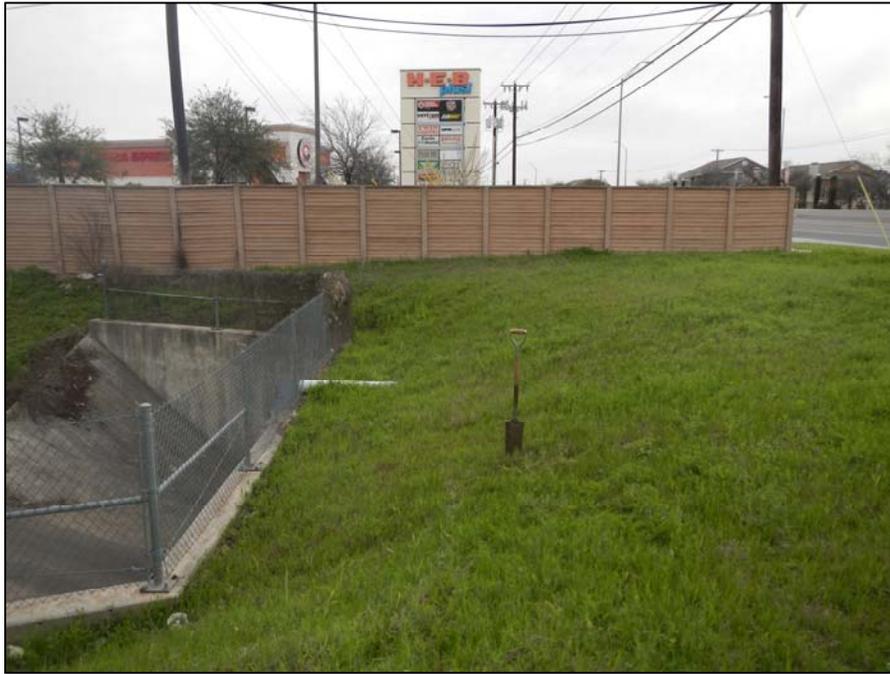
Photo 13: Crossing 2 - Alternate view of the culvert's headwall, viewing west. Note the pipe and US 79 (right of frame). The small pipe connects to an inlet in the ditch adjacent to US 79 that drains stormwater from the roadway and surrounding area.

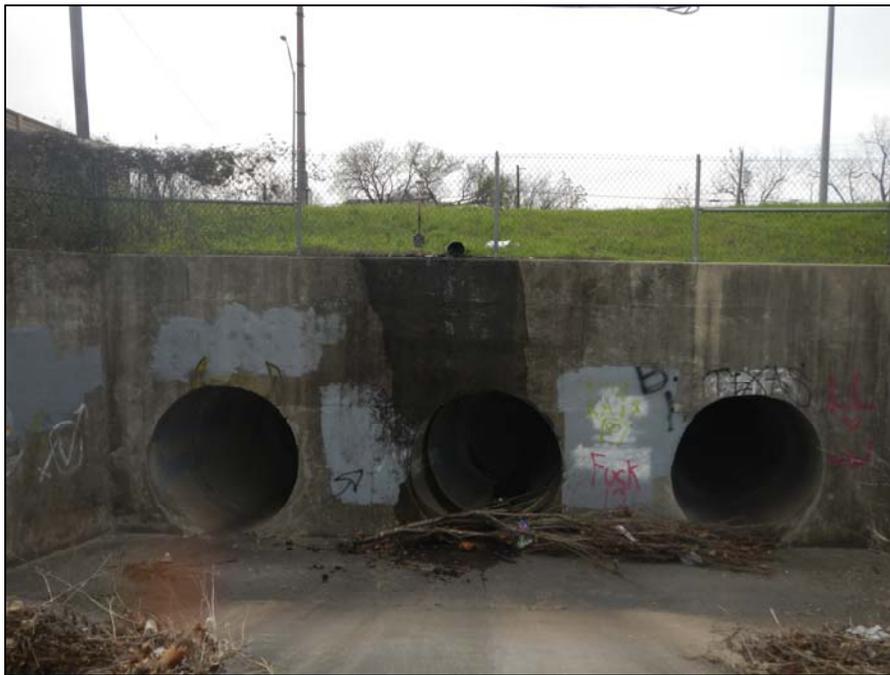
Photo 14: Crossing 2 - Culvert's inlet. Note the wet area of the headwall is under the small pipe's outlet and that the pilot channel is dry. Spring flow inside the culvert resulted in considerably larger volumes of flow, viewing south (downstream).

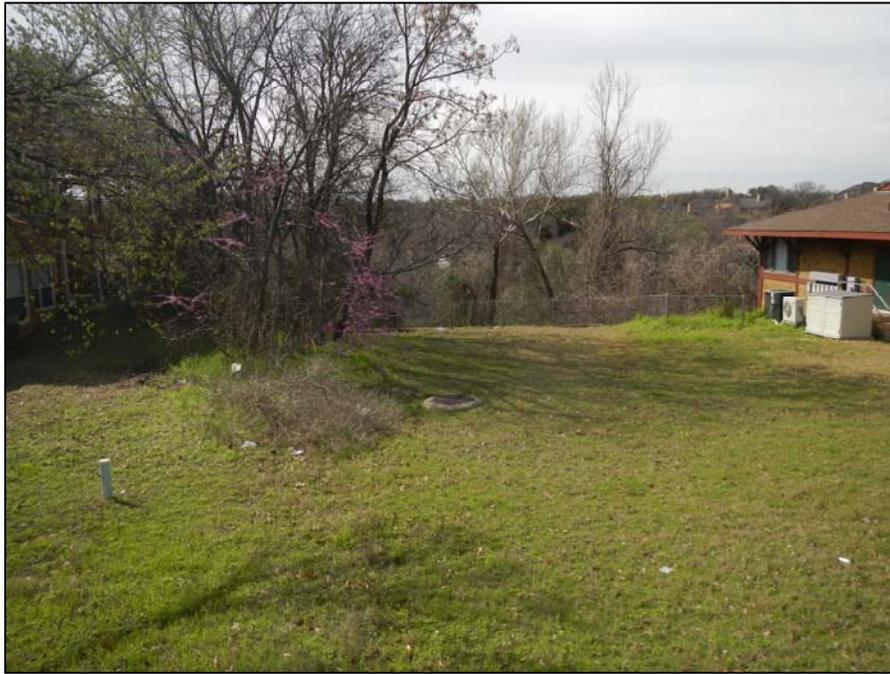
Photo 15: Crossing 2 - View south along the alignment of the culvert. US 79 is behind the photo point. The culvert's outfall and Brushy Creek are over the bluff that begins just beyond the maintained lawn (outside of right of way).

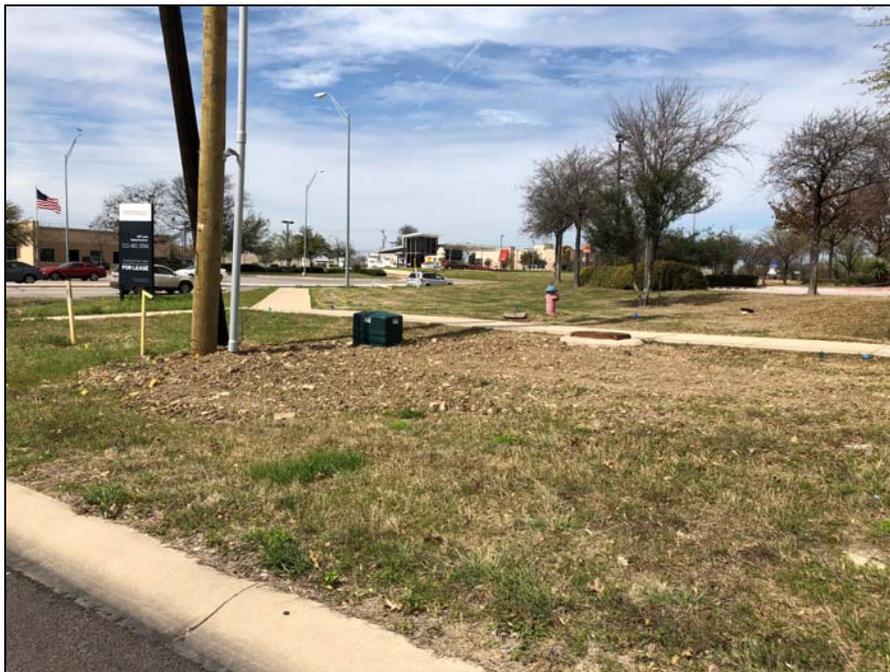
Photo 16: Crossing 3 - View northwest across recently developed area in the vicinity of the westernmost manmade pond that was identified through desktop analysis. US 79 is in the foreground and FM 1460 is in the distance.

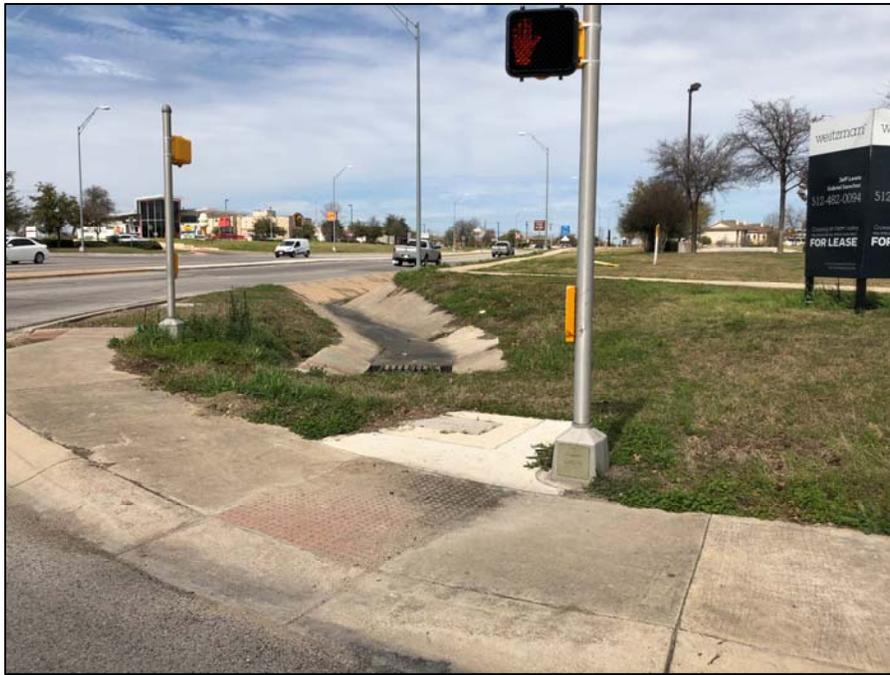
Photo 17: Crossing 3 - Alternate view of the area shown in Photo 16. US 79 is in the foreground and FM 1460 is in the distance, viewing north-northwest.

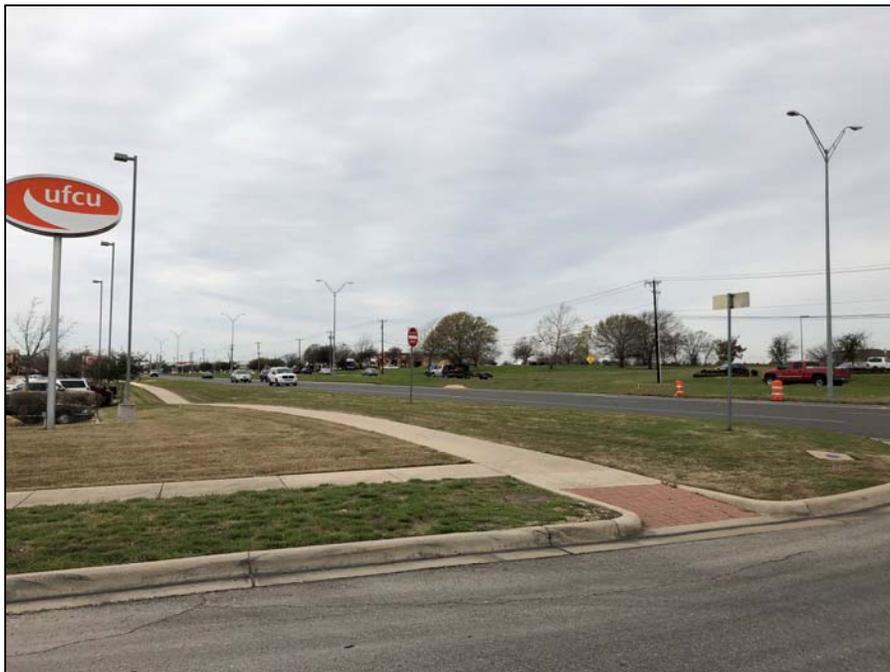
Field observations revealed that these features have been obliterated by recent commercial development and no sign of them was found. See **Figure 5**, **Figure 6c**, and **Photos 16 – 18**.

Photo 18: Crossing 3 - View west across recently developed area in the vicinity of the manmade ponds south of US 79 that were identified through desktop analysis. An unnamed access drive is in the foreground and US 79 is in the distance.

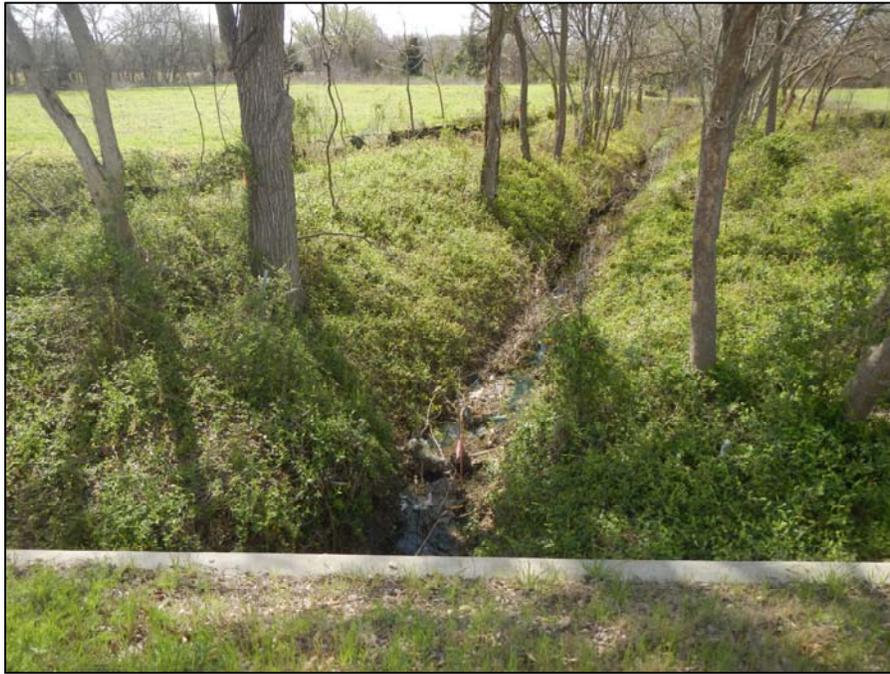
Photo 19: Crossing 4 - View south (downstream) along the manmade ditch. Note the concrete headwall in the foreground. US 79 is behind the photo point.

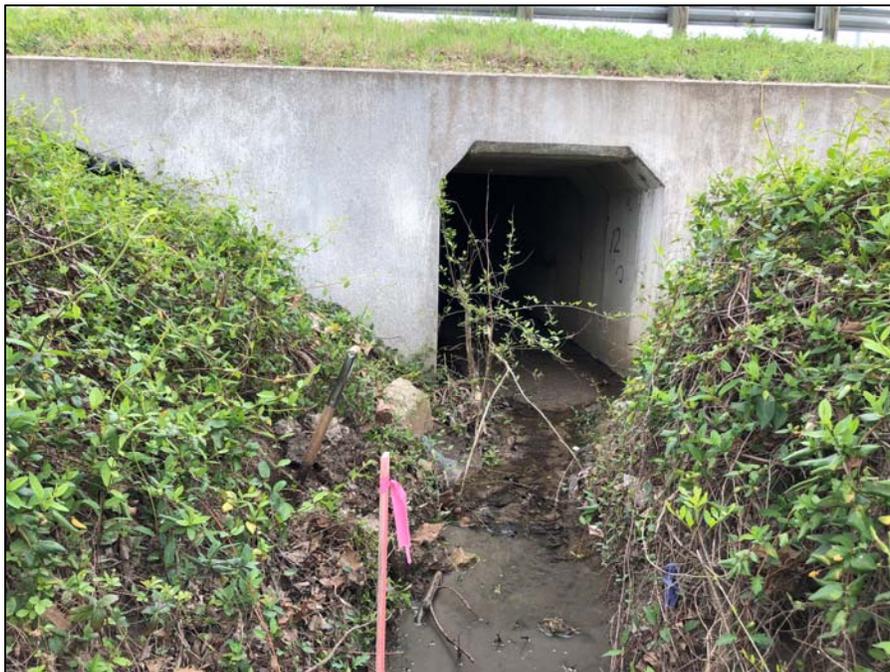
Photo 20: Crossing 4 - View north (upstream) toward the culvert that discharges to the manmade ditch.

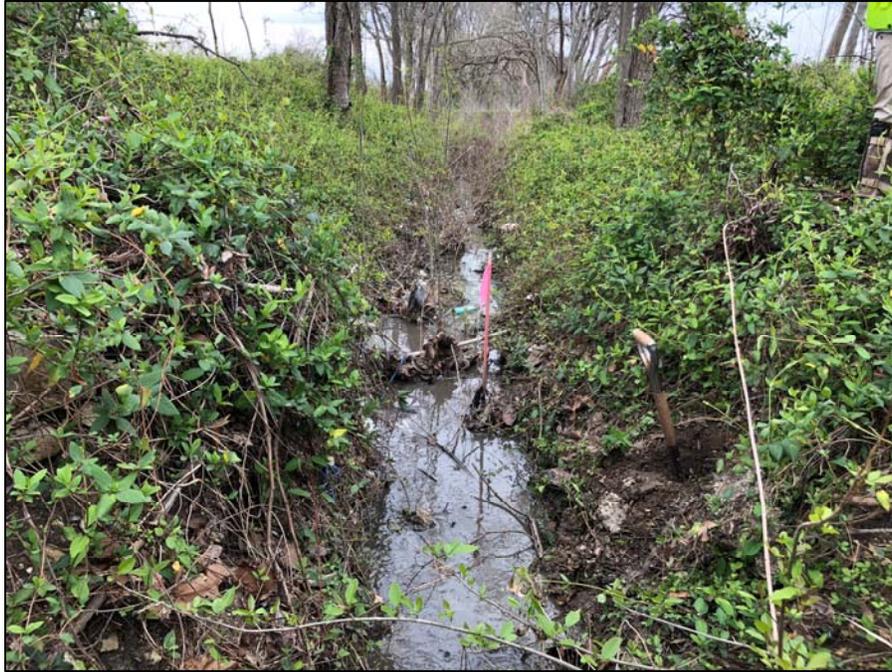
Standing water, approximately 2 inches deep, was observed in the manmade ditch at the time of the field visit. Erosional scour had removed vegetation from the bottom of the ditch and clear shelving was observed at the approximate height of the standing water. The limits of this channel were delineated and are identified on **Figure 6d**. The banks off the manmade ditch were trapezoidal, approximately 5 feet deep, and steeply sloped. The channel and the ditch were cut in an approximately straight line perpendicular to US 79. Wetland Determination Data Form 3 was completed adjacent to the channel south of US 79 (**Attachment C**).

Photo 21: Crossing 4 - View south (downstream) along the manmade ditch. Soil tests for Wetland Determination Point 3 were taken from the pictured soil pit. Note the steep banks and straight alignment of the trapezoidal channel.

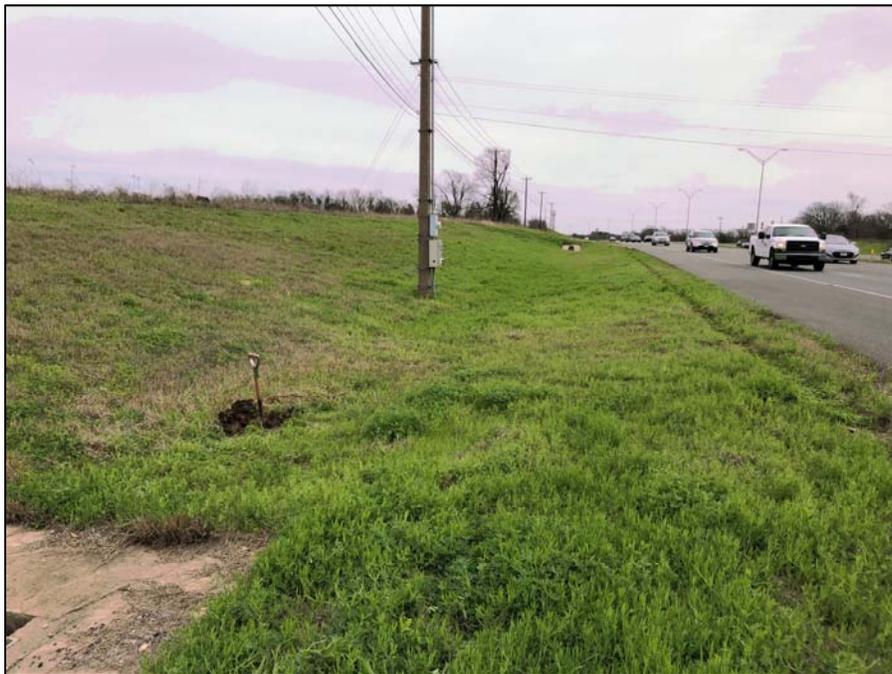
Photo 22: Crossing 4 - View east along the roadside ditch adjacent to US 79 (right of frame). Note the inlet in the foreground. This is one of several inlets that flow to the culvert that discharges into the manmade ditch. Soil data were collected from the pictured soil pit for Wetland Determination Point 4, viewing east.

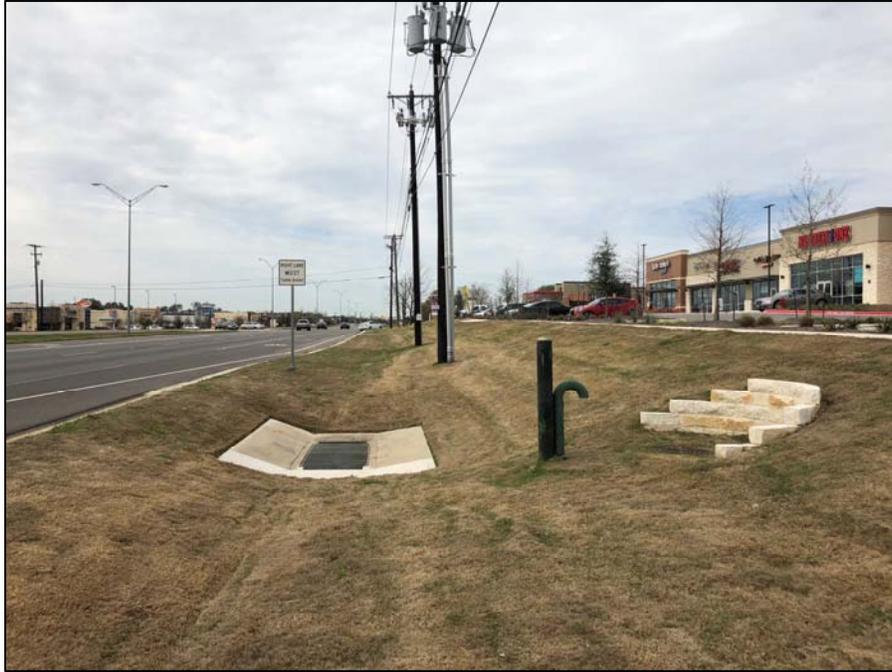
Photo 23: Crossing 4 - View west along a roadside ditch and US 79 (left of frame). Note the pictured inlet, which is one of several that flow to the culvert that discharges to the manmade ditch.
