Subject: Internal review under the First Amended Programmatic Agreement Among the Federal Highway Administration, the Texas Department of Transportation, the Texas State Historic Preservation Officer, and the Advisory Council on Historic Preservation Regarding the Implementation of Transportation Undertakings (PA-TU), and internal review under the Memorandum of Understanding (MOU) Between the Texas Historical Commission and the Texas Department of Transportation

Figure 1
Project Location
Cotton Belt Trails

**STRUCTURE NO. 36
SINGLE-TRACK STEEL GIRDER BRIDGE
OVER IRA E. WOODS AVENUE (TARRANT COUNTY, TX)**

60 Percent Design Plans for the railroad bridge of Ira E. Woods Avenue

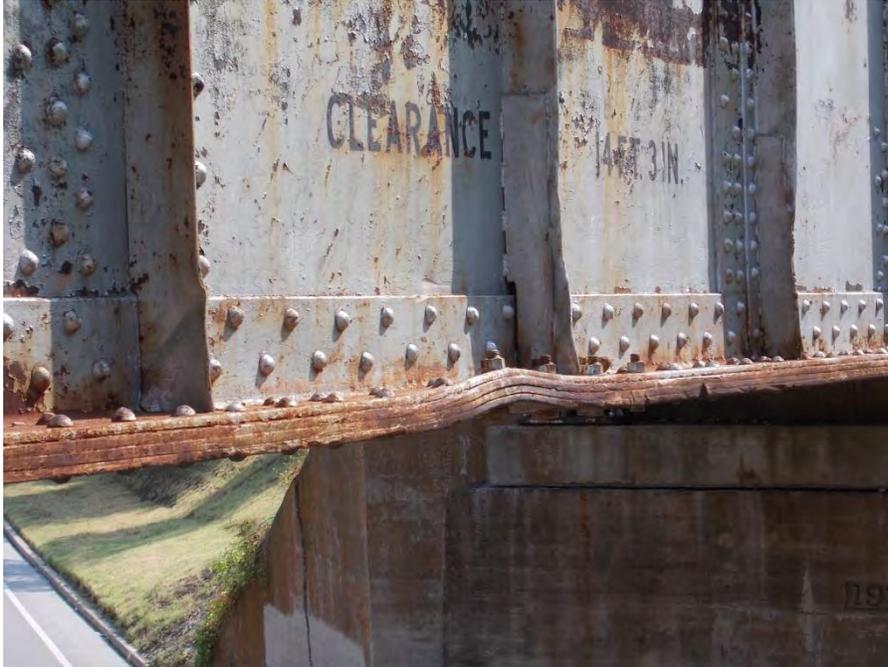
Photo 1: Impact Damage to Bottom Flange Cover Plates; South Girder

2. The outer edge of the bottom flange of the south girder has impact damage near midspan (See Photo 1). There is an upward permanent deformation of $\pm 1-1/2"$ to $2"$ along an $\pm 18"$ length. Rivets in the vicinity of impact have been replaced by bolts which are in good condition.

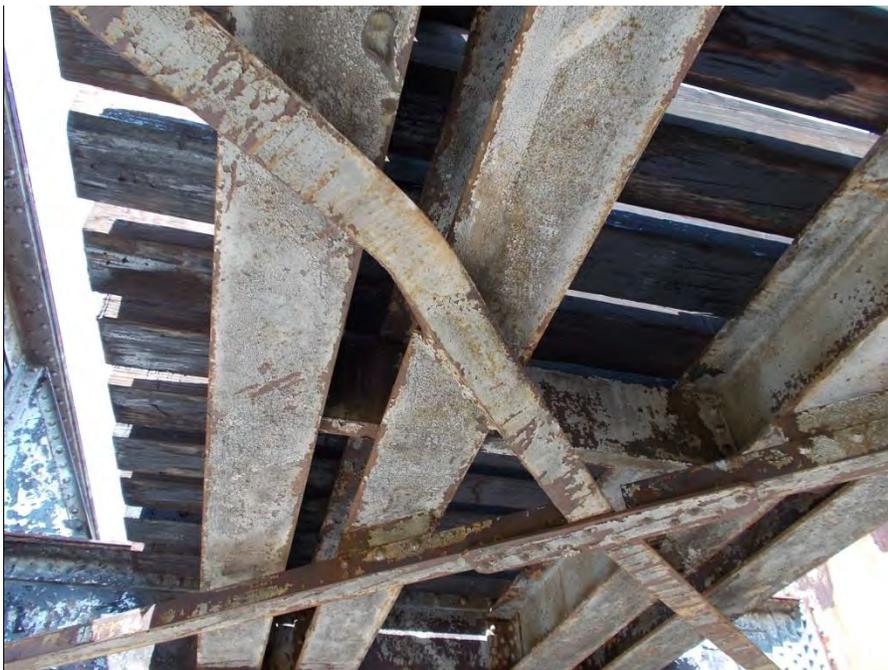
Photo 2: Impact Damage to Midspan Bay Lateral Bracing Angles

3. In the same bridge section as the impact damage described above, there is evidence of impact that extends across the full width of the bridge, to the inside bottom flange of the north girder. The severity of damage decreases to the north. The midspan bay lateral bracing angle members have moderate impact damage (See Photo 2). Permanent impact distortions of the interior steel lateral bracing members and connection plates are typically smooth and moderate, and have no fractures or broken rivets. The inside edge of the north girder bottom flange has minimal damage (See Photo 3).

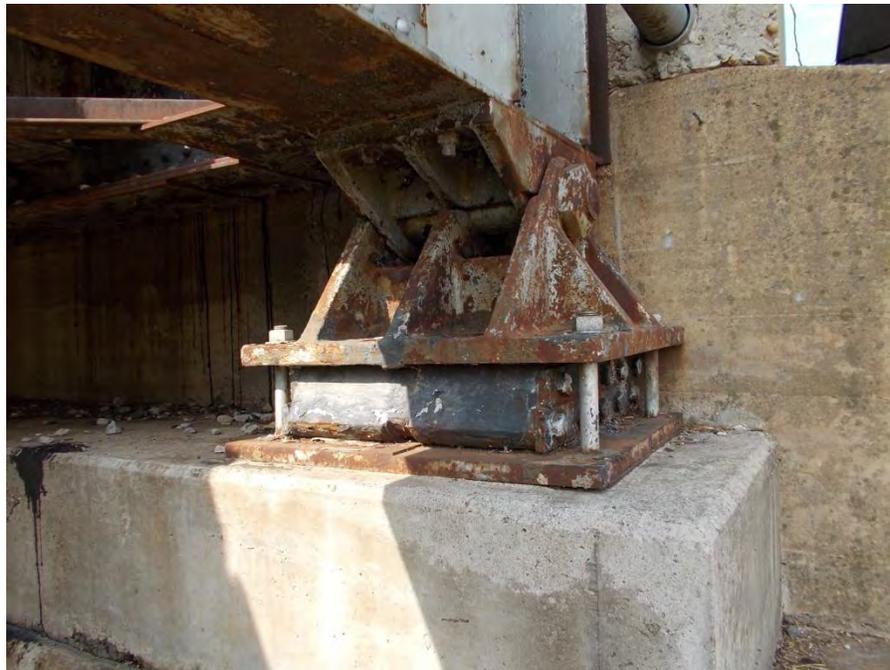
Photo 4: North Steel Plate Nested Rocker Expansion Bearing at West Abutment

4. The west abutment bearings are steel plate, nested rocker assemblies and are in fair condition (See Photo 4). All components have moderate surface corrosion. The rocker bars have moderate/heavy surface corrosion and are likely frozen. Both bearing assemblies have translated beyond their maximum range of movement in the direction of the backwall. The excessive movement is evident by bent anchor bolt shafts which butt against the ends of the slotted holes of the sole plates. The shafts are deflected $\pm 1\text{-}1/2$ " horizontally x $6\text{-}1/2$ " height, and lean towards the backwall (See Photo 5). The north bearing sole plate and the west end of the north girder are in contact with the backwall (See Photo 6).

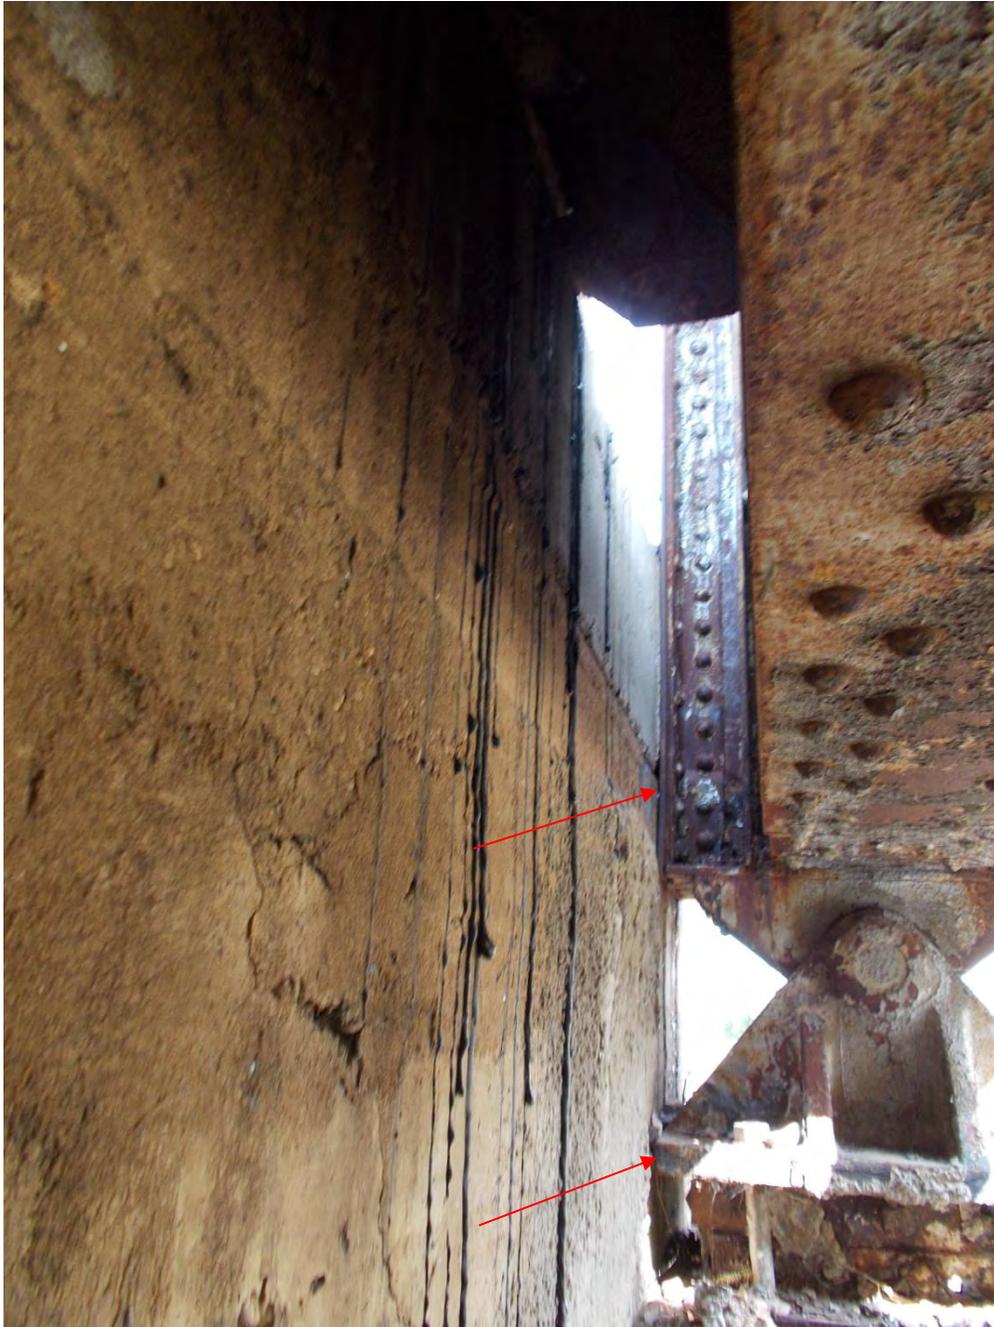
**Photo 6: Sole Plate and Girder End in Contact with Backwall;
North Beating, West Abutment**

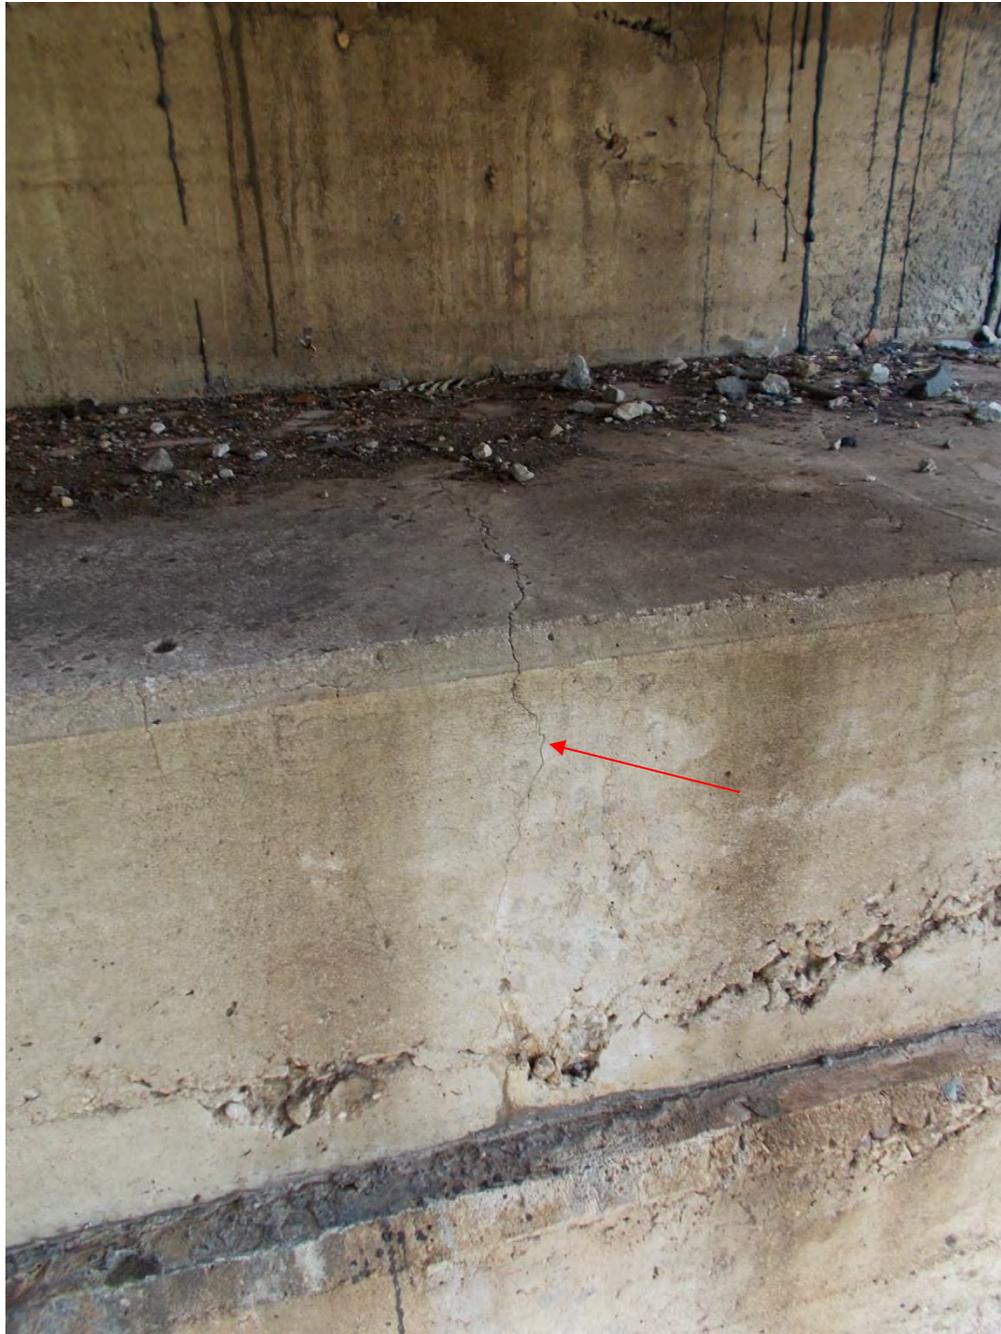
5. The west abutment is in satisfactory/fair condition. The pedestal concrete has a hairline-to- $1/32$ " wide x full height vertical crack near the centerline with edge spalls to $1/16$ " wide (See Photo 7). The crack extends across the top face. The pedestal is an encasement repair and is in satisfactory condition. The concrete backwall has several hairline-to- $1/32$ " wide x full-height vertical cracks; some have up to $1/4$ " wide edge spalling (See Photo 8).

**Photo 7: Open Crack in Bearing Pedestal with 1/16" Edge Spalls;
West Abutment, Near the Centerline**

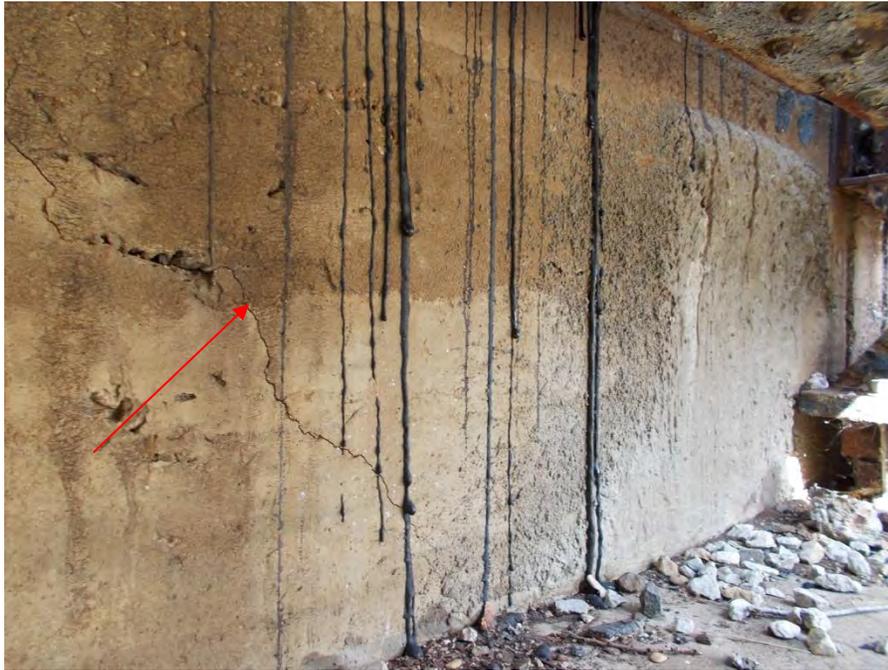
**Photo 8: Full-Height Vertical Open Crack in the West Abutment Backwall
(Note $\pm 1/4$ " Edge Spalling)**

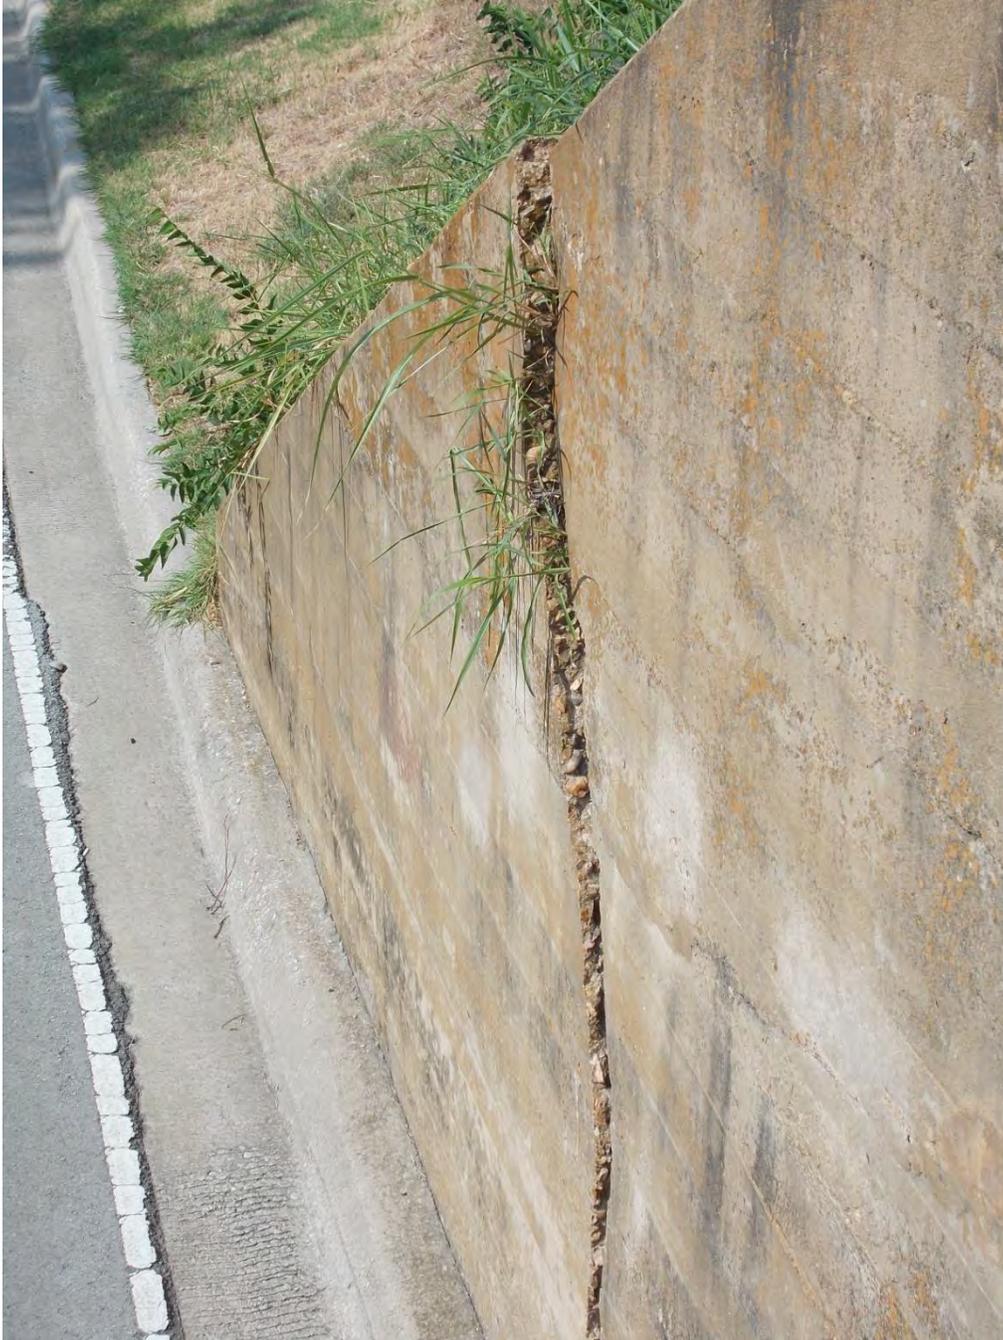
6. The southwest concrete wingwall has a full-height fracture near mid-length (See Photo 9). The portion of the wingwall near the backwall is intact; the end portion is detached from the main body and is displaced outward by ± 2 " to 3".

Photo 9: Full-Height Fracture in the Southwest Wingwall, Near Mid-Length

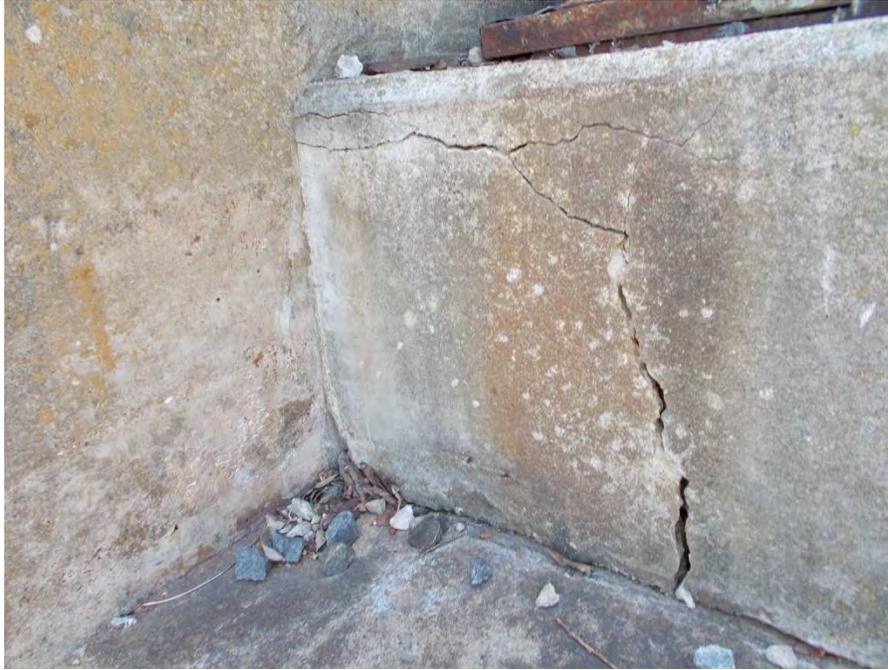
Photo 10: Full-Height Vertical Fracture in North Face of Bearing Pedestal; East Abutment

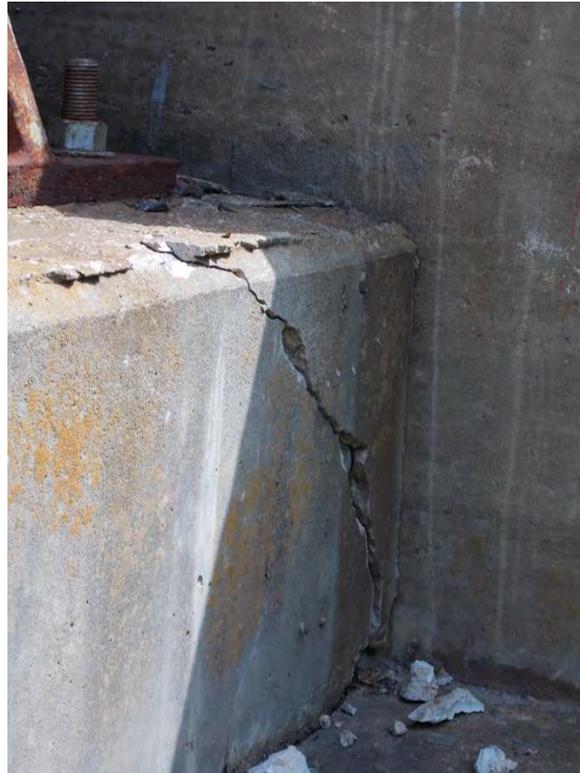
Photo 11: Full-Height Vertical Fracture in South Face of Bearing Pedestal; East Abutment

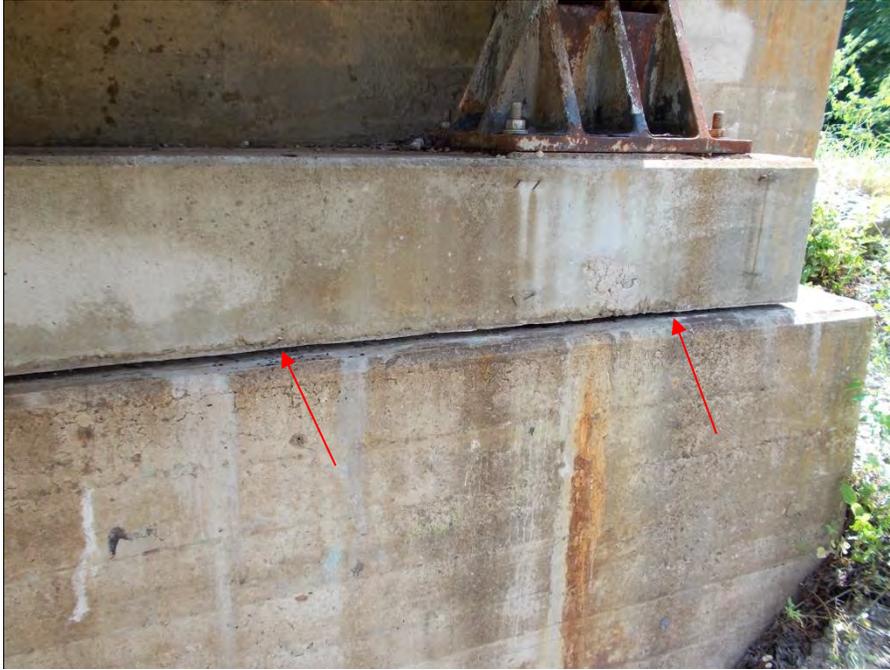
Photo 12: Open Full-Width Construction Joint beneath Bearing Pedestal; East Abutment

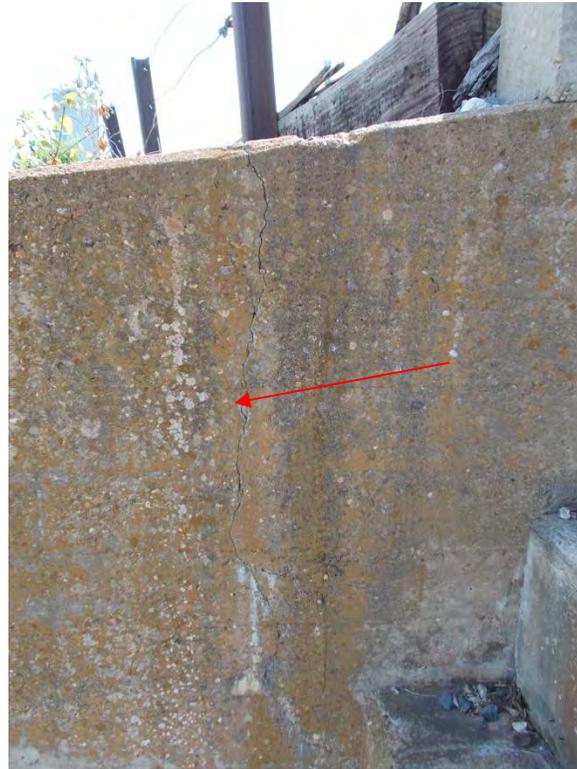
Photo 13: Open Vertical Crack in the East Abutment Backwall (Near the North Bearing)

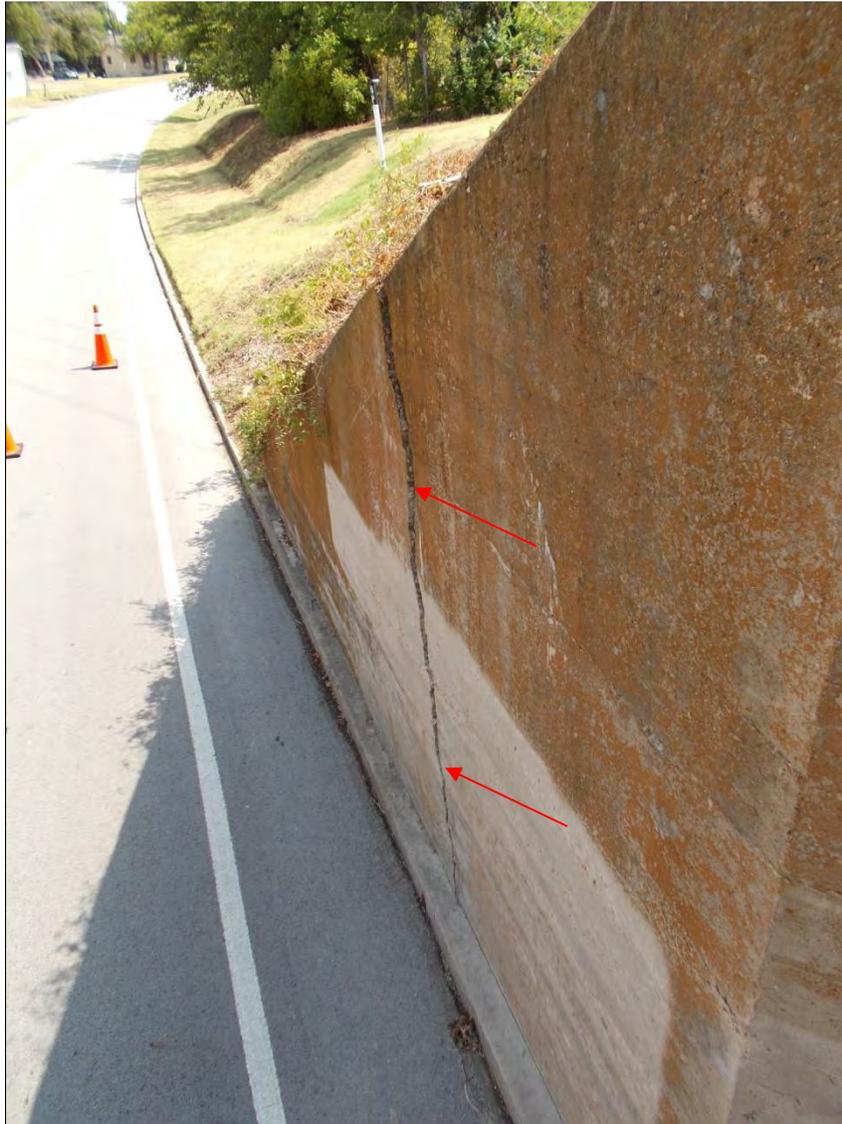
Photo 14: Full-Height Fracture, and Displacement of Northeast Wingwall Section

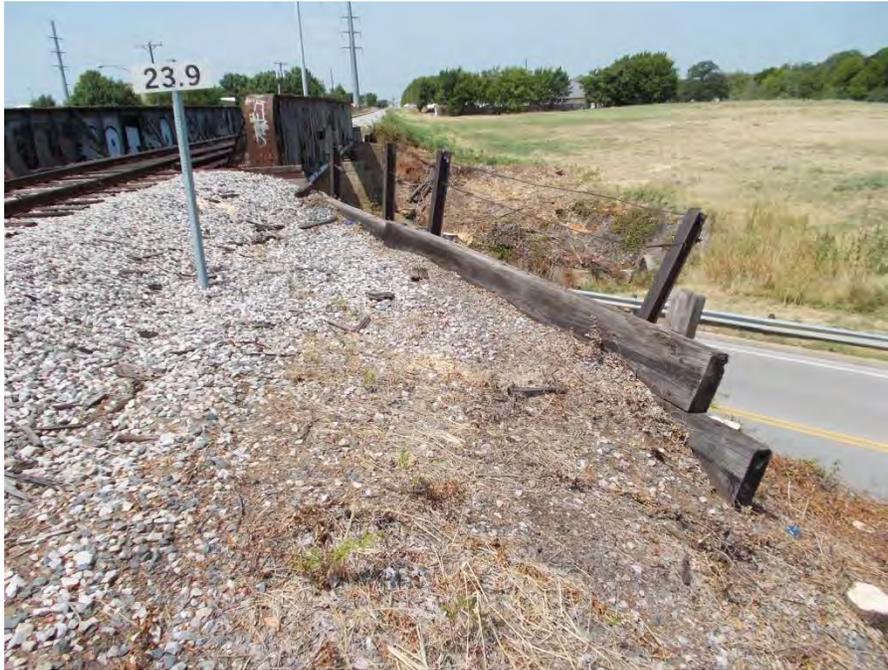
Photo 15: Partially Failing Northeast Timber Retaining Wall

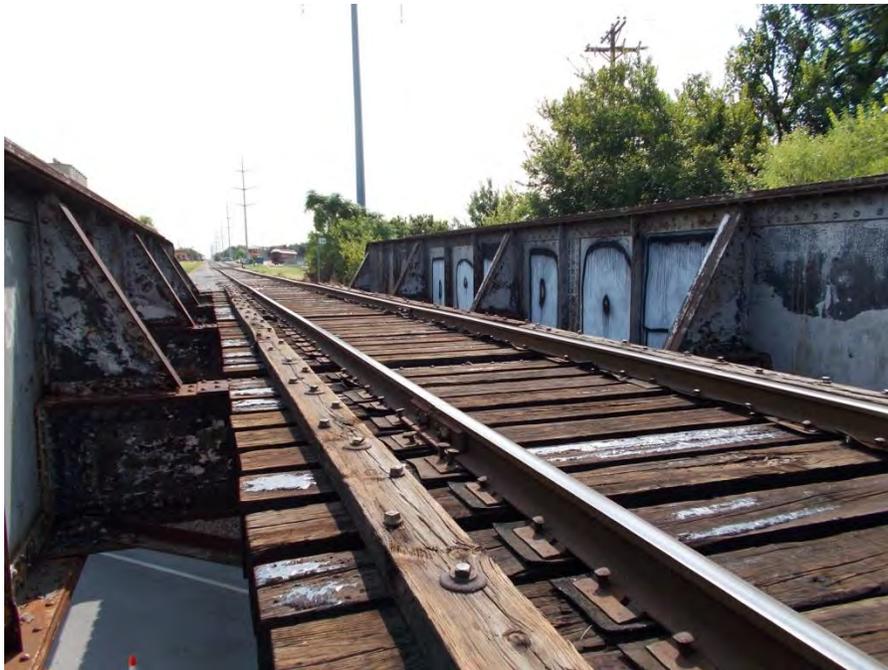
Photo 16: Typical Satisfactory Deck Condition (Note Guard Timbers and Timber Ties)

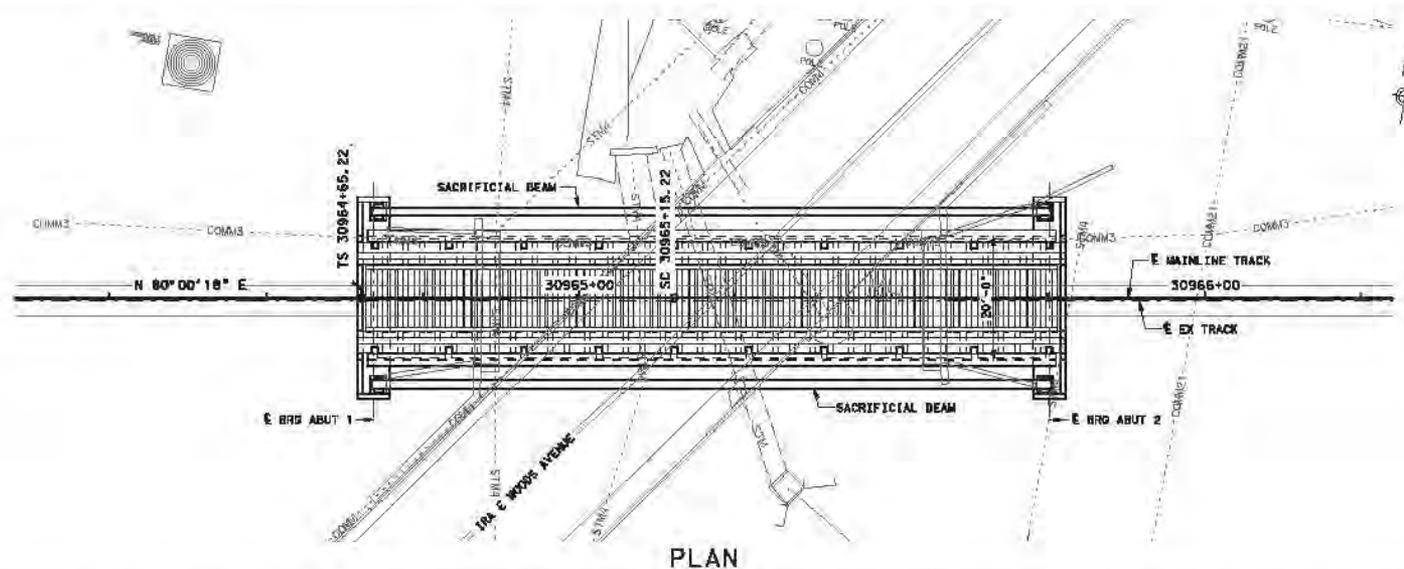
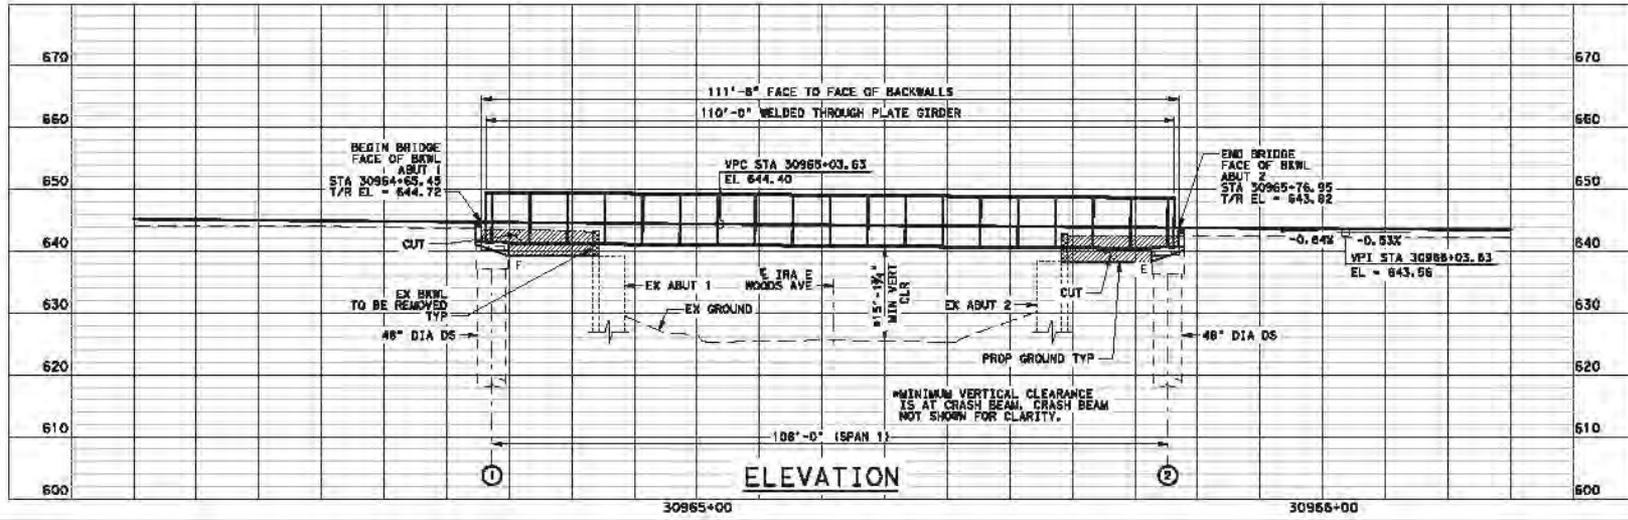
PLAN

This bridge crosses Ira E. Woods Street with a single open deck 110' welded through plate girder span that replaces the existing open deck through plate girder bridge. The new bridge is an in-line replacement of the existing bridge. The two new abutments are constructed behind the existing abutments utilizing drilled shafts placed outside and clear of the tracks and existing abutments. These drilled shafts can be constructed prior to the track window that is required to construct the abutment beams. Once the abutment beams are constructed, they will be backfilled around and train traffic resumes. After remaining superstructure is assembled on site, a track window will be utilized to remove the fill placed around the new abutments and place the precast backwalls and precast pedestals on the abutment beams. In addition, the embankment between the new abutments and old abutments will be removed to form the berm in front of the abutments. The existing abutments will remain in place and act as the retaining walls in front of the new abutments but require some modifications (cut down) to clear the new through plate girders. Once all of this construction is completed, the new superstructure will be placed and track will be placed back into service.

TEX Rail has worked to design a bridge that reflects the historic character of the existing bridge, but does not duplicate it. As stipulated in the MOA, the new bridge will have an open deck, be located in the general vicinity of the original bridge and at the same elevation. Overall, it will have similarities with the historic bridge, but will clearly be representative of the current era. The new structure will retain the alignment of the existing bridge, which is a distinctive feature of the bridge. The original riveted through plate girder span design will be replaced with a similar welded through plate girder span. The new bridge will not have the rounded corners at the end of the rails like the original bridge, but will have the familiar solid rails. The footings of the original bridge will be left in place and the new footings located behind them.

The existing bridge is a through plate girder bridge, which refers to the design that allows traffic to pass through the truss without cross bracing above the bridge deck. Railroads commonly used these bridges over short spans in the early twentieth century, but in later years they were frequently replaced by concrete girders. The new design uses the historical style of bridge, the same alignment, similar massing and materials, but will be constructed with modern methods including welded joints. Overall, TEX Rail has worked to achieve a design that retains the key elements of the existing bridge and is compatible with the surrounding historic district.

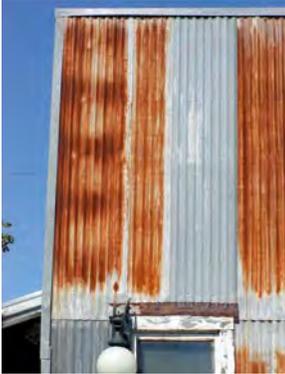
CORREGATED METAL,
SHOWING RUSTING.

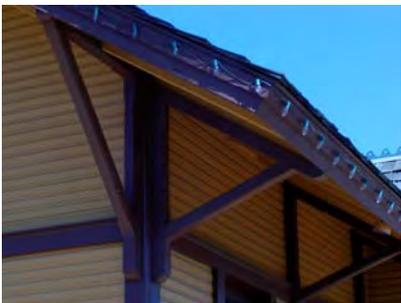
BRACKET AT EAVE DETAIL
AT TRAIN DEPOT
