Biological Evaluation Form

Main CSJ: 0313-02-057 and 0171-03-070

Roadway Name: Farm-to-Market (FM) Road 51 and State Highway (SH) 99

FARM-TO-MARKET ROAD 51 AND STATE HIGHWAY 199: RARE PLANT SURVEY REPORT

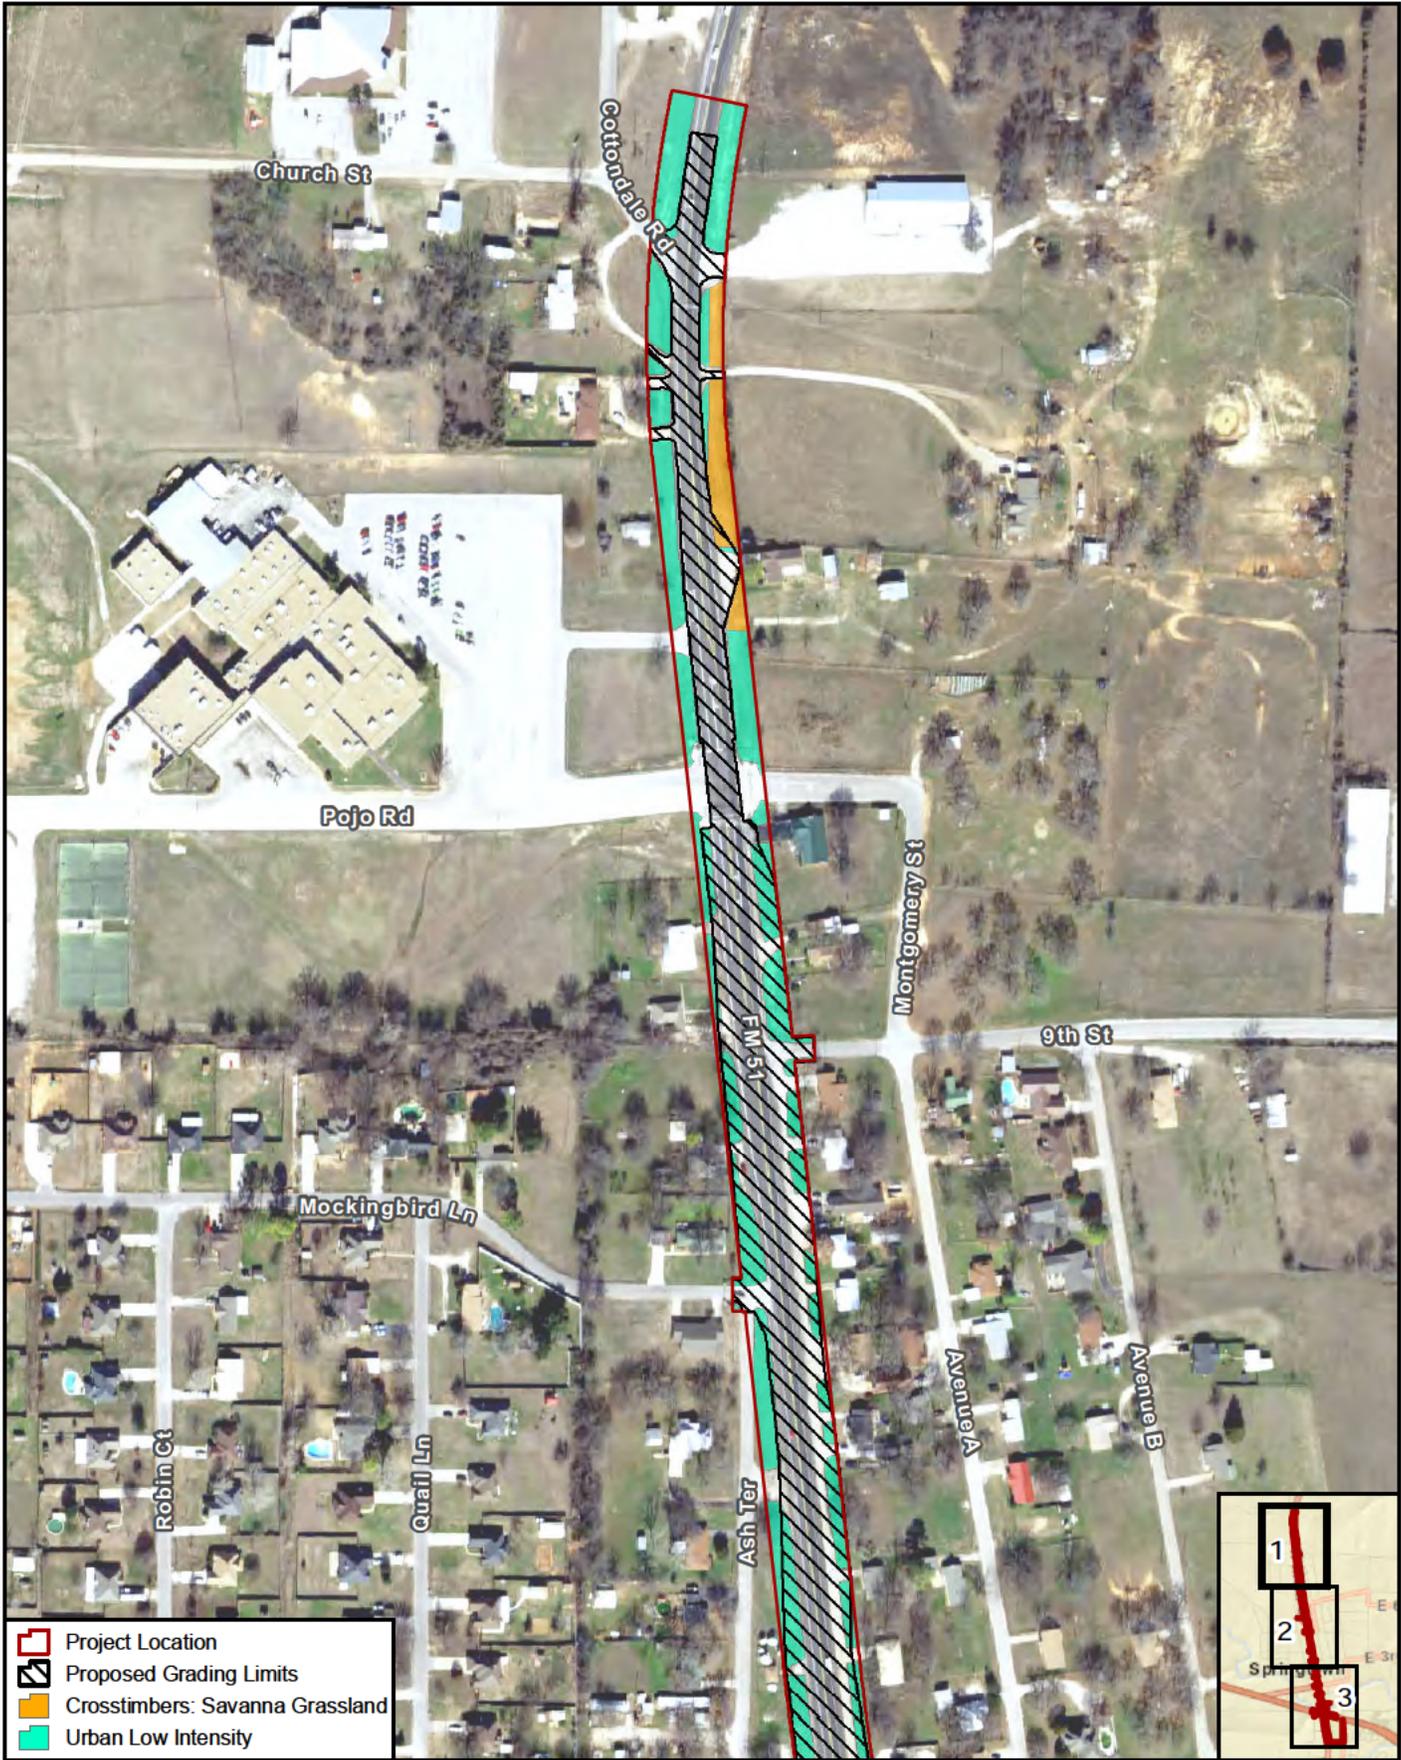
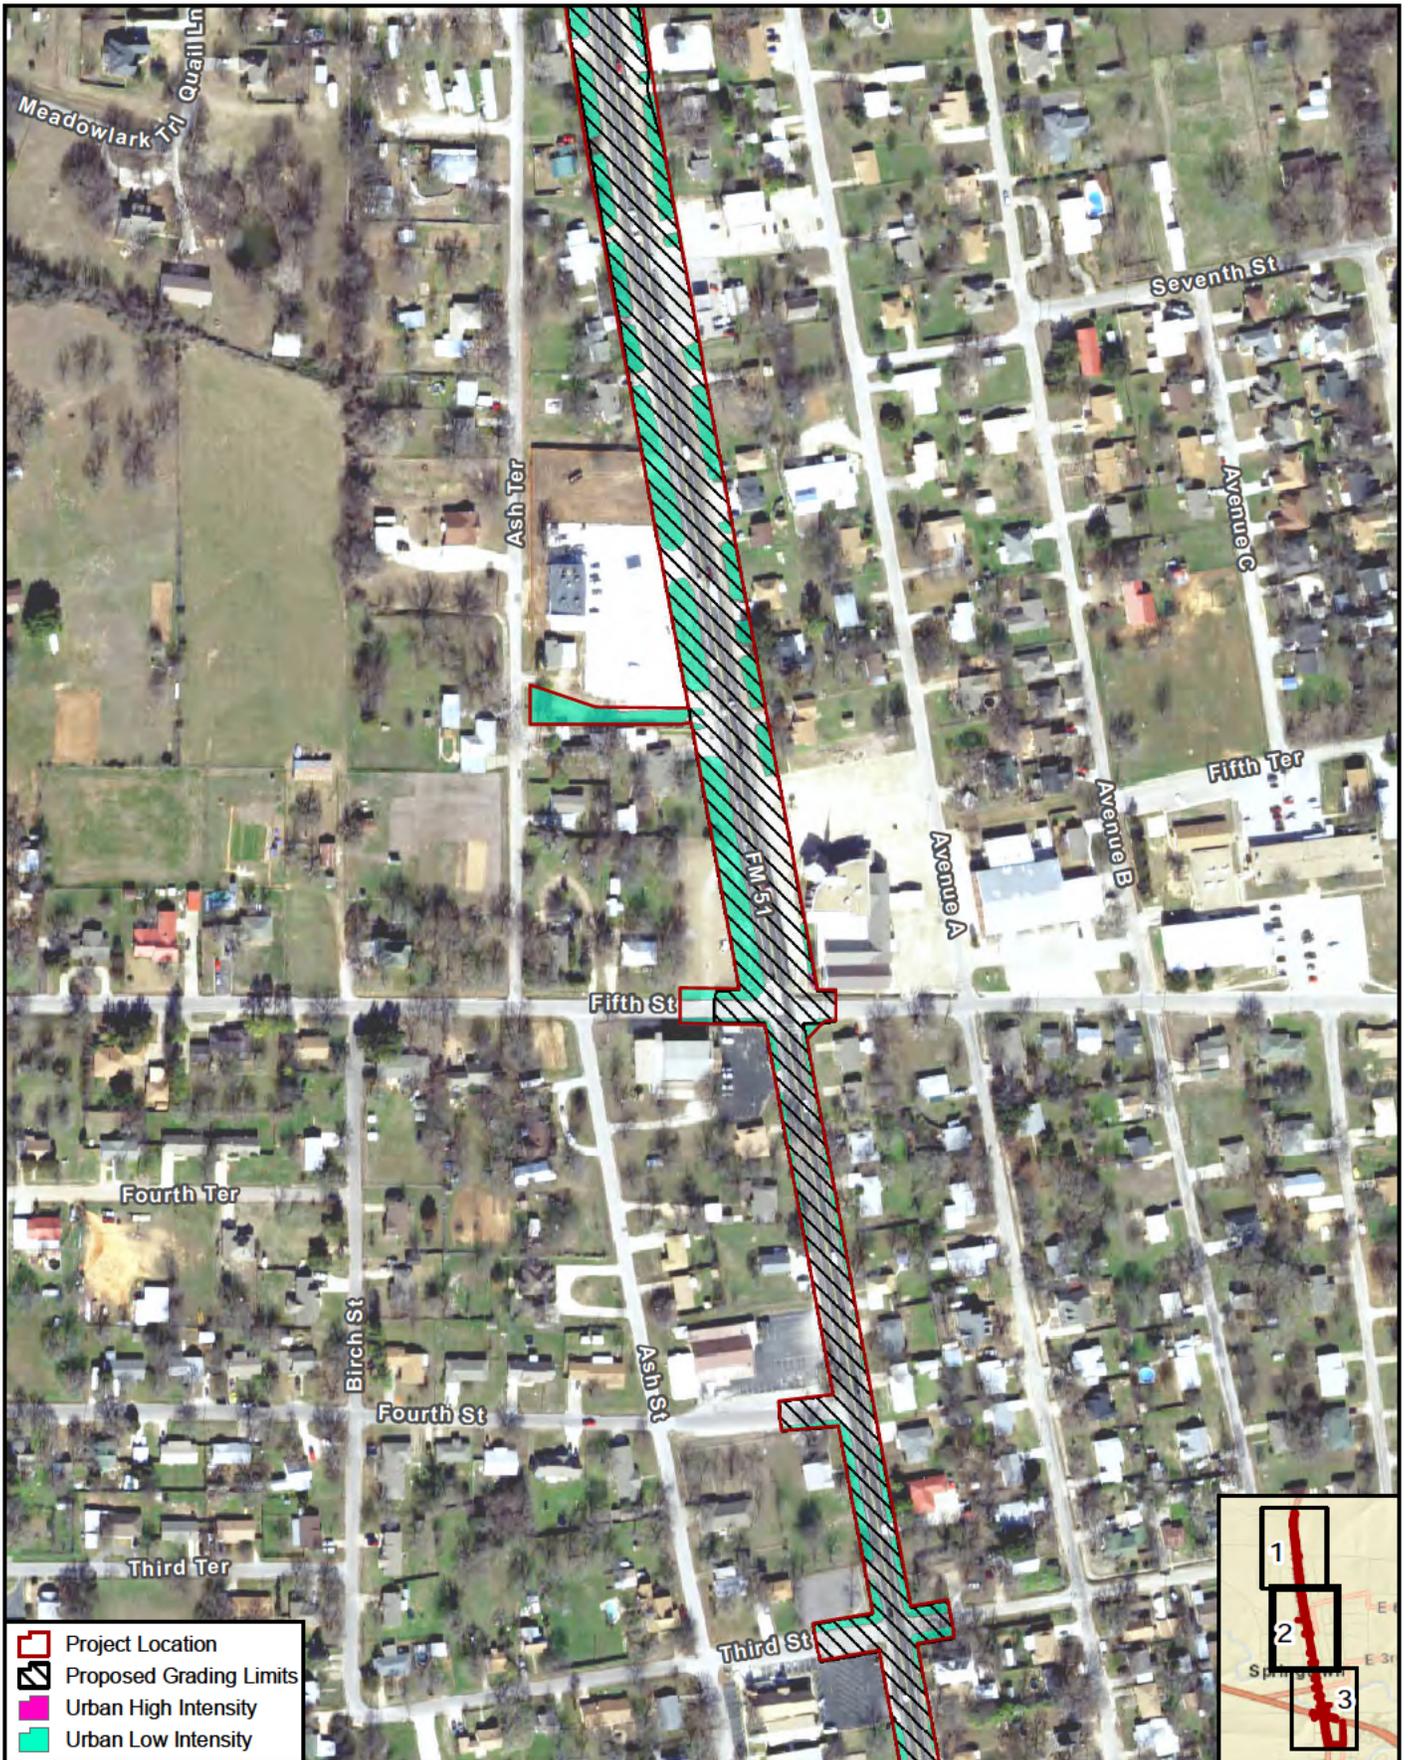
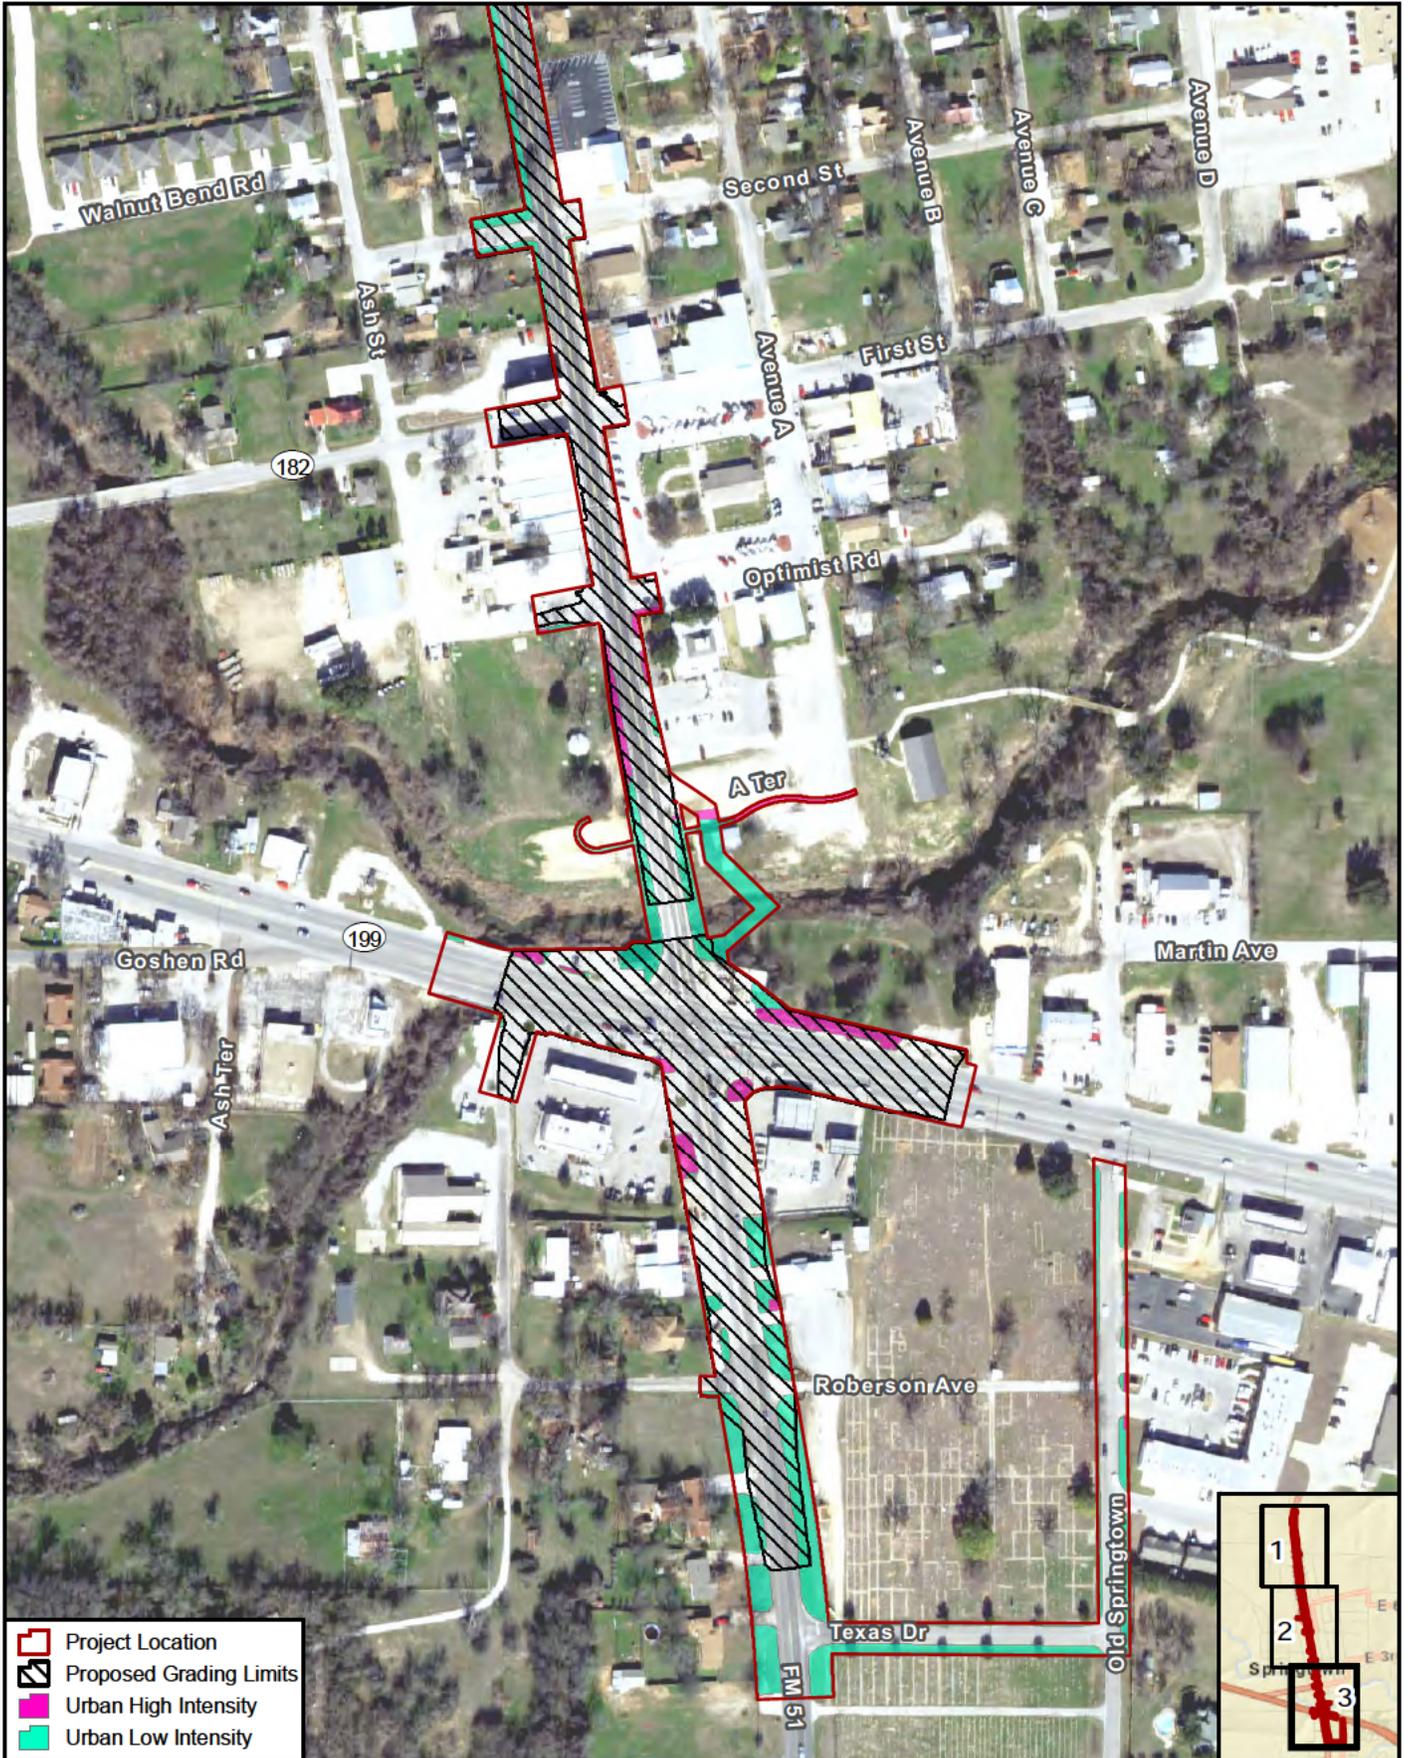
EMST Mapped Vegetation Types

- Project Location
- Proposed Grading Limits
- Urban High Intensity
- Urban Low Intensity

The EMST mapped vegetation types did not correspond with the observed vegetation types. Near the northern terminus of the proposed project area the EMST map shows an area mapped as "Crosstimbers: Savanna Grassland" vegetation type. However, during the October 2017 site visit this areas was better represented as "Urban Low Intensity" vegetation type. In addition, "Central Texas: Riparian Herbaceous Vegetation" was verified by qualified biologists along the banks of Walnut Creek (Crossing 1), near the intersection of FM 51 and SH 199.

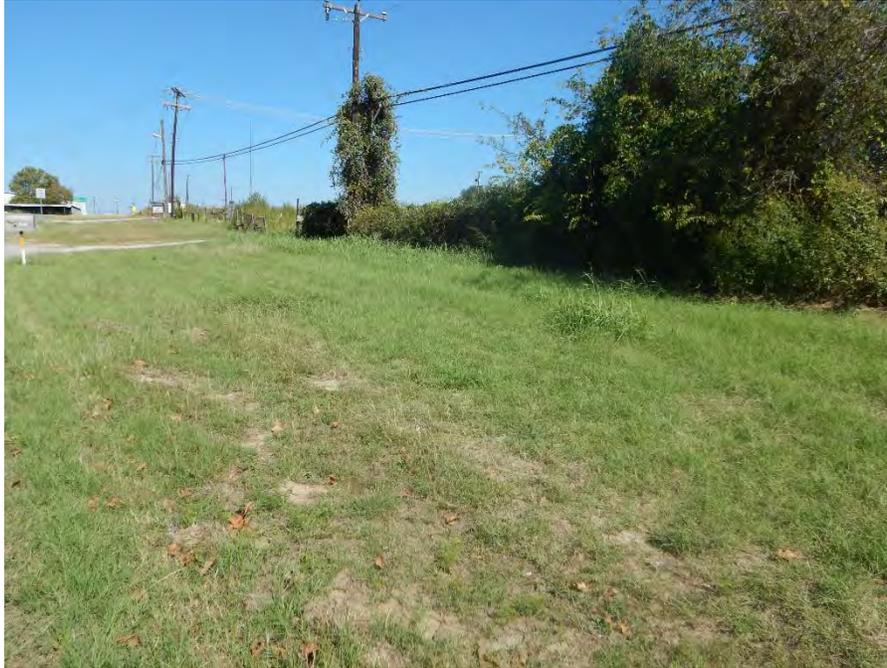
Photo 1: Observed Vegetation Type 1: Urban Low Intensity

Observed Vegetation Type 1: Urban Low Intensity (corresponds with MOU Urban habitat type), is dominated by a thick herbaceous layer of Bermudagrass (*Cynodon dactylon*), common yellow oxalis (*Oxalis stricta*), and Johnsongrass (*Sorghum halepense*). Encroaching mustang grape (*Vitis mustangensis*) and trumpet creeper (*Campsis radicans*) are located along fence lines. The canopy cover is patchy and is comprised of mostly planted and ornamental species which have been pruned and maintained. Woody species include American elm (*Ulmus americana*), crape myrtle (*Lagerstroemia indica*), and live oak (*Quercus virginiana*). The diameter at breast height (DBH) of woody species ranged from 4 inches to 18 inches. This observed vegetation type is located along the majority of the project area which is located in existing medians and along the shoulders of SH 199 and FM 51. Residential maintained yards, and Springtown Park was also covered by Urban Low Intensity vegetation. These areas are highly disturbed and were likely seeded at one time. Approximately 7.411 acres of Observed Vegetation Type 1 is located within the project area and approximately 3.980 acres would be potentially impacted by the proposed project.

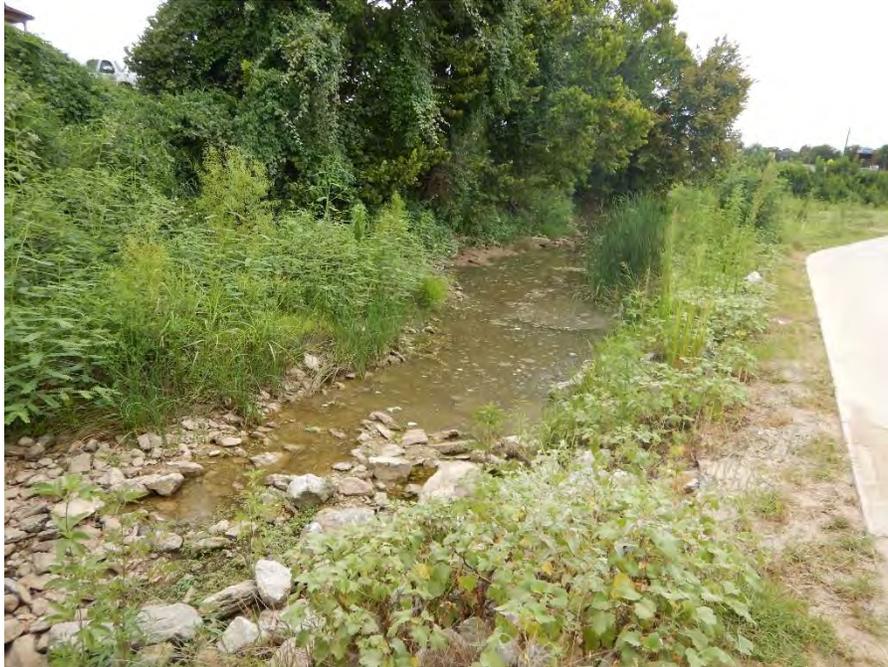
Photo 2: Observed Vegetation Type 2: Central Texas: Herbaceous Riparian Vegetation

Observed Vegetation Type 2: Central Texas: Herbaceous Riparian Vegetation (corresponds with MOU Riparian habitat type), is dominated by thick herbaceous groundcover comprised of rough cocklebur (*Xanthium strumarium*), Johnsongrass, great ragweed (*Ambrosia trifida*), black willow saplings (*Salix nigra*), common spikerush (*Eleocharis palustris*), and annual bastardcabbage (*Rapistrum rugosum*). Thick mats of mustang grape and tall morning-glory (*Ipomoea purpurea*) are also located throughout this observed vegetation type. Observed Vegetation Type 2 is located along the banks of Walnut Creek. These areas are small remnant pockets of unmaintained native vegetation which have significant encroachment of introduced/invasives. Approximately 0.111-acre of Observed Vegetation Type 2 is located within the project area and approximately 0.026- acre would be potentially impacted by the proposed project.

Approximately 0.026-acre of Central Texas: Riparian Herbaceous Vegetation (Riparian MOU) would be impacted by the proposed project area, as verified by a qualified biologist. Please see the Project EMST Vegetation Types, EMST Mapped Vegetation Type Figure, Observed Vegetation Types, and Observed Vegetation Types Figure found in the uploaded file "Biological Evaluation Form and Tier I Site Assessment Form Attachments (0313-02-057 & 0171-03-070).pdf ".

According to current project plans, approximately 0.026-acre of Central Texas: Riparian Herbaceous Vegetation (Riparian MOU) will be impacted by the proposed project. The Riparian MOU Type Threshold for the Crosstimbers Ecoregion is 0.10-acre. The proposed project is not expected to exceed the Riparian MOU type threshold. Please see the Project EMST Vegetation Types, EMST Mapped Vegetation Type Figure, Observed Vegetation Types, and Observed Vegetation Types Figure found in the uploaded file "Biological Evaluation Form and Tier I Site Assessment Form Attachments (0313-02-057 & 0171-03-070).pdf ".

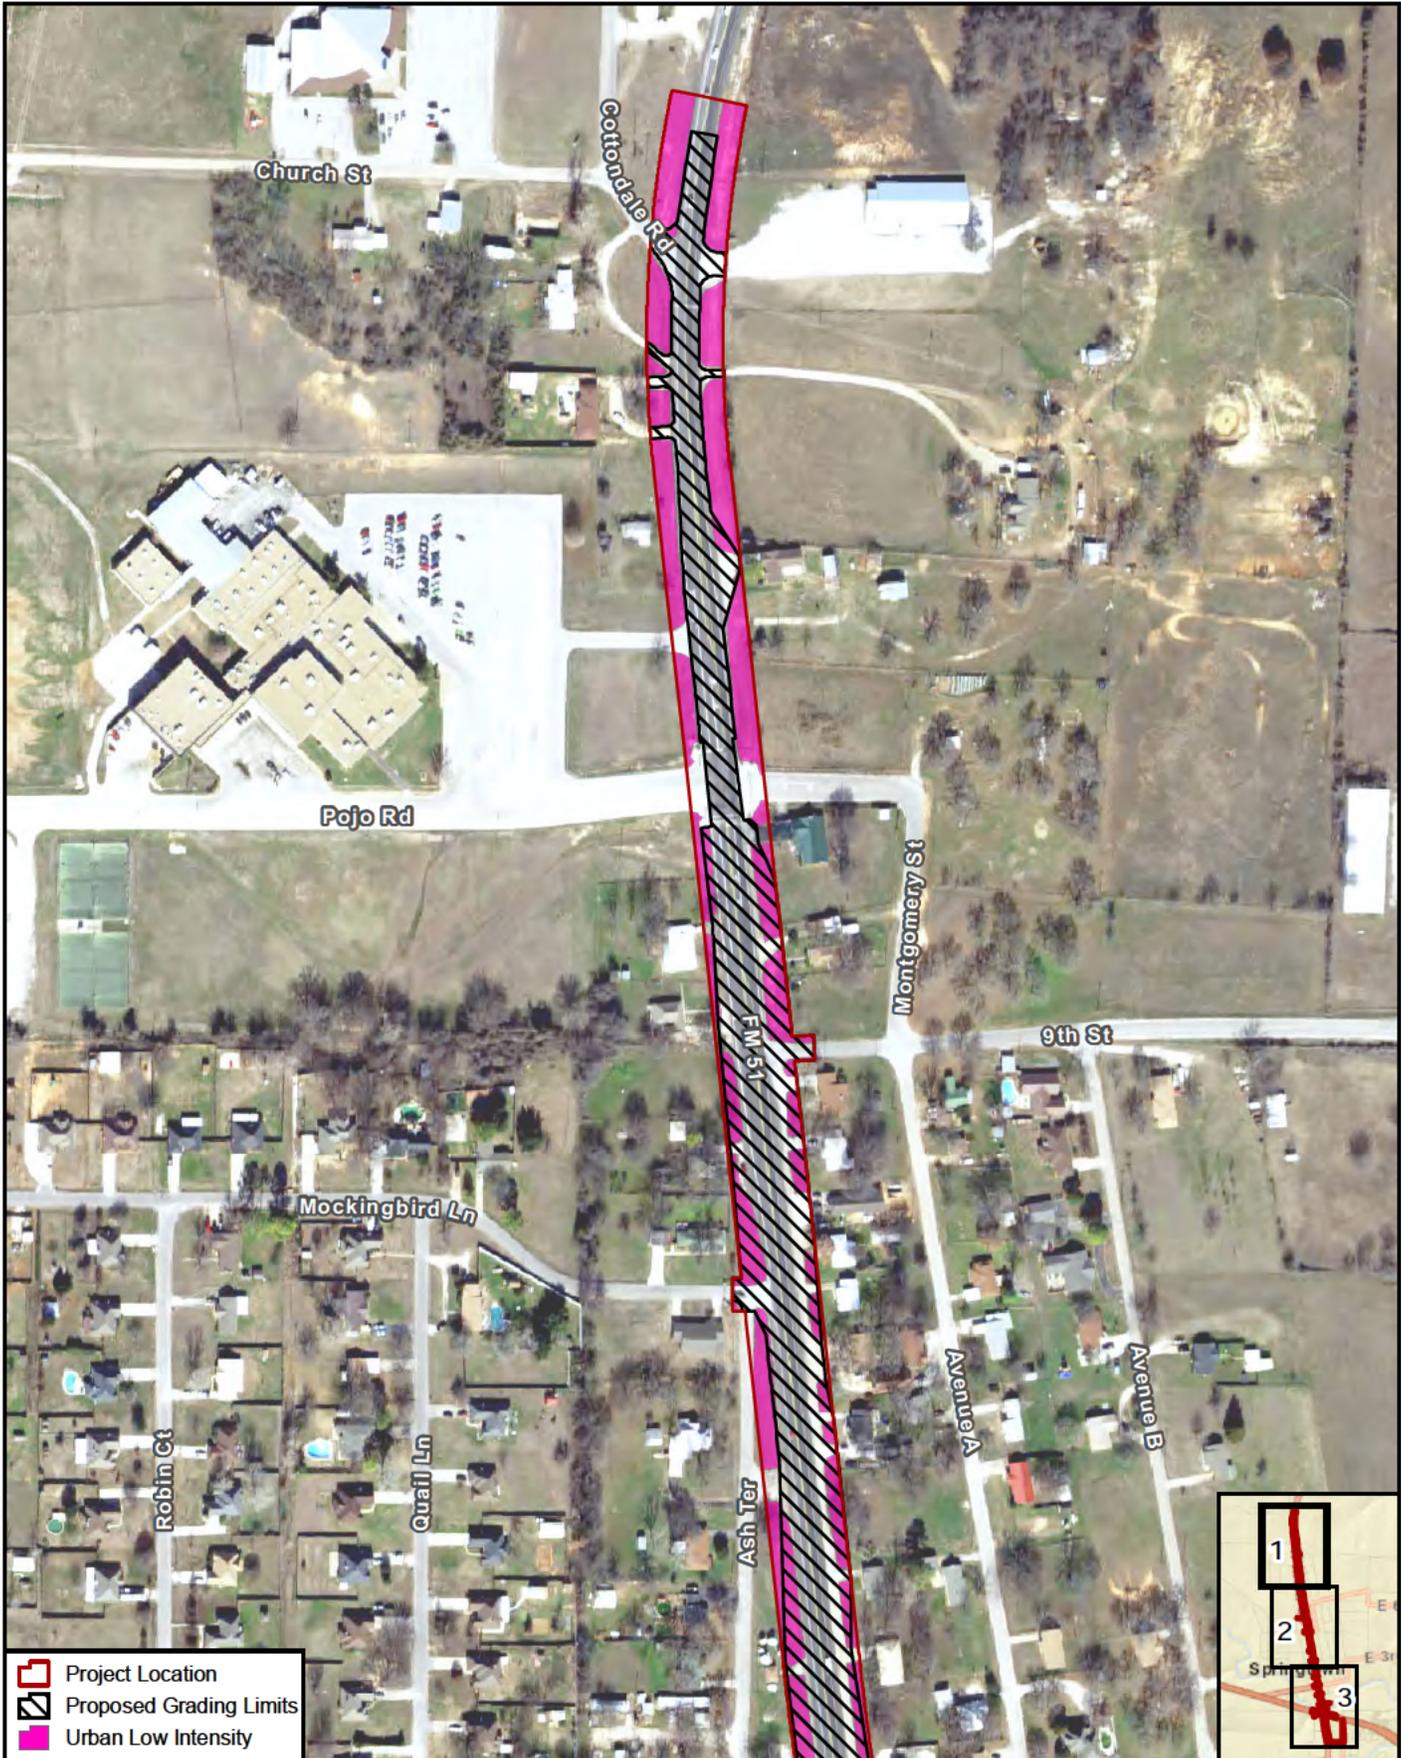
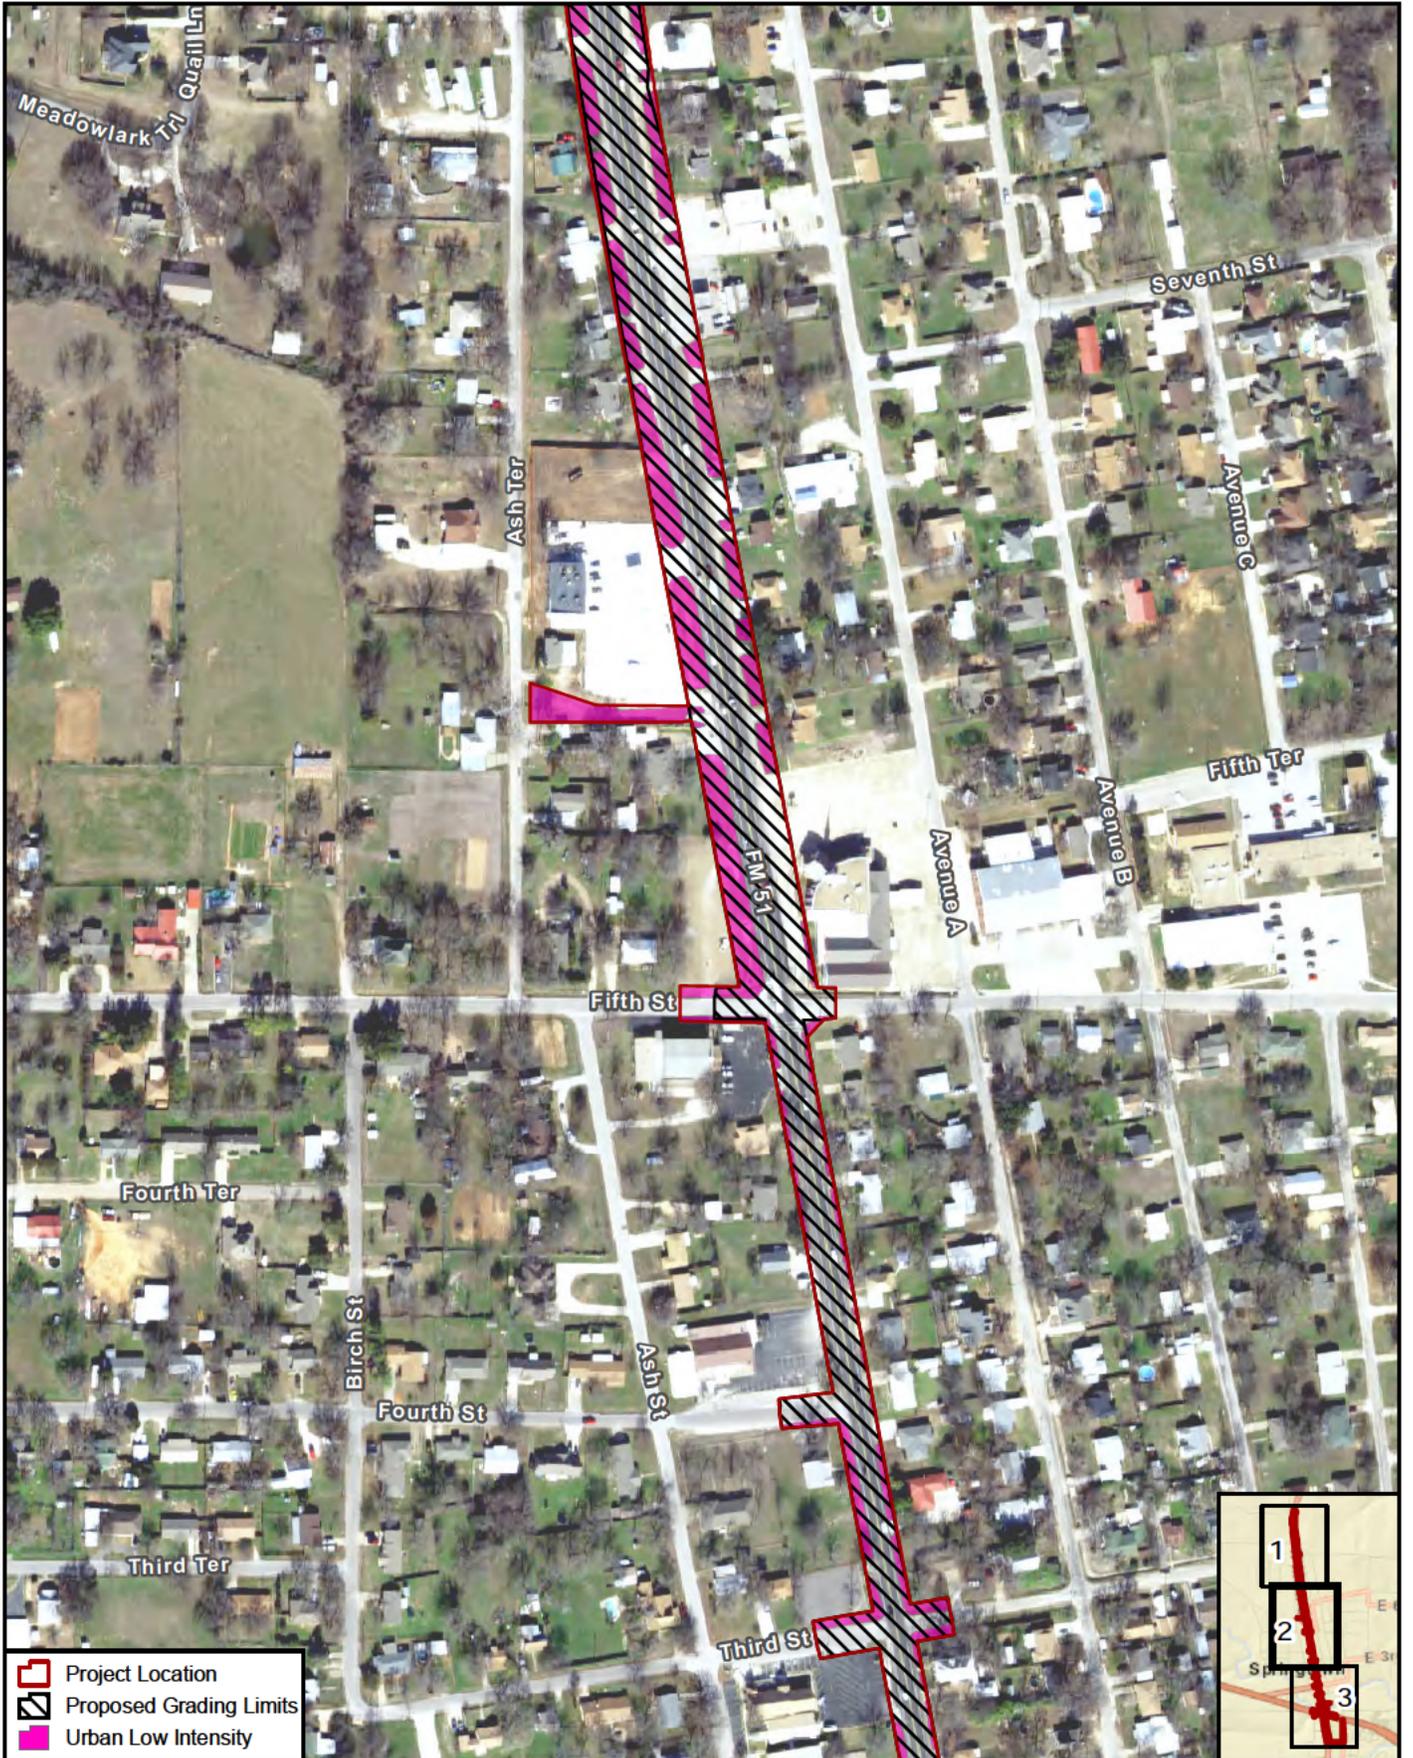
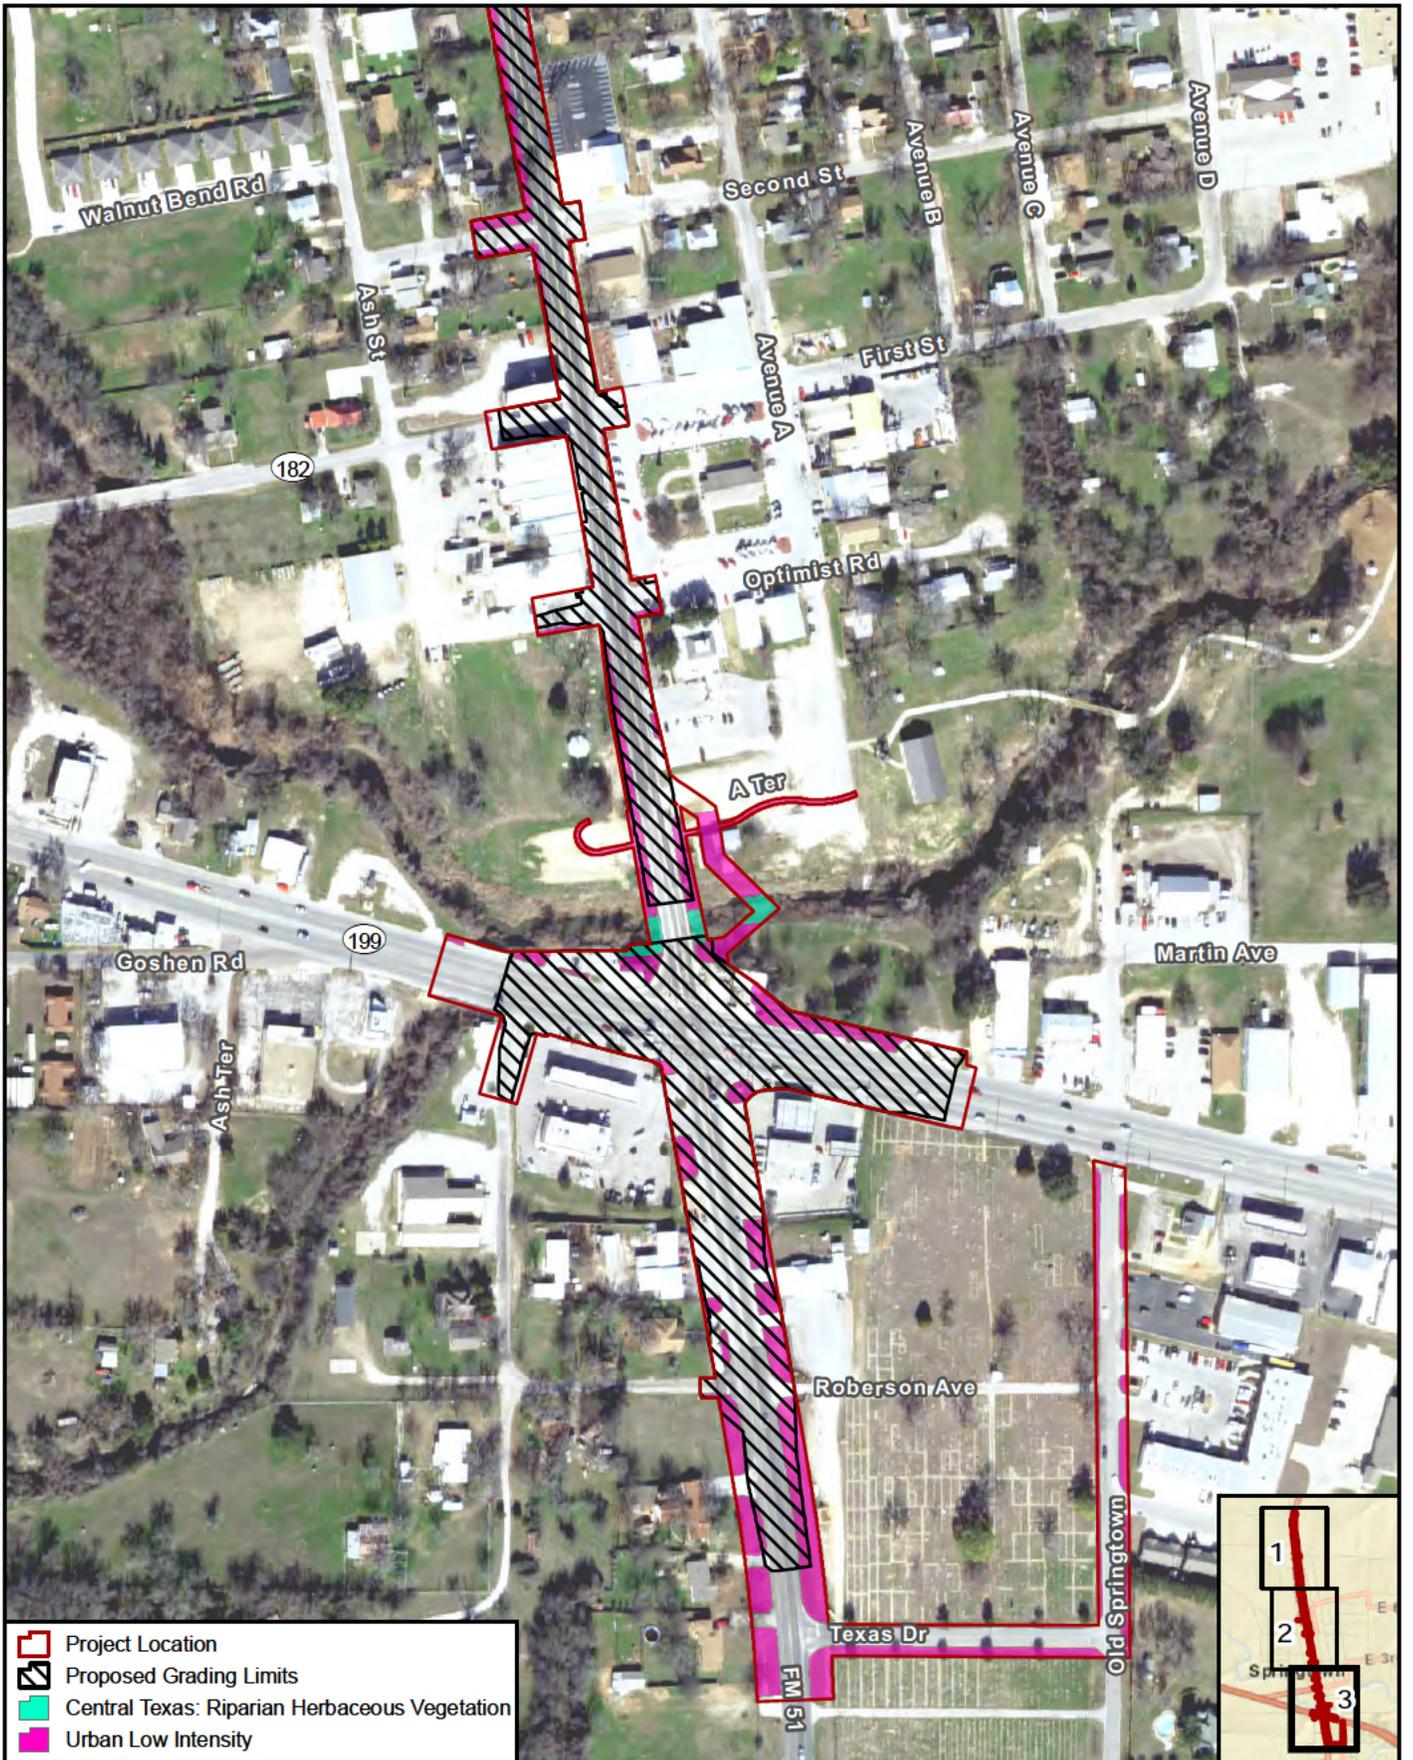
Observed Vegetation Types

- Project Location
- Proposed Grading Limits
- Central Texas: Riparian Herbaceous Vegetation
- Urban Low Intensity

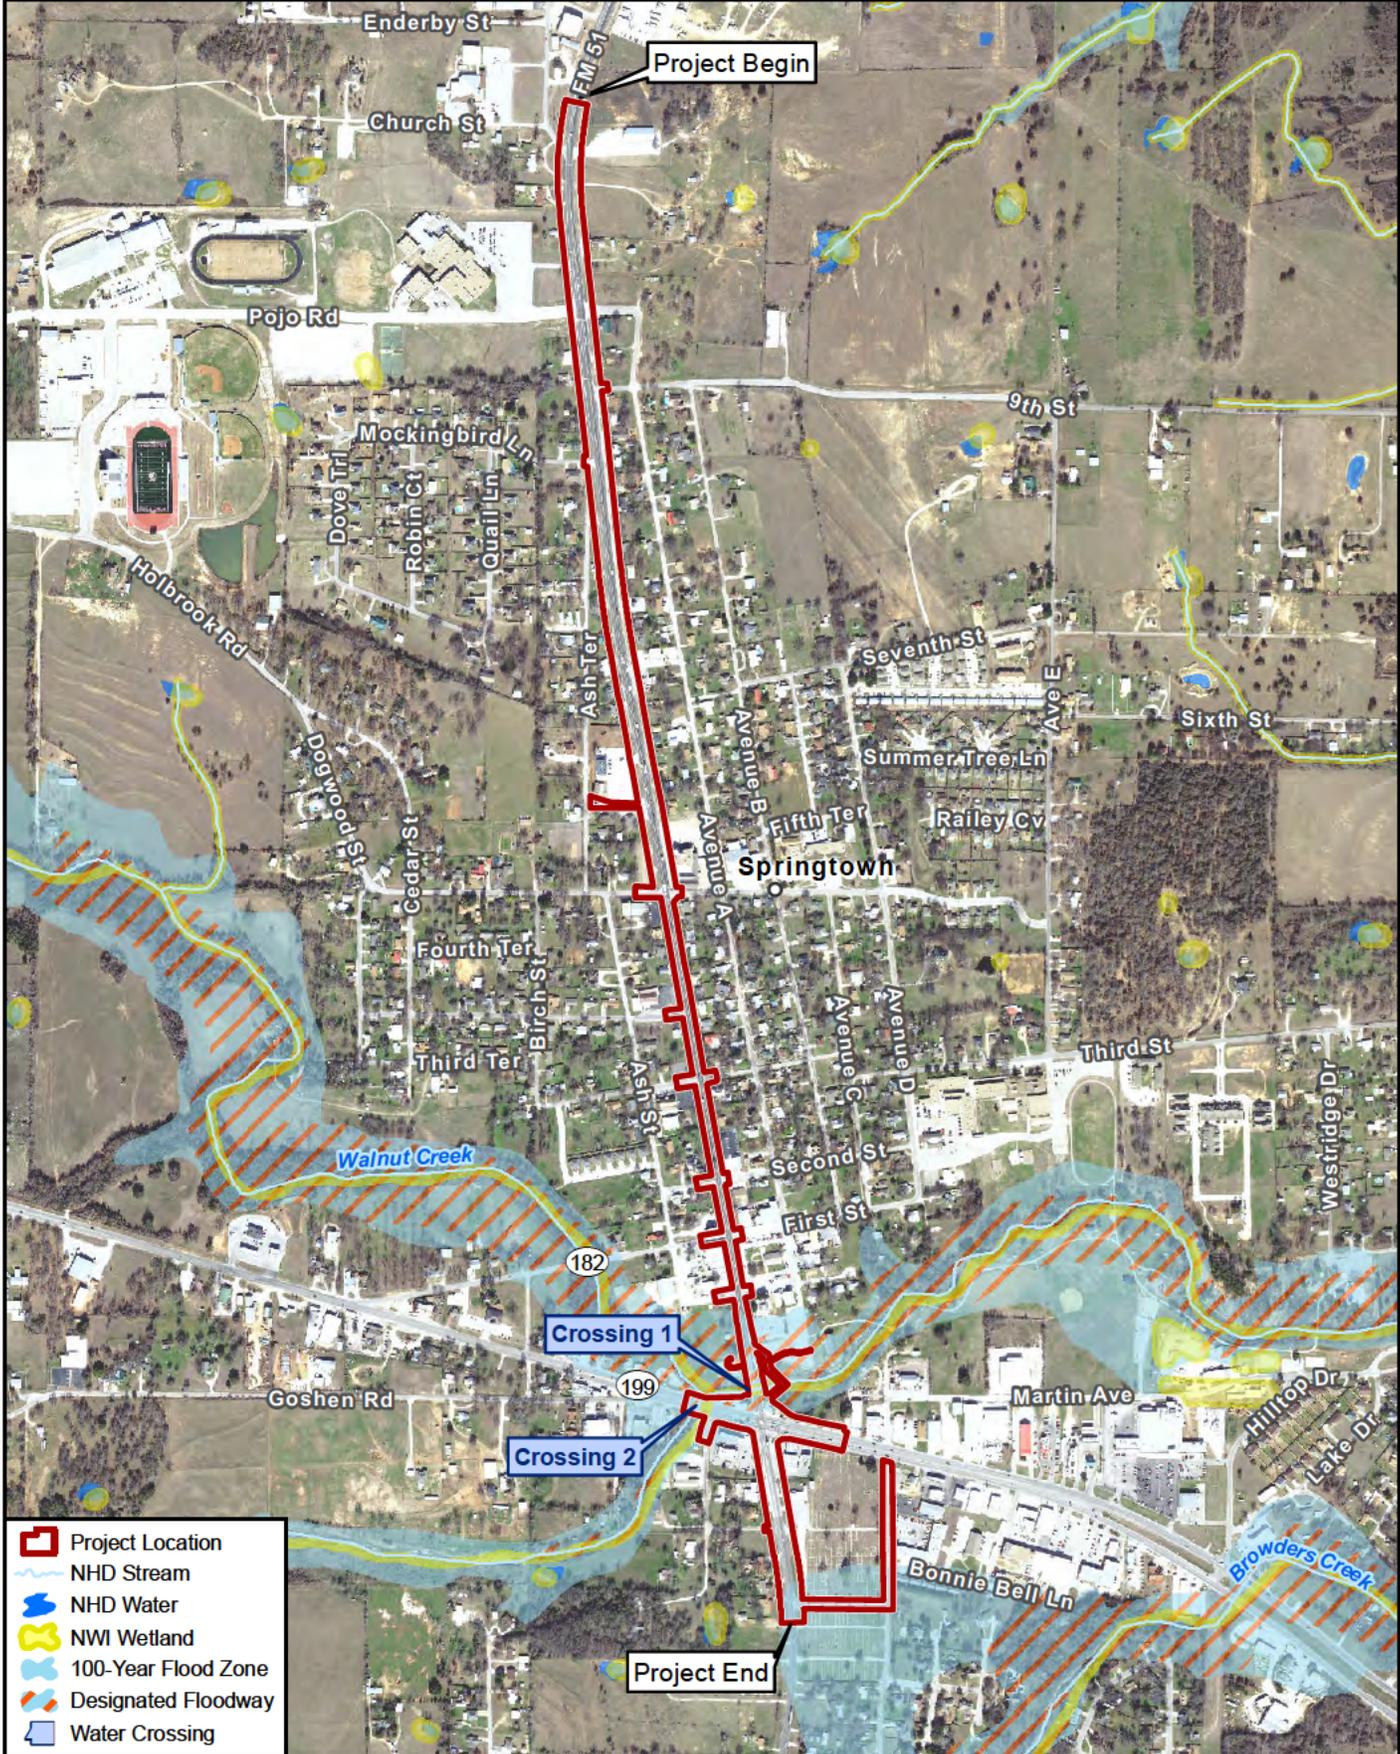
Water Resources
 In the Project Vicinity
SH 199 and FM 51 Intersection and Roadway Reconstruction

- Project Location
- NHD Stream
- NHD Water
- NWI Wetland
- 100-Year Flood Zone
- Designated Floodway
- Water Crossing

According to current plans, the proposed project is anticipated to result in permanent and temporary impacts to Walnut Creek at crossing location #1, illustrated on the Water Resources Map found in the uploaded file "Biological Evaluation Form and Tier I Site Assessment Form Attachments (0313-02-057 & 0171-03-070).pdf".

According to current plans, the proposed project is anticipated to result in permanent and temporary impacts to Walnut Creek at crossing location #1, illustrated on the Water Resources Map found in the uploaded file "Biological Evaluation Form and Tier I Site Assessment Form Attachments (0313-02-057 & 0171-03-070).pdf ". These actions impacts would be authorized by a NWP 14, without a PCN.

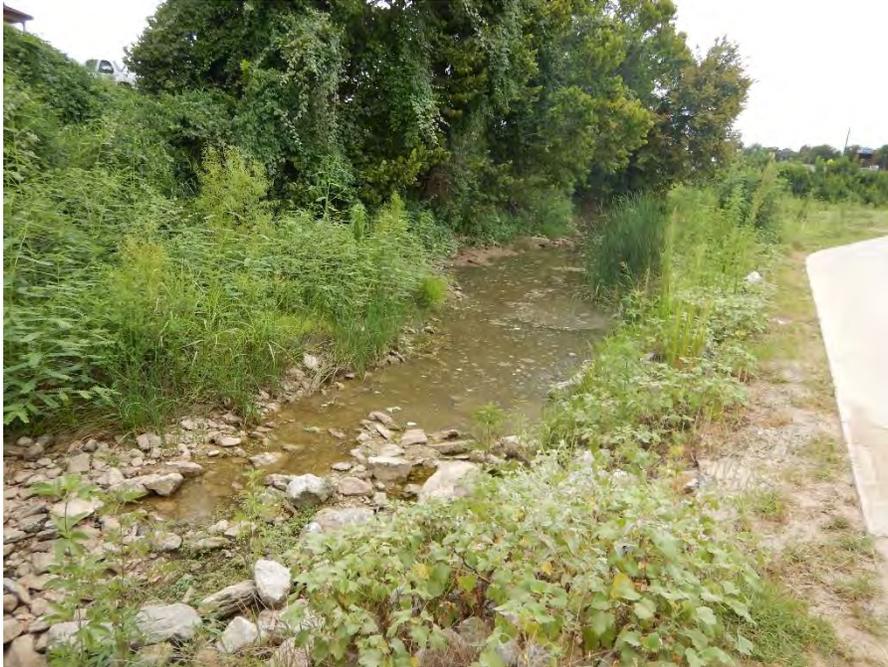
Photo 15: Central Texas: Herbaceous Riparian Vegetation observed along Walnut Creek from the US 51 bridge. Viewing upstream.

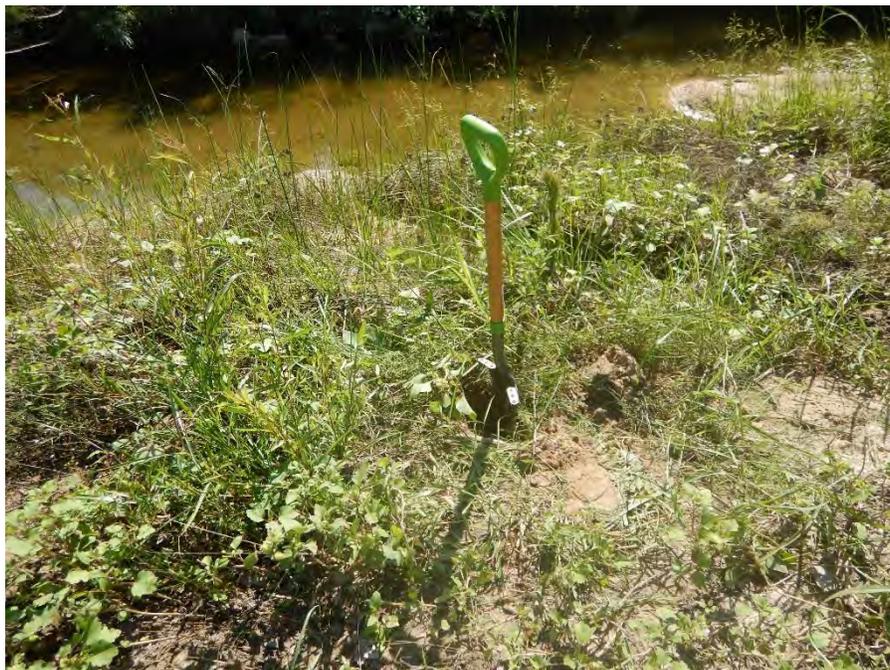
Photo 26: Wetland Determination Data Point WDP1 (upland). Located along the northern bank of Walnut Creek at Crossing 1.

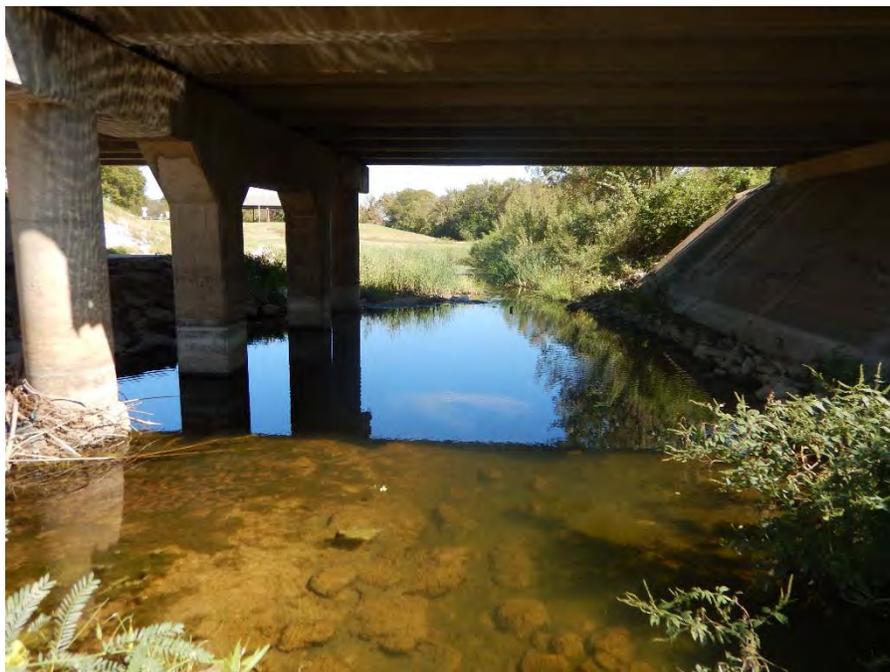
Photo 30: Crossing 1 (Walnut Creek) at the existing US 51 bridge. Viewing downstream.
