Biological Evaluation Form

Main CSJ: 0313-02-057 and 0171-03-070

Roadway Name: Farm-to-Market (FM) Road 51 and State Highway (SH) 99

FARM-TO-MARKET ROAD 51 AND STATE HIGHWAY 199: RARE PLANT SURVEY REPORT

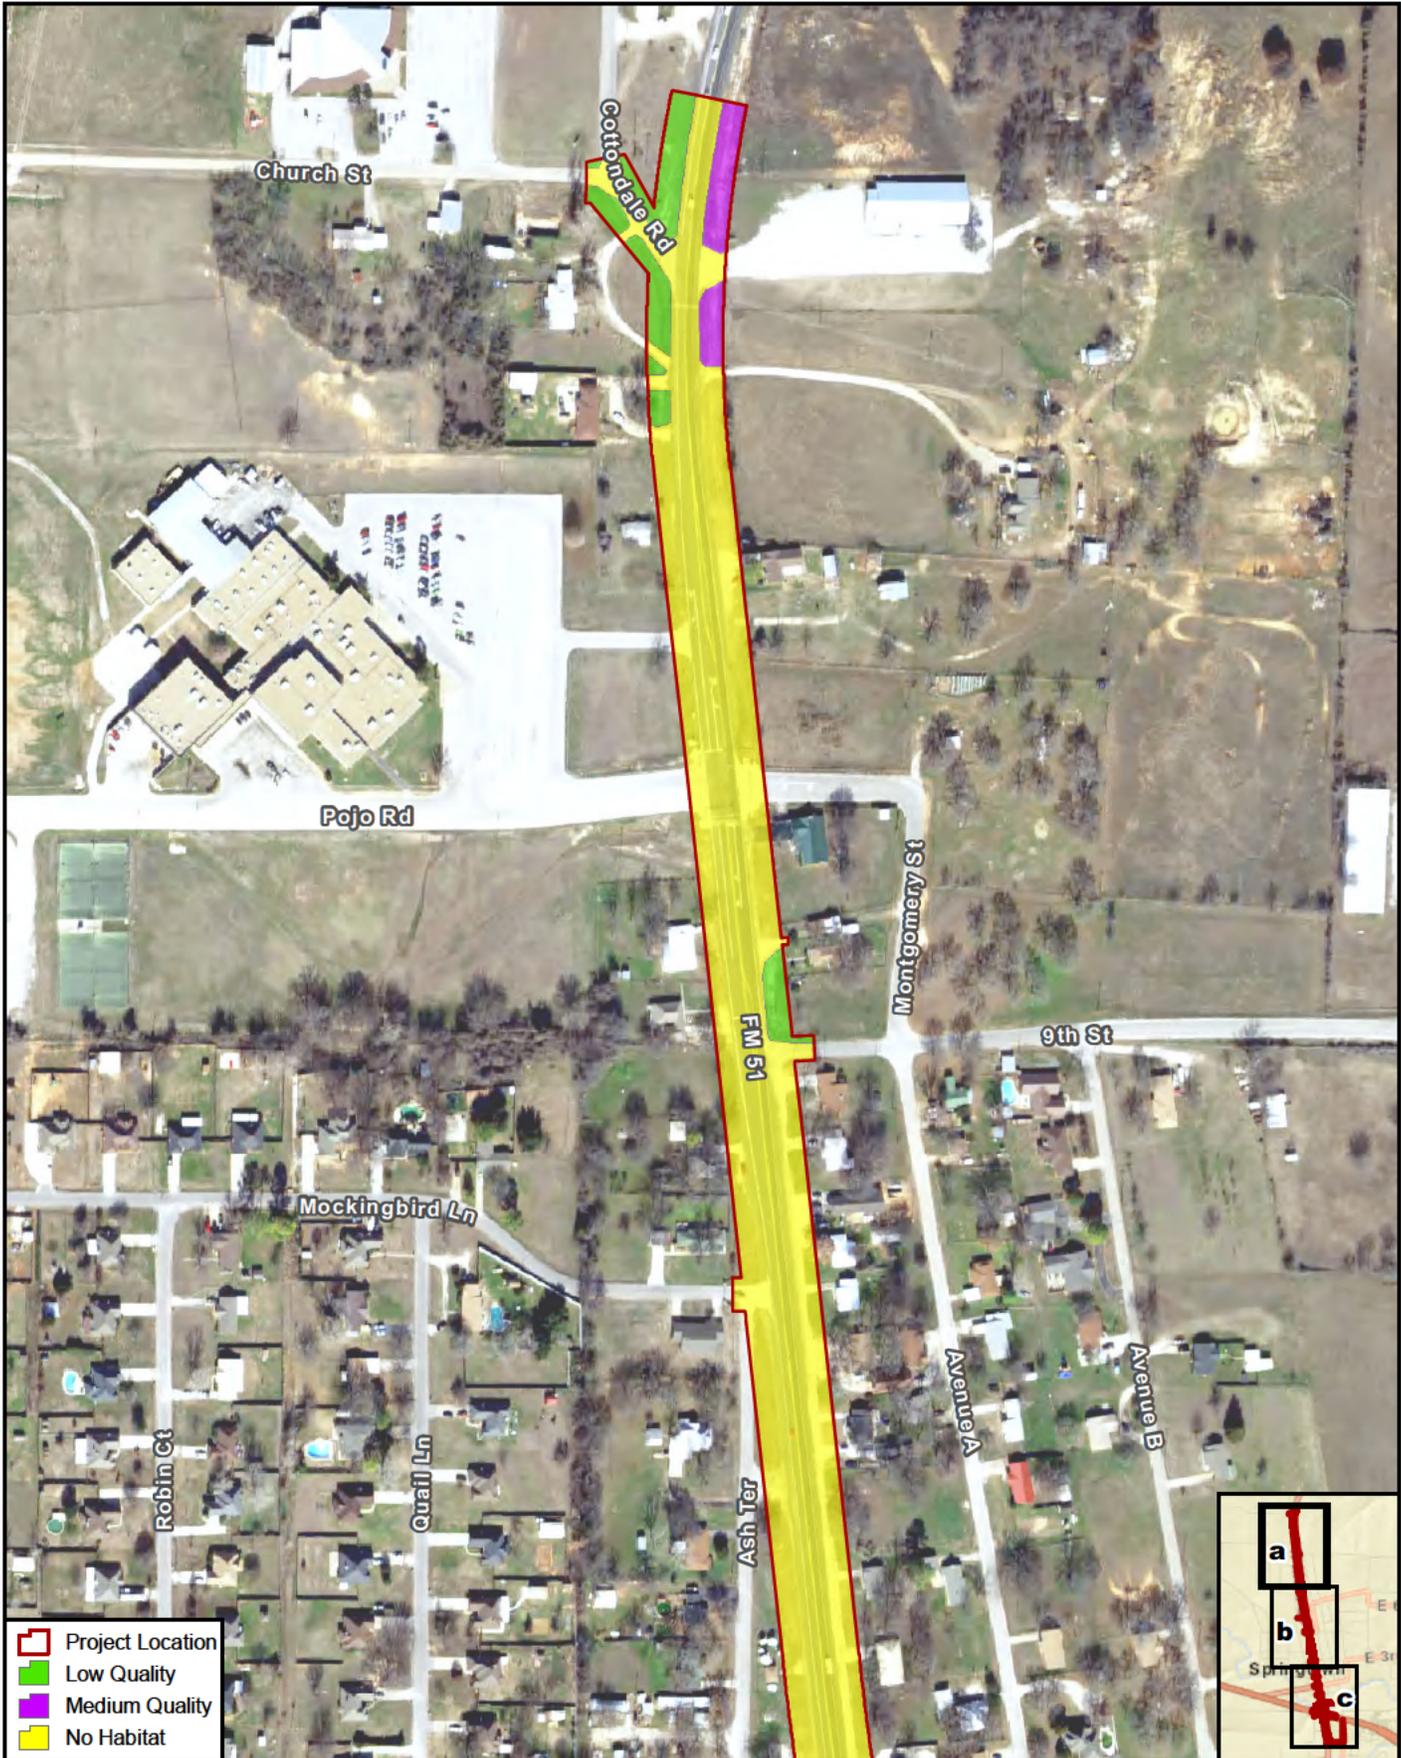
Figure 1a
Habitat Quality
 SH 199 and FM 51 Intersection and Roadway Reconstruction

- Project Location
- Low Quality
- Medium Quality
- No Habitat

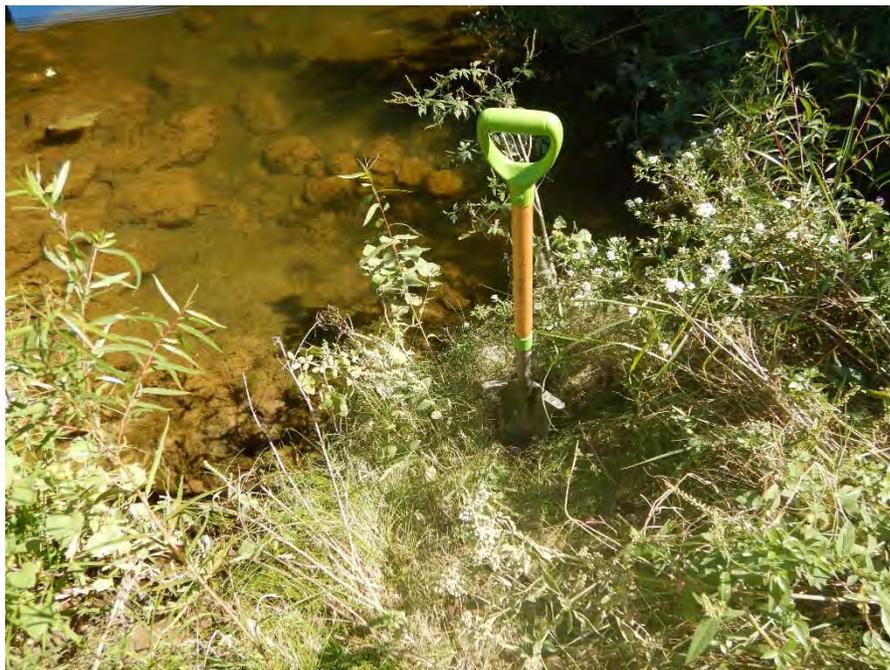
Photo 8: Wetland Determination Data Point WDP2 (wetland). Located within a marginal emergent wetland (Wetland 1) along the banks of Walnut Creek at Crossing 1.

A wetland delineation of the proposed project area was conducted on October 12, 2017. During these investigations a single emergent wetland was identified at crossing # 1, within the proposed project area. However, based on the current project design, no impacts to this wetland are anticipated. Please see the Water Resources Map found in the uploaded file "Biological Evaluation Form and Tier I Site Assessment Form Attachments (0313-02-057 & 0171-03-070).pdf ".

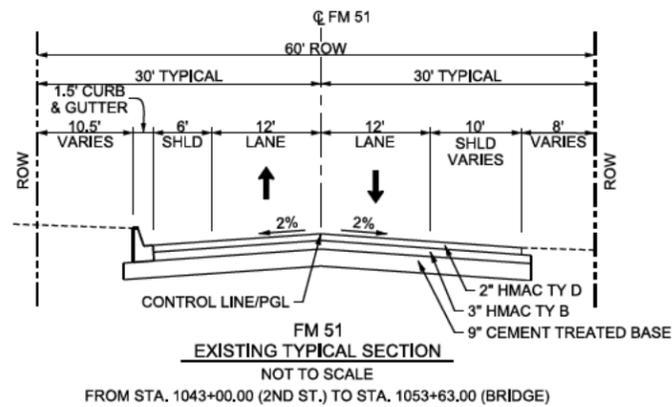
EXISTING TYPICAL SECTION
NOT TO SCALE
FROM STA. 1043+00.00 (2ND ST.) TO STA. 1053+63.00 (BRIDGE)

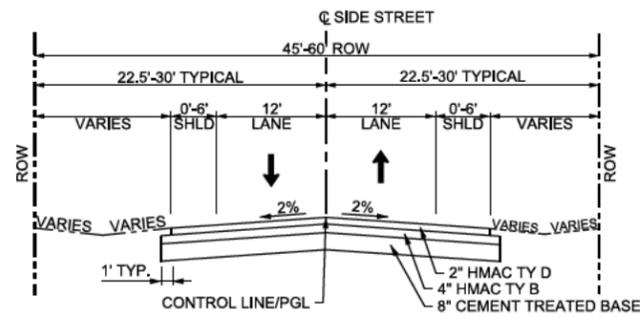
EXISTING TYPICAL SECTION

1. EAST OPTIMIST, 1ST, AND 2ND ST ARE CONCRETE FOR EXISTING CONDITIONS.

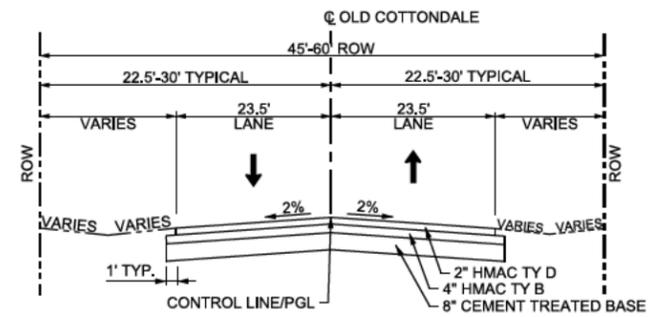
PROPOSED TYPICAL SECTION
