# Final Water Resources Technical Report

**Loop 88**

**Segments 1 and 2**

**Lubbock County, Texas**

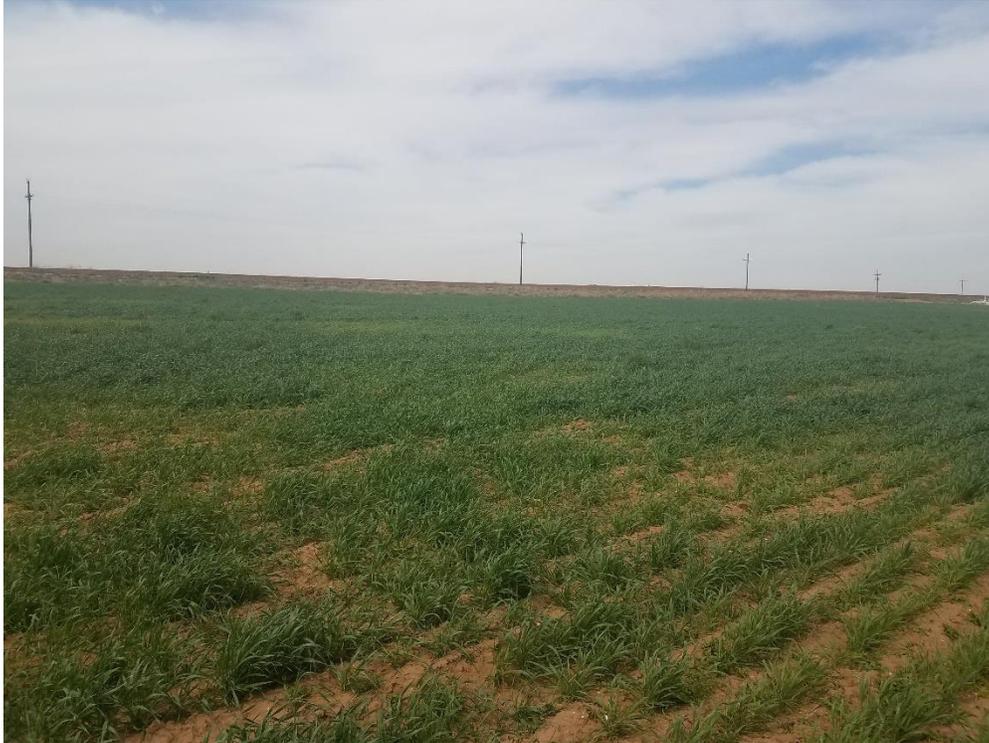
**Photo 1.** Facing southeast toward Playa 1.

Review of aerial photography from various years and observations made during the April 2019 field investigations show that Playas 1, 4, 5, and 6 hold water after large rainfall events but are plowed and used for crop production during dry periods. Based on field investigations from public access points and where ROE was granted, vegetation in Playas 1, 4, 5, and 6 appeared similar to surrounding agricultural fields, contained standing crops or crop stubble (wheat and cotton), and were either plowed or showed recent signs of plowing. Standing water was present in the lowest portion of Playa 6, but aerial photographs show the water is not permanent. Wetland determinations at four observation points (see data forms in **Appendix C**) indicate these playas do not typically contain hydrophytic vegetation, nor do they contain soils that meet hydric soil criteria.

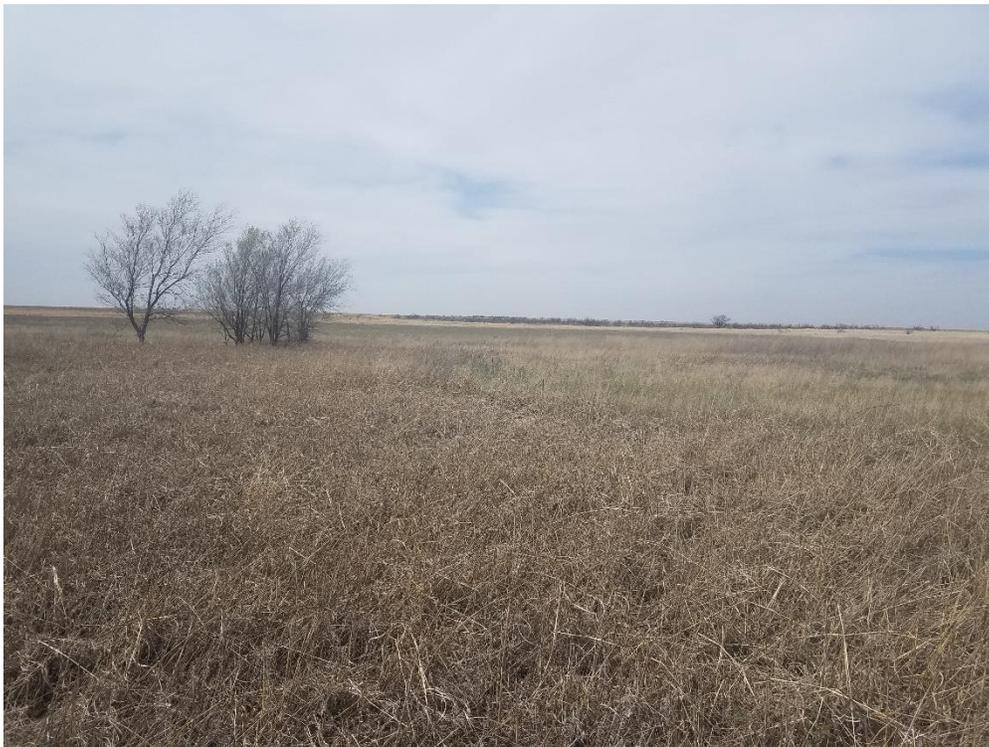
**Photo 2.** Facing northwest towards Playa 2.

Playas 2 and 3 appear to be fallow fields with upland vegetation. During field investigations, Playa 2 was dominated by sand dropseed (*Sporobolus cryptandrus*), while Playa 3 was dominated by careless weed (*Amaranthus palmeri*) and Arkansas lestdaisy (*Chaetopappa asteroides*). Review of aerial photography and field observations did not reveal standing water or other signs of a playa in the proposed ROW at these locations. Wetland determinations at two observation points (see data forms in **Appendix C**) indicate these playas do not typically contain hydrophytic vegetation, nor do they contain soils that meet hydric soil criteria.

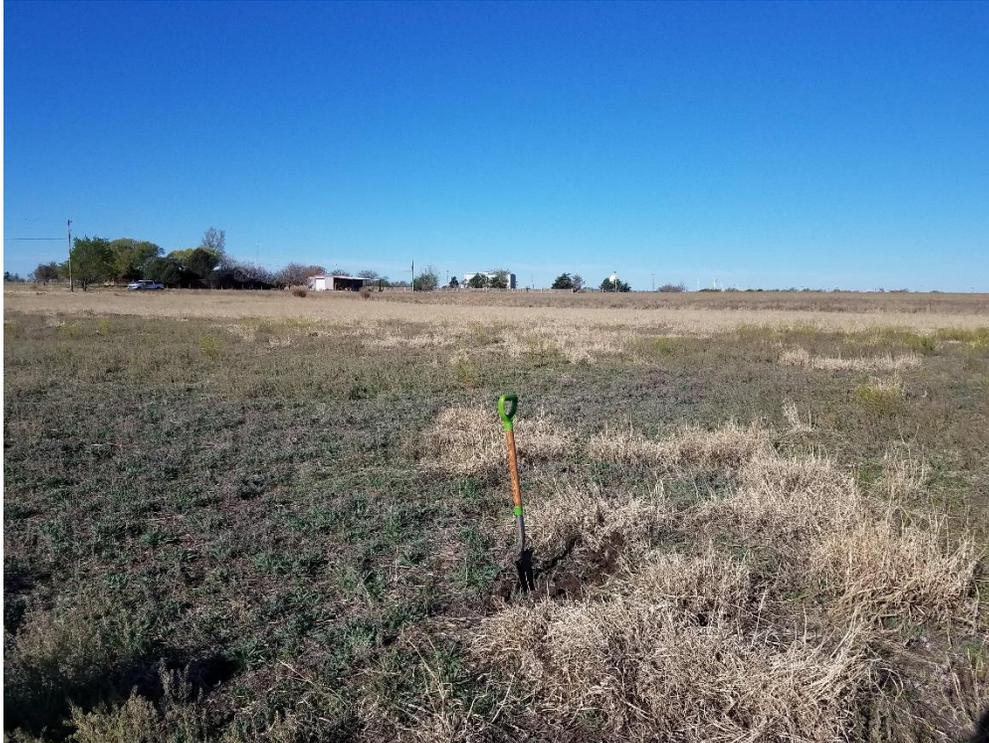
**Photo 3.** Playa 3 at OP-02, facing east.

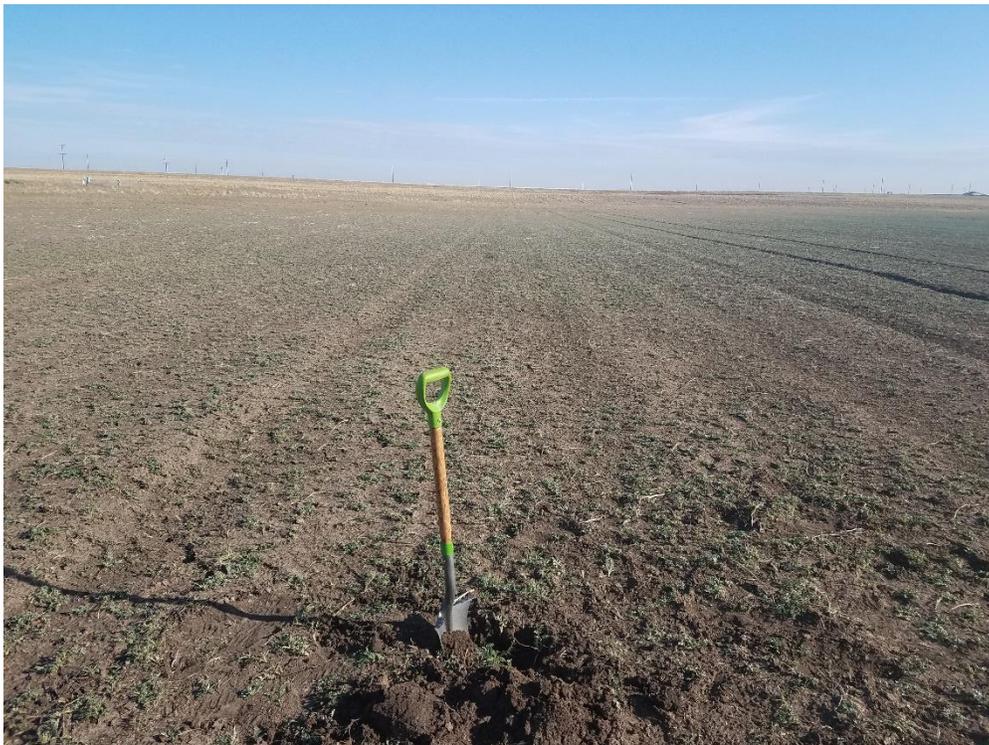
**Photo 4.** Playa 4 at OP-04, facing west.

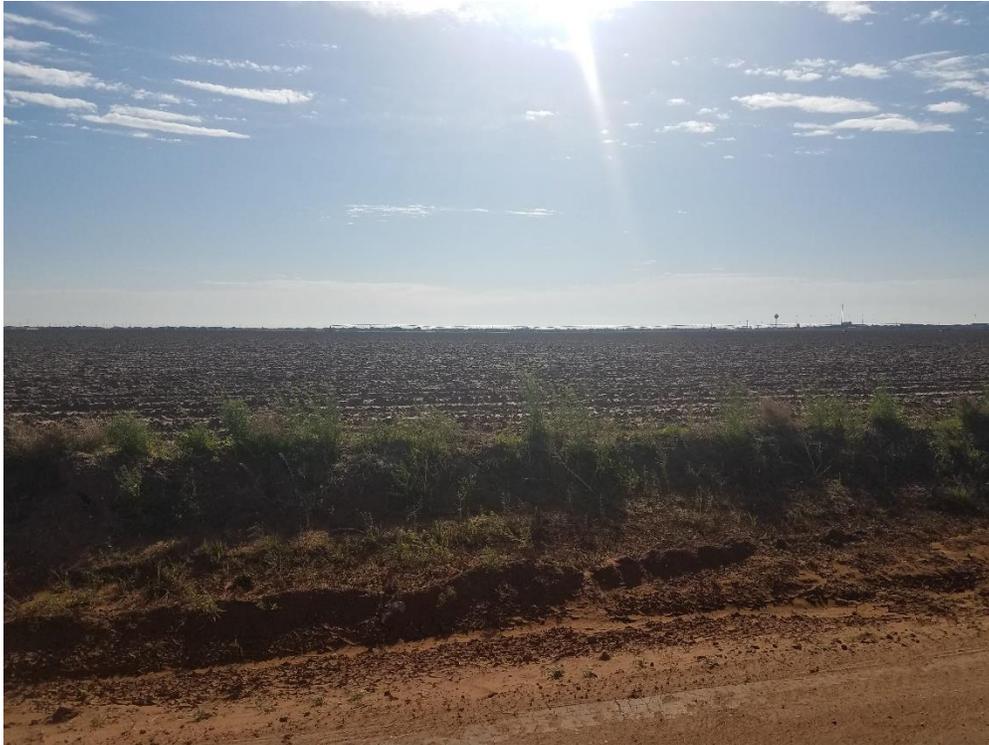
**Photo 5.** Facing west toward Playa 5.

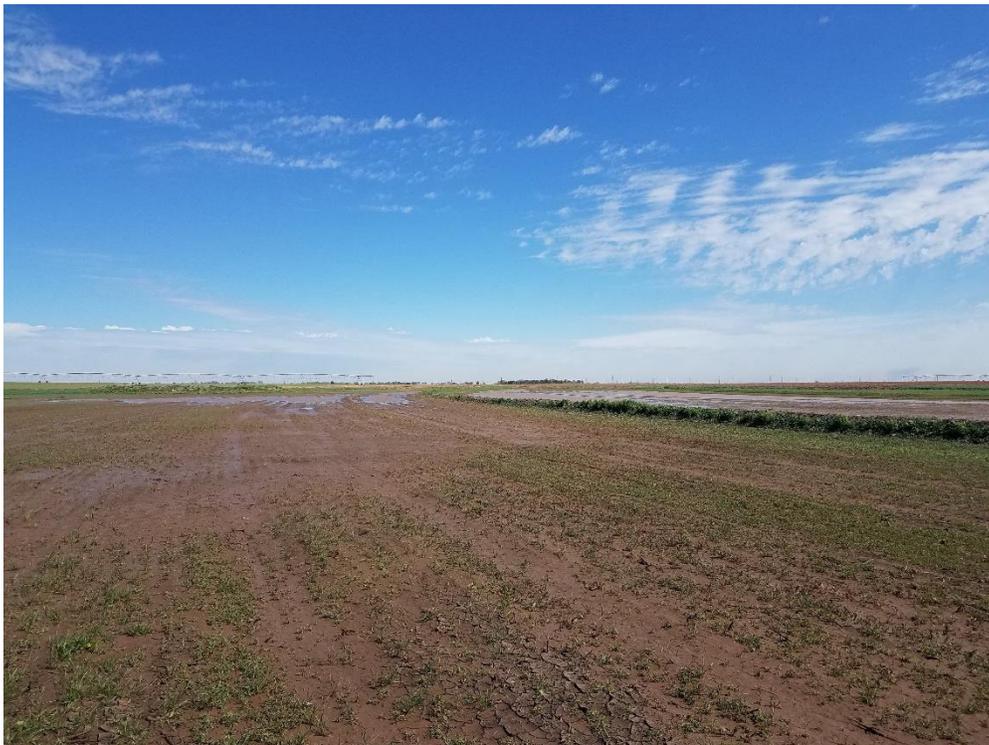
**Photo 6.** Playa 6, facing southeast.
