Final Water Resources Technical Report

Loop 88 Segment 4

From US Highway 87 to US Highway 84
Lubbock County, Texas

CSJ: 1502-03-006

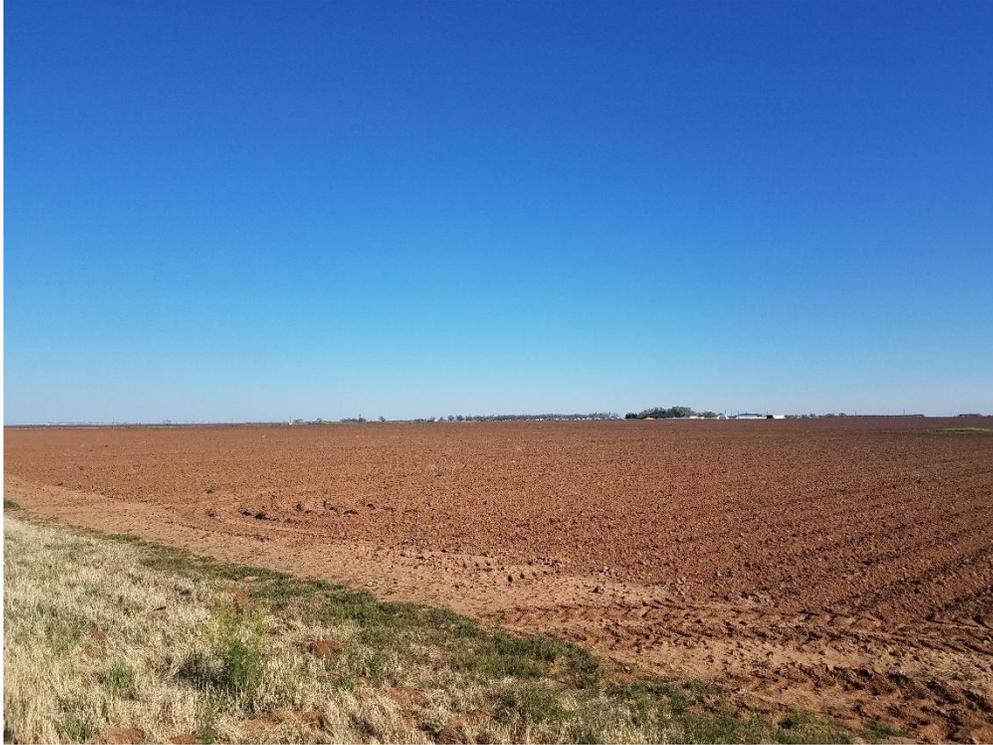
Review of aerial photography from various years and observations made during the April/May 2019 field investigations show that Playas 1, 2, and 3 hold water after large rainfall events but are plowed and used for crop production during dry periods. Based on field investigations from public access points and where ROE was granted, vegetation in Playas 1, 2, and 3 appeared similar to surrounding agricultural fields, contained standing crops or crop stubble (wheat and cotton), and were either plowed or showed recent signs of plowing. Standing water was present in the lowest portion of Playa 3, but aerial photographs show the water is not permanent. Wetland determinations at two observation points (see data forms in **Appendix C**) indicate the playas do not typically contain hydrophytic vegetation, nor do they contain soils that meet hydric soil criteria.

Photo 1. Facing southwest toward Playa 1.

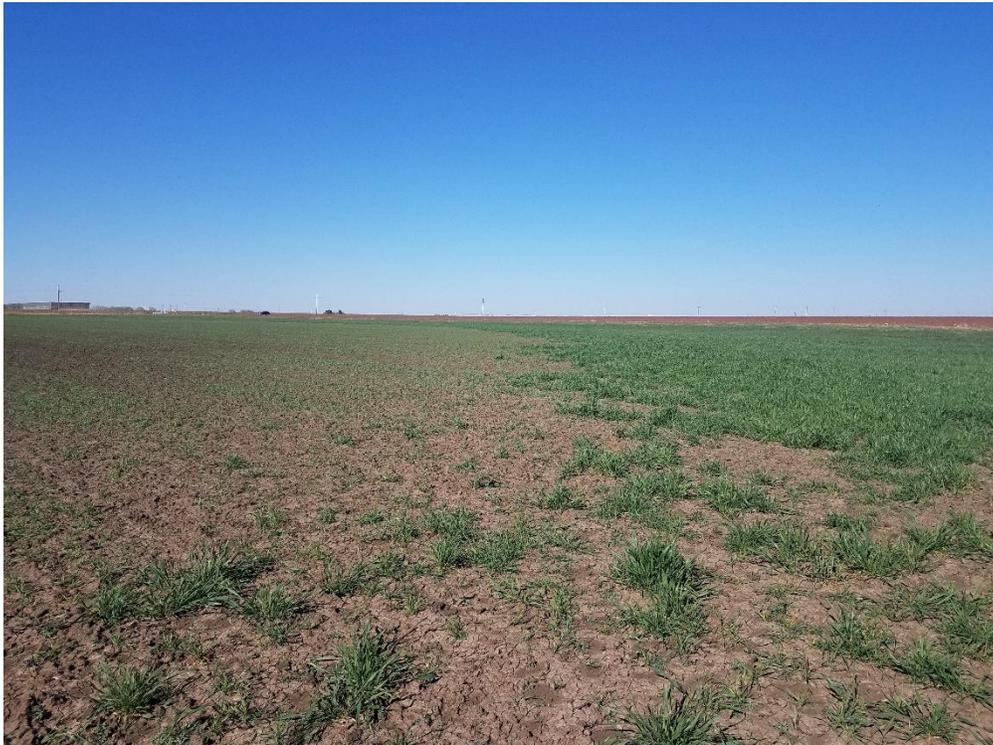
Photo 2. View of Playa 2 and adjacent field, facing east

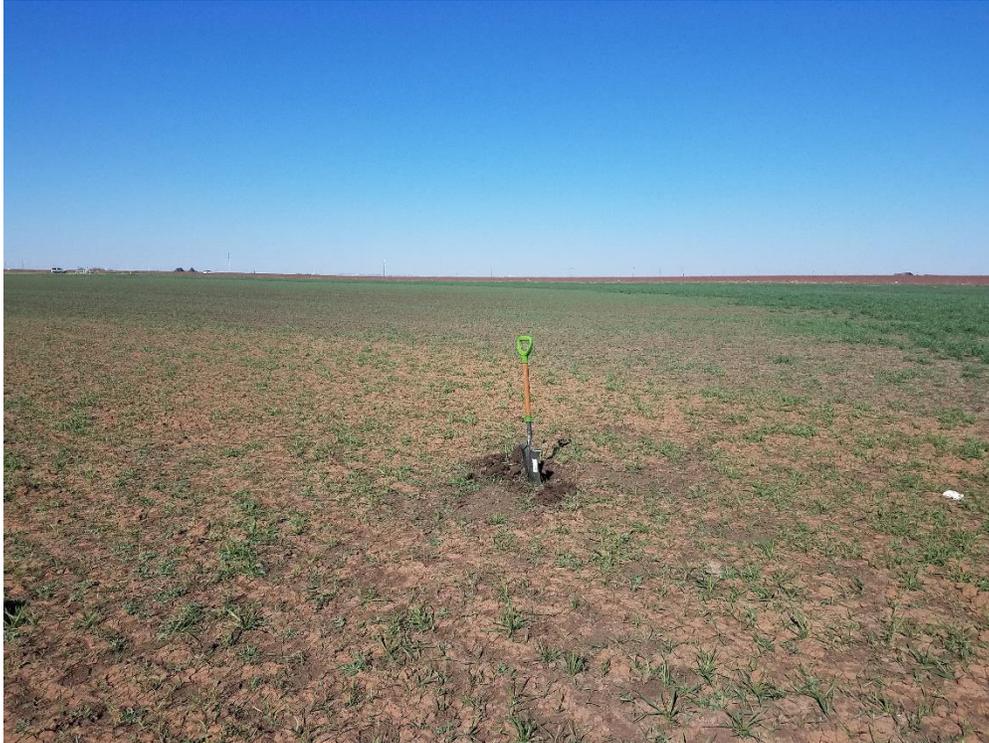
Photo 3. View of Playa 2, OP 01.

Remarks: Does not meet the three criteria for a wetland.

Remarks: Does not meet the criteria for hydrophytic vegetation.

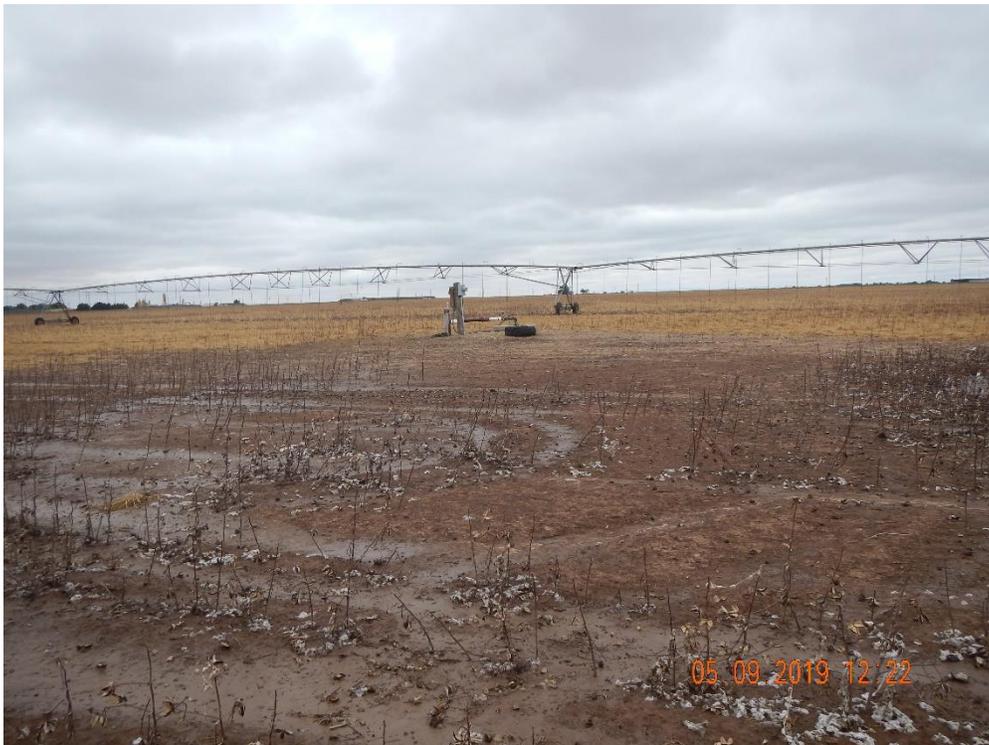
Photo 4. View of Playa 3, facing southwest.

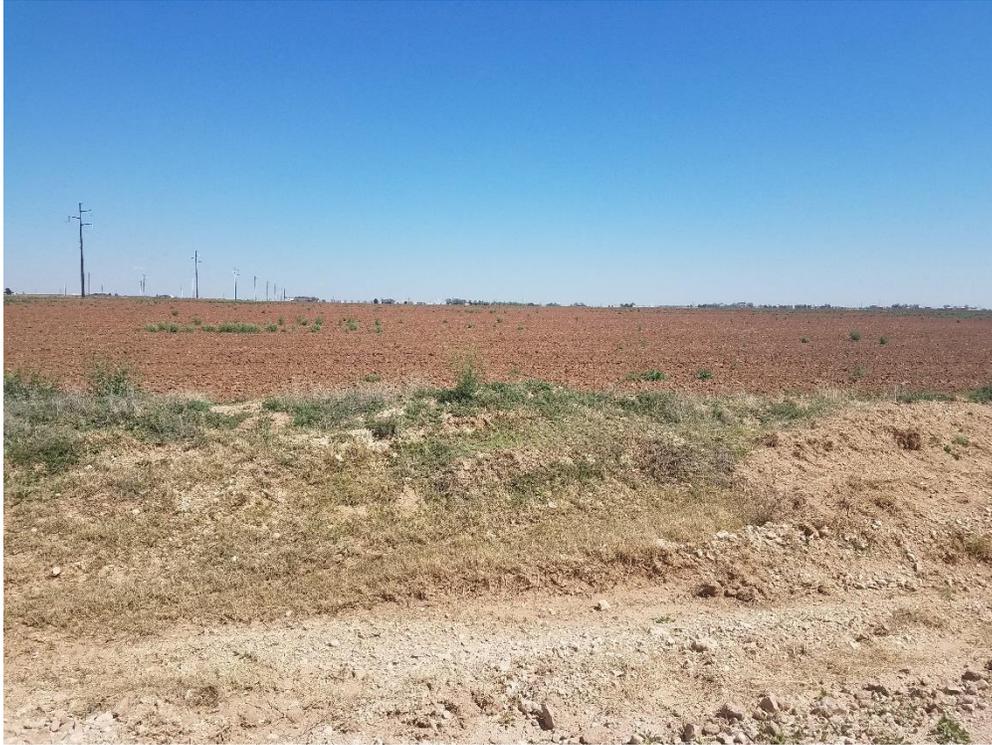
Most of the project area consists of irrigated agricultural fields, and the primary crops observed during field investigations include cotton (*Gossypium hirsutum*), sorghum (*Sorghum bicolor*), and wheat (*Triticum aestivalis*). Common plant species observed in fallow fields and roadsides include sideoats grama (*Bouteloua curtipendula*), Texas grama (*B. rigidiseta*), silver bluestem (*Bothriochloa laguroides*), common pepperweed (*Lepidium densiflorum*), redstem stork's bill (*Erodium cicutarium*), and Ram's-horn (*Proboscidea louisianica*).

Photo 5. Typical farm field within the project area, located south of CR 7500.
