Water Resources Technical Report

US 59 Upgrade Redland, TX

From FM 2021 to 0.34 mi North of
State Loop 287
Angelina County, Texas
CSJ: 0176-02-118
May 2018

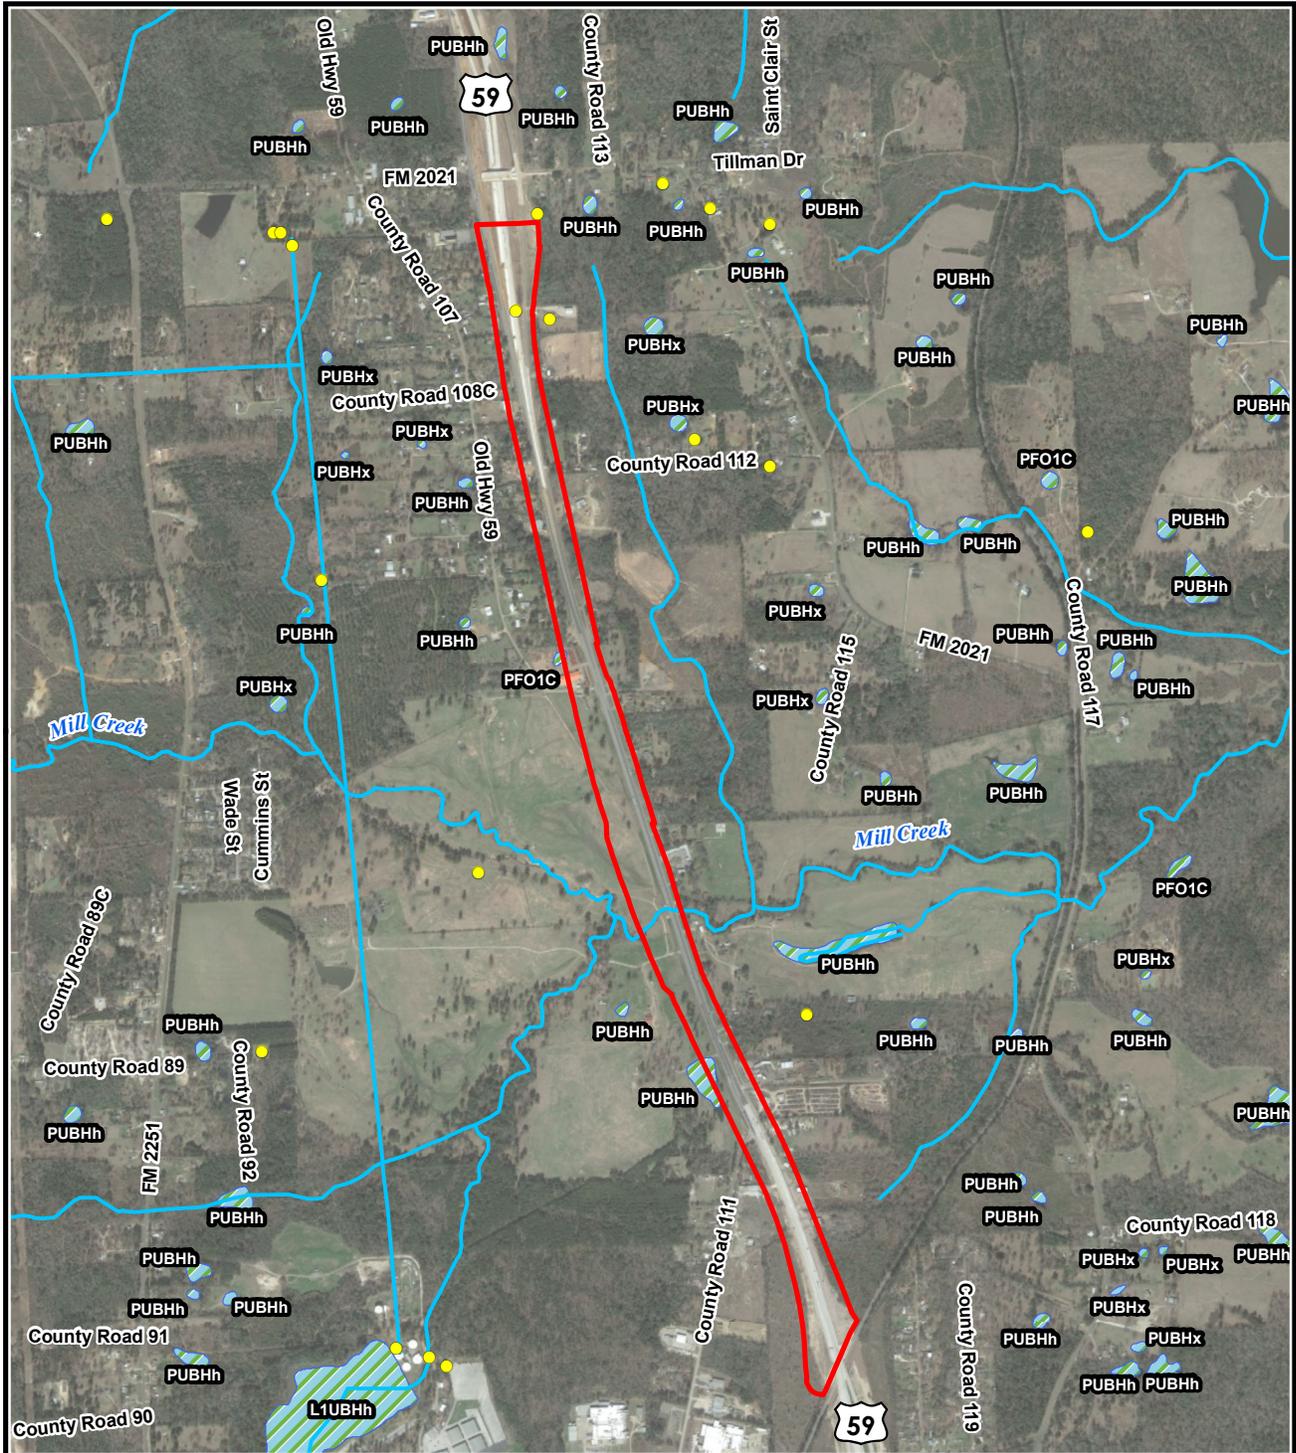
**FIGURE 3
 ENVIRONMENTAL CONSTRAINTS
 (WATER SOURCES)
 US 59: UPGRADE REDLAND, TX
 FROM SOUTH OF FM 2021 TO NORTH OF LOOP 287
 ANGELINA COUNTY, TEXAS
 CSJ: 0176-02-118**

- Water Wells
 - Proposed ROW
 - River / Stream (NHD)
 - National Wetland Inventory
 - 59 US Route
- 0 1,000 2,000
 Feet

A review of the National Wetland Inventory (NWI), National Hydrologic Dataset (NHD) maps, and the Federal Emergency Management Agency (FEMA) floodplain maps (**Figures 3 and 4, Appendix A**), the Angelina County Soil Survey (Natural Resources Conservation Service [NRCS] 1988), USGS 7.5-minute quadrangle sheets (Westcott, Texas, USGS 1958a; and Cleveland, Texas, USGS 1958b), and recent aerial photography concluded that potential waters of the U.S. exist within the vicinity of the proposed project. Field reconnaissance conducted from June 26, 2017 through June 29, 2017 confirmed this conclusion.

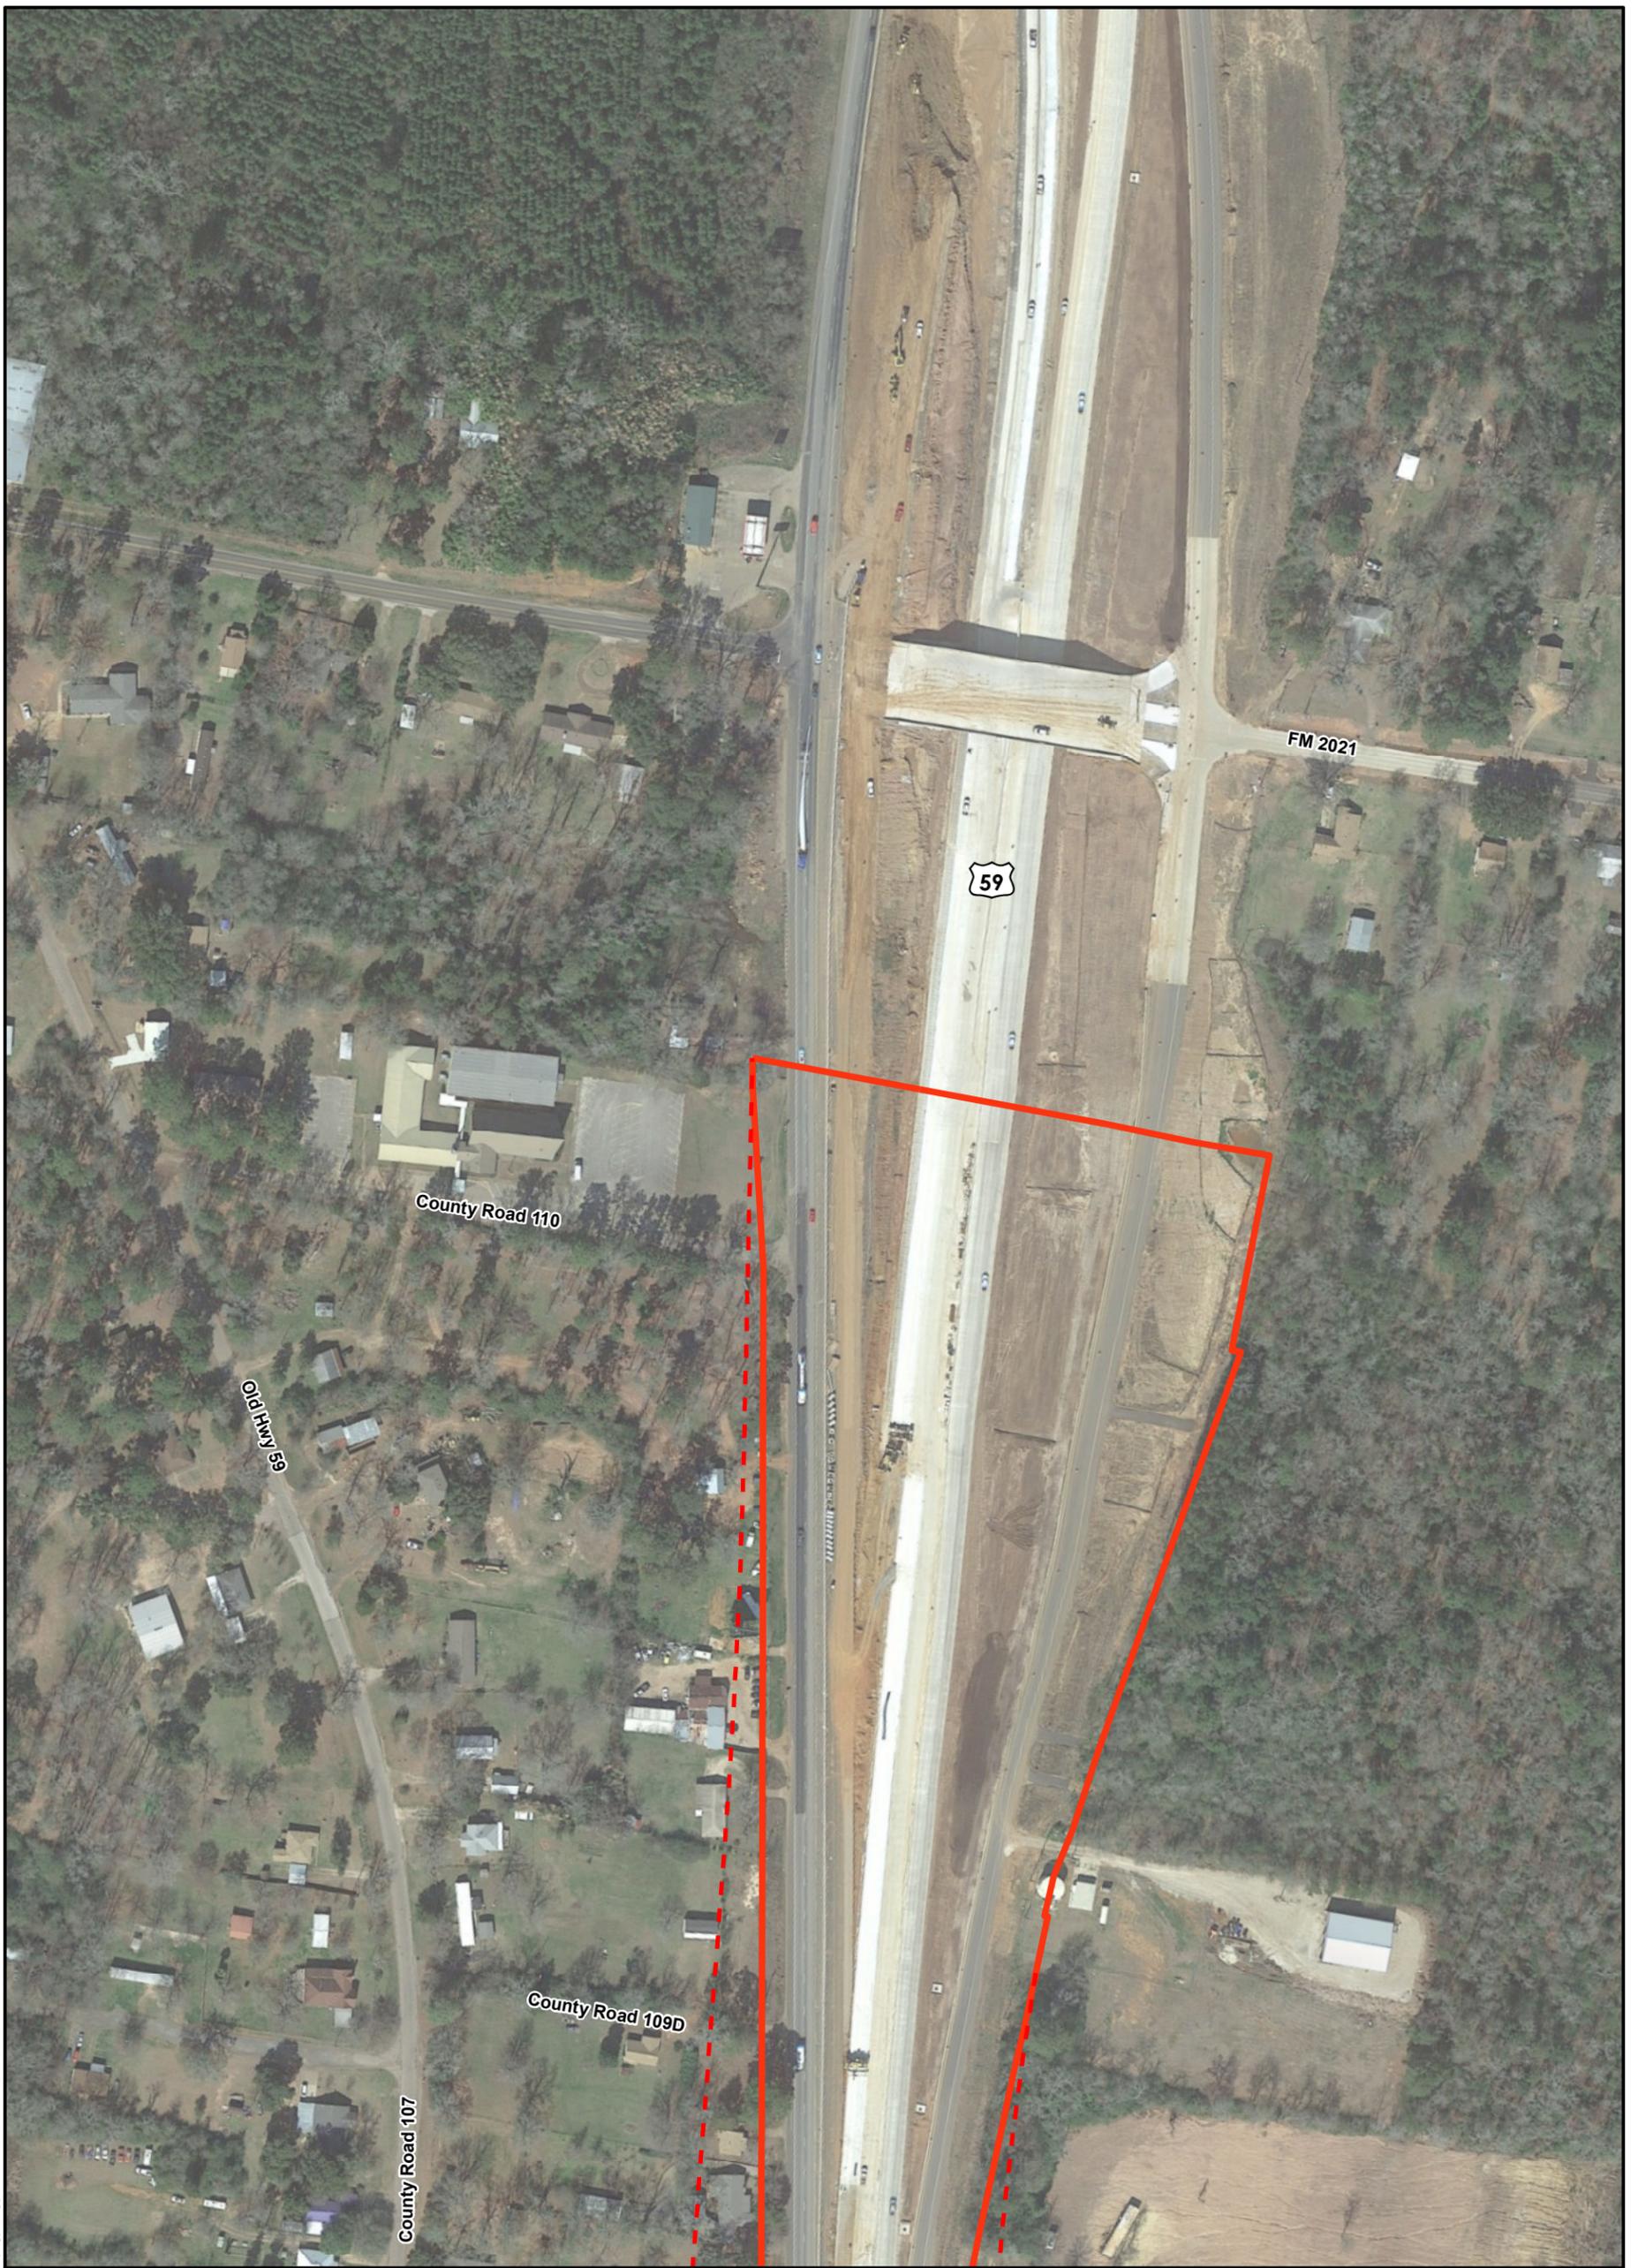
FIGURE 4
MAPPED POTENTIAL WATERS OF THE US
US 59: UPGRADE REDLAND, TX
FROM SOUTH OF FM 2021 TO NORTH OF LOOP 287
ANGELINA COUNTY, TEXAS
CSJ: 0176-02-118

- Potential WOTUS
- Upland Data Point (UDP)
- Proposed ROW
- Existing ROW
- Stream Crossing
- Wetland
- Pond
- 100-year Floodplain
- 59 US Route

Wetland 2 is a potentially jurisdictional PEM wetland associated with the floodplain of Mill Creek and located west of the existing US 59 ROW (**Figure 4, Page 4**). Wetland 2 is approximately 0.043 acre within the proposed ROW and is located within a low area that holds water and has developed wetland characteristics over time. Plants observed included such species as *Polygonum hydropiperoides* and *Rumex pulcher* (see DP WET 02 datasheet in **Appendix C**). Wetland 2 is incorrectly identified as a PFO1C wetland in the NWI and is located within the 100-year floodplain.

Wetland 3 is a potentially jurisdictional PEM wetland associated with the floodplain of Mill Creek and located west of the existing US 59 ROW (**Figure 4, Page 4**). Wetland 3 is approximately 0.021 acre within the proposed ROW and is located within a low area that holds water and has developed wetland characteristics over time. Plants observed included such species as *Polygonum hydropiperoides* and *Carex cherokeensis* (see DP WET 03 datasheet in **Appendix C**). Wetland 3 is incorrectly identified as a PFO1C wetland in the NWI and is located within the 100-year floodplain.

Wetland 5 is a potentially jurisdictional PEM wetland associated with the floodplain of Mill Creek and located west of the existing US 59 ROW (**Figure 4, Page 4**). Wetland 5 is approximately 0.116 acre within the proposed ROW and is located within a low area that holds water and has developed wetland characteristics over time. Plants observed included such species as *Polygonum hydropiperoides* (see DP WET 05 datasheet in **Appendix C**). Wetland 5 is not identified in the NWI and is located within the 100-year floodplain.

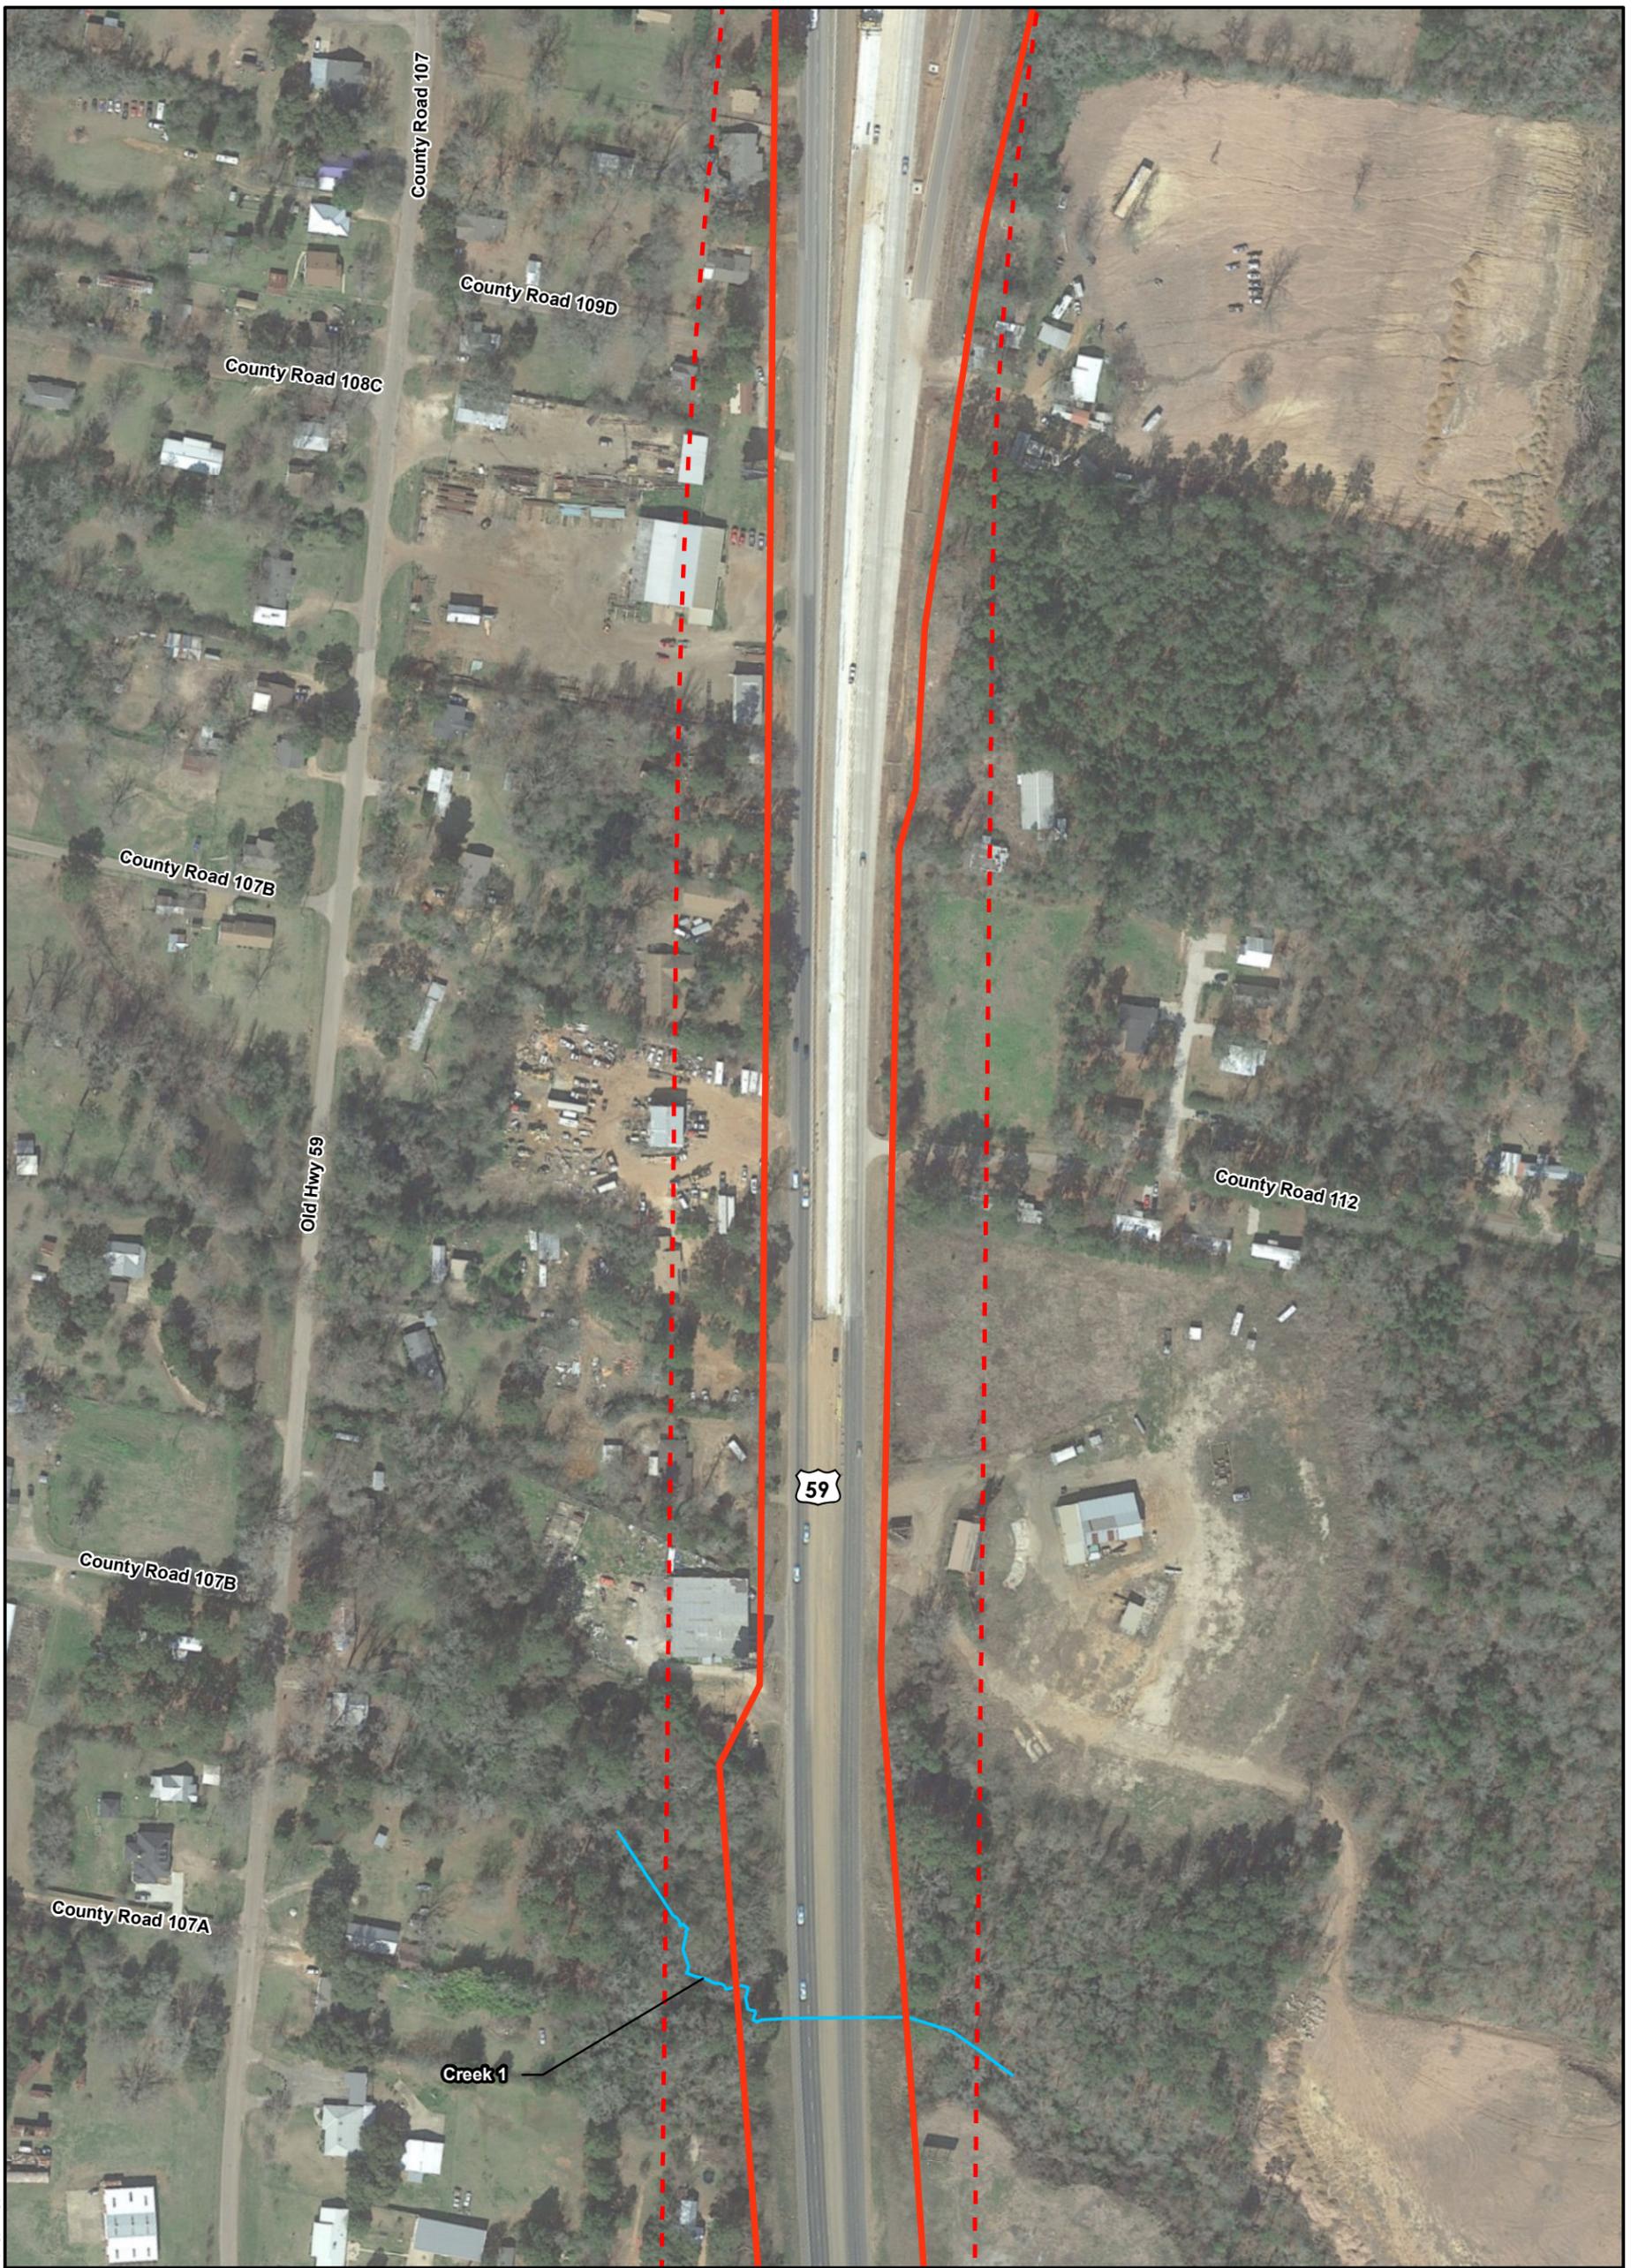
FIGURE 4
MAPPED POTENTIAL WATERS OF THE US
US 59: UPGRADE REDLAND, TX
FROM SOUTH OF FM 2021 TO NORTH OF LOOP 287
ANGELINA COUNTY, TEXAS
CSJ: 0176-02-118

Page 3 of 6

Wetland 4 is a likely non-jurisdictional PEM wetland located west of the existing US 59 ROW (**Figure 4, Page 3**). Wetland 4 is approximately 0.846 acres within the proposed ROW and is located within a low area that holds water and has developed wetland characteristics over time. Due to its lack of a hydrologic connection, other than sheet flow, to the 100-year floodplain, a relatively permanent water (RPW), or a traditionally navigable water (TNW), Wetland 4 is likely a non-jurisdictional feature. Plants observed included such species as *Carex cherokeensis*, *Axonopus fissifolius*, *Juncus effusus*, *Polygonum hydropiperoides*, and *Diodia virginiana* (see DP WET 04 datasheet in **Appendix C**). Wetland 4 is not identified in the NWI and is not located within the 100-year floodplain.

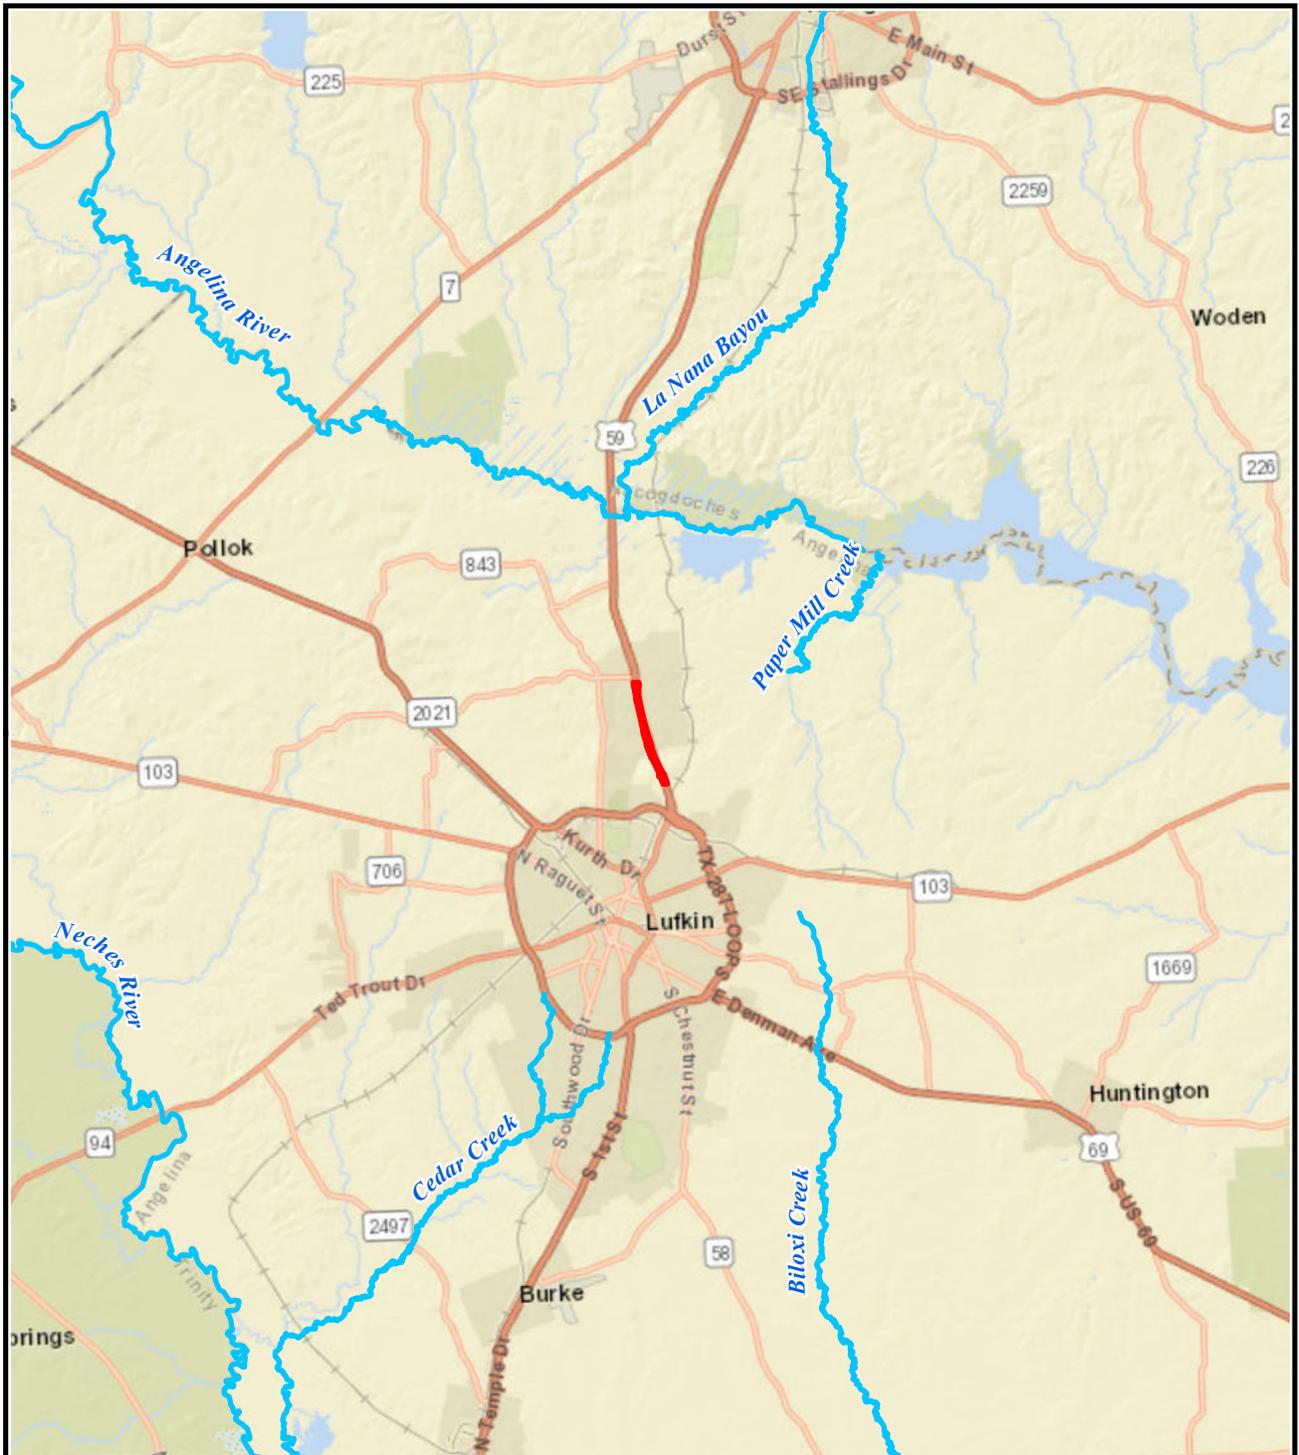
- Project Location
- Impaired Segment (TCEQ)

Paper Mill Creek, an impaired stream listed for high bacterial count, is located directly downstream of the proposed Project and Mill Creek. TxDOT will implement best management practices (BMPs) to avoid any degradation in water quality in the Project area or downstream. A map of the closest impaired stream segments is presented in **Figure 5, Appendix A**.

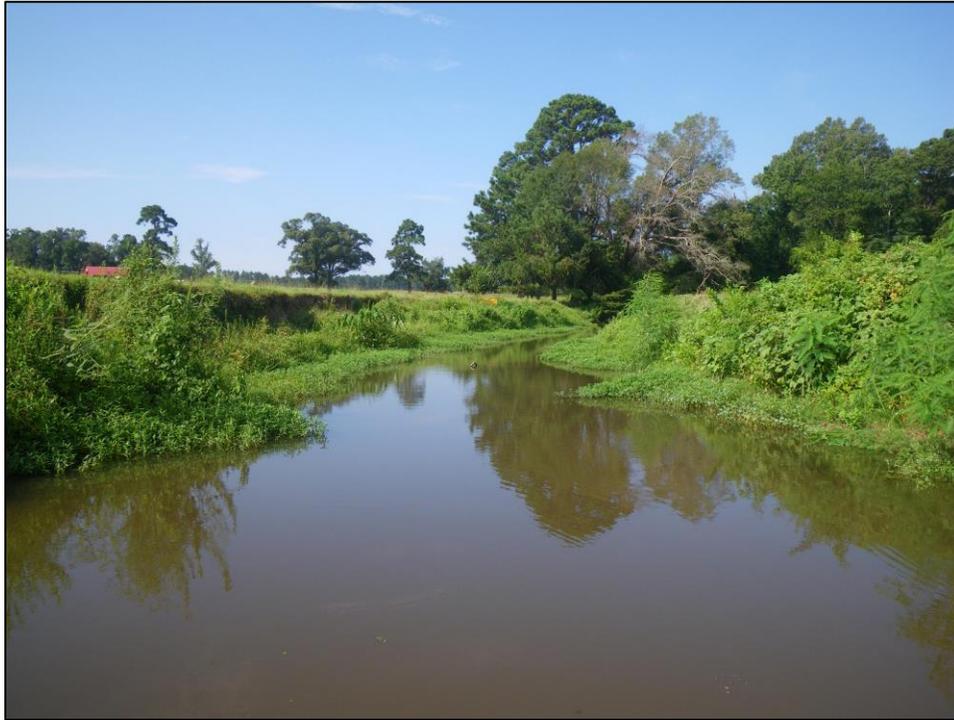
Photo 1: Mill Creek (Creek 3), a potentially jurisdictional perennial stream, located on the west side of US 59, facing upstream (31.388887°, -94.715974°).

Three potentially jurisdictional streams (one ephemeral, one intermittent, and one perennial) were identified during field surveys within the proposed Project area. Mill Creek, a perennial stream located within the proposed Project ROW, is a direct tributary to Paper Mill Creek, which then feeds into the Angelina River and the Sam Rayburn Reservoir. **Table 2** details the proposed impacts to potentially jurisdictional waters of the U.S. within the construction limits of the proposed Project.

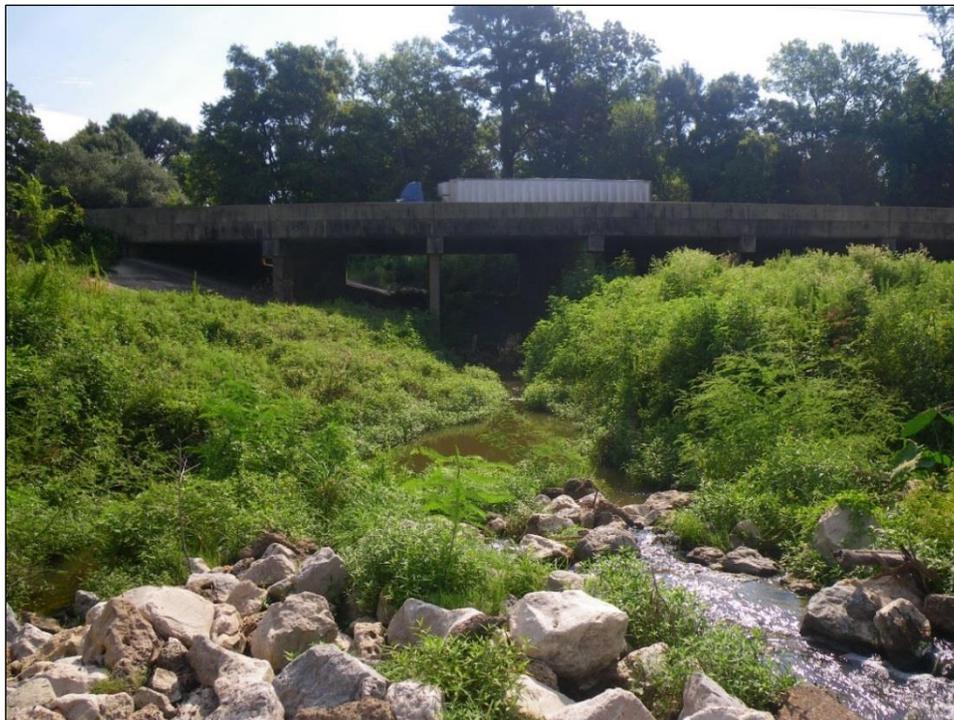
Photo 2: Mill Creek (Creek 3), a potentially jurisdictional perennial stream, located on the west side of US 59, facing downstream (31.388887°, -94.715974°).

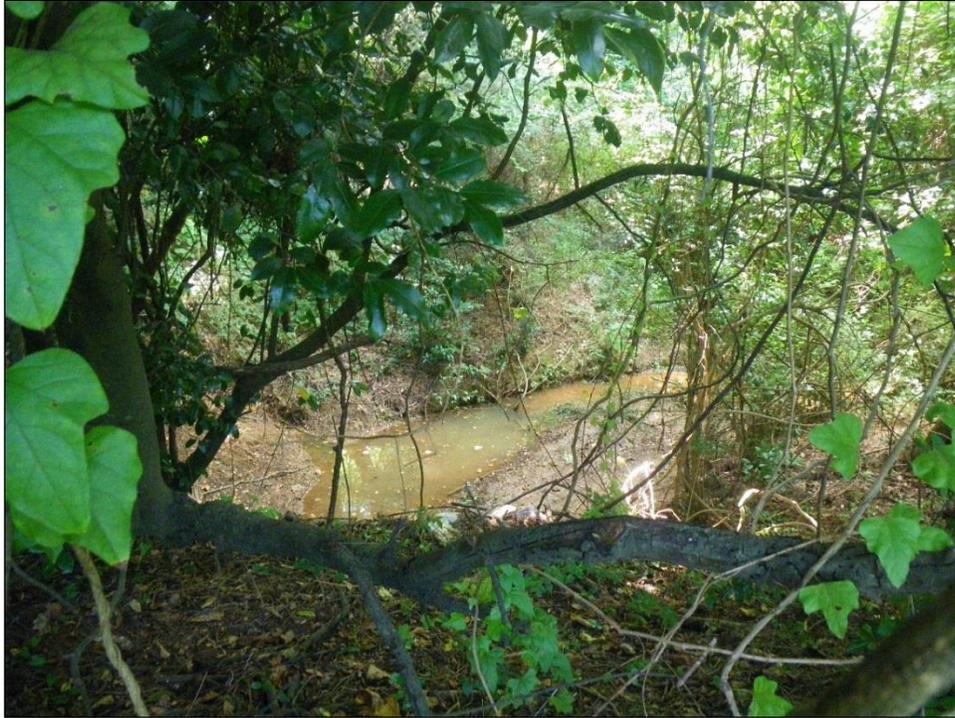
Photo 3: Creek 1, a potentially jurisdictional intermittent stream, located on the west side of US 59, facing upstream (31.398883°, -94.718981°).

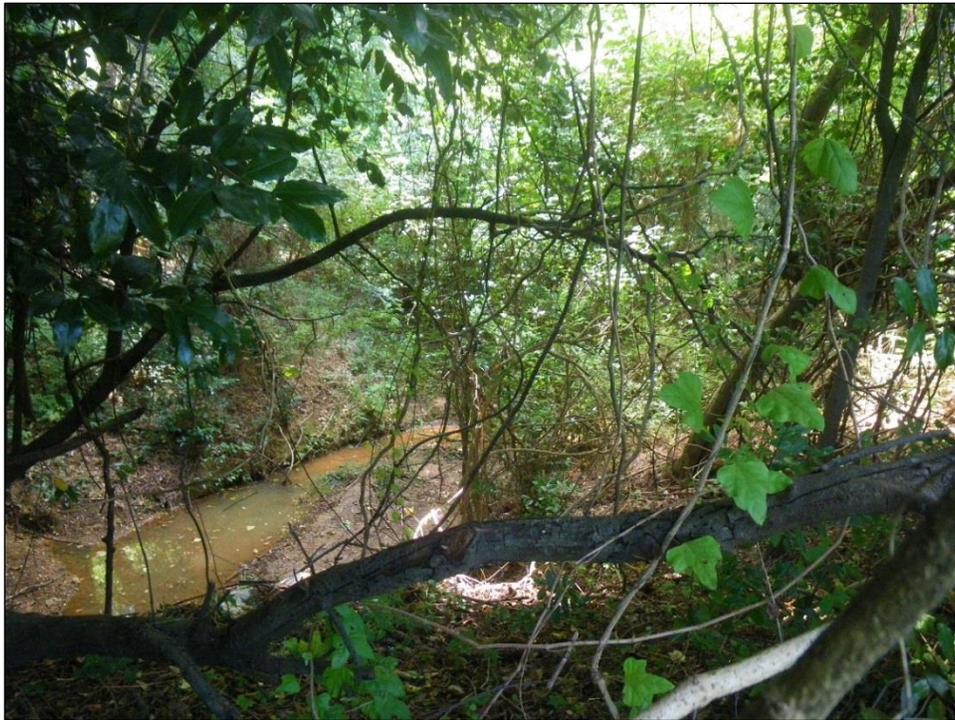
Photo 4: Creek 1, a potentially jurisdictional intermittent stream, located on the west side of US 59, facing upstream (31.398883°, -94.718981°).

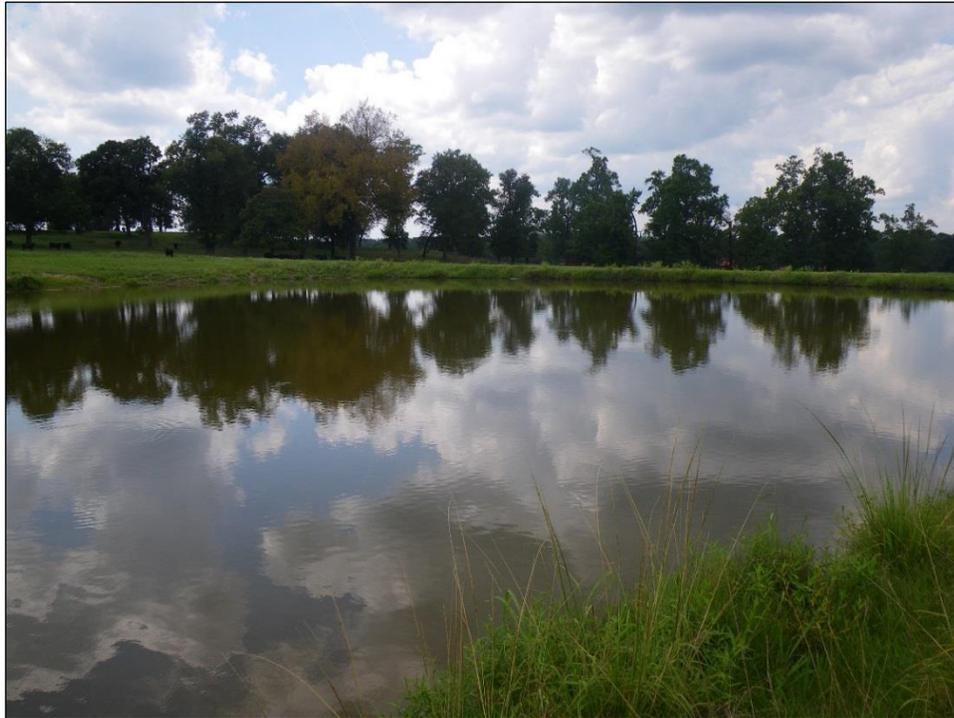
Photo 5: Pond 1, a potentially non-jurisdictional body of water, located west of US 59, facing west (31.383558°, -94.714049°).

Pond 1 is an excavated open water feature located west of the existing US 59 ROW and within the proposed Project area (**Figure 4, Pages 4 and 5**). This likely non-jurisdictional feature occurs on land that has been cleared of most woody vegetation, which is used for livestock grazing. It is identified as a PUBHh (palustrine unconsolidated bottom, permanently flooded, diked/impounded) wetland by the NWI maps. The feature is approximately 0.551 acres within the proposed ROW and is not located within the 100-year floodplain.

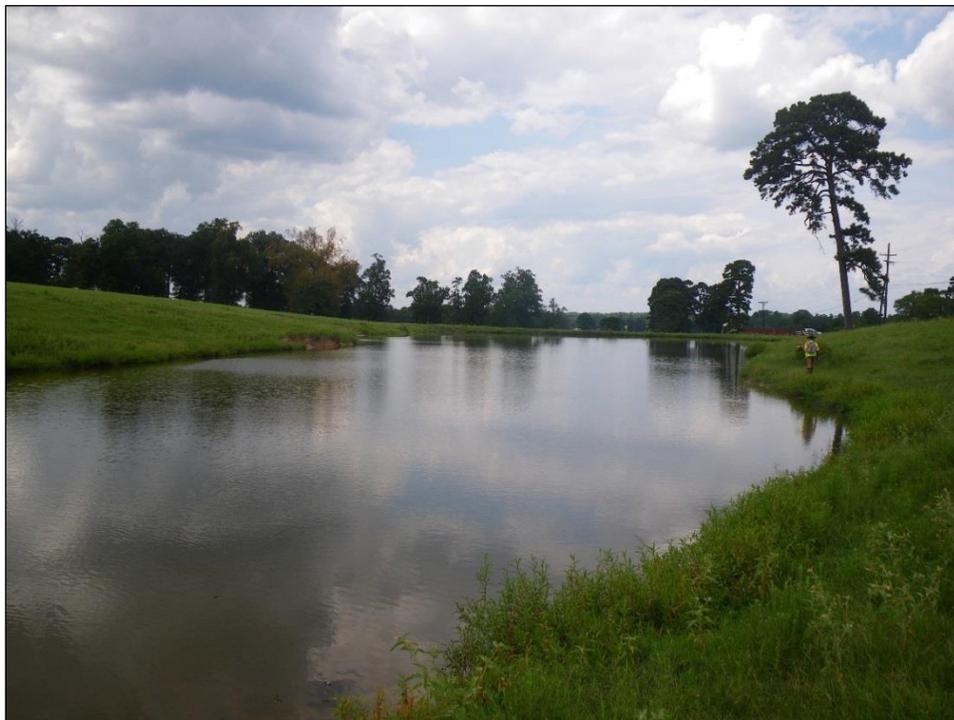
Photo 6: Pond 1, a potentially non-jurisdictional body of water, located west of US 59, facing south (31.383558°, -94.714049°).

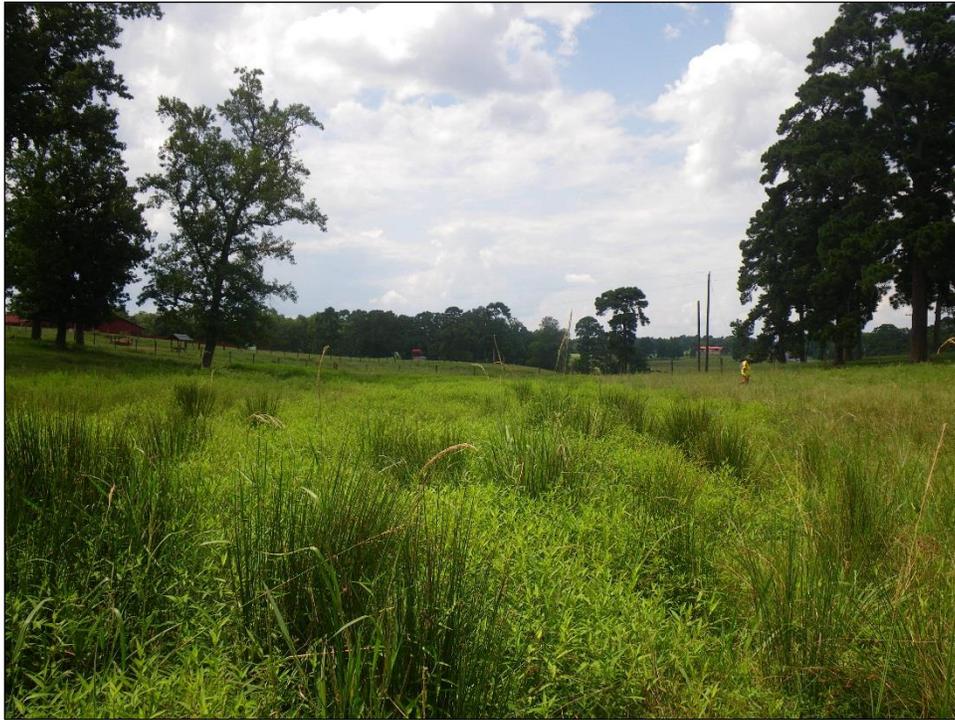
Photo 7: Wetland 7, a PEM wetland adjacent to Pond 1, facing north (31.385204°, -94.714944°).

Wetland 7 is a likely non-jurisdictional PEM wetland associated with the spillway of Pond 01 and located west of the existing US 59 ROW (**Figure 4, Page 4**). Wetland 7 is approximately 0.052 acres within the proposed ROW and is located within a low area that holds water and has developed wetland characteristics over time. Due to its lack of a hydrologic connection, other than sheet flow, to the 100-year floodplain, a RPW, or a TNW, Wetland 7 is likely a non-jurisdictional feature. Plants observed included such species as *Polygonum hydropiperoides*, *Paspalum urvillei*, and *Hydrolea ovata* (see DP WET 07 datasheet in **Appendix C**). Wetland 7 is not identified in the NWI and is not located within the 100-year floodplain.

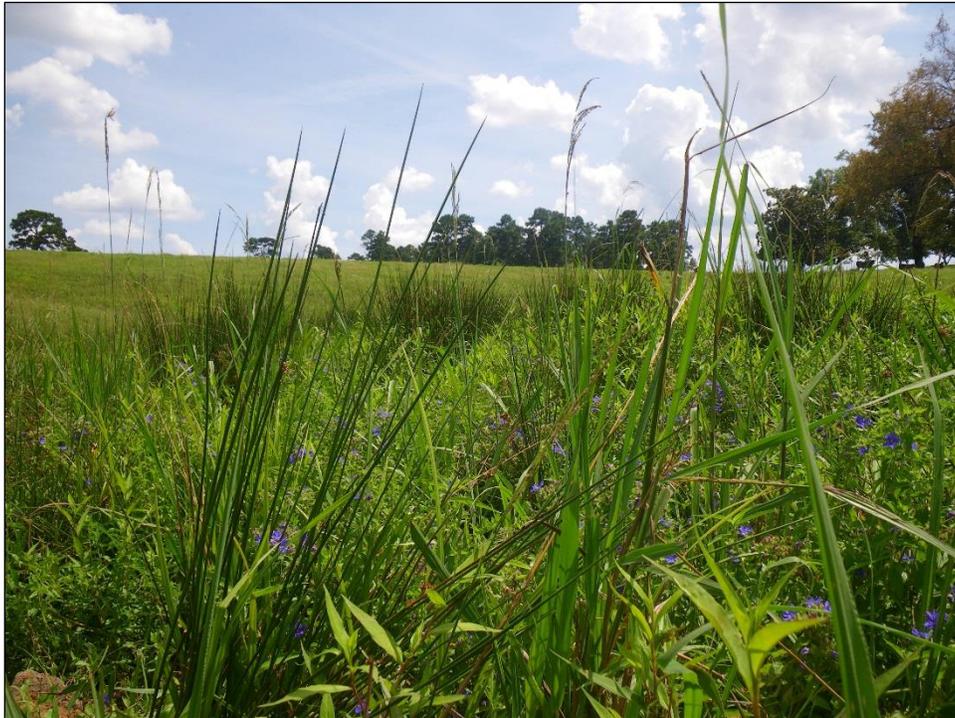
Photo 8: Wetland 7, a PEM wetland adjacent to Pond 1, facing south (31.385204°, -94.714944°).

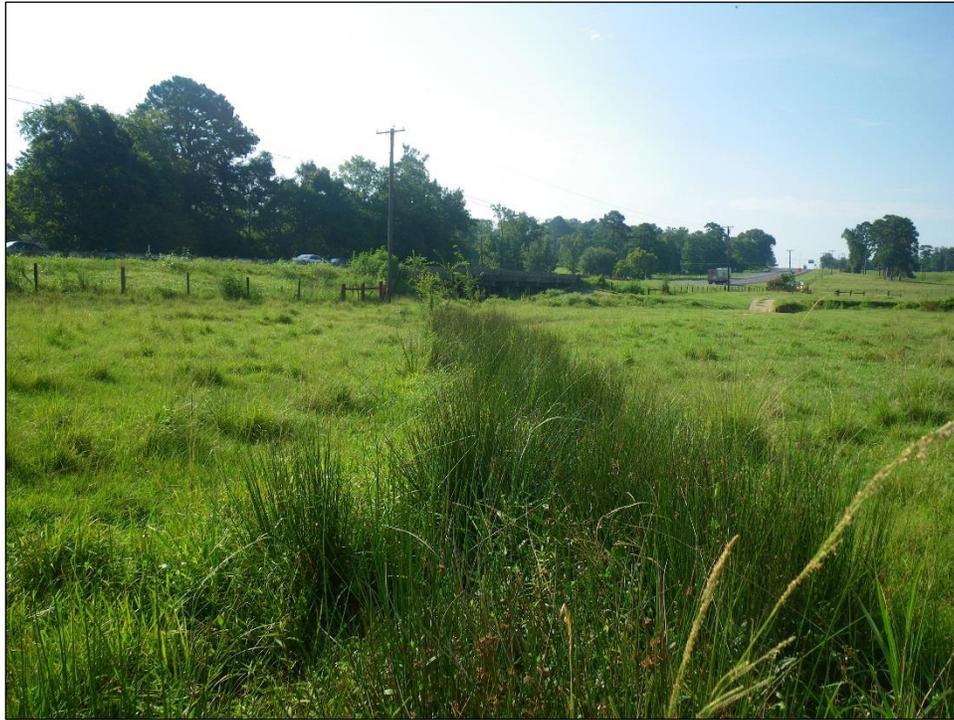
Photo 9: Wetland 1, a PEM wetland adjacent to Mill Creek, west of US 59, facing south east (31.389492°, -94.716155°)

The Wetland 1 complex consists of a series of potentially jurisdictional, hydrologically interconnected PEM wetlands (1A through 1F) located along the riparian corridor of Mill Creek (1C through 1F) and along a drainage ditch directly connected to Mill Creek (1A and 1B) west of the existing US 59 ROW (**Figure 4, Page 4**). Wetlands 1A and 1B are not identified in the NWI and are not in the 100-year floodplain. Wetlands 1C through 1F are incorrectly identified in the NWI as PFO1C (palustrine forested, broad-leaved deciduous, seasonally flooded) wetlands and are in the 100-year floodplain. Plants observed included such species as *Polygonum hydropiperoides*, *Juncus effusus*, and *Hydrolea ovata* (see DP WET 01 datasheet in **Appendix C**). Wetlands 1A, through 1F are approximately 1.025, 0.028, 0.053, 0.017, 0.038, and 0.043 acres within the proposed ROW, respectively.

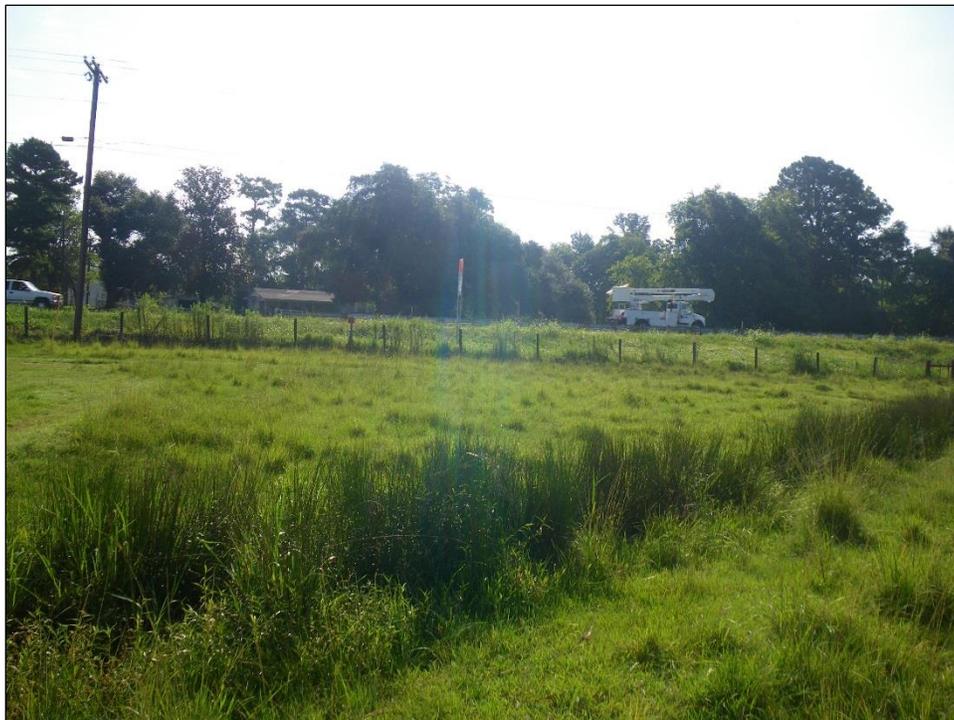
Photo 10: Wetland 1, a PEM wetland adjacent to Mill Creek, west of US 59, facing east (31.389492°, -94.716155°).
