Karst Technical Report

Loop 1604 from SH 16 to I-35,
Bexar County, Texas

Prepared by: Zara Environmental LLC and JACOBS
Date: 11 March 2020

**Karst Technical Report Loop 1604 from SH 16 to I-35, Bexar County, Texas
CSJs: 2452-02-083, 2452-03-087, 2452-03-113**

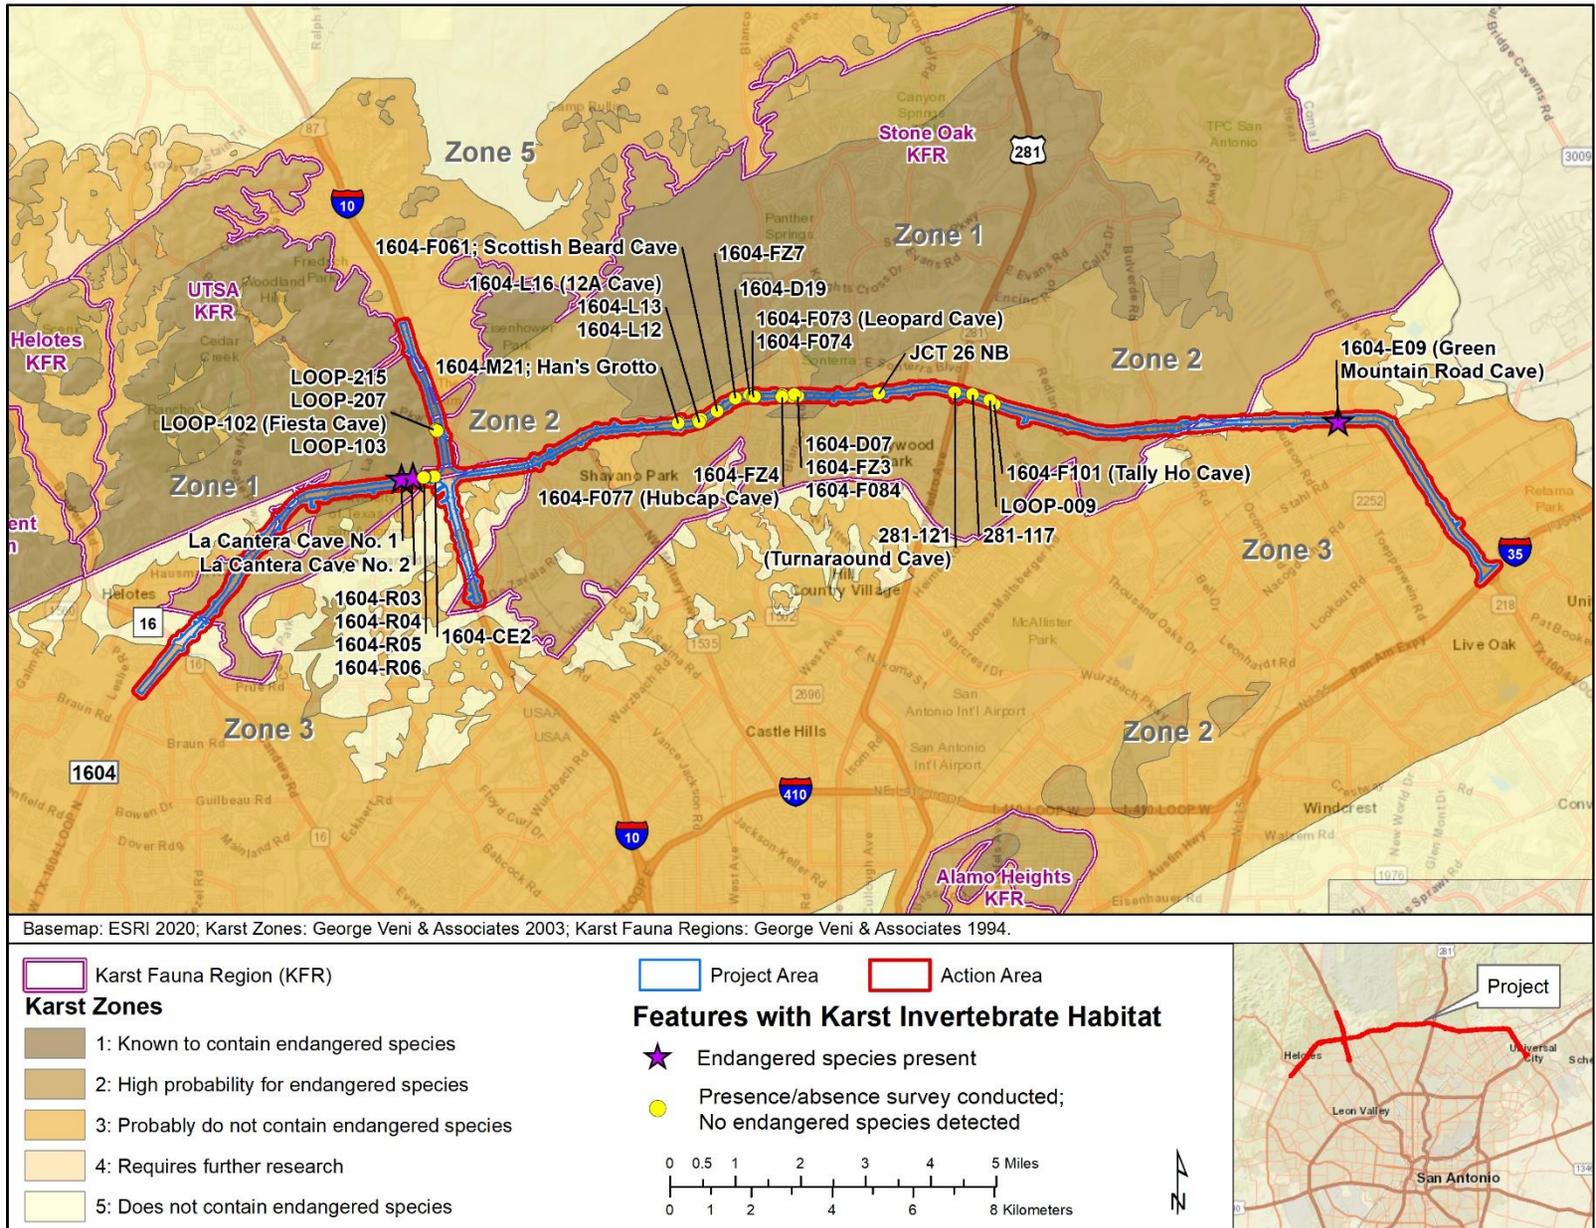
Figure 2. Location of 31 features in the Action Area that meet the criteria for karst invertebrate habitat.

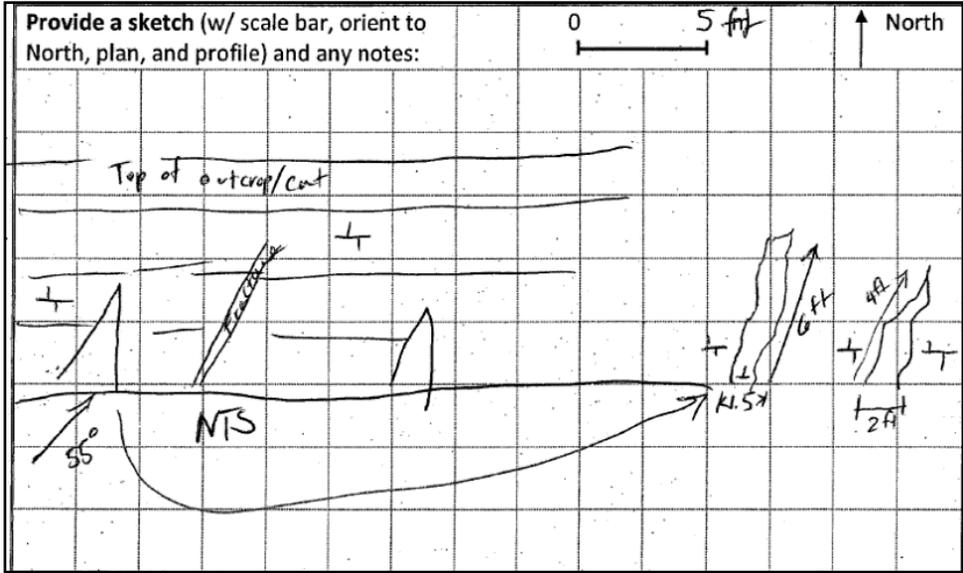
Figure 3. Field sketch of feature 1604-801.

This feature was located in the roadcut north of the westbound mainlanes of Loop 1604 east of Huebner Road (Figure 3 - Figure 5). It was evaluated on February 2, 2010, and on March 25, 2010 excavation was performed, and the feature was found to definitively end. The feature was again field evaluated on November 29, 2017, and the original datasheets were re-evaluated in 2019 to verify the potential for karst invertebrate habitat. It was a zone of three solution-enlarged fractures within an area that was 6 m (20 ft) wide by 1.8 m (6 ft) long by 1.8 m (6 ft) high. The largest opening was 0.5 m (1.5 ft) wide by 0.6 m (2 ft) high and extends 1.8 m (6 ft) into the roadcut (Figure 5). It contained exposed bedrock and breakdown. This feature was determined not to provide potential habitat for listed karst invertebrate species and no fauna surveys were performed (Table 2). A review of TxDOT 2019b and USFWS 2019 indicates that this feature may be removed during future construction at the Blanco Road intersection.

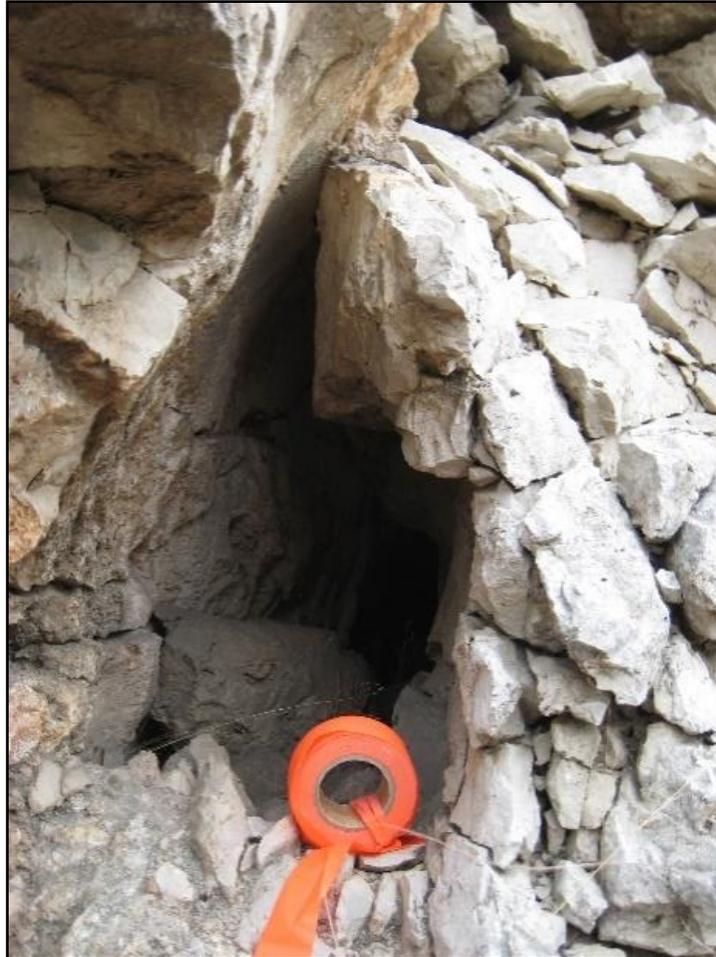
Figure 5. The largest of three solution-enlarged fractures in the zone feature 1604-801.

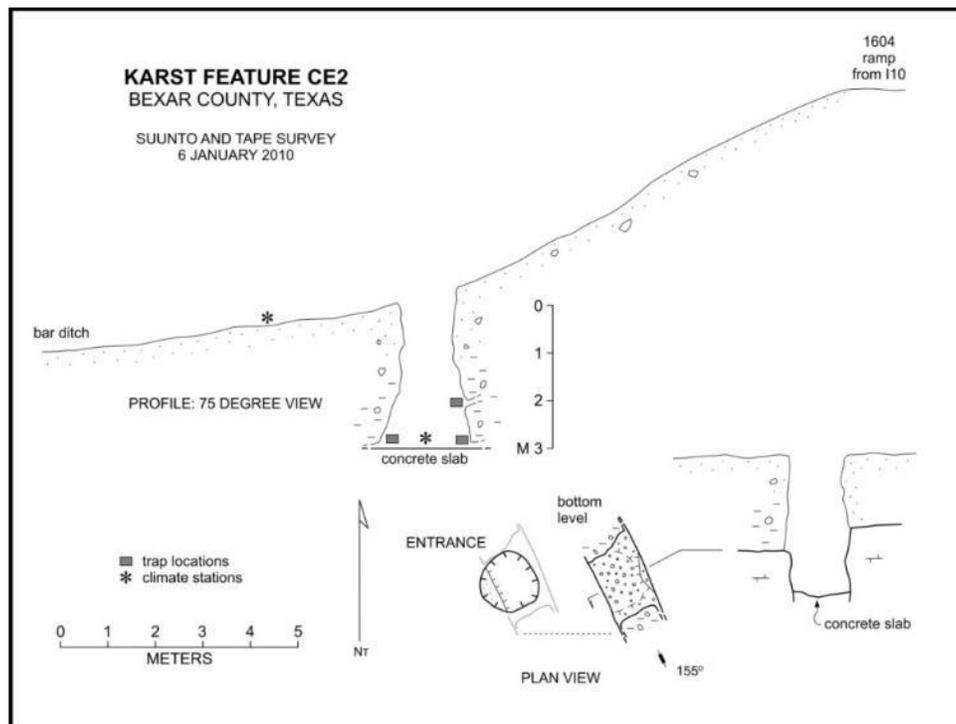
Figure 6. Map of feature CE2.

This 0.35 m (1.15 ft) diameter by 0.35 m (1.15 ft) deep hole had a loose fill bottom that was dropping below grade due to soil piping (Figure 6 -Figure 8). This site was excavated on January 5, 2010, resulting in the removal of 3 m³ (105.9 ft³) of material. It was excavated to a depth of 3 m (9.8 ft). Initial digging efforts involved removing the loose fill from the piping shaft. While the vertical walls of the 0.35 m (1.15 ft) diameter shaft were composed of consolidated clay and small rocks, the piping material was sand. This sand was likely dumped in the hole at some point, but by whom or under what circumstances is unknown. As the hole deepened it was necessary to widen to continue working at the bottom, so the consolidated clay walls were peeled back to make the shaft a little over 1 m (3.3 ft) in diameter. A linear bedrock wall was found on the west side at a depth of 1.5 m (4.9 ft), and on the east side at a depth of 2 m (6.6 ft) (Figure 8). No bedrock was found on the north or south sides of the shaft. The feature began to resemble a bedrock utility trench; however, the walls exhibited a natural surface. Sand continued to be removed to a depth of 3 m (9.8 ft), where a poured concrete floor was encountered. Concrete residue could be seen on the east bedrock wall; evidence of it having been poured in to fill a natural bedrock feature. The north and south walls of the shaft, still composed of clay and small rocks but also small voids, was dug only as far as was prudent considering the risk of collapse due to unstable

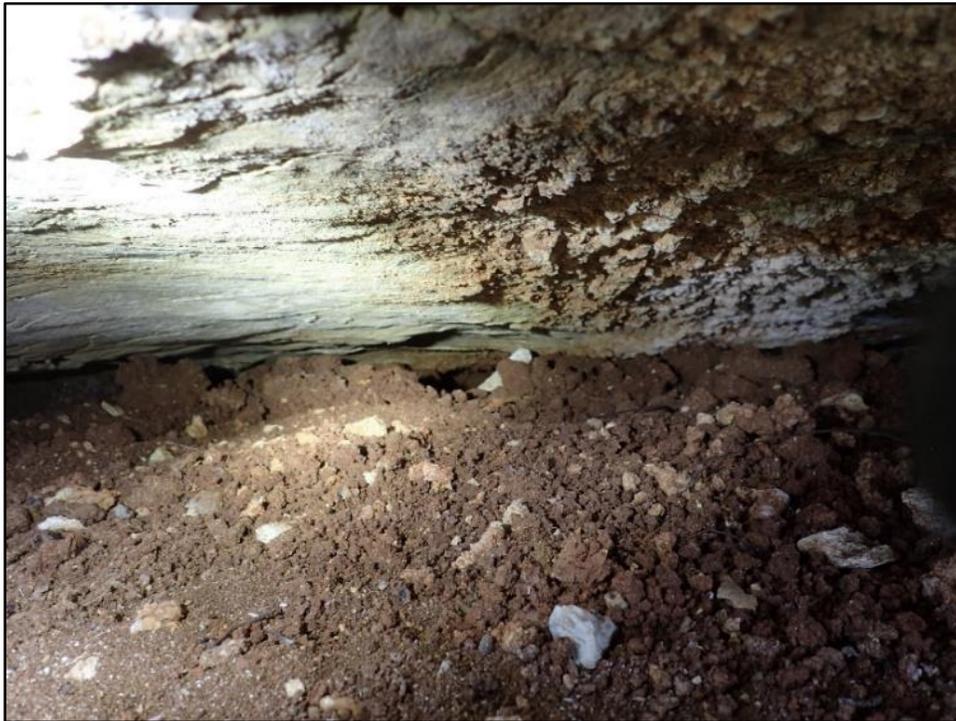
Figure 35. Interior of feature 1604-D13.

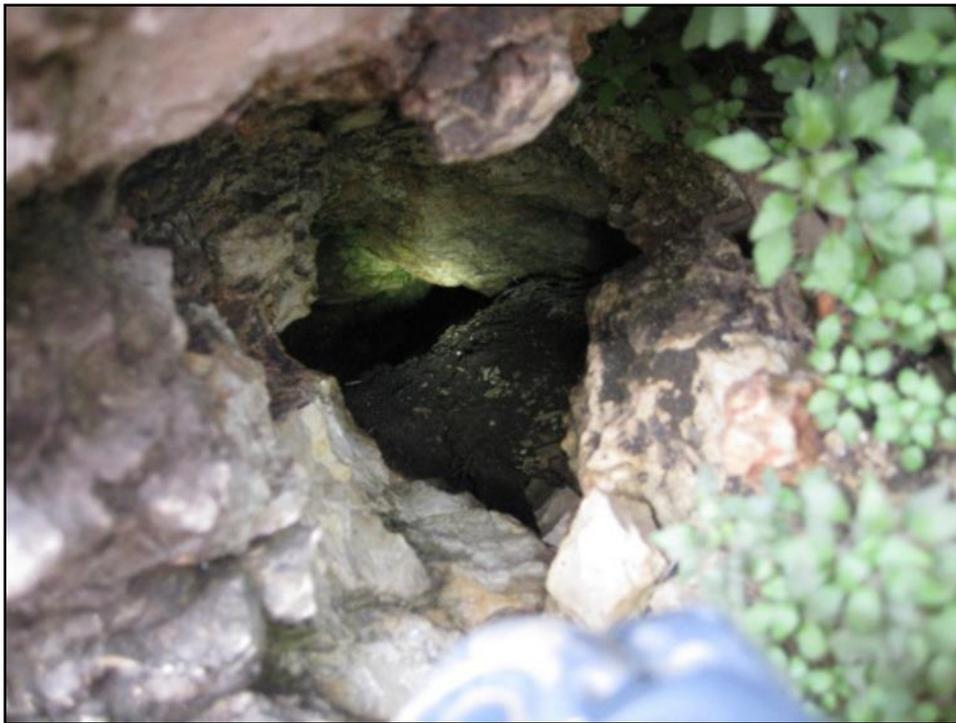
Figure 38. Interior of feature 1604-D15

This feature was located in the roadcut south of the eastbound mainlanes of Loop 1604 west of Huebner Road (Figure 36 - Figure 37). It was originally evaluated in 2010 (Zara 2010b), again in 2016, then again on August 15, 2019. This feature consists of two holes, one was a blind solution cavity, to the east, which had no voids extending from it. The other solution cavity measured 0.2 m (0.6 ft) in diameter at its opening, but inside measured 0.1 m (3.3 ft) wide and 0.3 m (1.0 ft) tall and extends 0.9 m (3.0 ft) into the roadcut. The floor of the feature had a thin layer of loose rocks and dark brown soil (Figure 38); however, it is best characterized as a tight, sinuous bedrock tube. Past evaluations noted that some void space can be seen continuing off from the feature, but during the 2019 evaluation we determined the maximum distance that could be sampled with a pole and sticky trap was less than one meter, and during this visit that space was entirely filled with a young possum. Excavation of the site was not warranted because it was nearly entirely bedrock with only a thin layer of loose debris available to move, such that excavation would not yield additional sampleable habitat. This feature was determined not to provide potential habitat for listed karst invertebrate species and no fauna surveys were performed (Table 2). A review of TxDOT 2019b and USFWS 2019 indicates that this feature may be removed during future construction at the Blanco Road intersection.

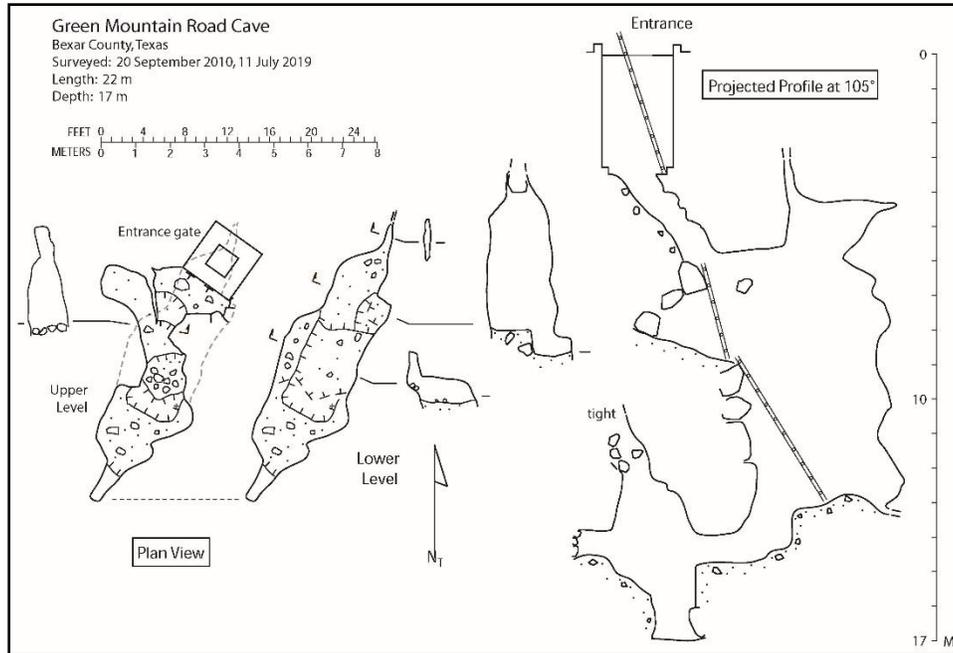
Figure 57. Map of feature 1604-E09 (Green Mountain Road Cave) after excavation. Note that the end of the cave was too narrow to continue.

Due to the possible presence of endangered species, a gate was installed at the cave on June 11, 2012 (Figure 60). Integrated into this gate was a concrete retaining structure designed to prevent loose material from collapsing into the cave. Fauna detected in 2010 included five troglobites, one of which is an eyeless *Cicurina* sp. spider. One author examined the spider tissue from this site, and due to an incongruence between nuclear and mitochondrial DNA concluded that the site needs more study before a species name could be assigned (Hedin et al. 2018). Another author examined only mitochondrial DNA and concluded the best match for that site is *Cicurina baronia* (in prep). Under advice from USFWS (Jenny Wilson, personal communication, 16 August 2019), in this document the species is treated as the endangered *Cicurina baronia* (Figure 61).

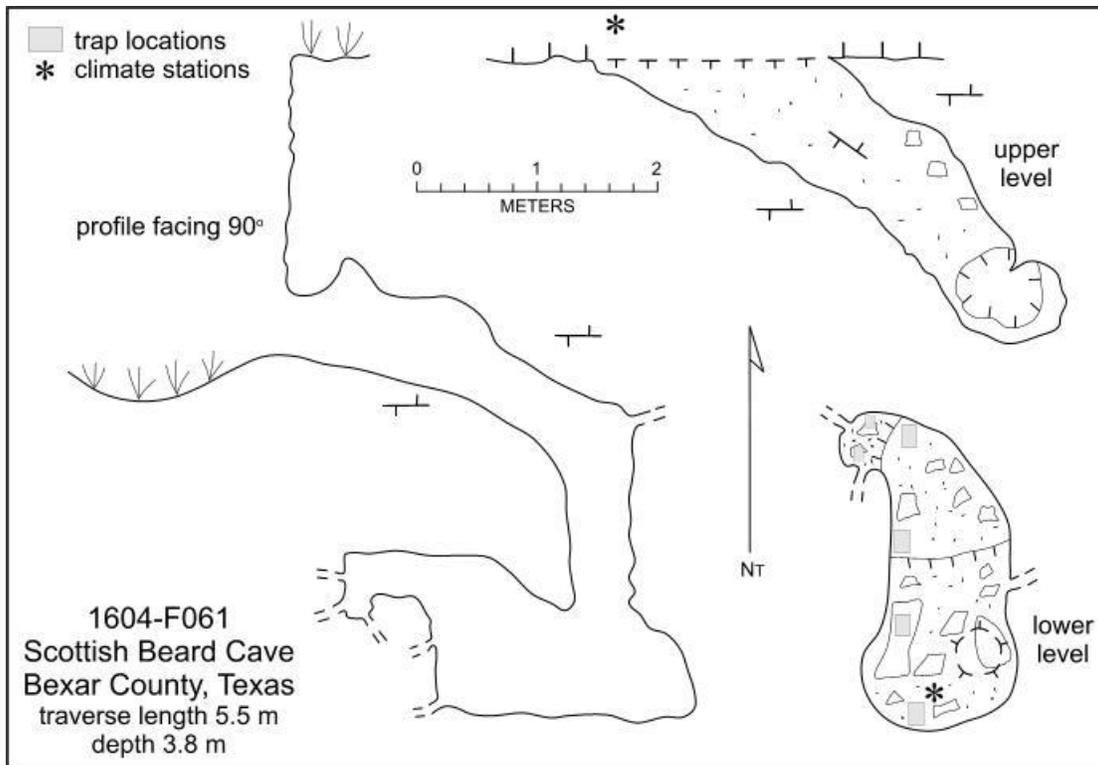
Figure 63. Map of feature 1604-F061 (Scottish Beard Cave).

In July 2019, rocks which had been placed over the entrance were removed. Presence/absence surveys were conducted in June and July 2019 (Table 8); notable fauna is summarized in Table 1. Three non-listed troglobites (*Brackenridgia* sp., *Chinquipellobunus* sp., and *Texoreddellia* sp.) were found during the 2019 surveys.

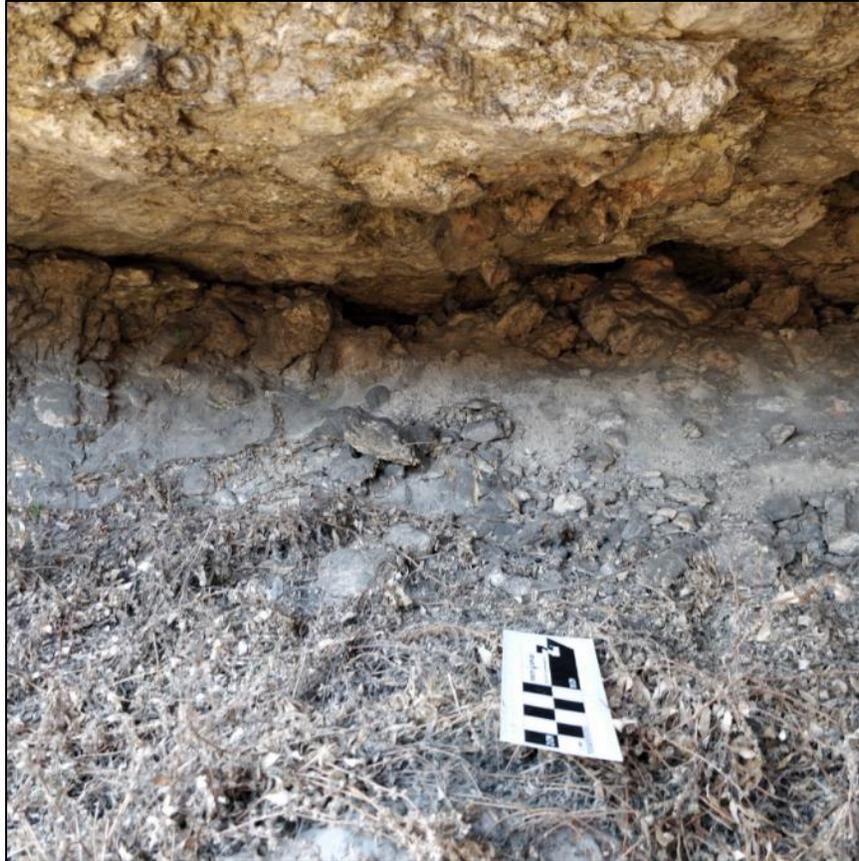
Figure 77. Interior of feature 1604-F069.

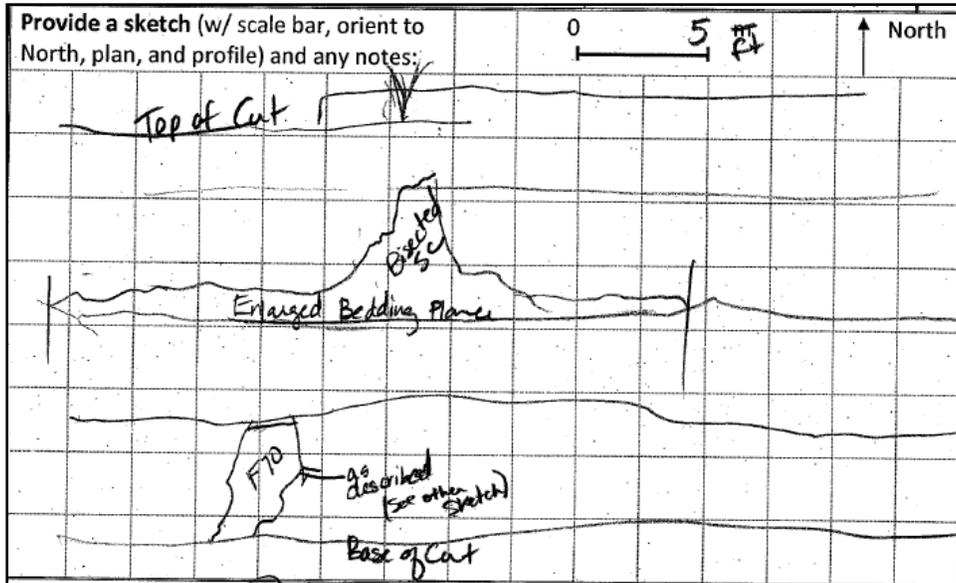
Figure 78. 2017 field sketch of feature 1604-F070.

This zone of features was located in the roadcut south of the eastbound mainlanes of Loop 1604 and east of Huebner Road (Figure 78 - Figure 81). Field evaluations were performed on August 2, 2009 and November 30, 2017, and field datasheets were re-evaluated in 2019 to verify the potential for karst invertebrate habitat. The feature had a solution-enlarged fracture located at the base of the roadcut that was 0.5 m (1.6 ft) wide by 1.0 m (3.3 ft) high and 0.7 m (2.3 ft) long. In addition to the solution-enlarged fracture, a solution-enlarged bedding plane and bisected solution cavity are also present immediately above the solution-enlarged fracture. The zone containing all three features measured 15.2 m (50 ft) wide by 0.8 m (2.5 ft) long by 4.3 m (14 ft) high. These features are infilled with loose soils, rocks, bedrock, and vegetation. Flowstone was present in the solution-enlarged fracture. There was no airflow, no mesocavernous voids, and the feature was not humanly enterable. This feature was determined not to provide potential habitat for listed karst invertebrate species and no fauna surveys were performed (Table 2). A review of TxDOT 2019b and USFWS 2019 indicates that this feature may be removed during future construction at the Blanco Road intersection.

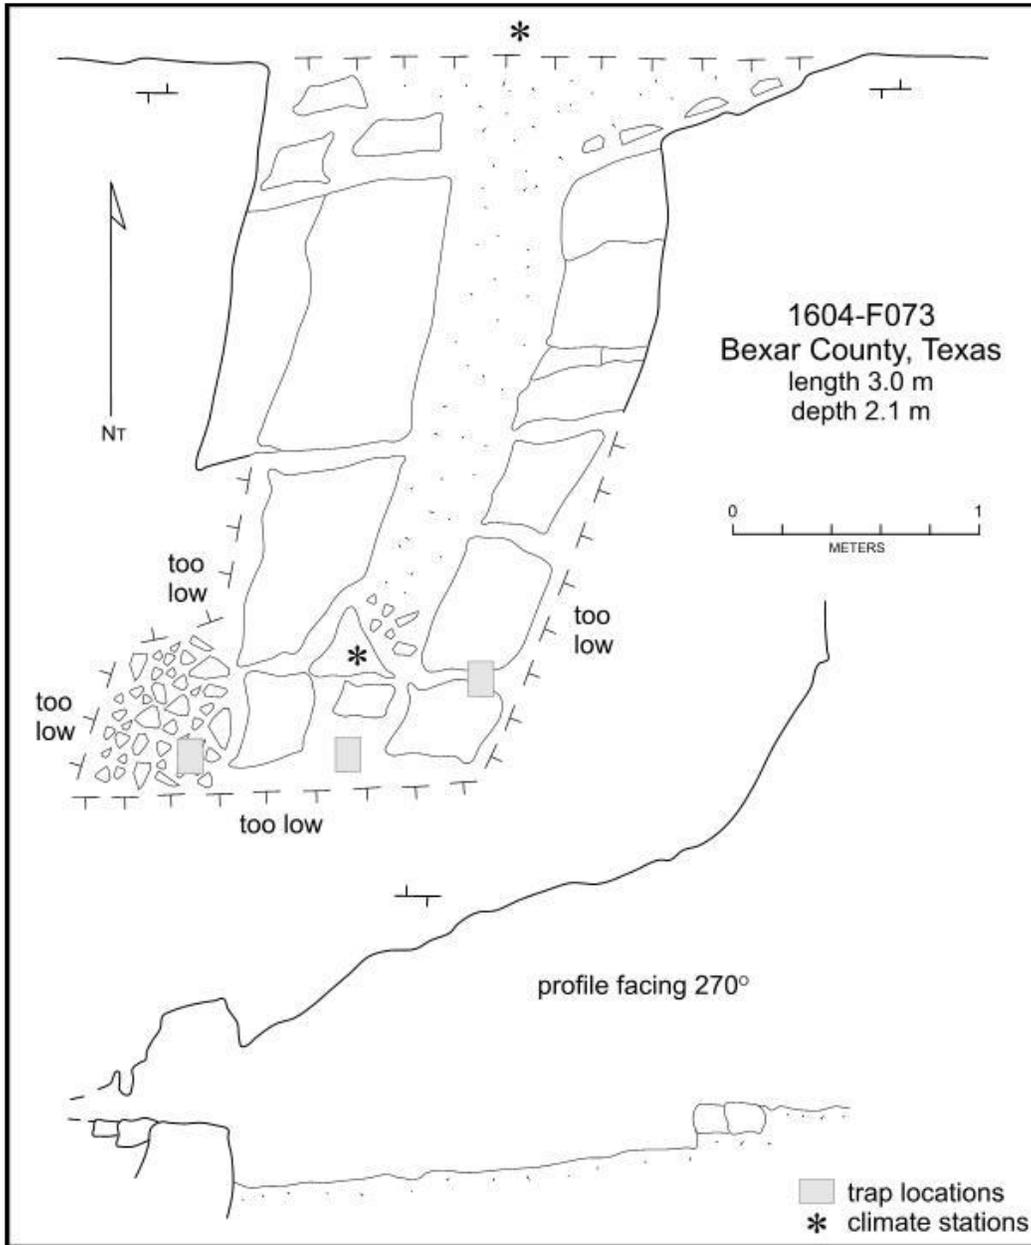
Figure 88. Map of feature 1604-F073 (Leopard Cave).

This cave was located at the base of the roadcut south of the eastbound mainlanes of Loop 1604, east of Huebner Road (Figure 88 - Figure 90). It was evaluated on August 2, 2009 and on March 22, 2019 (TxDOT 2015a, 2019a). It was formed on a solution-enlarged bedding plane at the base of the roadcut, and appears to be developed along a fracture trending 90 degrees with a dip of 35 degrees south. Infill consists of coarse rocks, calcite, and bedrock. The feature was 2.4 m wide (7.9 ft) wide at the entrance by 3.5 m (11.5 ft) long by 1.5 m (5 ft) high at the entrance. Excavation to remove a large block at the entrance occurred in October 2009, utilizing 39.5 person hours of labor, resulting in the removal of 3 m² (33 ft³) of material from the feature. This feature was infilled with speleothems, bedrock, and loose rocks, and it had mesocavernous voids extending off the back of it (Figure 90). This feature meets many of the criteria for potential habitat, including void size greater than or equal to 1 m, similarity to nearby caves and being humanly enterable (Table 2), and qualifies as potential karst invertebrate habitat. Presence/absence surveys conducted in October and November 2009 detected cave crickets, including the more rarely seen *Ceuthophilus cunicularis*, but no troglobites. Presence/absence surveys were conducted in March and April 2019 (Table 10) (TxDOT 2019a); notable fauna is summarized in Table 1. A review of TxDOT 2019b and USFWS 2019 indicates that this feature may be removed during future construction at the Blanco Road intersection.

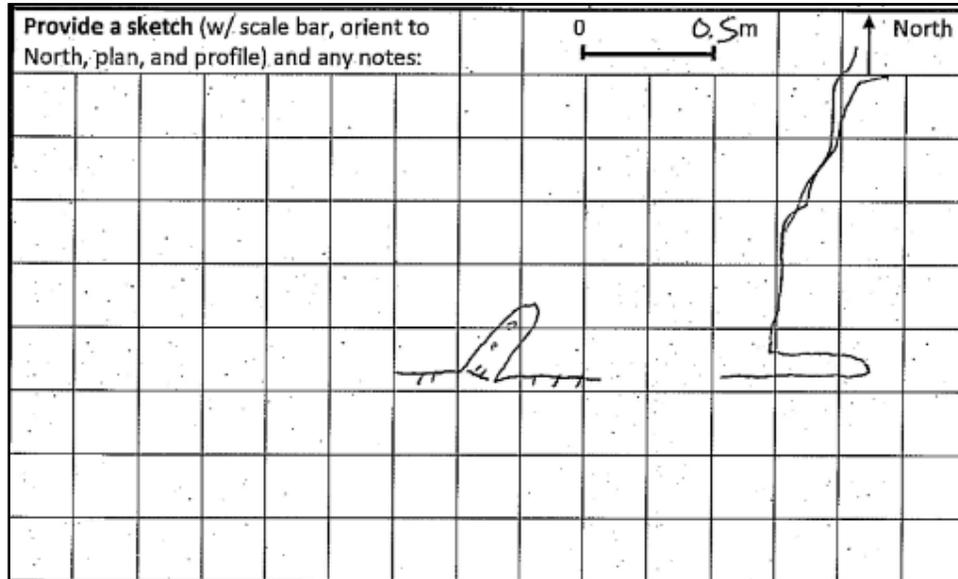
Figure 94. Field sketch of feature 1604-F076.

This feature was located at the base of a roadcut north of the westbound mainlanes of Loop 1604, west of Blanco Road (Figure 94 - Figure 96). It was evaluated on August 2, 2009 and July 3, 2019. The feature was a solution-enlarged fracture that measured 0.2 m (0.7 ft) wide, 0.5 m (1.6 ft) long, by 0.15 m (0.5 ft) high. This feature contained bedrock and was infilled with loose rocks, organic soil, and leaf litter. This feature was determined not to provide potential habitat for listed karst invertebrate species and no fauna surveys were performed (Table 2). A review of TxDOT 2019b and USFWS 2019 indicates that this feature may be removed during future construction at the Blanco Road intersection.

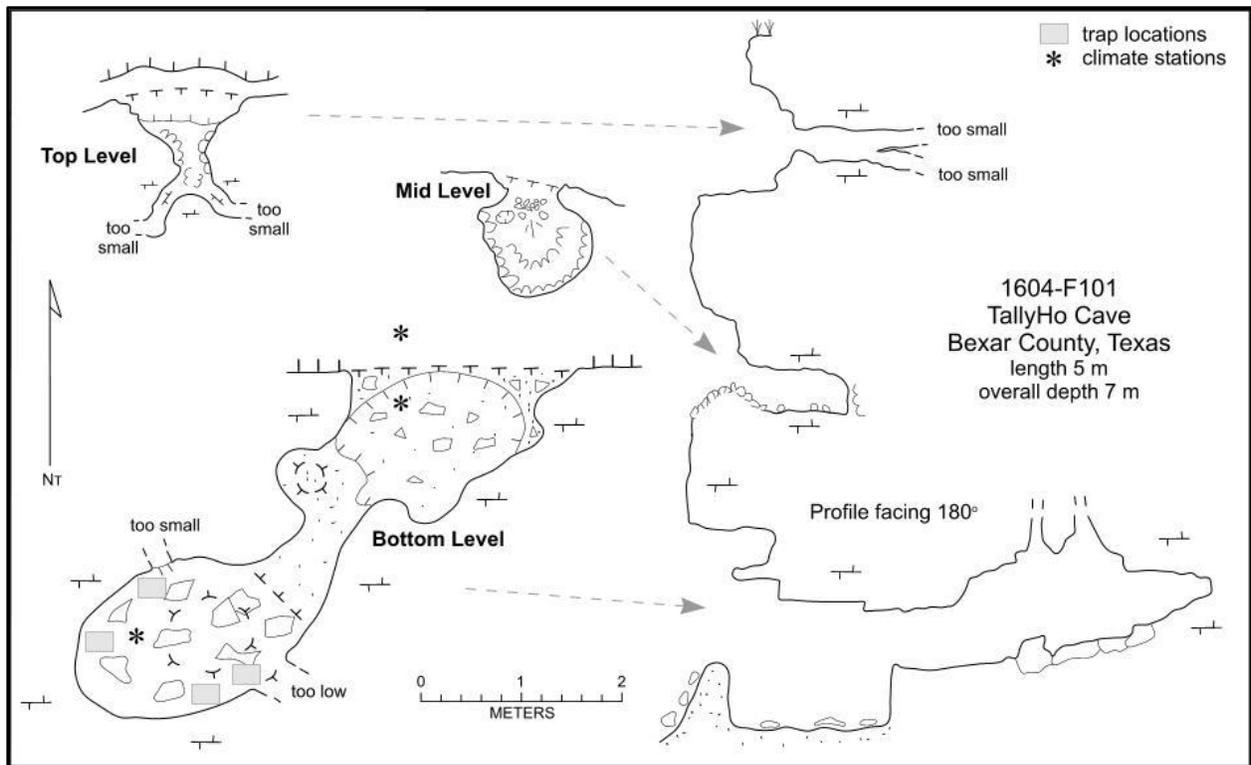
Figure 117. Map of feature 1604-F101 (Tally Ho Cave) prior to it being mined away.

This cave was found on 15 July 2009 on the south side of Loop 1604, just east of US 281 (Figure 117 - Figure 118). It was partially mined away for the 2012 construction of the 281/1604 interchange, with the remainder grouted shut as part of the Water Pollution Abatement Plan (WPAP) for that project (Figure 119). This feature was comprised of four holes stacked one above the other in the road cut, developed on an enlarged fracture. Initially, the lowest entrance, near ground level, was 2.2 m (7.2 ft) wide and extended 1.6 m (5.2 ft) into the face of the road cut. Total vertical extent of this feature was 5 m (16.4 ft). The lower part of the feature was excavated using 15.8 person hours of effort, with 7.5 m³ (80.7 ft³) of material removed from the feature, making it 5 m (16.4 ft) long and 2 m (6.6 ft) deep. After an initial drop-off at the entrance, there was a step-up at a narrow spot that then gives access to a room measuring 1.5 (4.9 ft) by 2 m (6.6 ft), with some small holes extending up into the ceiling. Biological surveys were conducted on October 6, 16, and 23, 2009 (TxDOT 2015a). An eyeless spider was collected in a glue trap that was identified as *Cicurina platypus*. This is a non-listed species known very few other localities. Since this feature was plugged with grout (Figure 120), it was not assessed for karst species in 2019 (Table 1).

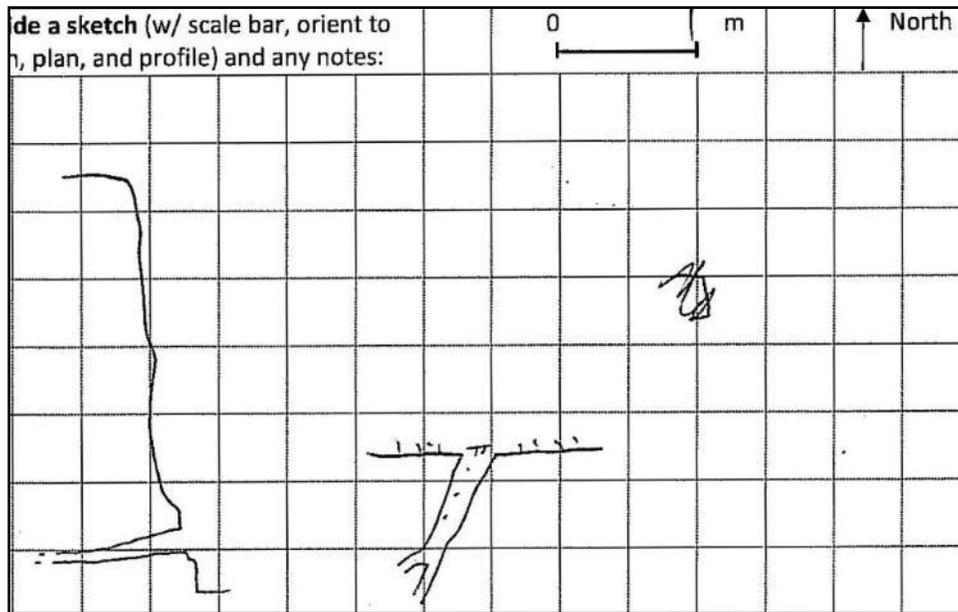
Figure 124. Field sketch of feature 1604-FZ4.

This feature was located in a roadcut south of the eastbound mainlanes of Loop 1604, west of Blanco Road (Figure 124 - Figure 126). It was evaluated on August 2, 2009 and July 3, 2019. The feature was a solution cavity 0.45 m (1.5 ft) wide by 1.1 m (3.6 ft) long, and 0.25 m (0.8 ft) high. There was no noticeable airflow and the feature was not humanly enterable. Mesocavernous voids were observed. This feature contained fine organic soil and leaf litter. In 2009, it did not meet the criteria for karst invertebrate habitat; however, the current criteria are more slightly more stringent (USFWS 2015a) and the 2019 set of measurements put this feature over that threshold. Due to it having mesocavernous voids and a length greater than 1 m (3.3 ft), it was considered potential karst invertebrate habitat (Table 2). Presence/absence surveys were conducted in August and September 2019 (Table 16); however, no troglobites were found (Table 1). A review of TxDOT 2019b and USFWS 2019 indicates that this feature may be removed during future construction at the Blanco Road intersection.

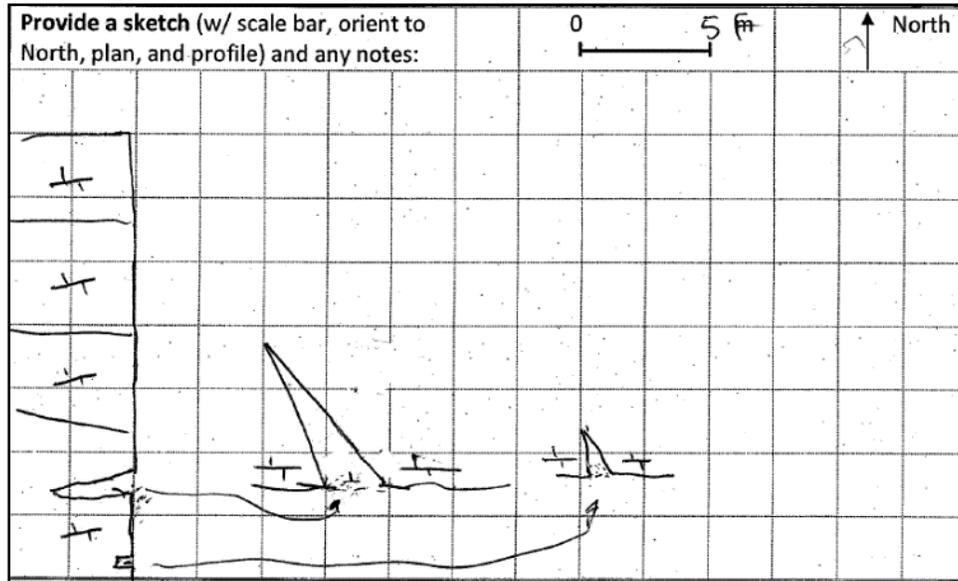
Figure 127. Field sketch of feature 1604-FZ6.

This feature was a zone containing two features in the roadcut north of the westbound mainlanes of Loop 1604 east of Huebner Road (Figure 127 - Figure 128). It was evaluated on August 2, 2009 and November 29, 2017 (TxDOT 2015a and TxDOT 2018a). The largest feature in the zone was a solution-enlarged fracture located 0.5 m (1.6 ft) above the base of the roadcut. It was 0.6 m (2 ft) wide by 0.97 m (3.2 ft) long by 0.5 m (1.8 ft) high (Figure 129). This feature contained loose rocks, fine sediment, and bedrock. A smaller solution cavity was also present at the base of the cut that was 0.2 m (0.6 ft) in diameter and extends 0.2 m (0.8 ft) into the roadcut (Figure 130). The features both trend at approximately 320 degrees into the roadcut and contain mesocavernous voids that extend into the roadcut along that trend. This feature was determined not to provide potential habitat for listed karst invertebrate species and no fauna surveys were performed (Table 2).

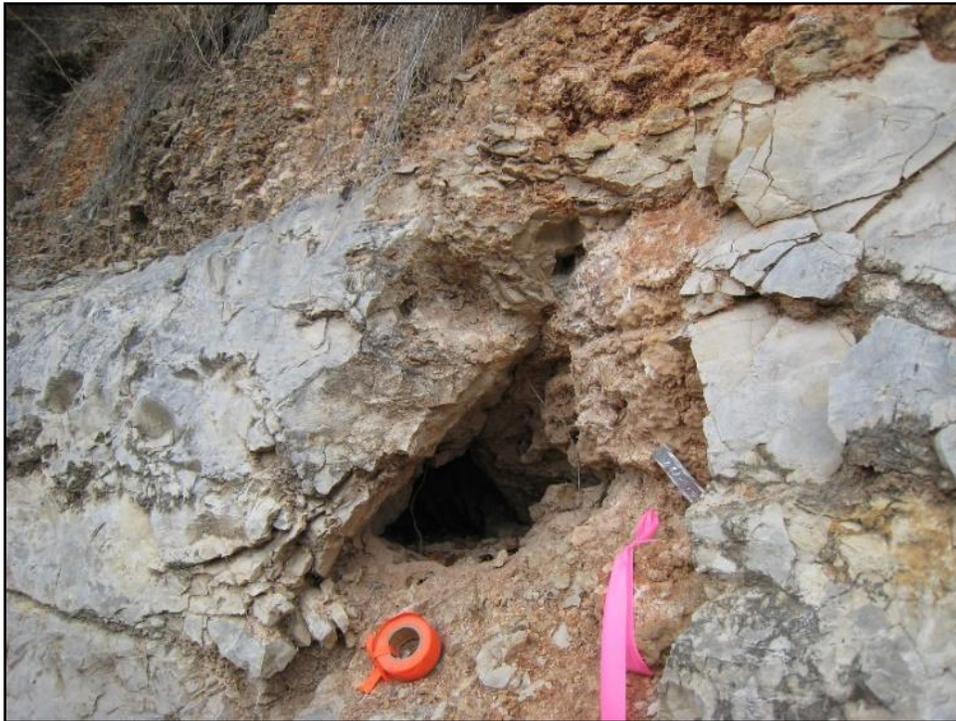
Figure 129. The larger solution-enlarged fracture of feature 1604-FZ6.

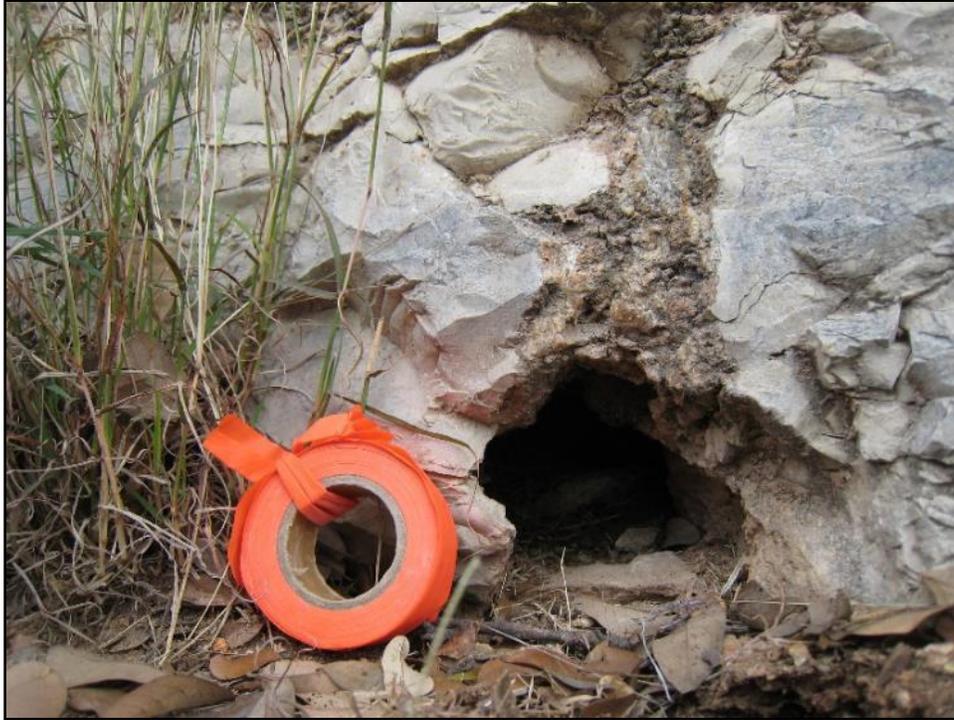
Figure 130. The smaller solution cavity of feature 1604-FZ6.

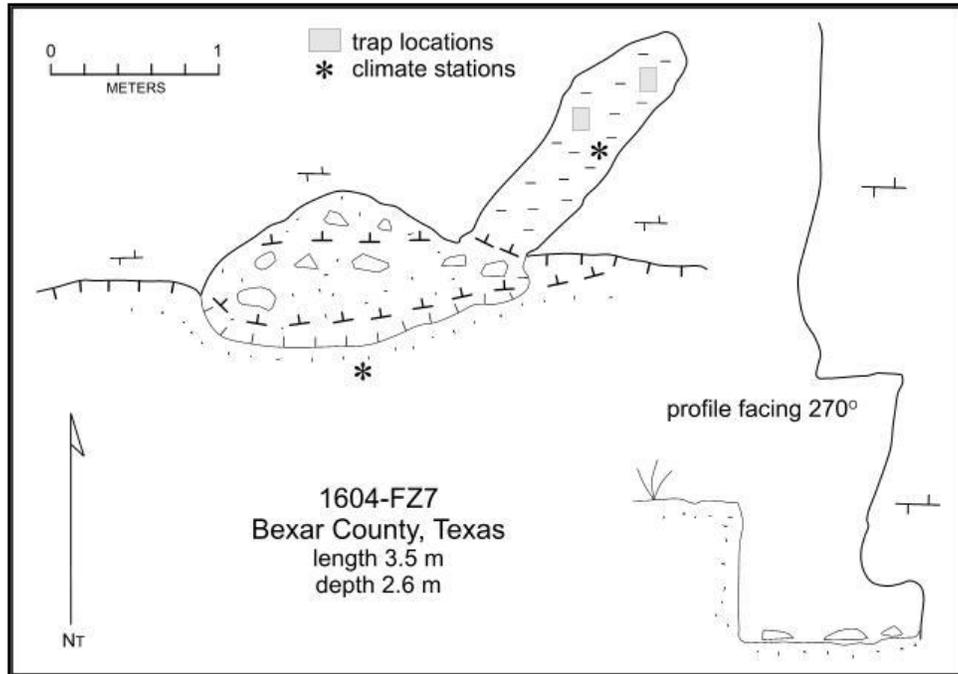
Figure 131. Map feature 1604-FZ7 after excavation.

This feature was located in the roadcut north of the westbound mainlanes of Loop 1604, west of Huebner Road (Figure 131 - Figure 134). It was evaluated on August 6, 2009 (TxDOT 2015a), November 29, 2017 (TxDOT 2018a), and August 19, 2019. It was a solution cavity that was 0.8 m (2.6 ft) wide by 1 m (3.3 ft) by 1 m (3.3 ft) high when originally examined in 2009. No voids could be seen extending from it; however, excavation on October 7, 2009 to remove loose rocks resulted in the removal of 1.2 m³ (43 ft³) of material, which appeared to be road base. The feature was excavated to a total width of 2.5 m (8 ft) by 3.5 m (11.5 ft) long by 2.6 m (8.5 ft) deep, where it ended in a mesocavernous drain. It was considered to be karst invertebrate habitat, and presence/absence surveys were conducted in October and November 2009, when a non-listed troglobitic species was found (*Brackenridgia* sp.). Presence/absence surveys were conducted in July 2019 (Table 18); notable fauna are summarized in Table 1. Troglobitic fauna encountered in 2019 included *Cicurina platypus/bullis* (Figure 135) whose identity was determined using mtDNA (Appendix C) and *Brackenridgia* sp.

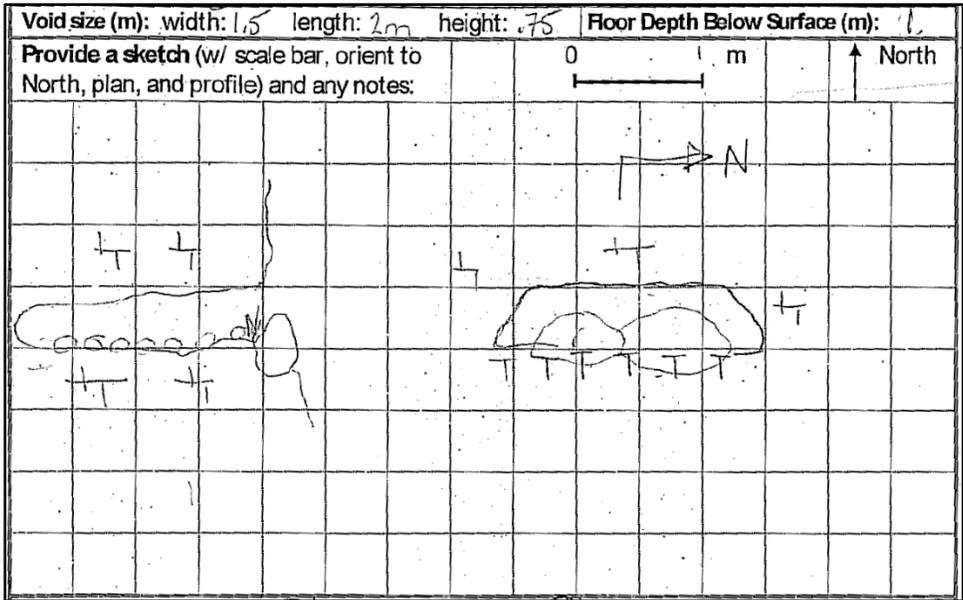
Figure 171. Field sketch of feature 1604-Q48.

This feature was located in a cliff under the westbound mainlanes of Loop 1604 and west of Interstate-10 (I-10). It was evaluated on December 15, 2009 and August 30, 2019 (Figure 171 - Figure 173). The feature was a solution cavity developed along a bedding plane, and measured 1.5 m (4.9 ft) wide, 2 m (6.5 ft) long, and 0.75 m (2.5 ft) high. The floor of the feature contained loose rocks, and fine, compact soil. The 2009 evaluation indicated that excavation was warranted, and that was conducted on March 10, 2010, at which time the feature was seeping water. The back of the feature was reached 2 m (6.6 ft) in. While the feature met the length criterion for habitat, the wide opening has made the feature desiccated and therefore determined not to provide potential habitat for listed karst invertebrate species, and no fauna surveys were performed (Table 2).

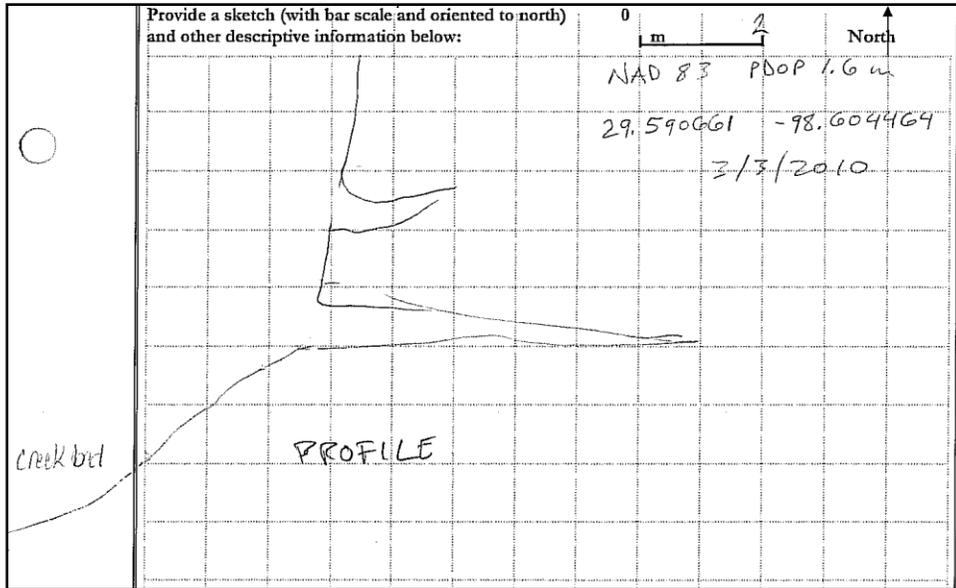
Figure 174. Profile sketch of feature 1604-R03.

Presence/absence surveys conducted in March and April 2010 detected no karst invertebrate species; however, hundreds of soft bodied ticks, which are known carriers of relapsing fever, were found in the cave. Presence/absence surveys were conducted in August 2019 by inserting traps on long poles into the cave so that surveyors would not have to risk entry (Table 26); however, no troglobites were found (Table 1, Table 27).

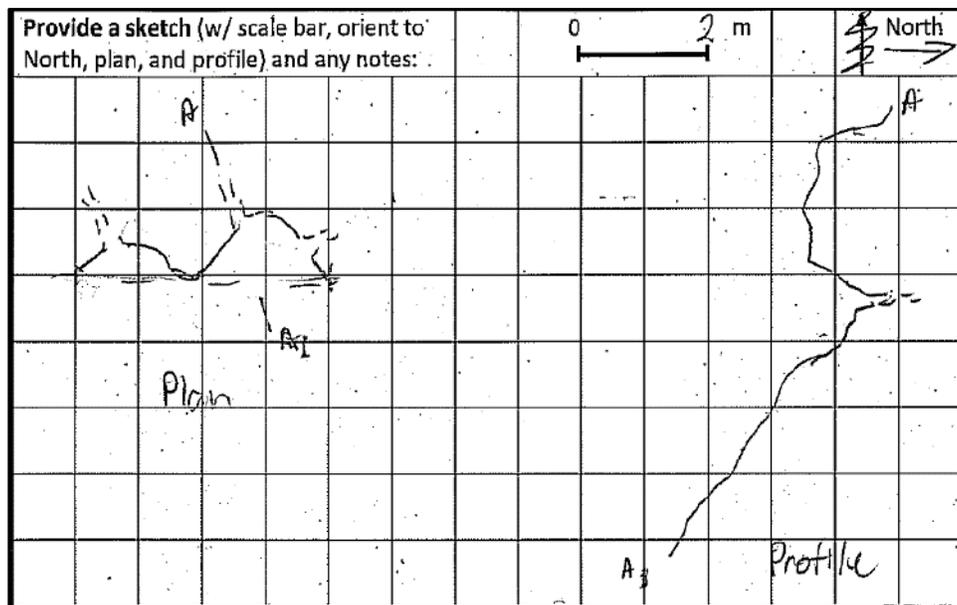
Figure 178. Field sketch of feature 1604-R04.

Presence/absence surveys were conducted in August and September 2019 (Table 28); however, no troglobites were found (Table 1, Table 29).

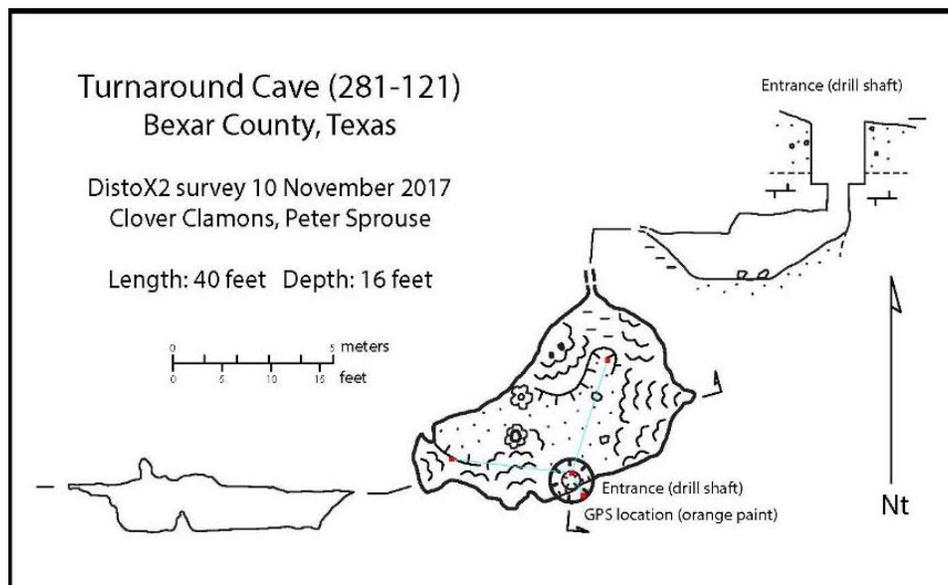
Figure 189. Cave map of feature 282-121.

This feature was considered potential karst invertebrate habitat due to being humanly enterable, being similar to nearby caves, and its extent (Table 2). Presence/absence surveys were conducted in November and December 2017; notable fauna are summarized in Table 1 and Table 35. Karst invertebrate habitat was confirmed with the observation of troglobitic silverfish (*Texoreddellia* sp.); however, no listed species were detected. After surveys were complete, the cave was destroyed by the installation of the flyover pier (Figure 192). The construction activities were covered under the 281 Biological Opinion (USFWS 2015b).

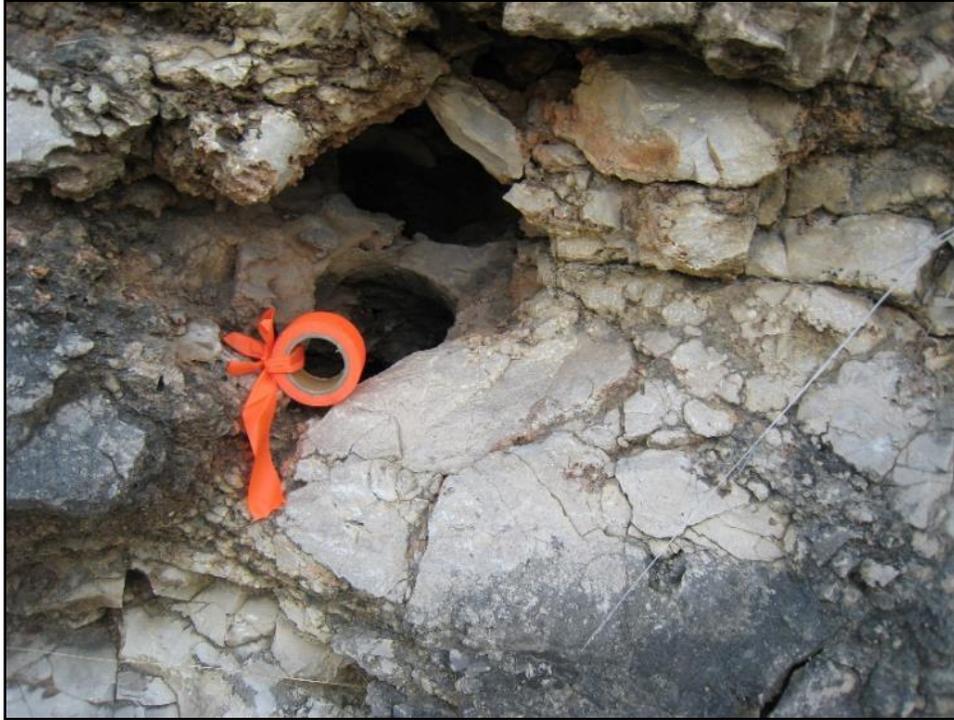
Figure 262. Interior of feature HB-038.

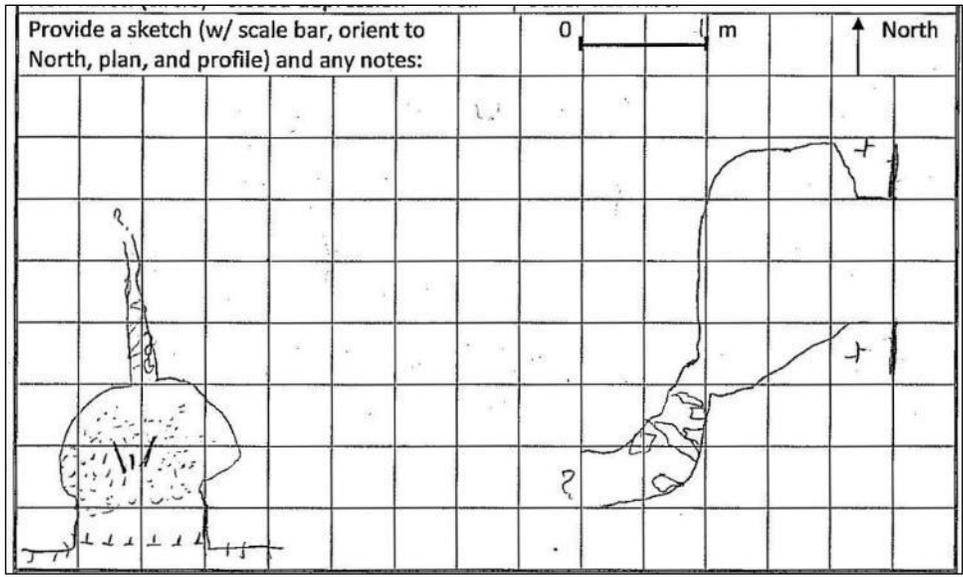
Figure 263. Field sketch of feature Junction 26 North B.

This feature was located on the south side of the eastbound Loop 1604 mainlanes, west of US 281. It was encountered during utility trench excavations for the construction of the Loop 1604/US 281 interchange in 2011 (Figure 263 - Figure 266). It was a conduit formed along a fracture. Some rocks were removed from the entrance to the feature, enabling biologists to partially enter it (Figure 264) and determine that it was humanly-traversable for about 1.5 m, then it continued an unknown distance at sub-human size (Figure 265). The feature was not excavated further because potential karst invertebrate habitat suitable for sampling was present (Table 2). Biological surveys were performed on November 11, 18, and 25, 2011. Baited glue traps retrieved from this feature contained subterranean silverfish (*Texoreddellia* sp.) and an adult male eyeless spider (*Cicurina* sp., Figure 266), which was examined by taxonomist James Cokendolpher (Texas Tech University), but the lack of comparative material or a key for males of the genus kept the specimen from being identified using morphology. The original report provides details of the setting (Zara 2012a). The species in this feature and others nearby were addressed under informal consultation number 21450-2010-I-0085 when the Alamo Regional Mobility Authority constructed direct connectors for the 1604 and 281 intersection. The feature was destroyed or sealed as part of the construction process, images of the likely location are available (TxDOT 2015a); the feature was not available for 2019 surveys. In 2020, the material collected in 2011 was analyzed using mtDNA and found to align with *Cicurina puentecilla*, a non-listed species (Appendix C).
