Karst Technical Report

Loop 1604 from SH 16 to I-35,
Bexar County, Texas

Prepared by: Zara Environmental LLC and JACOBS
Date: 11 March 2020

**Karst Technical Report Loop 1604 from SH 16 to I-35, Bexar County, Texas
CSJs: 2452-02-083, 2452-03-087, 2452-03-113**

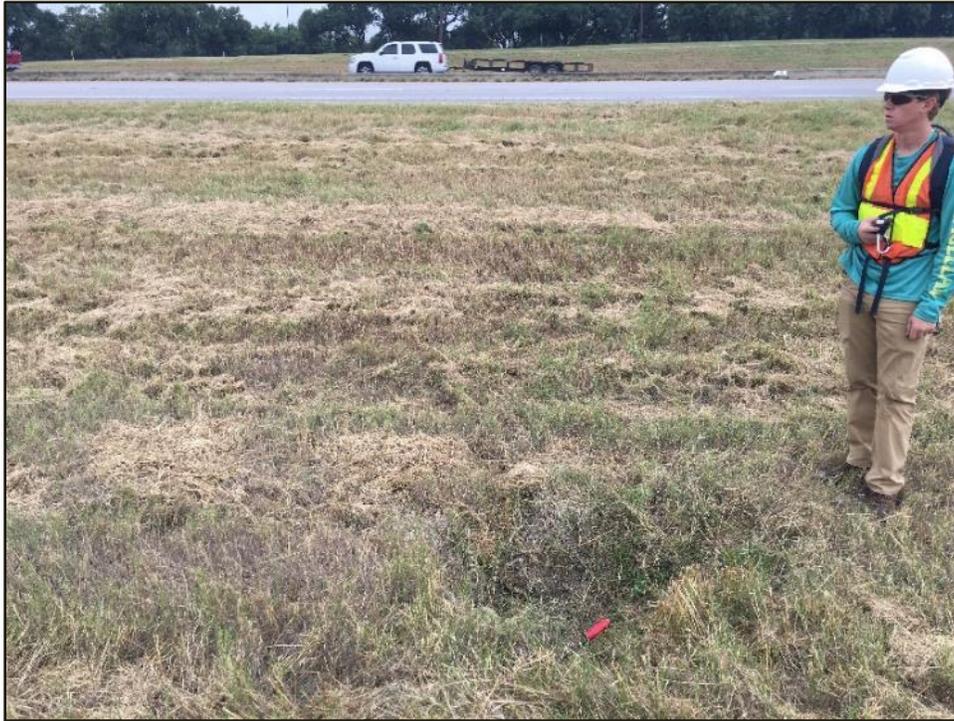
Figure 267. Overview of feature LOOP-005.

This feature was located in a median south of the eastbound mainlanes of Loop 1604 and east of Judson Road (Figure 267 - Figure 269). It was evaluated on June 4, 2019. The feature was a sinkhole that measured 2.5 ft in diameter and 0.8 ft deep. This feature contained loose soil, gravel, and vegetation. Reconnaissance excavation revealed a bedrock floor. This feature was determined not to provide potential habitat for listed karst invertebrate species and no fauna surveys were performed (Table 2).

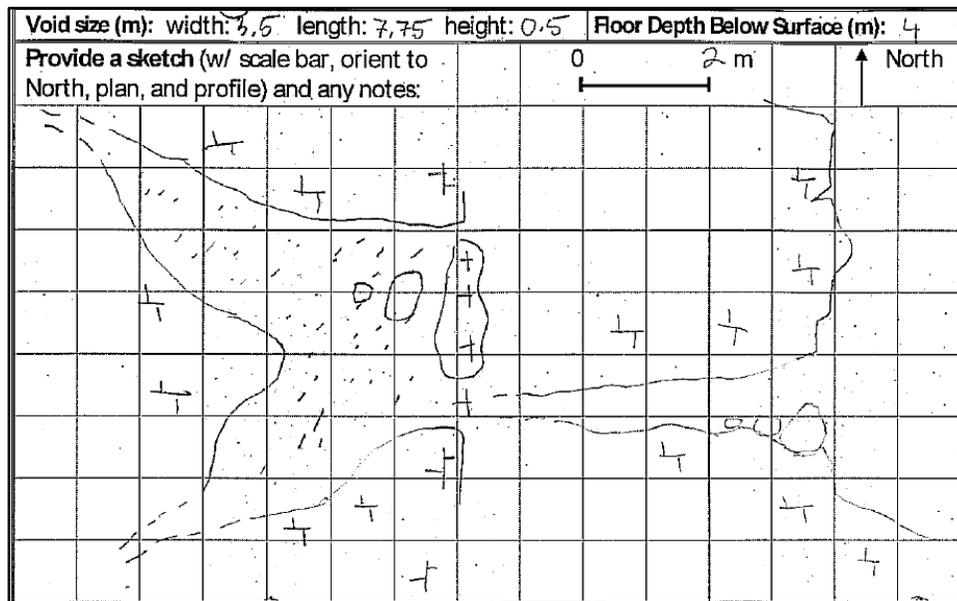
Figure 281. Field sketch of feature LOOP-102 (Fiesta Cave).

Feature LOOP-102 was considered potential karst invertebrate habitat due to length, an enterable void, and modern soil (Table 2). Presence/absence surveys were conducted in July and August 2019 (Table 38); notable fauna are summarized in Table 1. Troglotic species recorded from this feature include *Brackenridgia* sp. No listed species were observed or collected.

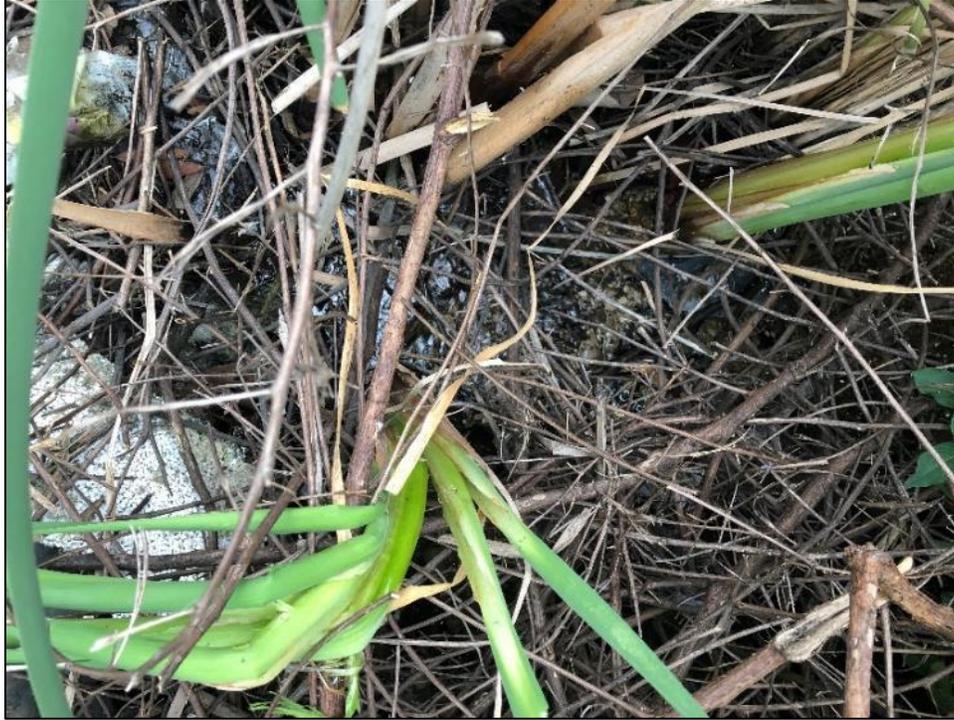
Figure 289. Close-up of feature LOOP-104.

This feature was located east of the northbound mainlanes of I-10, south of Loop 1604 (Figure 287 - Figure 289). It was evaluated on June 4, 2019. The feature was a non-enterable spring or sewage leak approximately 0.9 m (3 ft) wide and 0.01 m (0.02 ft) high with an unknown length extending underneath concrete. This feature had no mesocavernous voids and contained soft loose soil and vegetation which had a foul odor when disturbed. This feature was determined not to provide potential habitat for listed karst invertebrate species and no fauna surveys were performed (Table 2).

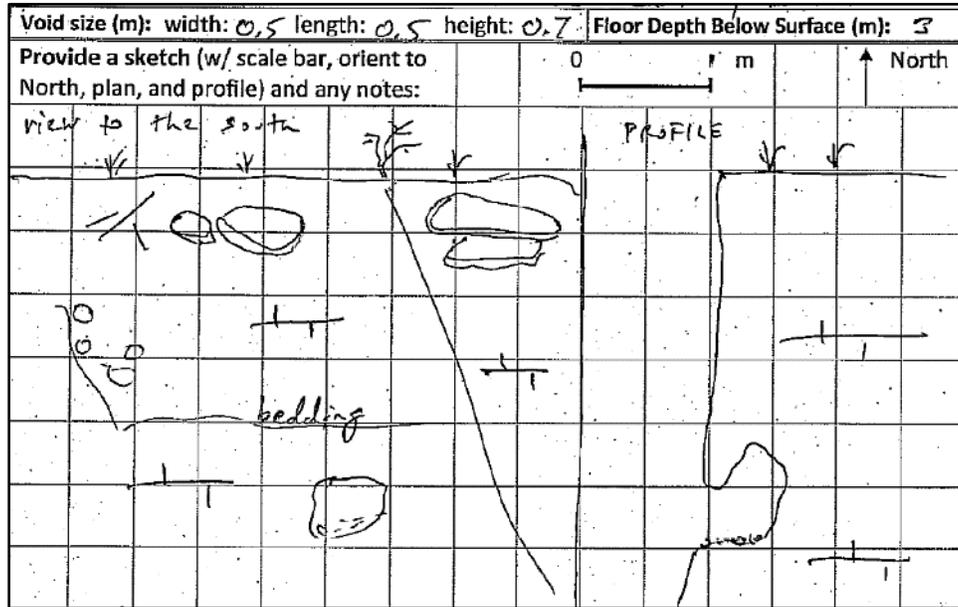
Figure 297. Field sketch of feature LOOP-110.

This feature was located in a roadcut south of the eastbound mainlanes of Loop 1604, east of Gold Canyon (Figure 297 - Figure 299). This feature was evaluated on July 24, 2019. This solution cavity was 0.50 m (1.6 ft) wide by 0.50 m (1.6 ft) long by 0.7 m (2.3 ft) tall. This feature contained exposed bedrock, calcite surfaces, and some gravel-sized rocks. There was no airflow and no fauna were observed, and it was found to definitively end. This feature was determined not to provide potential habitat for listed karst invertebrate species and no fauna surveys were performed (Table 2).

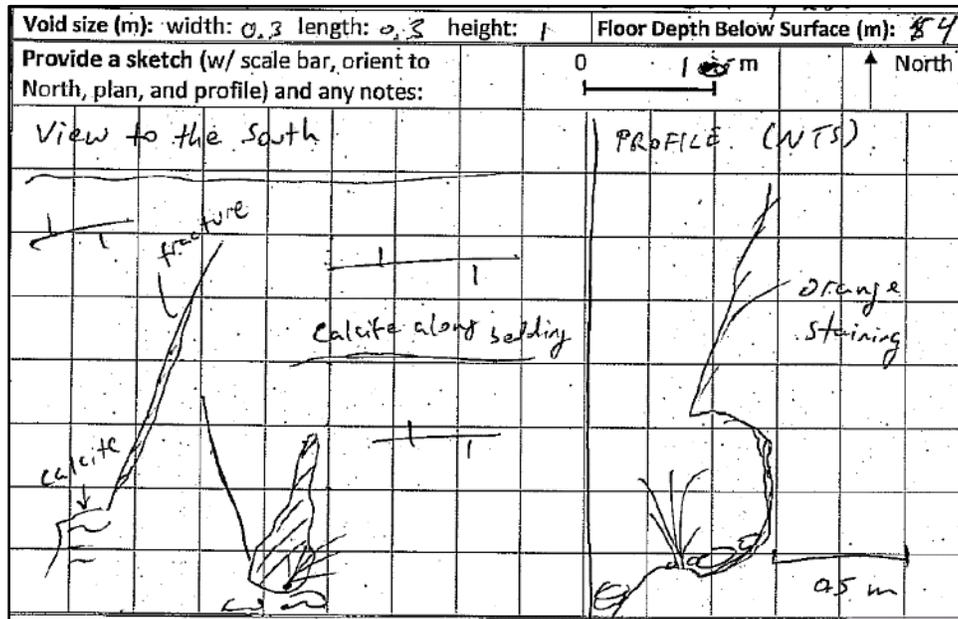
Figure 300. Field sketch of feature LOOP-111.

This feature was located in a roadcut south of the eastbound mainlanes of Loop 1604, west of Gold Canyon Road (Figure 300 - Figure 302). It was evaluated on July 24, 2019. This solution cavity was 0.3 m (1.0 ft) wide by 0.3 m (1.0 ft) long by 1.0 m (3.3 ft) tall (Figure 300 - Figure 302). It contained exposed bedrock with orange staining, gravel-sized rocks, and some grass. This feature was determined not to provide potential habitat for listed karst invertebrate species and no fauna surveys were performed (Table 2).

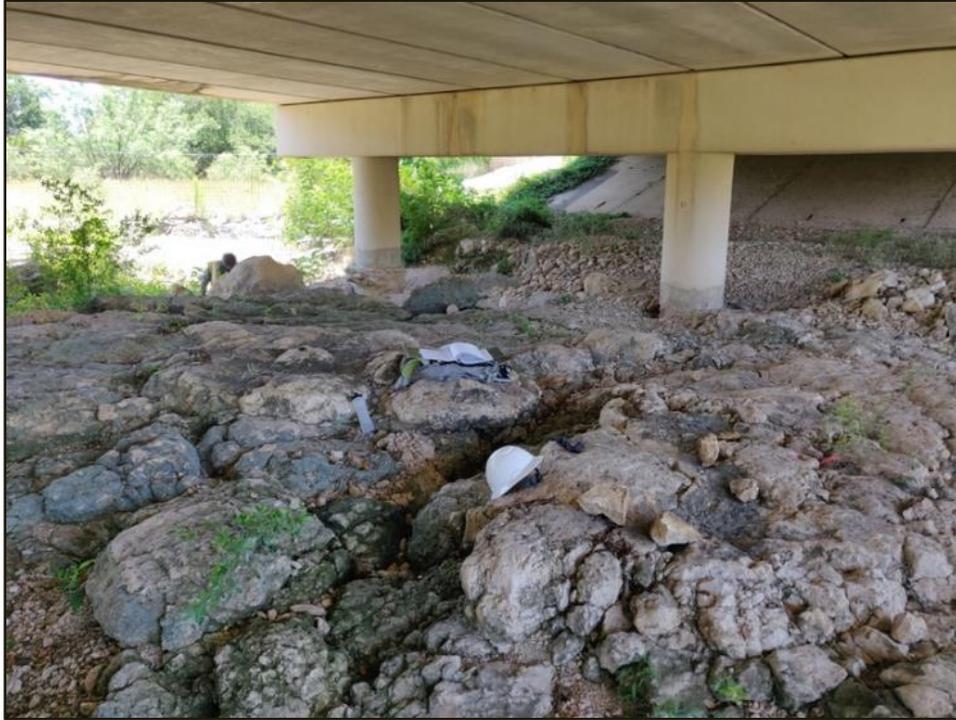
Figure 309. Overview of location of feature LOOP-202.

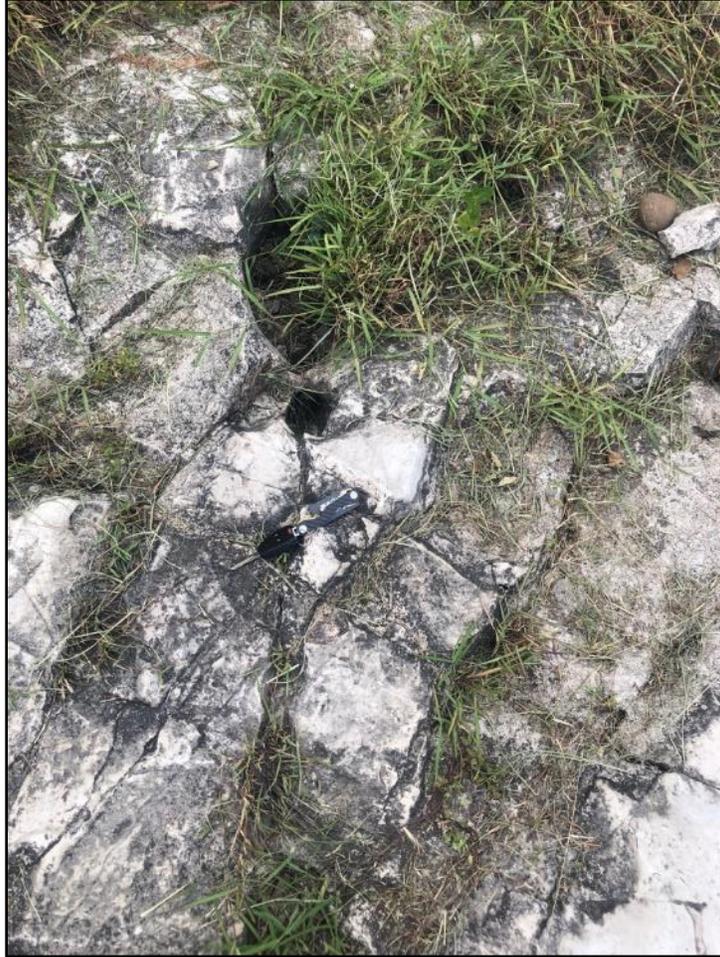
Figure 312. Close-up of feature LOOP-204.

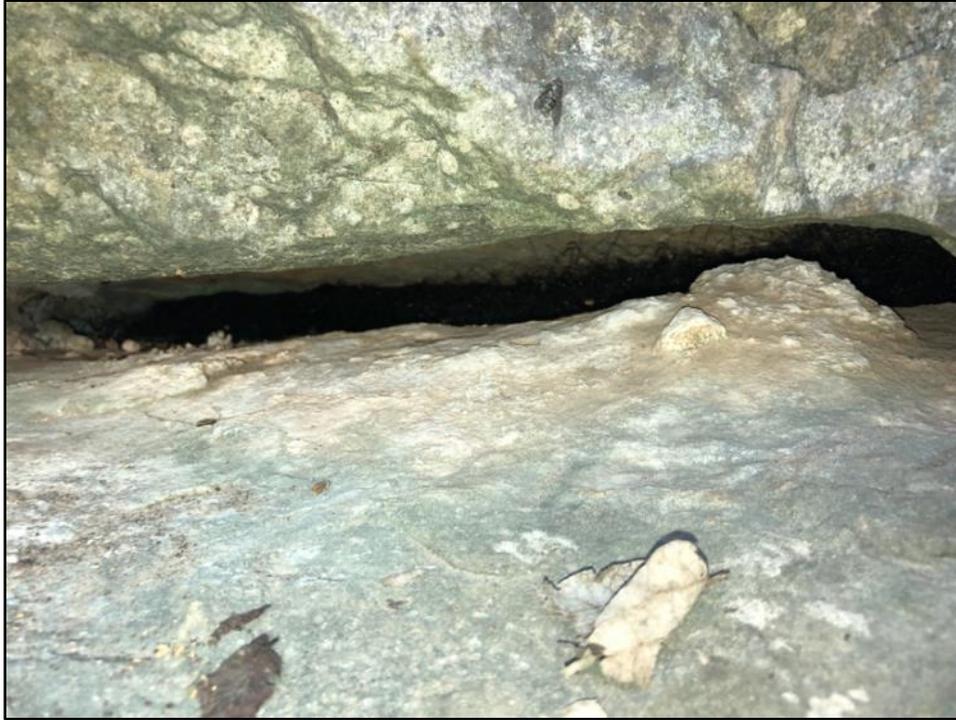
Figure 318. Interior of enlarged bedding plane at feature LOOP-213.
