Surface Water Resources Technical Report

Loop 1604 from State Highway (SH) 16 to Interstate Highway (I-) 35

Bexar County, Texas

August 2020

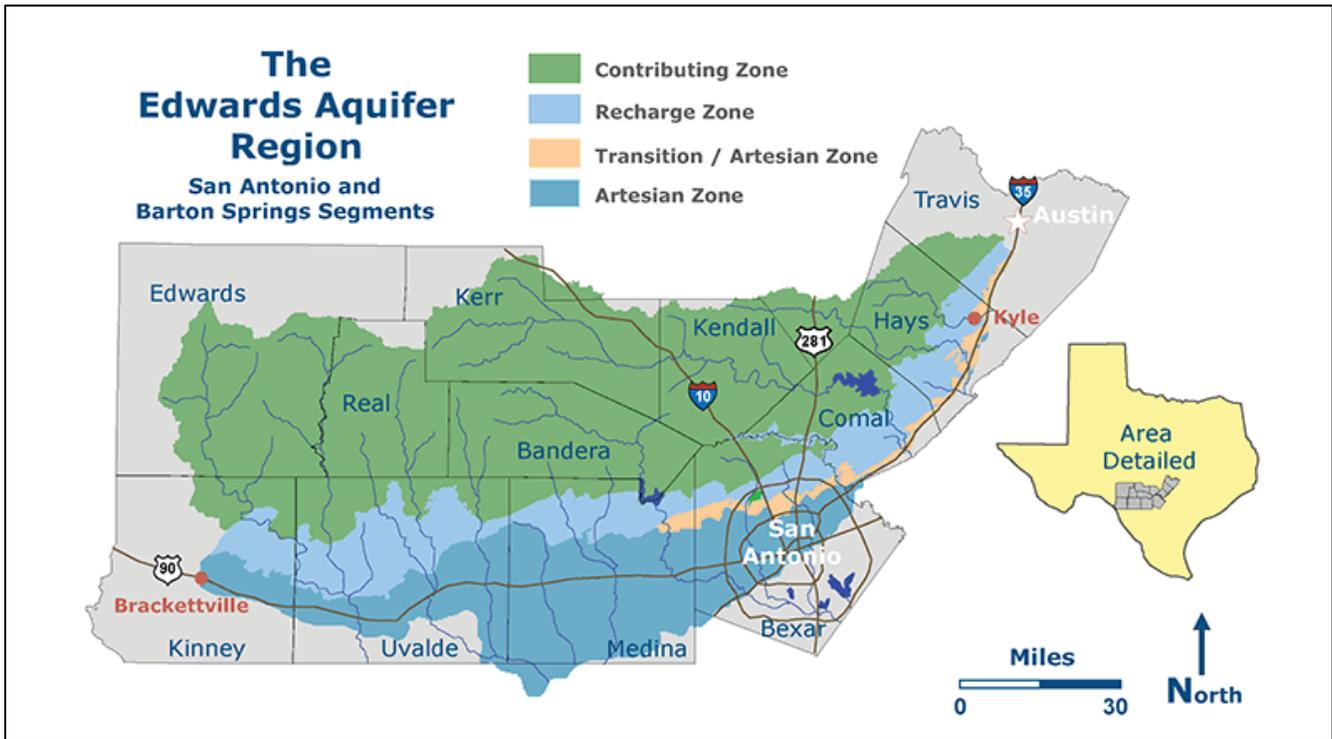
Exhibit 1: Edwards Aquifer Zones

Exhibit 1 shows the zones of the Edwards Aquifer.

The Edwards Aquifer is the most productive and most regulated of the aquifers within the project area. Collectively, the Georgetown, Person, and Kainer Formations (a.k.a. Edwards limestones) are the host rocks for the Edwards Aquifer. Where the Edwards limestones are exposed at the surface, the karst terrain is characterized by the presence of sinkholes, sinking (losing) streams, and caves. Underground, water moves through highly permeable fractures and voids, which results in prolific wells but also reduces the aquifer's ability to filter potential contaminants. This characteristic makes the aquifer's water quality highly dependent on the quality of surface water flowing over the recharge zone. The project would maintain compliance with the Edwards Aquifer rules by submitting an Edwards Aquifer WPAP prior to construction. The studies for this project include more detailed engineering and environmental reports on groundwater with an emphasis on the Edwards Aquifer.
