Hazardous Materials Initial Site Assessment (ISA)

SH 72 from FM 237 to US 87

CSJs: 0270-01-051, 0270-10-014

Hazardous Materials Initial Site Assessment (ISA) Report

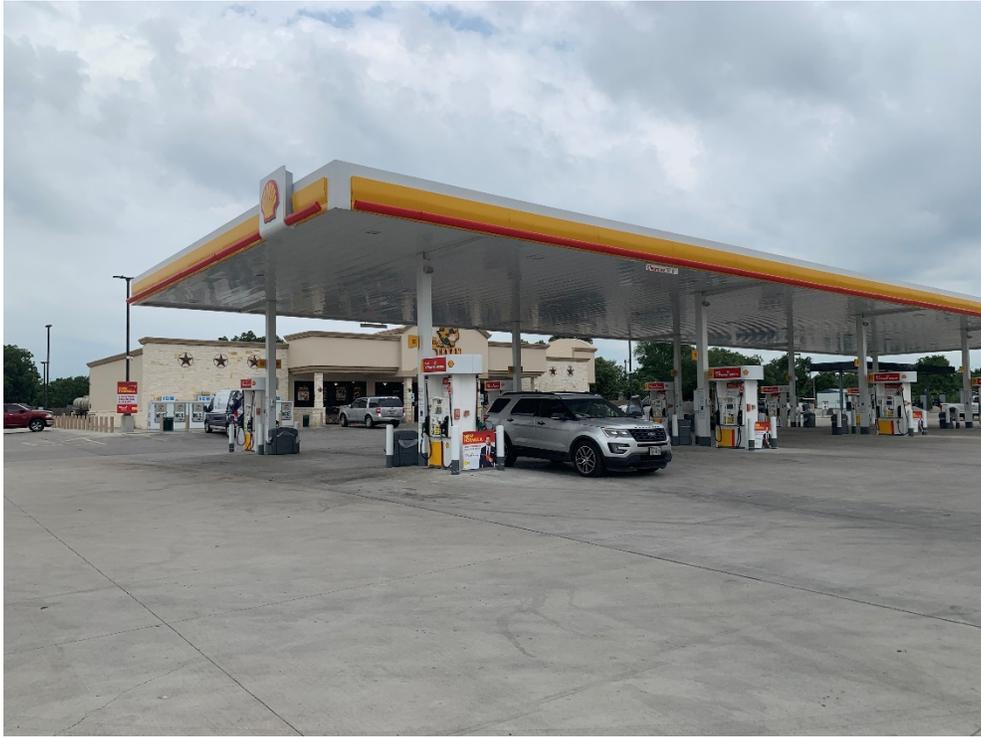
PHOTO 1: MAP ID #1 IS THE TEXAN 5 RETAIL REFUELING STATION. FACING SOUTH.

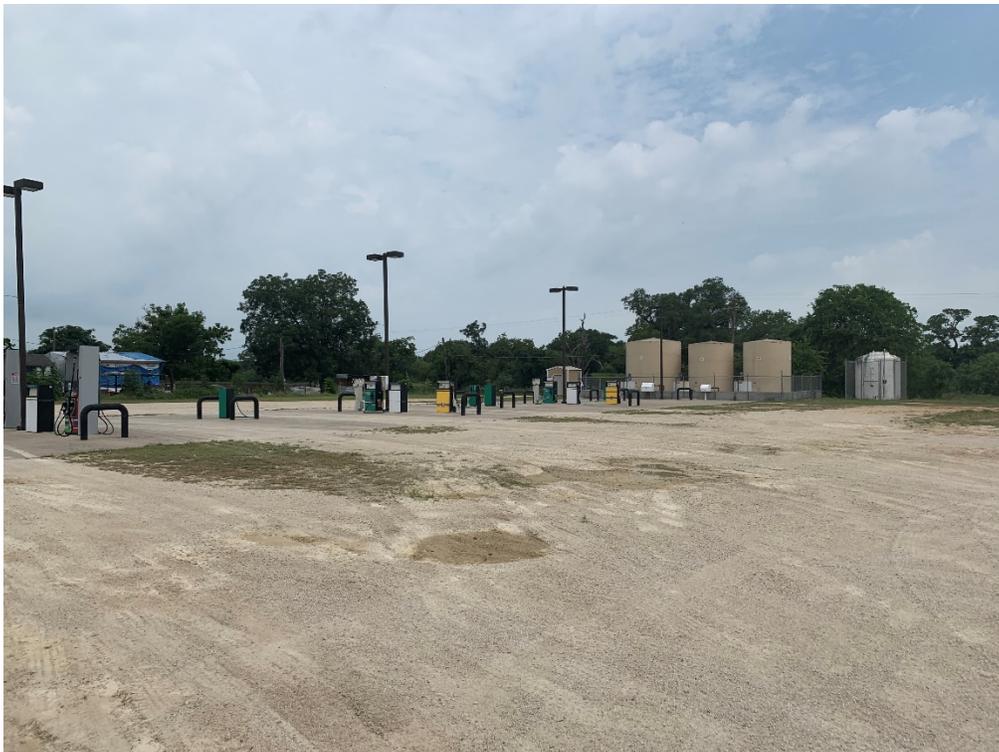
PHOTO 2: THIS SITE APPEARS TO BE THE QUERO GASCARD STATION. THE ASTS LISTED CAN BE SEEN ABOVE IN THE BACKGROUND. VIEWING NORTH.

Map ID #4 is identified as Quero Gascard 270323 and is located at 1522 State Highway 72 in Cuero, Texas. This PST site is listed for fleet refueling for Quero Gascard. Three ASTs are registered for this location that are used for diesel and gasoline. This property adjoins the project area and additional ROW is proposed. Due to the distance of the ASTs from the proposed ROW, further investigation for this site is not recommended.

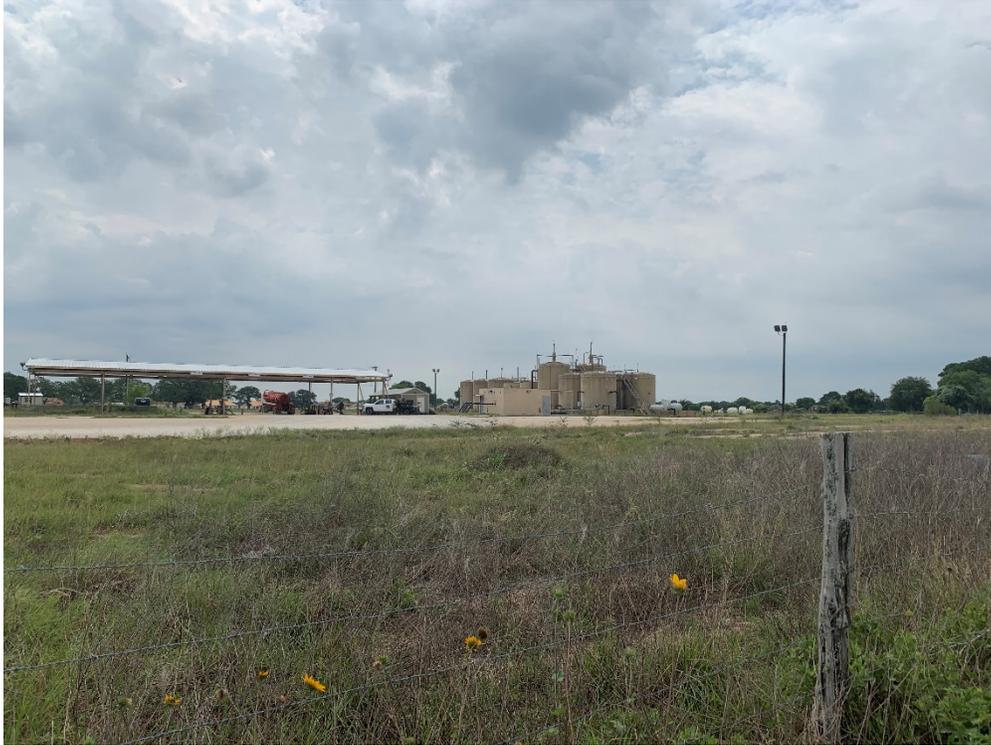
PHOTO 3: AN OILFIELD SERVICES COMPANY WITH ABOVE GROUND STORAGE TANKS WAS NOTED ACROSS FROM MAP ID #4 TO THE SOUTH. VIEWING SOUTHEAST.

Explain Unresolved or Resolved Issues: While conducting the site investigation, an oil/gas well, an oilfield services site, and a service company designated "AST site" were identified adjacent to the project. The ASTs associated with the oilfield services site and the "AST site" did not appear to be within the ROW and would not impact the project (Attachment 1, Figure 2).	
<input type="checkbox"/> Unresolved <input type="checkbox"/> Resolved <input type="checkbox"/> No Issue <input checked="" type="checkbox"/> N/A	Interview Concerns: These concerns are associated with any hazardous material issues discovered during an interview listed in Section 7, that were not previously discovered during the database search in Section 5.1, during the current and past land use review in Section 4, or during the Site Survey in Section 6.1. Note: For ECOS IIR development, the Available Contaminated Media would be “Other”.

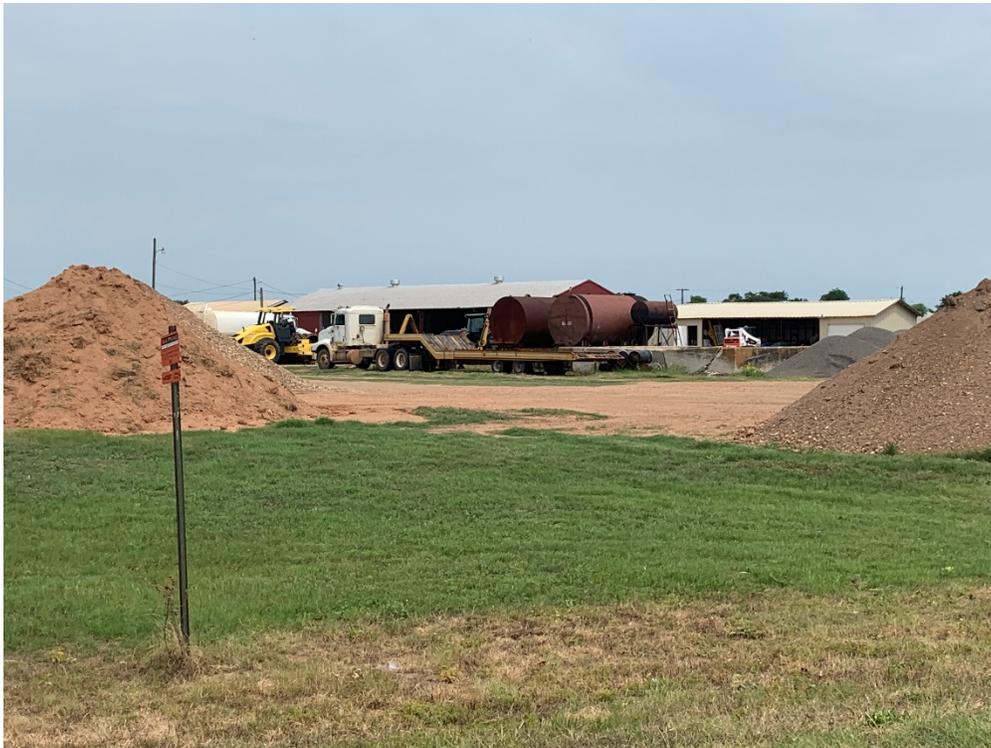
PHOTO 4: ASTS WERE NOTED IN THE YARD OF THE FACILITY LOCATED WEST OF MAP ID #2. VIEWED NORTH.

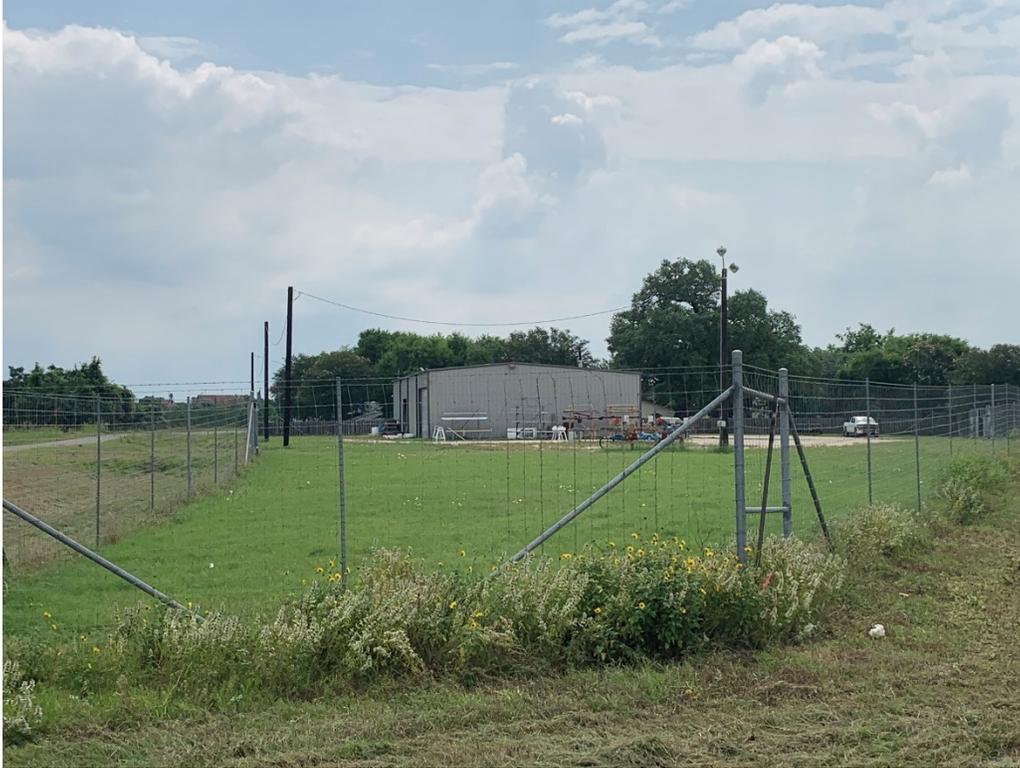
PHOTO 5: MAP ID #2 WAS LISTED AS SPITFIRE SERVICES COMPANY. VIEWED NORTHEAST.

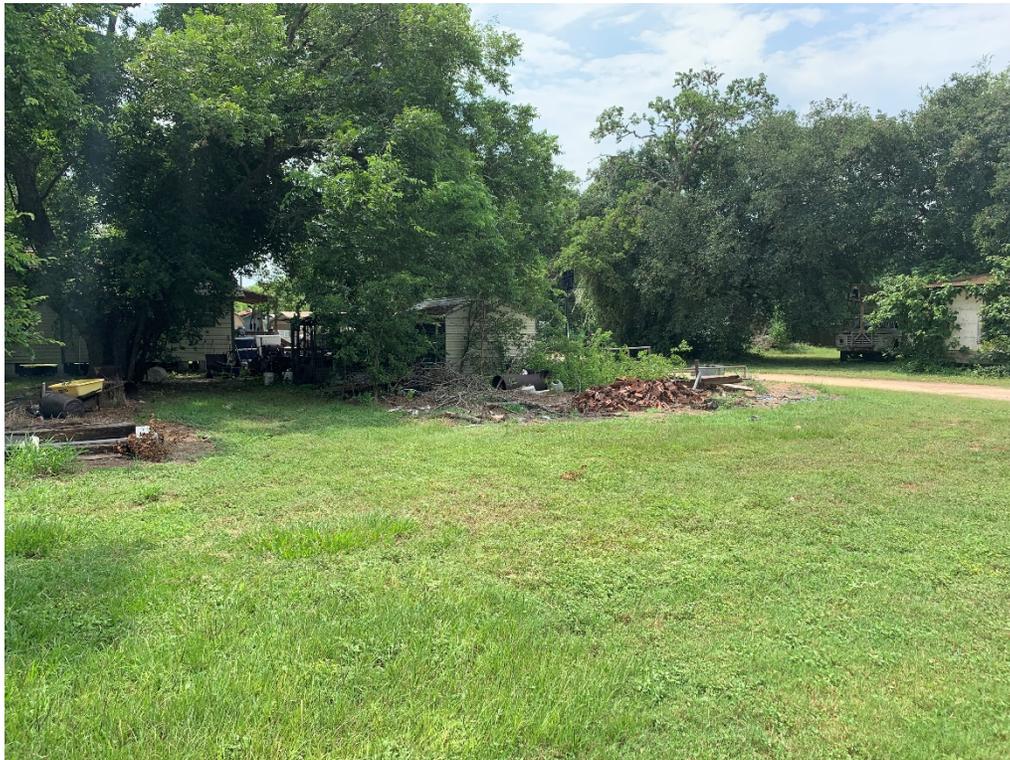
PHOTO 6: MAP ID #3 IS AN ERNS SITE WHICH WAS NOTED FOR A VAC TRUCK DUMPING INTO A HOLE IN THE GROUND. EVIDENCE WAS NOT PRESENT DURING THE SITE VISIT BUT DEBRIS WAS NOTED. VIEWED SOUTHEAST.

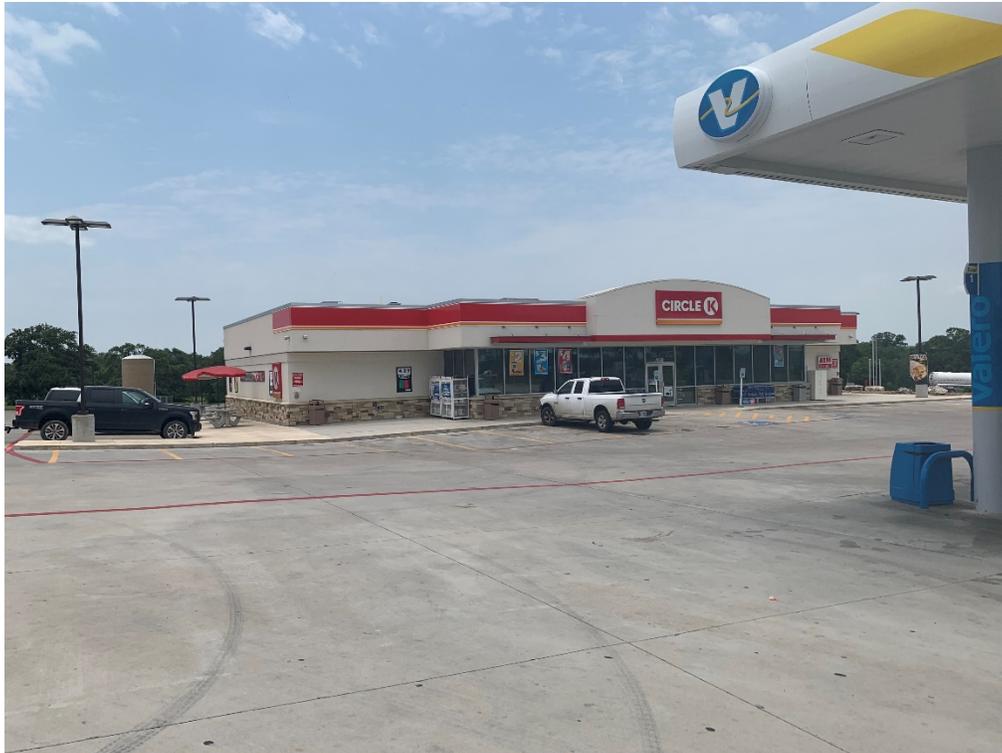
PHOTO 7: MAP ID #5 IS LISTED AS AN ACTIVE RETAIL GAS STATION. VIEWING WEST.

Map ID #5 is identified as Corner Store 1545 and is located at 4150 State Highway 72 in Cuero, Texas. The Corner Store 1545 is an active retail gas station with three active USTs. This site adjoins the project area and minimal ROW is proposed. Due to the distance of the USTs from the proposed ROW, further investigation is not recommended.

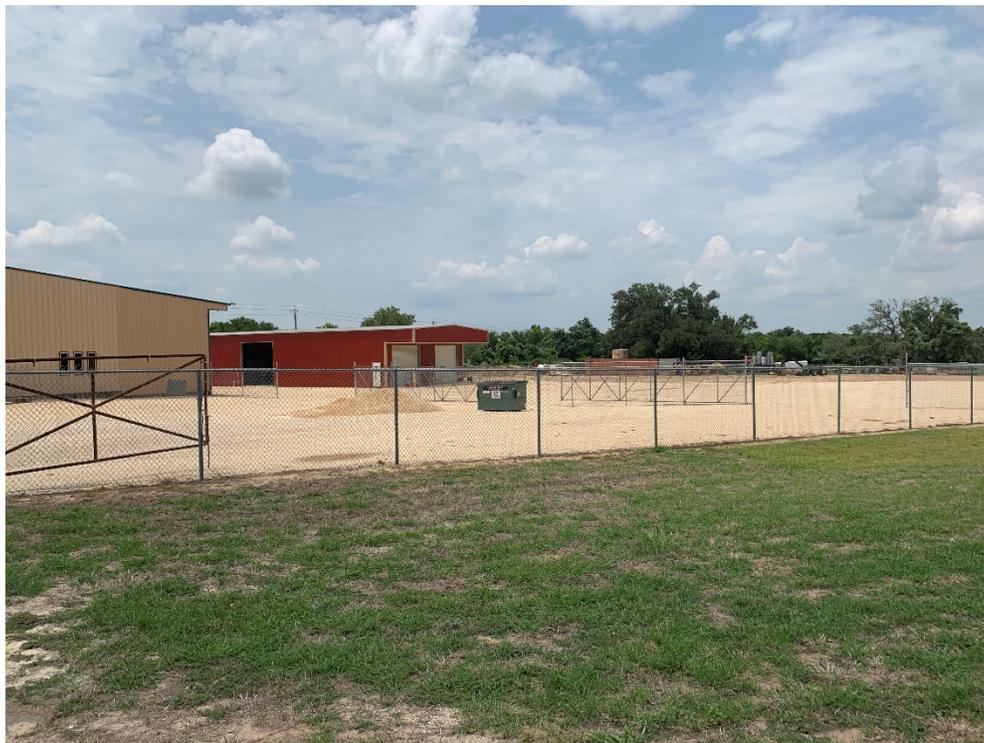
PHOTO 8: AN UNMAPPED AST SITE WAS NOTED ADJACENT TO THE ROW NEAR YORKTOWN, TEXAS. VIEWED NORTHWEST.

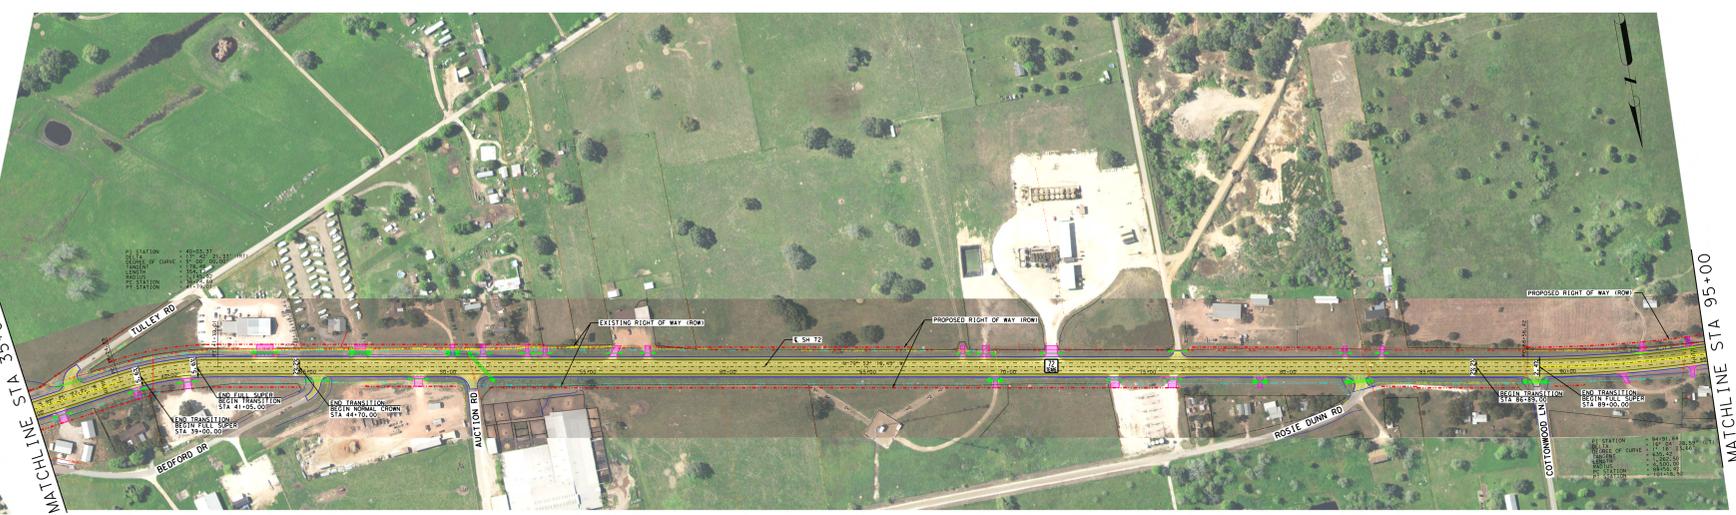
SH 72
 SCHEMATIC LAYOUT
 F-12040

YOAKUM DISTRICT ENGINEER
 DIRECTOR OF TRANSPORTATION,
 PLANNING & DEVELOPMENT
 DESIGN SPEED 50 MPH
 FUNCTIONAL CLASS MINOR ARTERIAL
 FROM US 87 TO US 87/77A
 2019 = 9,500
 2049 = 18,100
 ADT SH 72 FROM FM 237 TO US 87
 2019 = 5,100
 2049 = 9,500

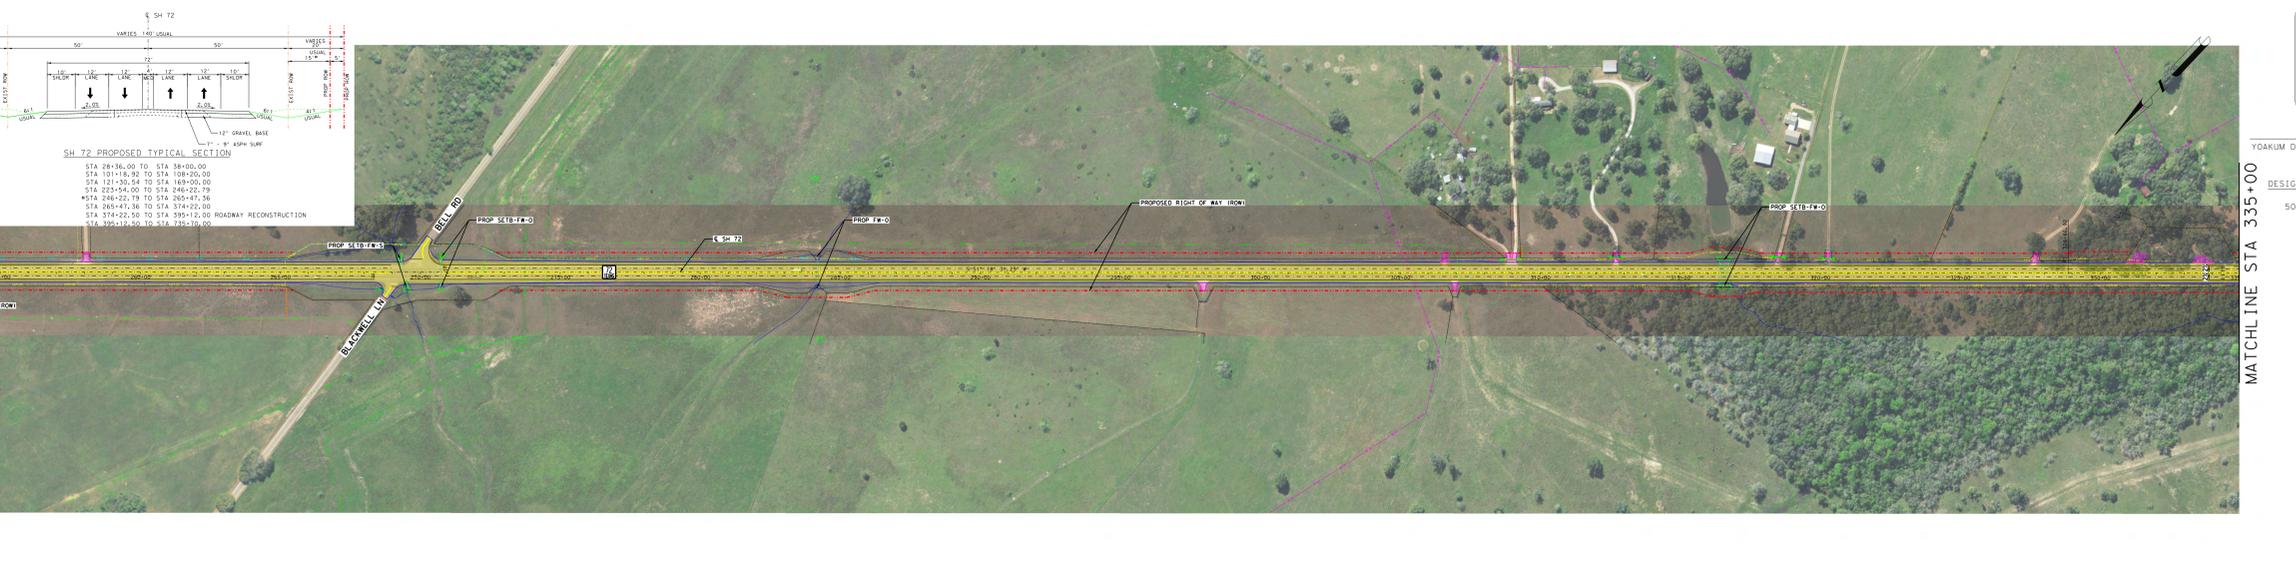
F-12040
SH 72 SCHEMATIC LAYOUT
 SHEET 2 OF 5
 PROJECT NO. COUNTY SHEET NO.
 6 DEWITT 160
 DATE DIST. COUNTY
 0270 01 051, ETC SH 72

YOAKUM DISTRICT ENGINEER
 DIRECTOR OF TRANSPORTATION,
 PLANNING & DEVELOPMENT
 DESIGN SPEED FUNCTIONAL CLASS FROM US 87 TO US 87/77A
 50 MPH MINOR ARTERIAL
 2019 = 9,500
 2049 = 18,100
 ADT SH 72 FROM FM 237 TO US 87
 2019 = 5,100
 2049 = 9,500

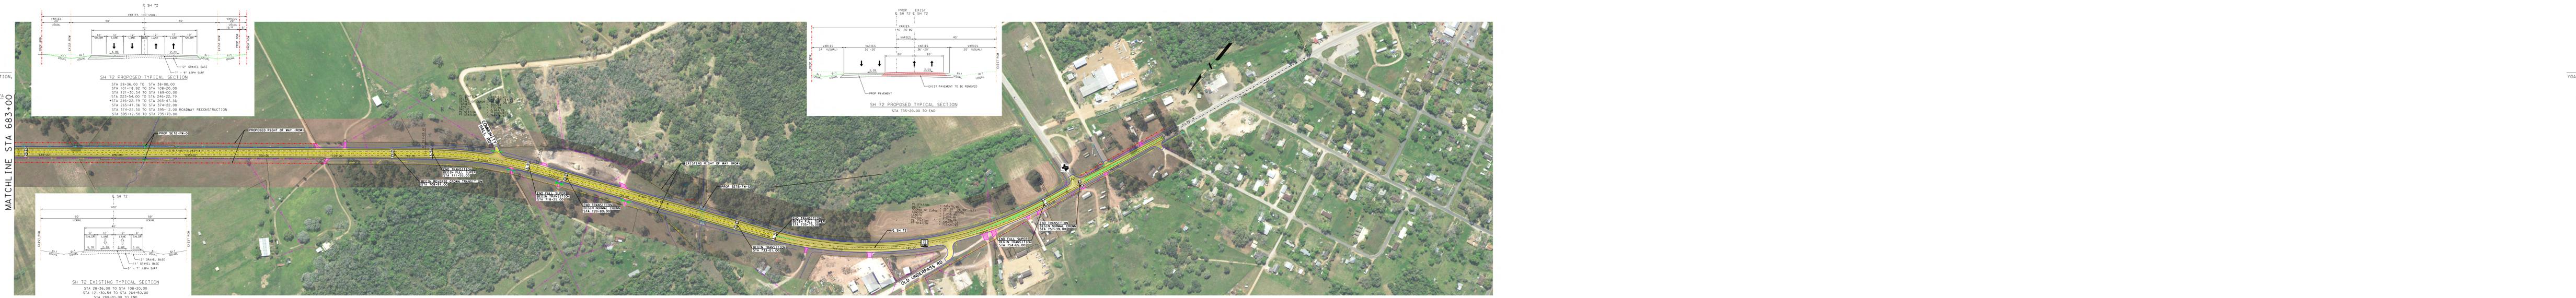
SH 72 SCHEMATIC LAYOUT

SH 72
 CSH 0270-01-051, ETC.
 PRELIMINARY DESIGN SCHEMATIC
 COUNTY
 LIMITS: FM 237 TO US 87/77A
 PROJECT LENGTH: 14.50 MILES
YOAKUM DISTRICT

YOAKUM DISTRICT ENGINEER
 DIRECTOR OF TRANSPORTATION,
 PLANNING & DEVELOPMENT
 DESIGN SPEED FUNCTIONAL CLASS FROM US 87 TO US 87/77A
 50 MPH MINOR ARTERIAL 2019 = 9,500
 2049 = 18,100
 ADT SH 72 FROM FM 237 TO US 87
 2019 = 5,100
 2049 = 9,500
