# Appendix B

## Existing Safety Analysis

FM 76 (North Loop Drive) Feasibility Study

November 2023

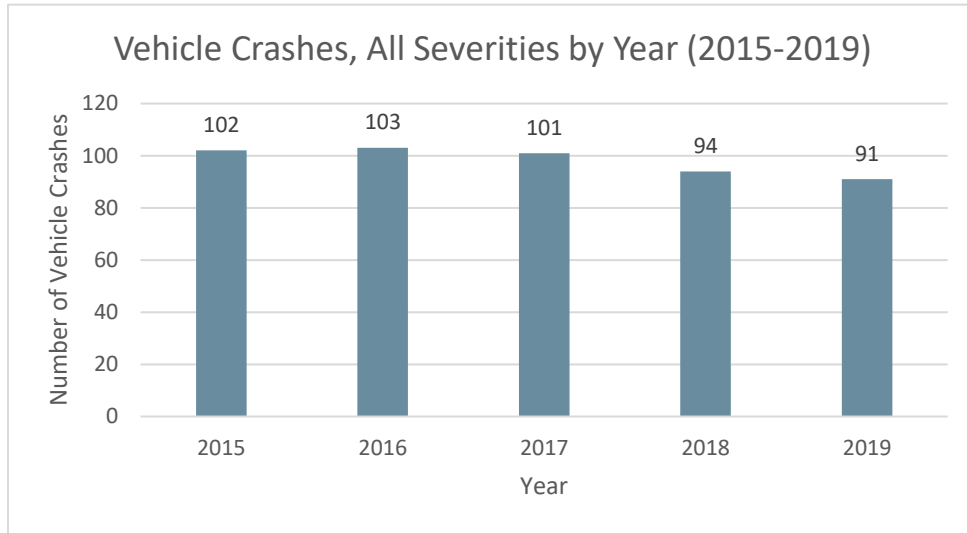
**Figure 2: Crashes by Year**

**Figure 2** shows the yearly trend of crashes within the corridor between 2015 and 2019. The trend indicates a fairly consistent number of crashes from 2015 to 2017 with a decline in the years 2018 and 2019.

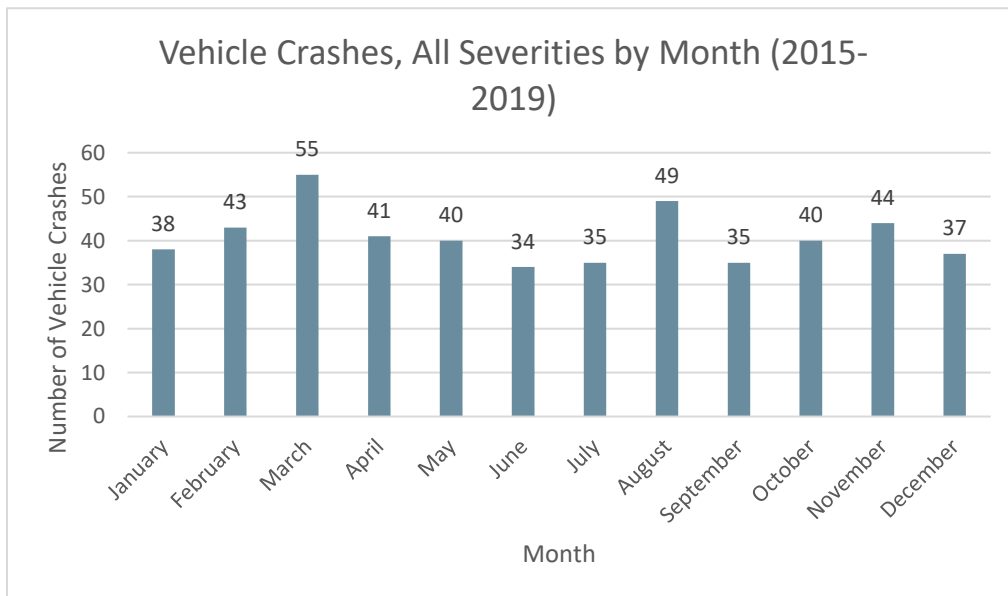
**Figure 3: Crashes by Month**

**Figure 3** shows that between 2015 and 2019, the month with the highest number of crashes on the FM 76 corridor from Horizon Blvd. to Fabens Rd. was March.

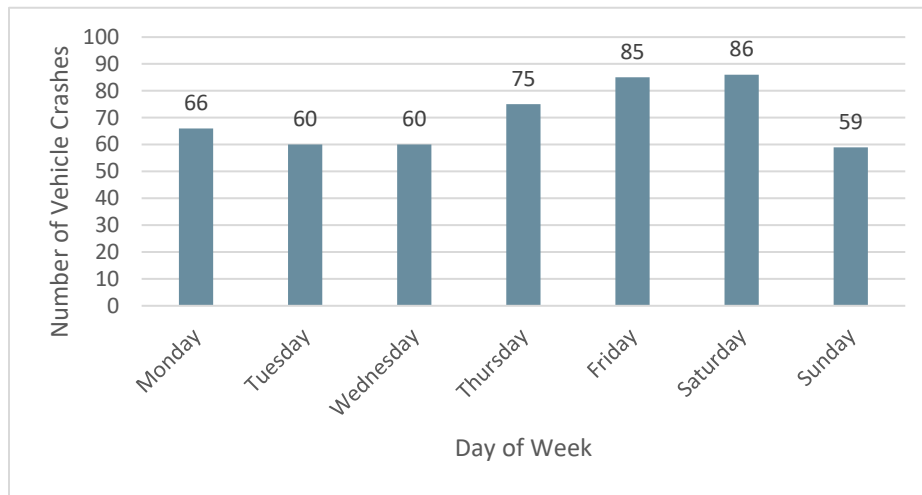
Figure 4: Crashes by Day of Week

Figure 4 shows that Fridays and Saturdays witnessed the highest number of crashes among all the days of the week, about 23 and 24 percent more than the weekday average, respectively.

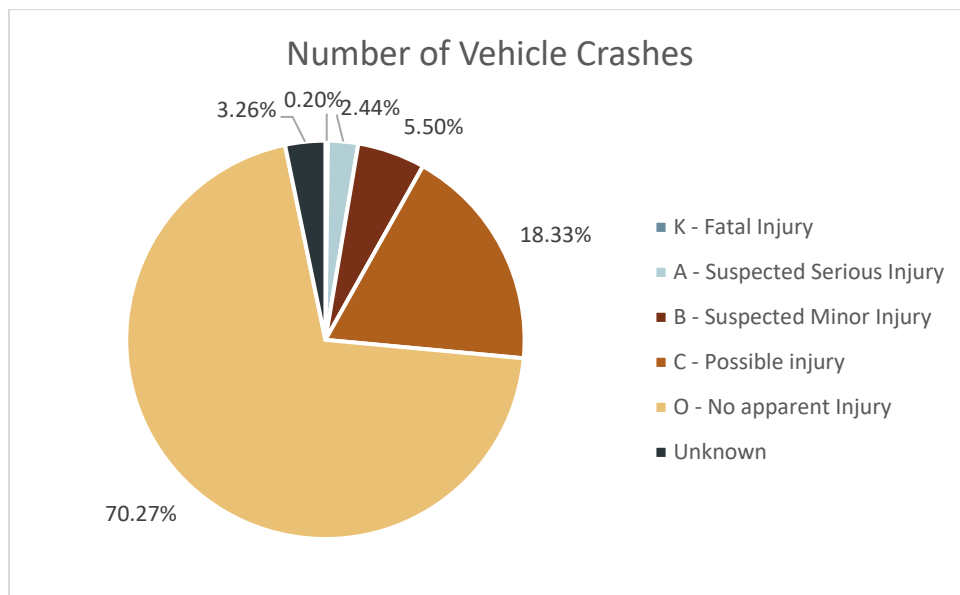
Figure 5: Crashes by Injury Severity

Figure 5 shows that of the 491 crashes on FM 76 between Horizon Blvd. and Fabens Rd., approximately 70% did not result in an apparent injury and approximately 24% resulted in a suspected minor or possible injury. Suspected serious injury and fatal injury crashes represent less than 3% of total crashes.
