Hazardous Materials Initial Site Assessment (ISA)

October 2017 District: Lufkin

US 59 Upgrade Redland From south of FM 2021 to north of US 59/SL 287

Angelina County, Texas CSJ: 0176-02-118

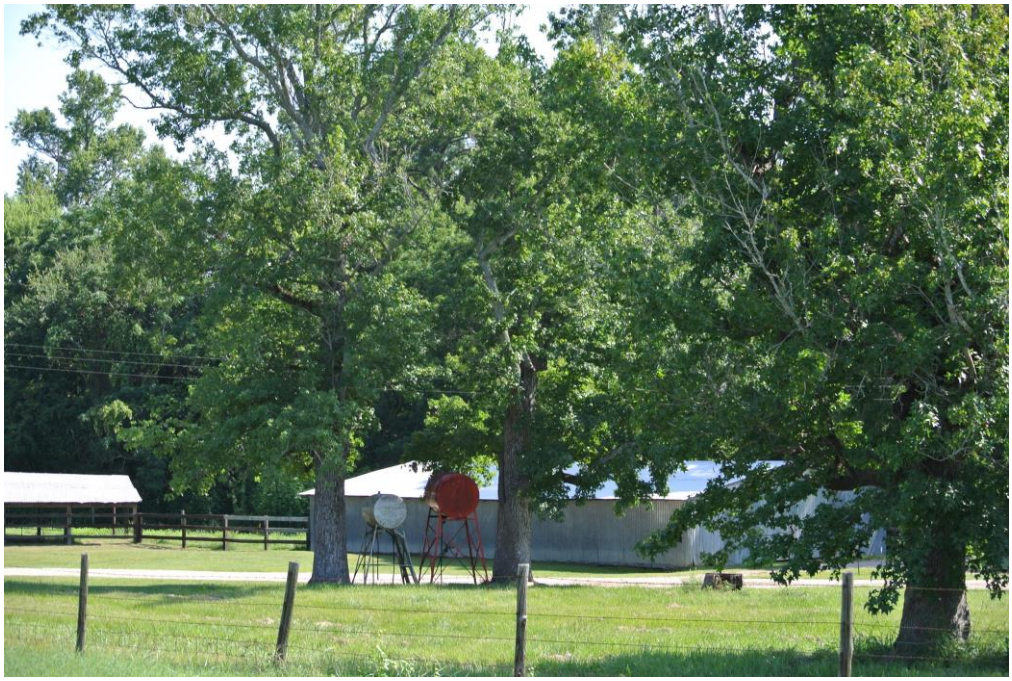
Photograph 12 – View of ASTs located at 4200 US Hwy 59 N, Lufkin, TX.
