2015
Annual Inspection of the
South Orient Rail Line
Under Lease to
Texas Pacifico Transportation Company

May 11 - 14, 2015

South Orient Annual Inspection

Inspection Dates May 11 – 14, 2015

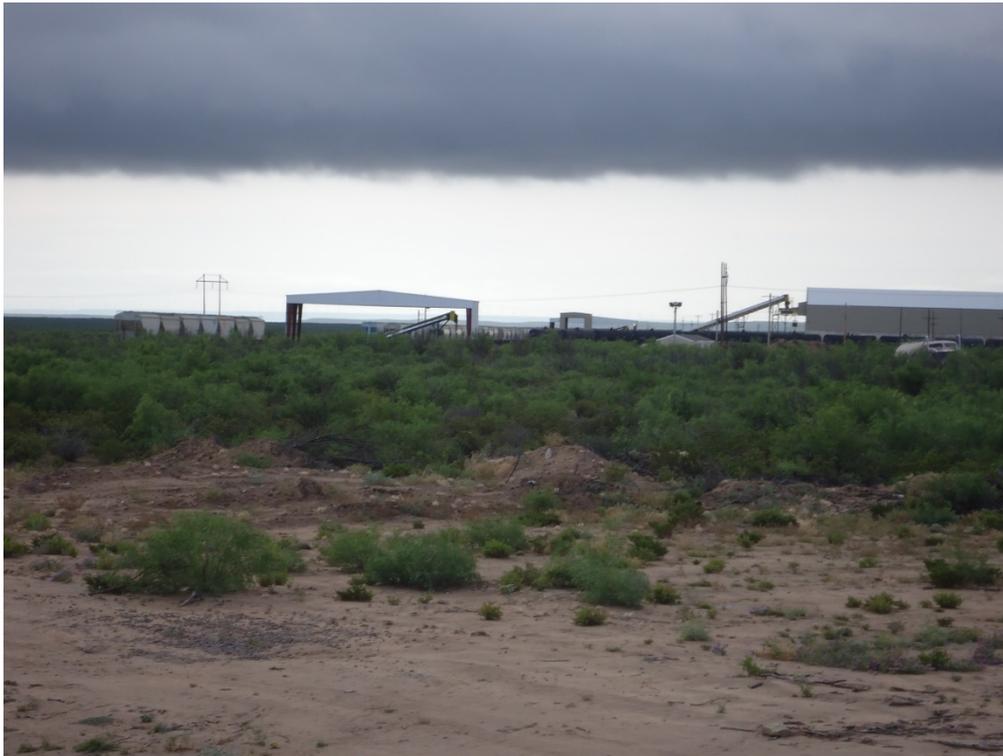
Figure 1 – Sand Unloading, Sulphur Junction

The largest volume of traffic on the line in 2014 continues to be due to the dramatic increase in oil and gas exploration efforts in the region. Sand unloading facilities are located in San Angelo, Barnhart, Big Lake, McCamey, Rankin, Fort Stockton, Harriet, Sulphur Junction (Figure 1), and Fort Stockton. Crude oil loading facilities have opened at San Angelo, Barnhart, McCamey (Figure 2) and Sulphur Junction.

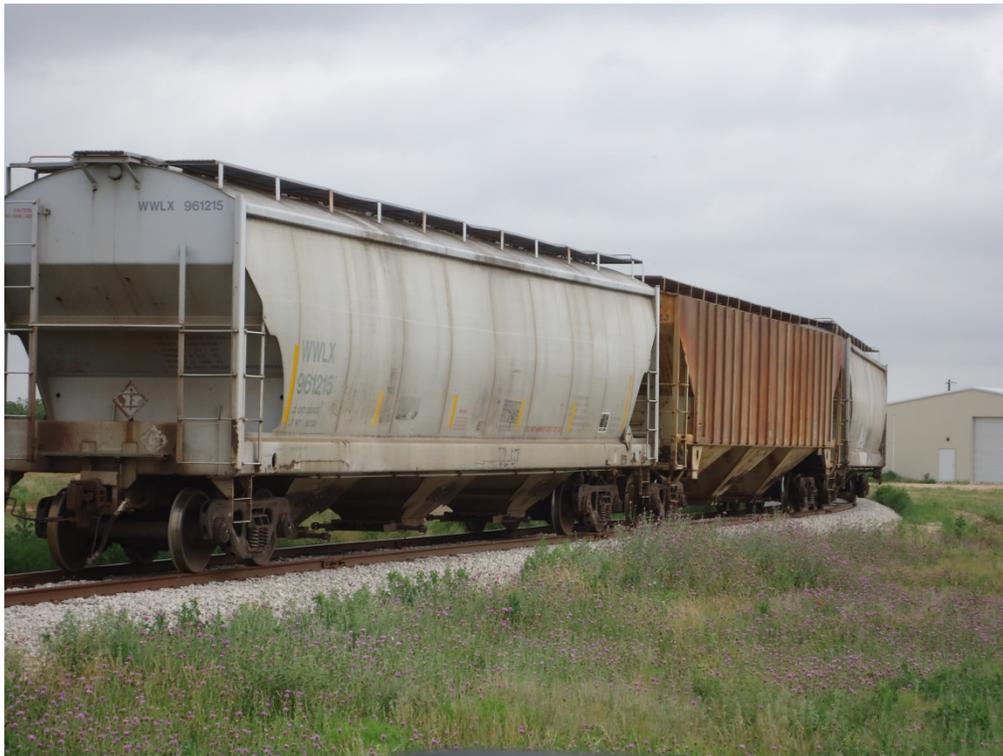
Figure 3 – Western Towers Facility at MP 63.3

There are new sand unloading and crude oil loading facilities in various stages of development at this time. Western Towers, located east of San Angelo, has completed the expansion of their facility, and is providing some transloading services for others on their property (Figure 3).

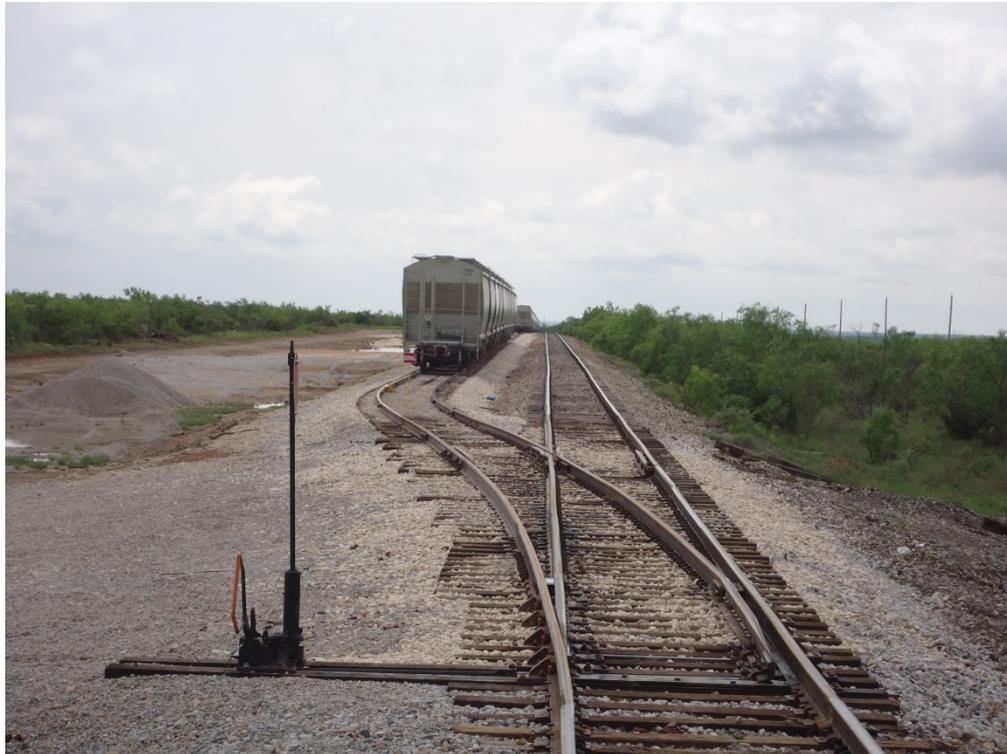
Figure 6 – MP 796.0, new siding

The railroad is designated as Class II (25 mph) from MP 738.1 to 869.7. The track is constructed predominantly of 112#, 115#, and 131# continuously welded rail between MP 738.1 and 855.6 with jointed rail between MP 846 and MP 849.7. TXPF constructed a new 7,300' siding near Barnhart (Figure 6).

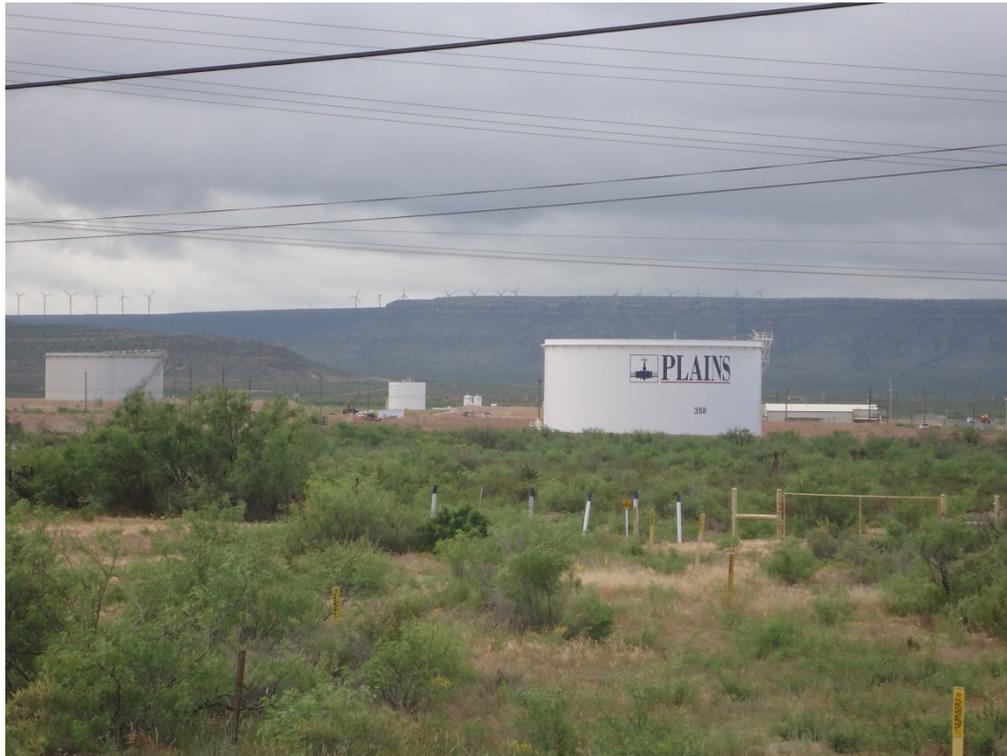
Figure 7 – MP 836.6, Crude Oil Tanks

The new crude facility near McCamey includes a large tank farm (Figure 7) and a new mile-long spur into the facility (Figure 8).

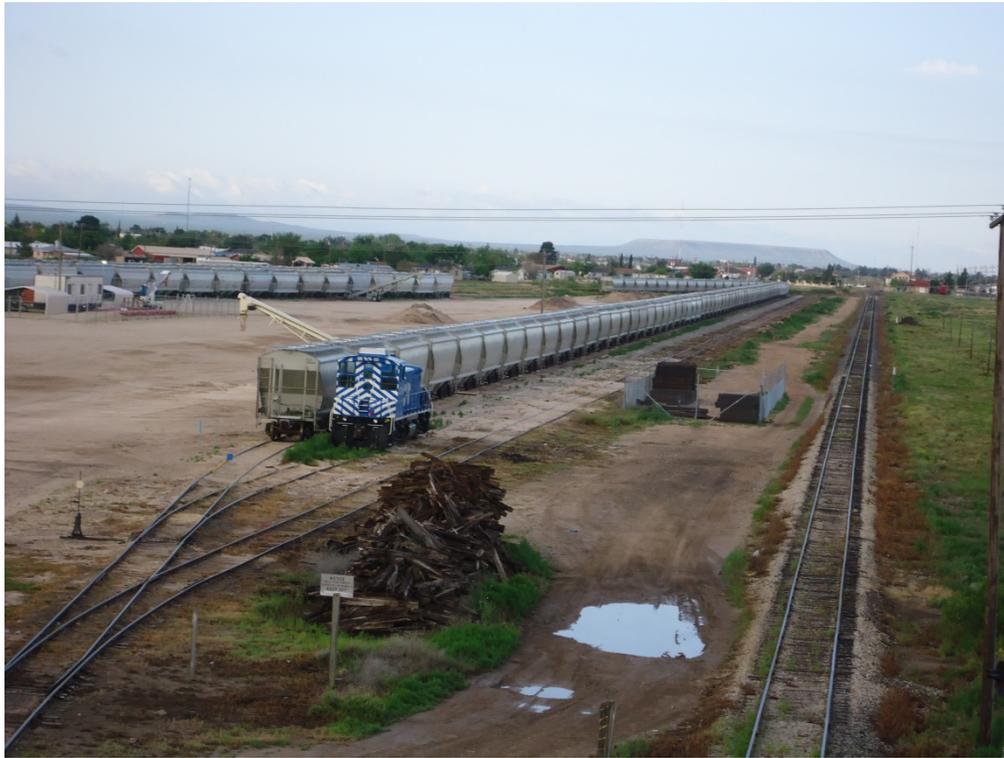
Figure 10 – MP 881, Sand Transloading

The yard at Fort Stockton is still being used by sand transloaders (Figure 10). The siding at Belding was recently leased for pipe transloading (Figure 11). The 70# rail continues for a distance of approximately 75.6 miles to the Union Pacific interchange (MP 945.34) at Alpine. This section of the line is also limited to 10 mph due to rail size and track conditions.

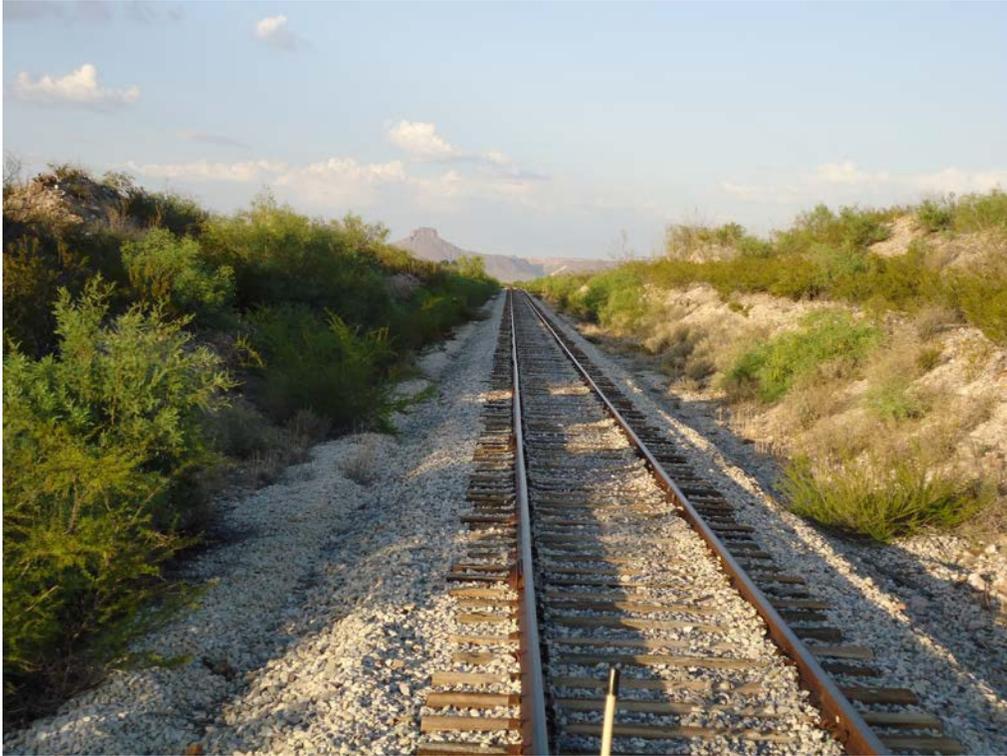
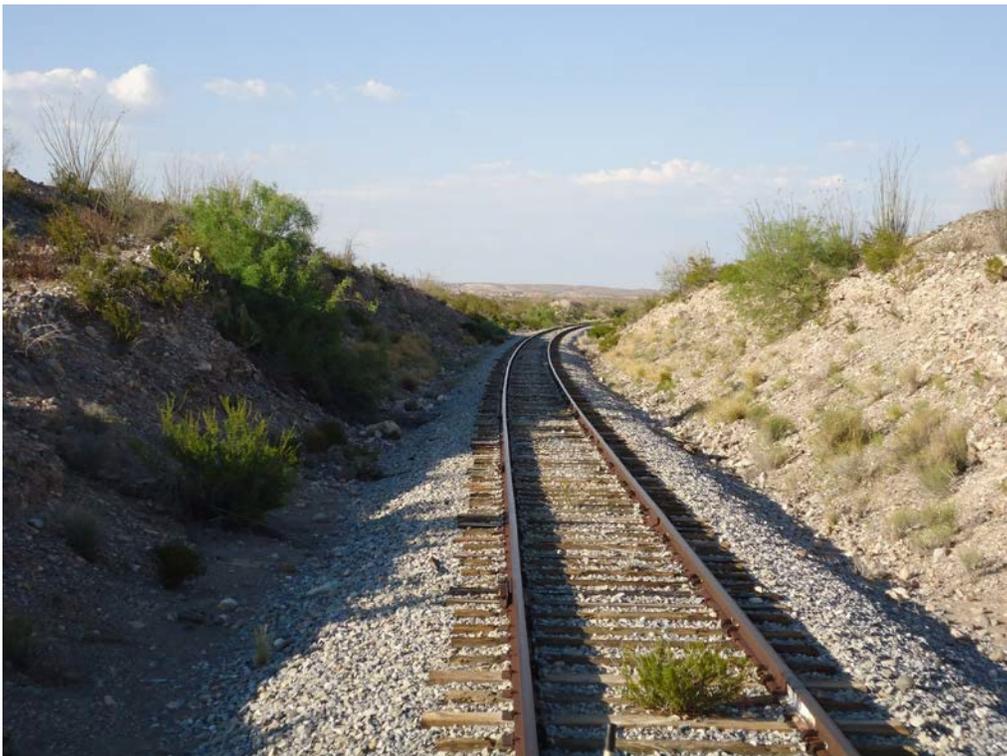
The section of tracks between MP 968 and Presidio still displays the benefit of TxDOTs rehabilitation project during 2005 and early 2006. Over 37,000 ties were installed with associated ballast and surfacing in this segment of the line (Figures 16 and 17).

Figure 16 – MP 1006.6

Figure 17 – MP 1024.8

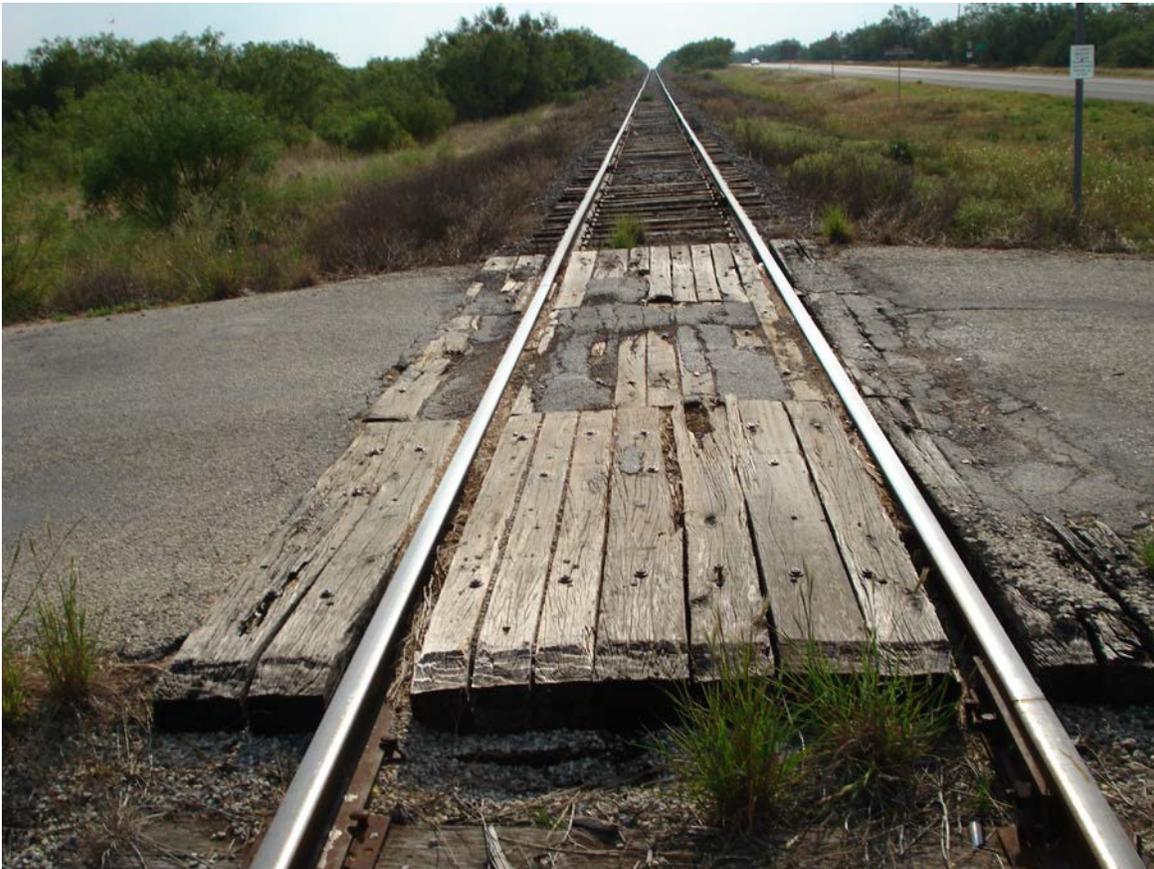
Figure 18 - MP 735.1

TxDOT's rehabilitation project on the east end included the reconstruction of 119 grade crossings between San Angelo Junction (MP 0) and the west side of San Angelo (MP 721.52). Additional crossings will be reconstructed west of San Angelo as the rehabilitation program continues. (Figure 18).

The need for reconstruction of these crossings is impacted by the inability of small local governments to fund crossing rehabilitations.

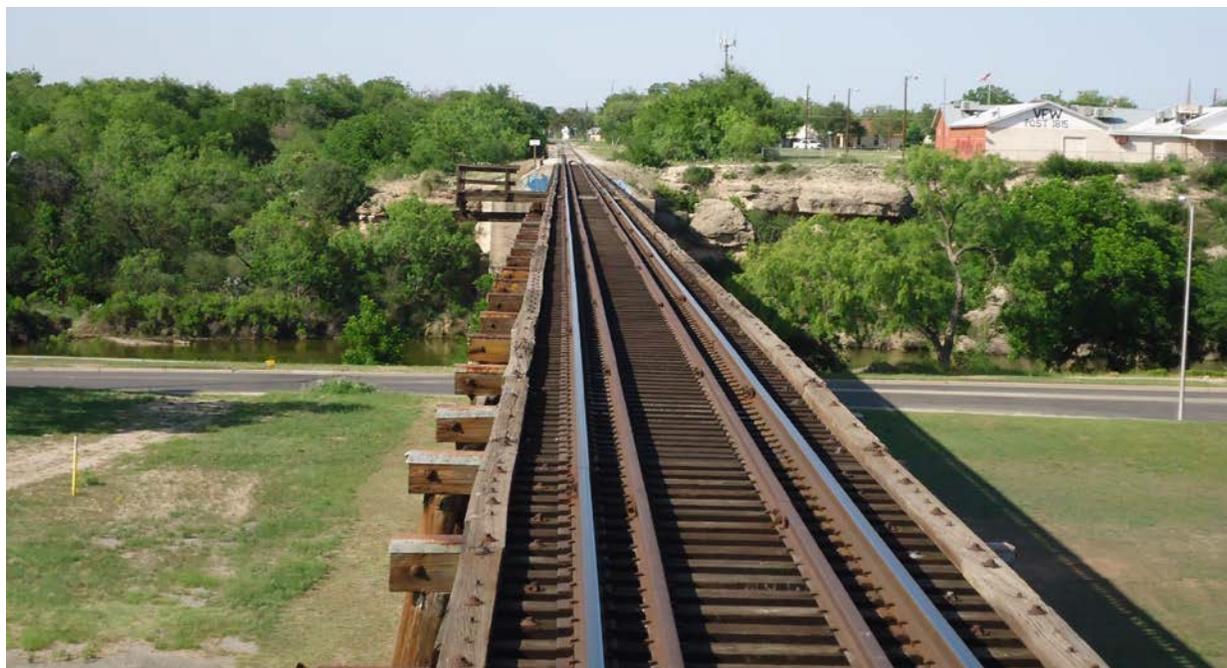
Figure 20 – MP 716.6

TxDOT's work on the east end of the line included rehabilitation work to 30 bridges, the replacement of a structurally deficient bridge with corrugated metal pipe, the replacement of a decayed, timber box culvert with corrugated metal pipe, other drainage repairs, and the replacement of a fire-damaged bridge at MP 715.1 with a concrete structure (Figure 19). Ties were also replaced on all open-deck bridges (Figure 20) and on most ballasted deck bridges.
