ANNUAL INSPECTION OF THE SOUTH ORIENT RAIL LINE
UNDER LEASE TO TEXAS PACIFICO TRANSPORTATION COMPANY

May 16 - 19, 2016

Calendar Year 2015

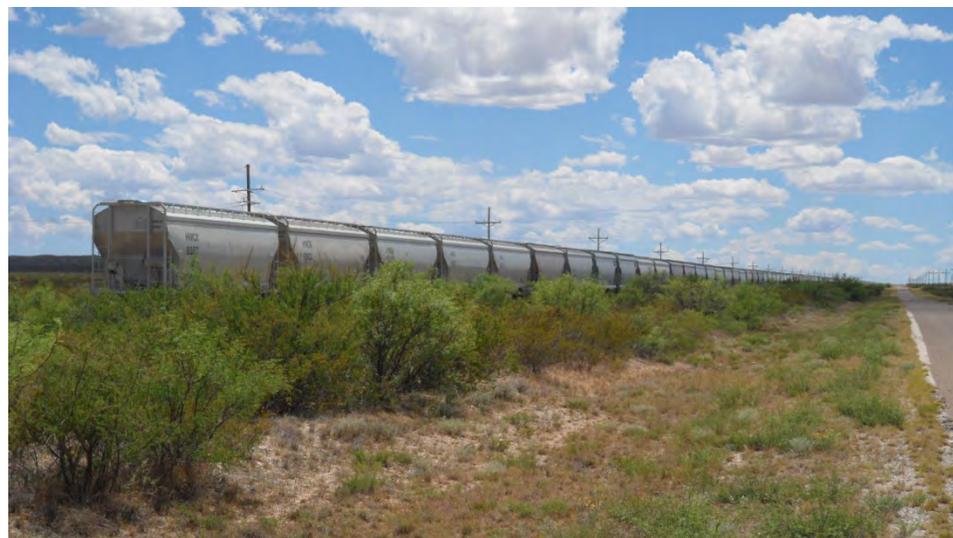
The largest volume of traffic on the line in 2015 continues to be due to the dramatic increase in oil and gas exploration efforts in the region. Sand unloading facilities are located in San Angelo, Barnhart, Big Lake, McCamey, Rankin, Fort Stockton, Harriet, Sulphur Junction (Figure 1), and Fort Stockton. Crude oil loading facilities have opened at San Angelo, Barnhart, McCamey (Figure 2) and Sulphur Junction. Pipe traffic has been steady throughout the first half of the year with shipments to various stockpile locations adjacent to the rail line including the Belding siding (Figure 3), and near Fort Stockton (Figure 4). Texas Pacifico is currently storing approximately 150 empty sand cars on the main track west of the Belding siding (Figure 5).

Figure 5: Sand cars stored on the main line

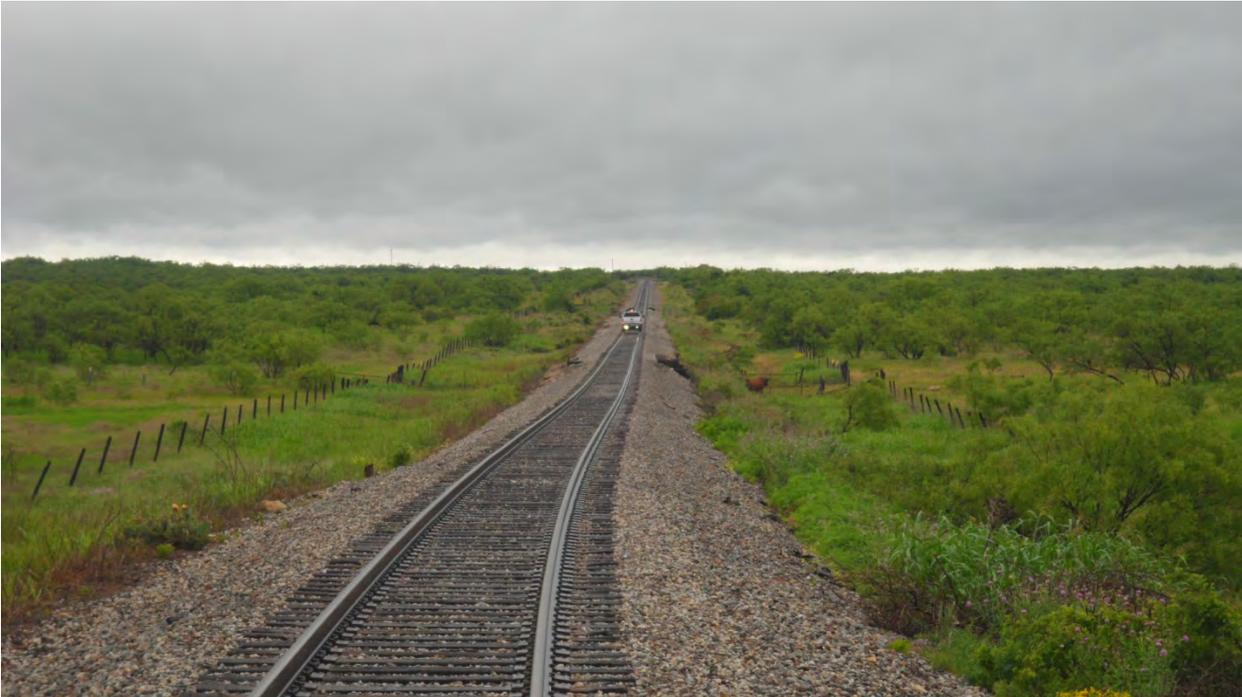
San Angelo Junction at the eastern part of the line is where the interchange with BNSF and Fort Worth & Western Railway occurs. Rail is classified by weight (in pounds) per linear yard. The jointed rail between San Angelo Junction and San Angelo primarily consists of 70#, 85#, and 90# rail that was manufactured between 1915 and 1966. TSPF has continued their annual rail replacement program, and have placed 39 miles of rail between MP 0 and MP 722. There are 9 miles of 112# rail west of Ballinger, from MP 39 to MP 48. TxDOT has replaced a total of 52,751 linear feet of worn rail in some curves in this section with 132# and 136# continuously welded rail (CWR). TSPF has continued the relaying of worn or small-sized rail in curves with 115# or higher CWR. In the past year Texas Pacifico has completed 7 miles of CWR rail relay from MP 20 to MP 35 (Figure 11, Figure 12).

Figure 11: MP 33 - CWR rail relay

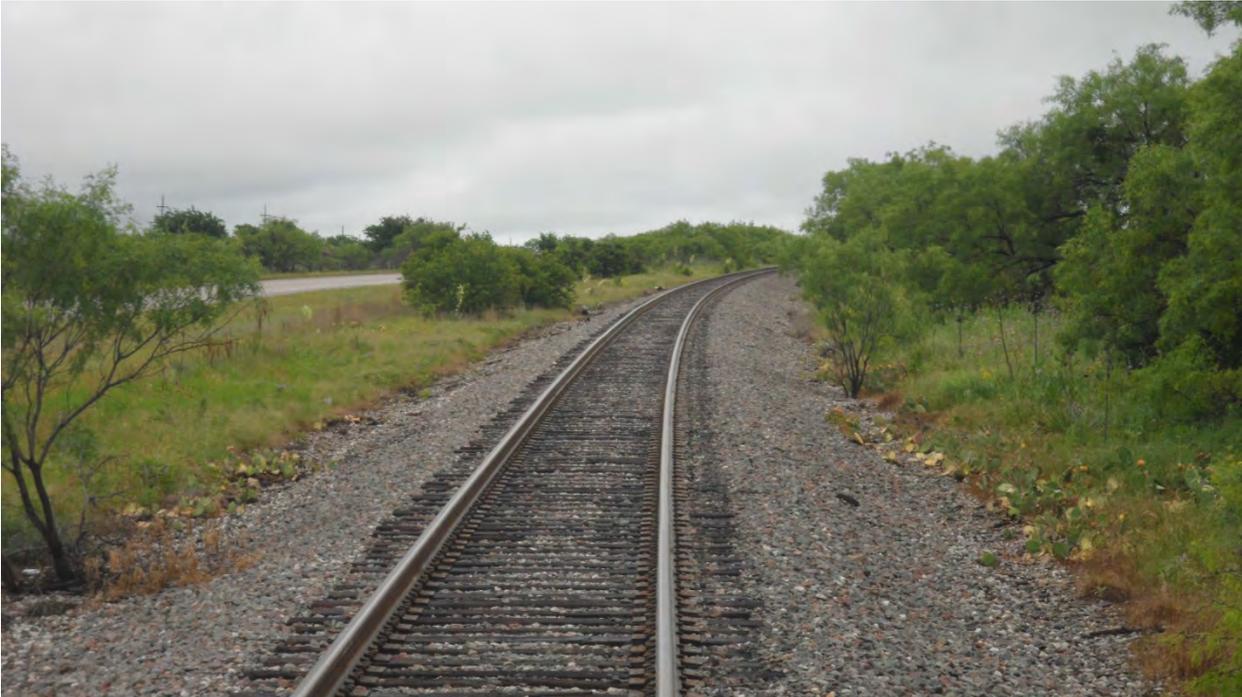
Figure 12: MP 20 - CWR rail relay

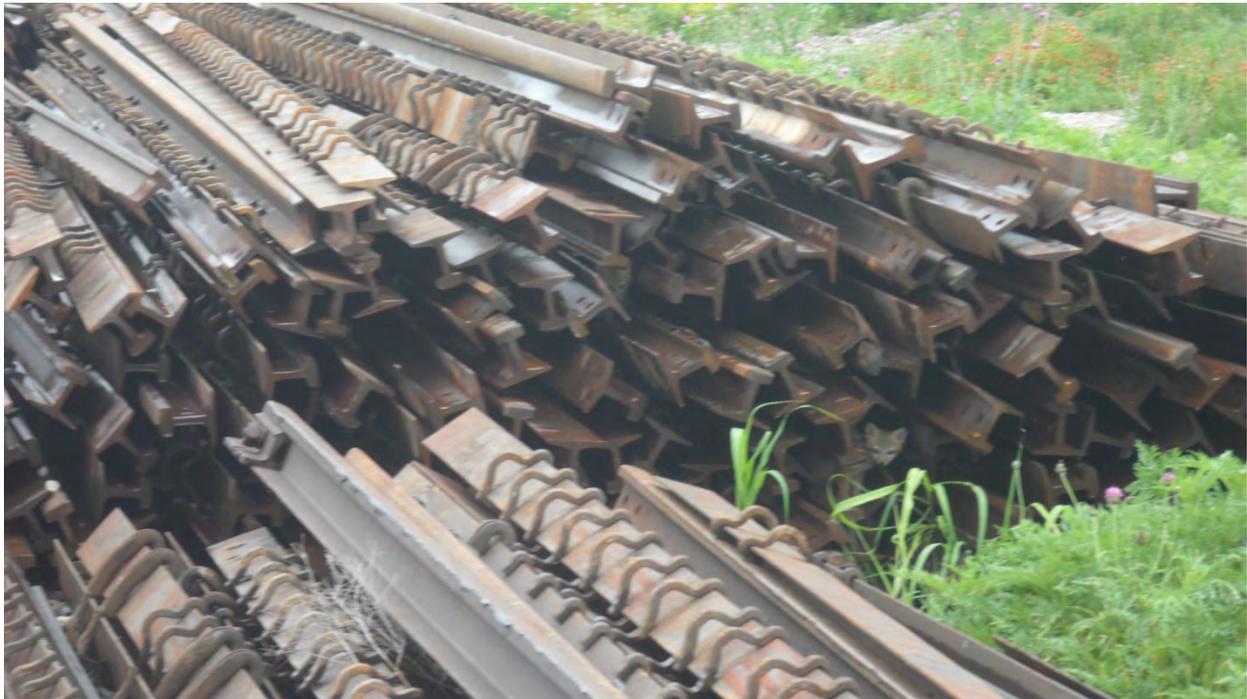
Figure 13: MP 22 - Stockpile of old rail (replaced with CWR)

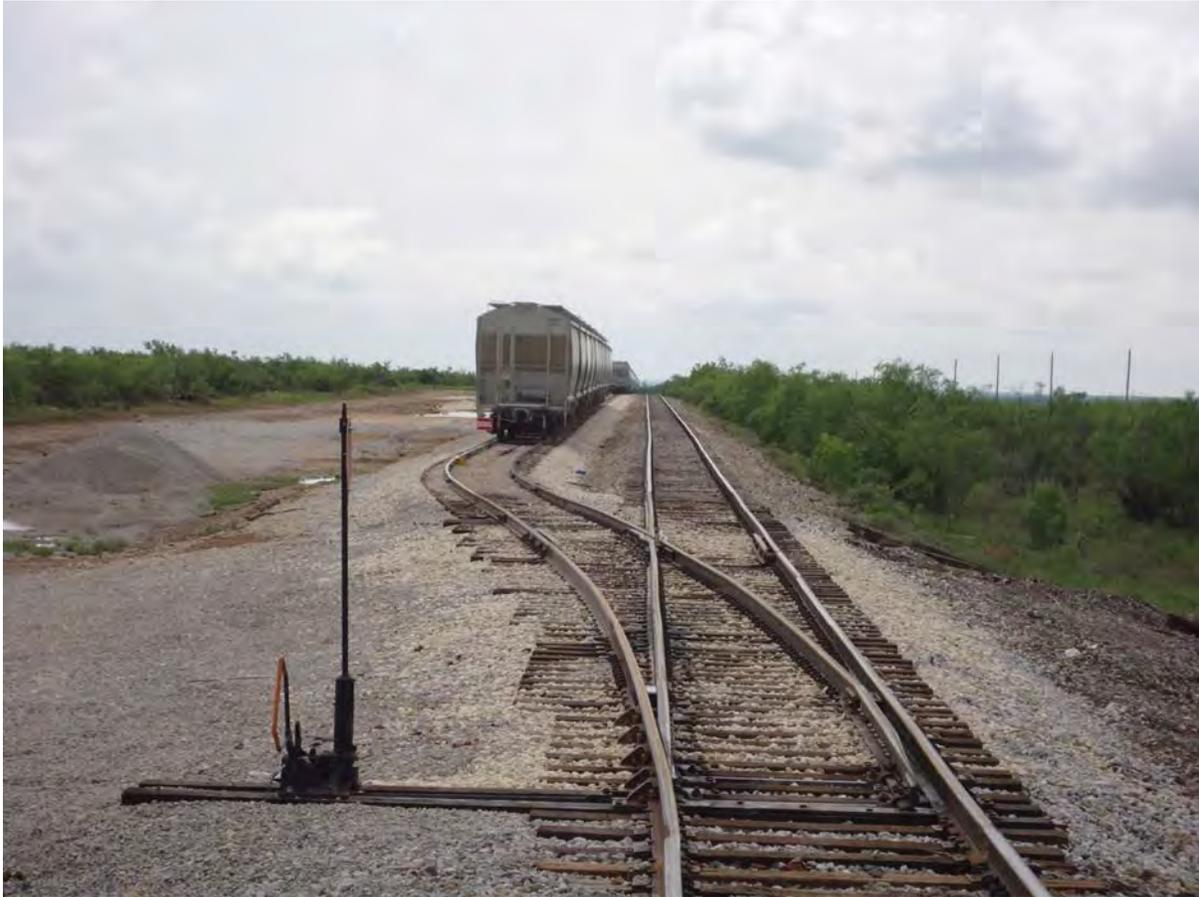
The railroad is designated as Class II (25 mph) from MP 722 to 869.7. The track is constructed predominantly of 112#, 115#, 119# and 131# continuously welded rail (CWR), with 6.15 miles of 132# CWR between MP 809.2 and 815.35, and jointed rail between MP 846.0 and 849.8. TXPF constructed a new 7,300' siding near Barnhart (MP 796.0) in 2015 (Figure 14).

Figure 14: MP 796.0, new siding

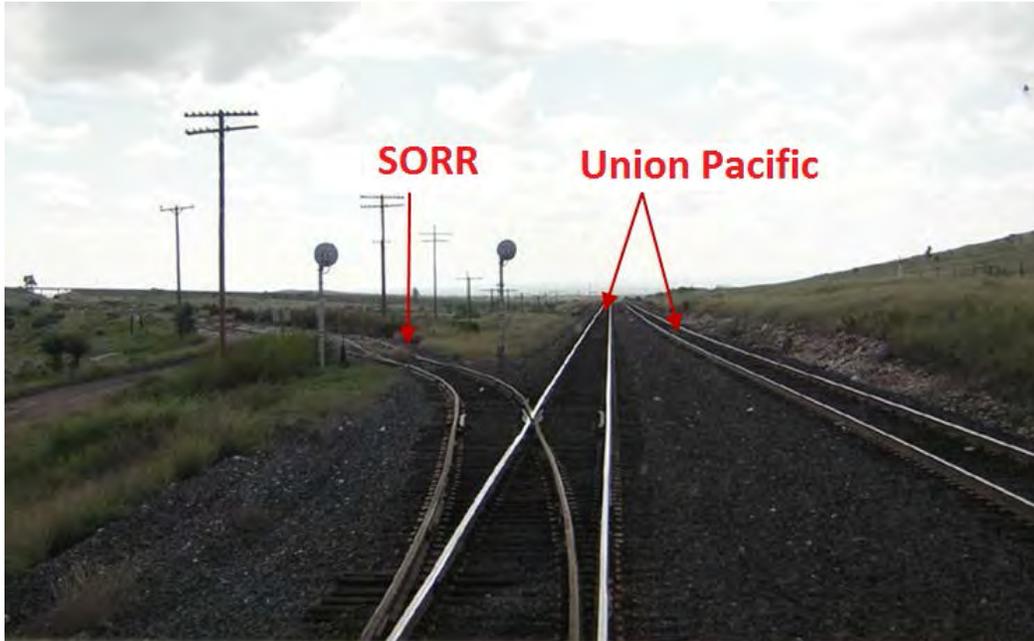
The inspection team does not travel over Union Pacific (UP) trackage from MP 945 to MP 957, due to restrictions in the trackage rights agreement. The South Orient infrastructure begins again at MP 956.76, also known as Paisano Junction (Figure 25).

Figure 25: MP 956.76 - Paisano Junction (South Orient curving to the left, UP straight through)

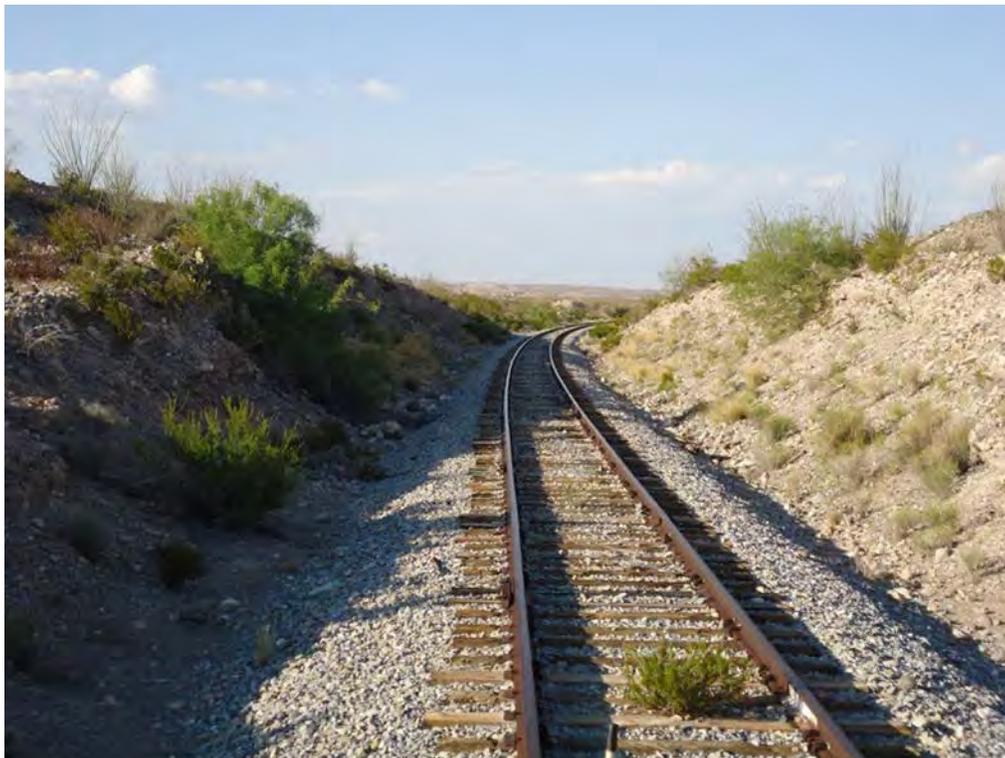
The section of track between MP 968 and Presidio still displays the benefit of TxDOT's rehabilitation project during 2005 and early 2006. Over 37,000 ties were installed with associated ballast and surfacing in this segment of the line (Figure 31).

Figure 31: MP 1024.8 – Curved track

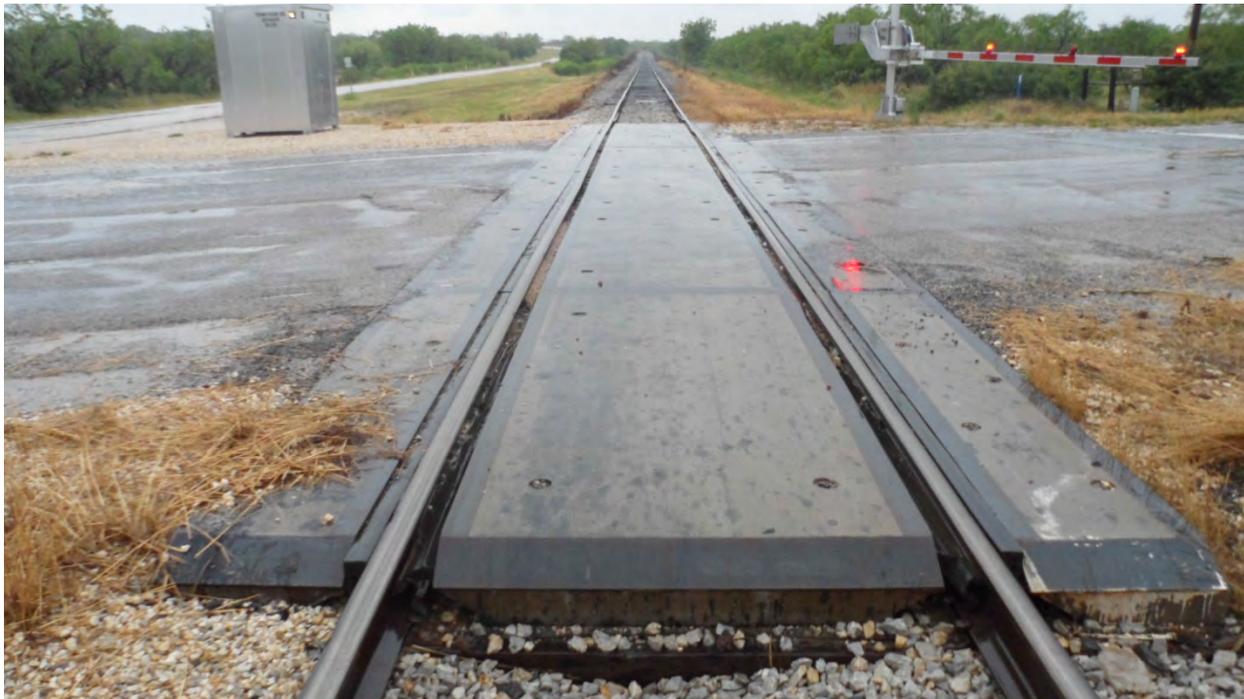
TxDOT's rehabilitation project on the east end included the reconstruction of 119 grade crossings between San Angelo Junction (MP 0) and the west side of San Angelo (MP 721.52). In the latest project completed by TxDOT, 19 crossings were either repaired or replaced between MP 722 and MP 757. Many more still need attention and will be addressed as the rehabilitation program continues. Figure 43 shows a typical crossing in need of repair and Figure 44 shows one that has been completely replaced. The need for reconstruction of these crossings is impacted by the inability of small local governments to fund crossing rehabilitation projects.

Figure 44: MP 61 - Reconstructed grade crossing
