Geologic Assessment

Regulated Entity Name: IH-10 Scenic Loop Road to Fair Oaks Parkway

GEOLOGY NARRATIVE

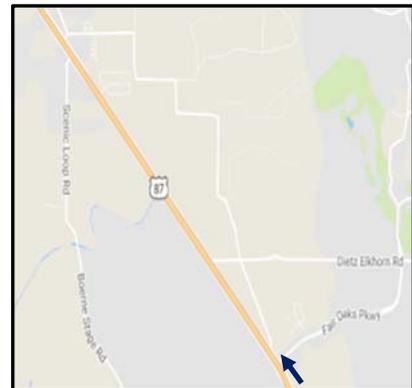
Location

S-1: Sewer Lines lie along the length of the Site in buried trenches. Utility covers mark the location of the sewer lines in many places. The sewer lines are buried and as long as the piping is intact, there is little chance of storm water migrating through the trenches into the Edwards Aquifer. An example of one of the many sewer utility covers located along the easement of IH-10 at the driveway to the CVS pharmacy on the northside of IH-10 is shown in Attachment E1-Photograph 4.

Photograph 4. View facing northwest at driveway to CVS on the northside of IH-10. A sewer manhole is evident near the driveway and Old Fredericksburg Road is visible in the background (S-1).

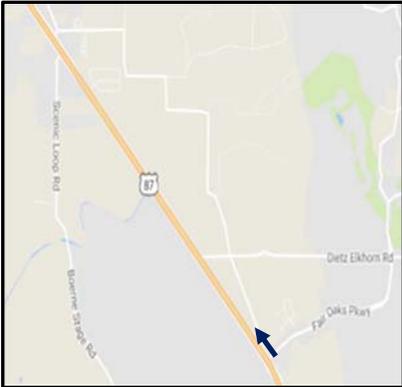
Location

S-2: Sewer Lines lie along the length of the Site in buried trenches. Utility covers mark the location of the water lines in many places. The sewer lines are buried and as long as the piping is intact, there is little chance of storm water migrating through the trenches into the Edwards Aquifer. An example of one of the many sewer utility covers located on Old Fredericksburg Road is shown in Attachment E1-Photograph 5.

Photograph 5. View facing southwest on Old Fredericksburg towards sewer manhole, utility pole, and strip mall evident in the background (S-2).

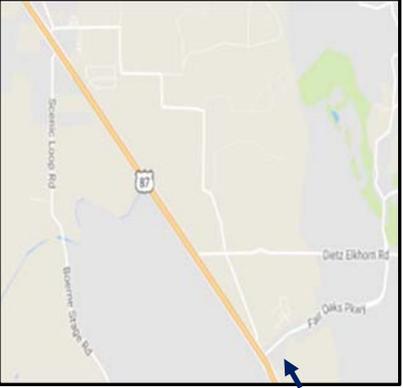
Location

S-3: Example of a concrete drainage culvert and associated scour within the ROW along the Frontage Road of the west bound lane of IH-10 (Attachment E1-Photograph 8). The culverts are constructed of and paved with concrete so there is little chance of recharge of water entering the Edwards Aquifer from these features.

Photograph 8. View facing northwest showing a culvert and associated scour within the ROW along the Frontage Road of the west bound lane of IH-10 (S-3).

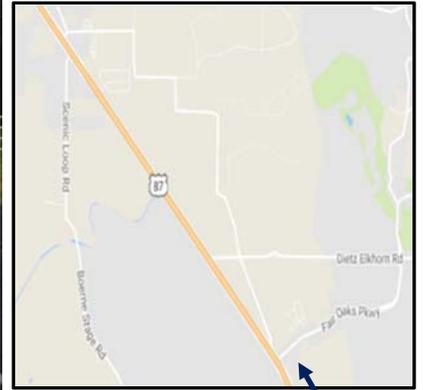
Location

Photograph 9. View of a BMP utilized between the Frontage Road and west bound lanes of IH-10 west of Fair Oaks Pkwy (S-4).

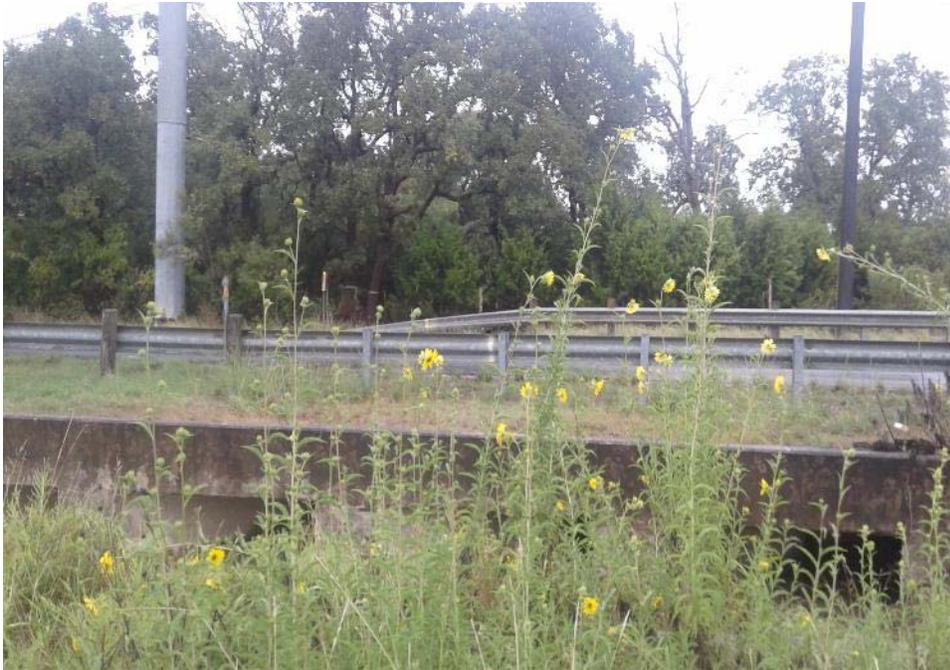
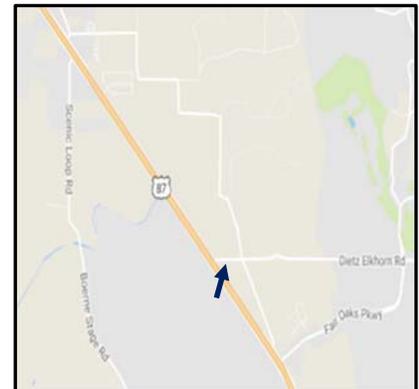
Photograph 13. View facing northeast of the culvert at Dietz Elkhorn.

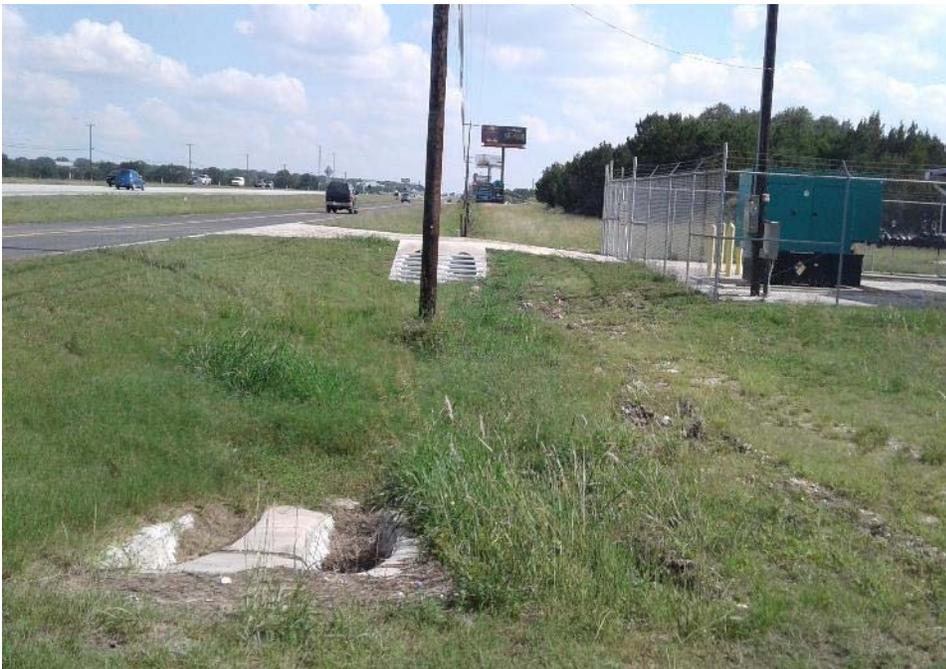
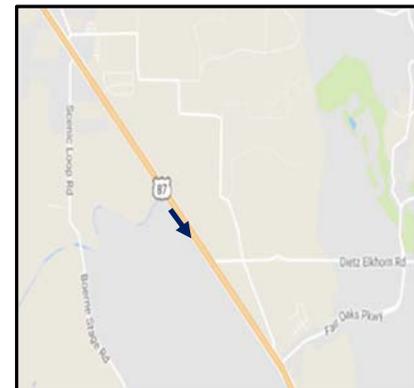
S-5: Example of a concrete drainage culvert located in the ROW west of the east bound lane of IH-10 and the Frontage Road (Attachment E1-Photograph 19). The culverts are constructed of and paved with concrete so there is little chance of recharge of water entering the Edwards Aquifer from these features.

Photograph 19. View facing southeast of culvert (S-5) located in the ROW west of the east bound lane of IH-10 and Frontage Road.

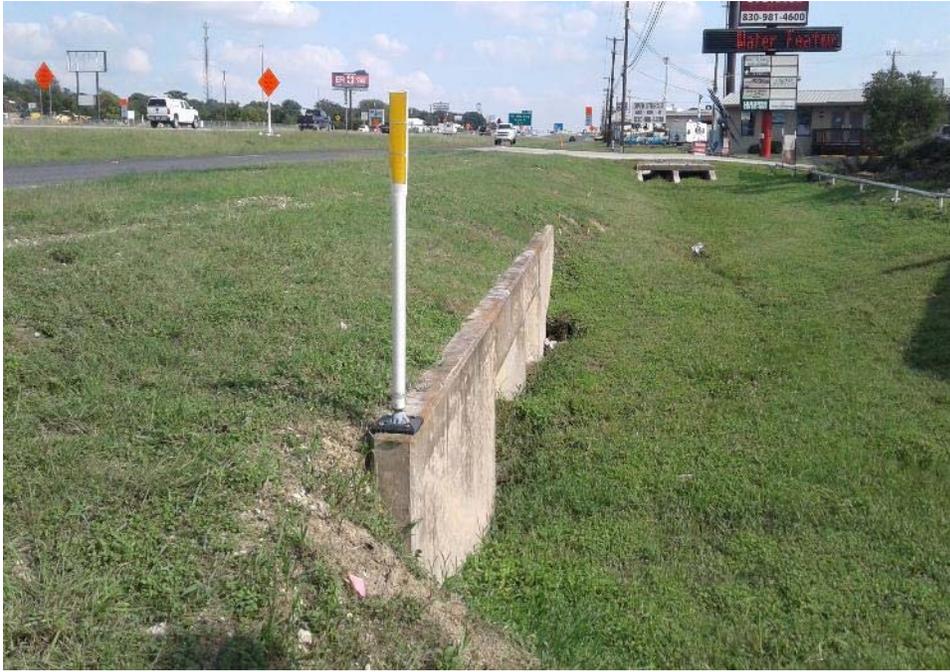
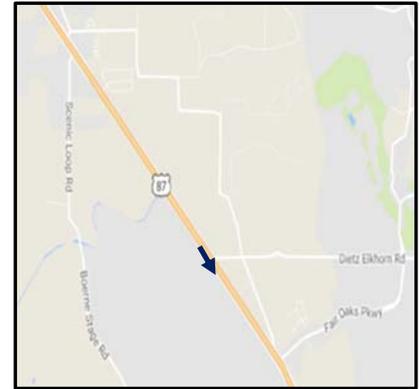
Photograph 20. View facing southeast of the east bound lanes of IH-10 and associated Frontage Road, and the San Antonio Water System substation adjoining the project site west of IH-10 and the Frontage Road. Culvert in photograph is associated with S-5 in photograph 19.

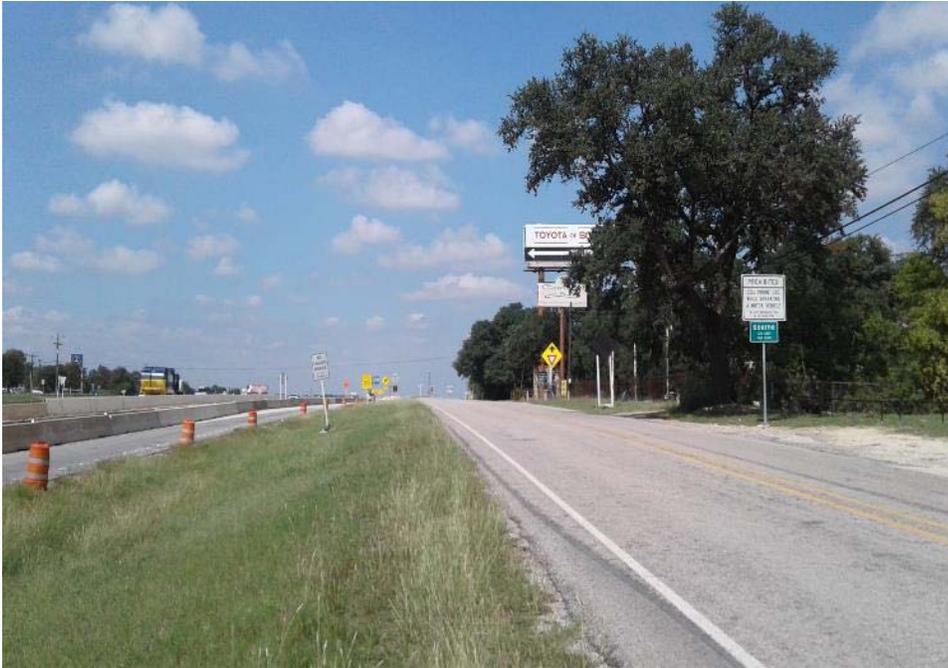
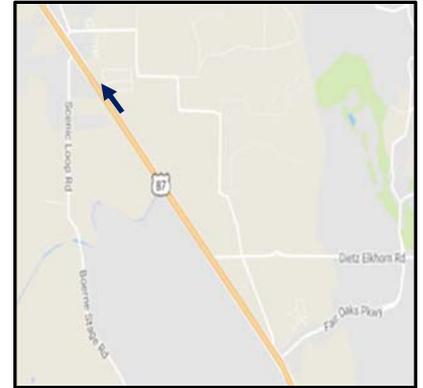
S-6: Numerous concrete box culverts for drainage under side roads, the interstate highway, and driveways are present along the Site. The culverts are constructed of and paved with concrete and are mostly underlain by concrete. There is little chance of recharge of water entering the Edwards Aquifer from these features. An example of one a boxed culvert within the ROW is shown in Attachment E2-Photograph 3.

Photograph 4. View facing northwest of cement drainage associated with the boxed culvert (S-6; photograph 3). Businesses and utilities present in the background.
