Appendix A

Existing Conditions Analysis

FM 76 (North Loop Drive) Feasibility Study

January 2023

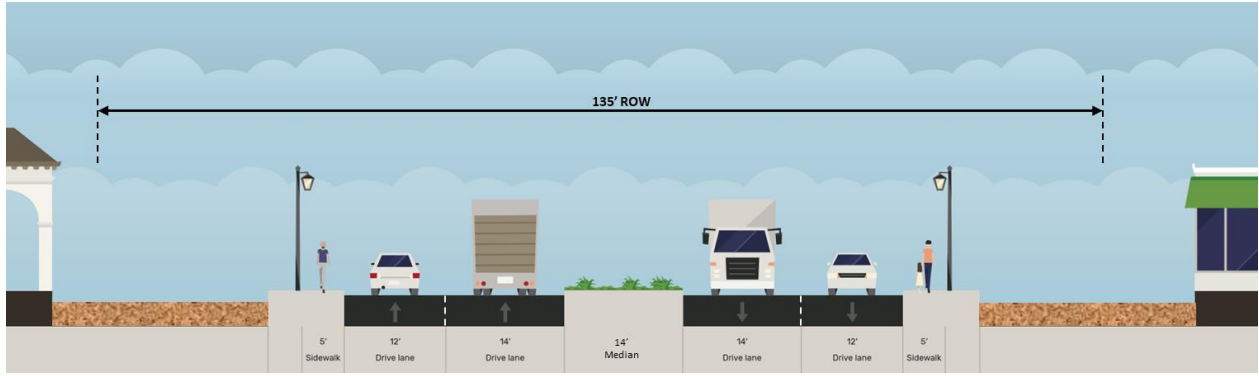
Existing Typical Four Lane Section – Close to Horizon Blvd Intersection

As previously mentioned, the corridor consists of a two-lane undivided roadway configuration, except for the 0.2 miles long segment between Horizon Blvd (FM 1281) and Milo Dr, which has a four-lane configuration with a median. The lane width in this section, varies between 11 ft and 14 ft, with a paved shoulder of around 11 ft wide on both sides. A 5 ft wide sidewalk is also observed on both sides along this section.

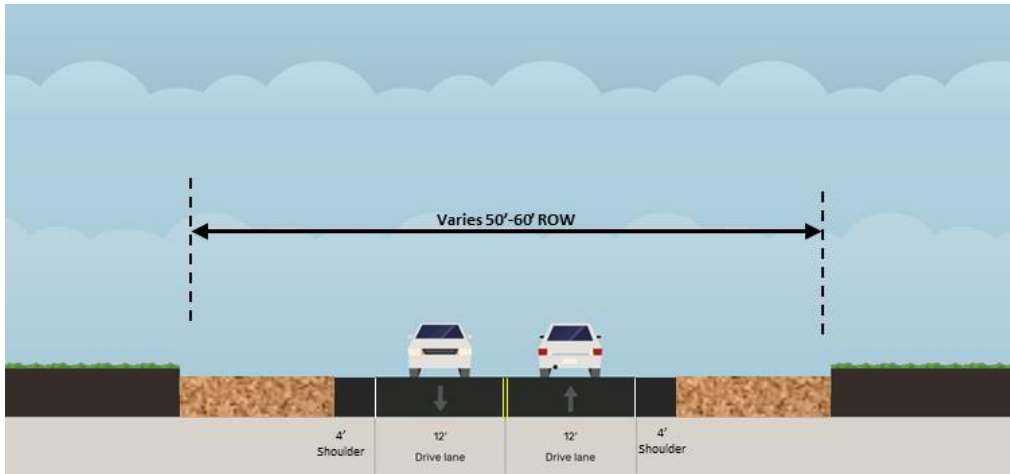
Typical Two Lane Rural Section

The rest of the corridor consists of two lanes, with a lane width between 11 ft and 12 ft, and a paved shoulder between 3 ft and 4 ft observed on either side of the roadway, except at intersections, where additional turn lanes are observed. There is no sidewalk available throughout the remainder of the corridor, except at the intersection of FM 76 (North Loop Dr) with Fabens Road (Rd), extending over to Alameda Ave (SH 20), for a length of around 0.2 miles. The corridor's existing typical cross sections are shown in **Figure 4**. The lane widths adhere to TxDOT standards throughout the corridor length and no deficiencies were observed in the existing configuration.

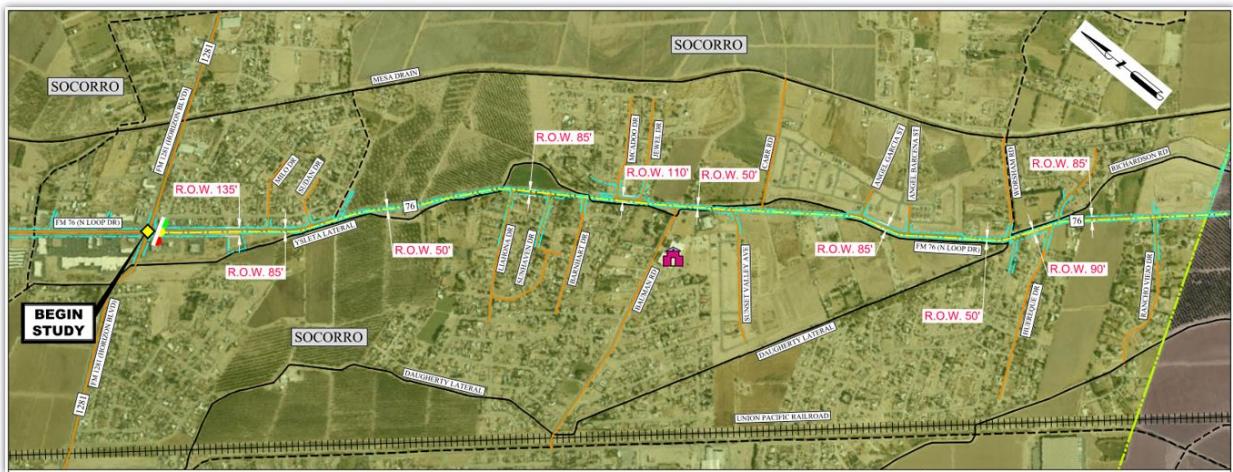
Figure 5: Schematic ROW Map

The majority of the existing ROW from Horizon Blvd (FM 1281) to Fabens (end of the corridor) ranges from 50 ft to 60 ft (around 63% of the corridor length). The initial section located at the intersection of Horizon Blvd has a ROW of 135 ft (for a length of 0.29 miles), while the ROW reduces down to 50 ft within the Fabens city limit. ROW reduces to an average width of 55 ft at the areas where the irrigation canals are adjacent to roadway. And also, approximately 1,800 ft of 35 ft ROW is dedicated to the City of Socorro, adjacent to TxDOT ROW in Leonor Estates Subdivision. A schematic ROW map is shown in **Figure 5**. Refer to **Appendix A.1** for further details about ROW along the corridor including detailed maps.

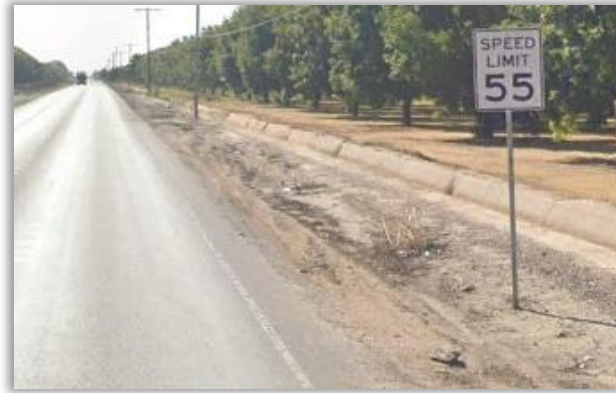
Figure 6: Posted Speed Limit

The posted speed limit along the corridor varies between 35 miles per hour (mph) and 55 mph. The speeds are reduced at curve locations within the corridor. A posted speed limit of 45 mph is observed between Horizon Blvd (FM 1281) and Anderson Rd for a length of 3.1 miles. The speed limit is 55 mph from Anderson Rd to 5th St at Fabens. From there, the speed reduces to 45 mph up to 3rd St, where it is further reduced to 35 mph until the end of the corridor. The posted speed limit on the corridor is shown in the **Figure 6**.

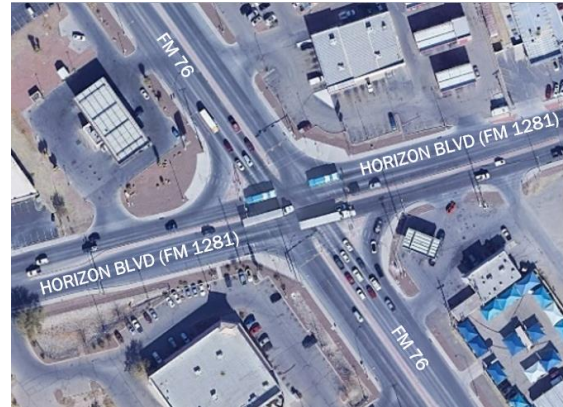
Figure 8: FM 76 and Horizon Blvd (FM 1281) Intersection

The intersection of FM 76 (North Loop Dr) and FM 1281 (Horizon Blvd) is a four-legged signalized intersection, and both corridors have a four-lane configuration with a pedestrian crossing. The northbound and southbound approaches of FM 1281 (Horizon Blvd) have two through-lane movements with dedicated left and right-turn lanes. The east and westbound approaches of FM 76 (North Loop Dr) also have two through-lane movements with dedicated right and left-turn lanes. An overview of the intersection is shown in **Figure 8**.

Commercial activities were observed abutting the intersection, with gas stations located on the northeast and southwest corners of the intersection. Access roads were observed close to the turning lanes.

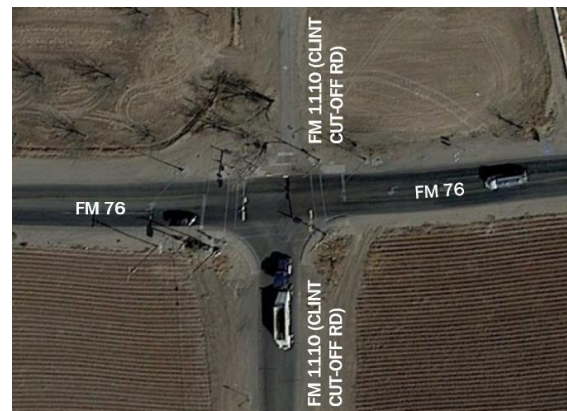
Figure 9: FM 76 and FM 1110 (Clint Cut-Off Rd) Intersection

The intersection of FM 76 (North Loop Dr) and FM 1110 (Clint Cut-Off Rd) is a four-legged signalized intersection. Both FM 76 (North Loop Dr) and FM 1110 (Clint Cut-Off Rd) have a two-lane configuration. The northern approach has a single-lane configuration and leads to several residential dwellings. Marked crosswalks are present at the intersection approaches, to facilitate pedestrian crossings. Dedicated left turn lanes were observed on the east and west approach of FM 76 (North Loop Dr). An overview of the intersection is shown in **Figure 9**. The intersection is surrounded by agriculture/open land.

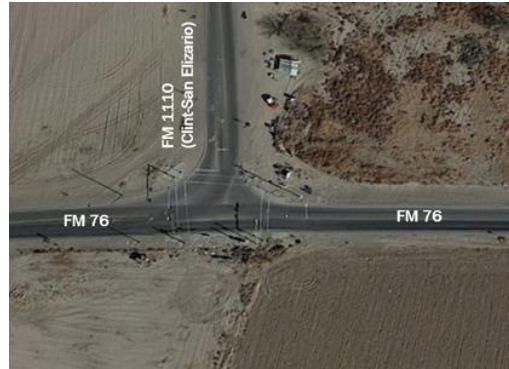
Figure 10: FM 76 and FM 1110 (Clint-San Elizario) Intersection

The intersection of FM 76 (North Loop Dr) and FM 1110 (Clint-San Elizario) is a three-legged signalized intersection. Both FM 76 (North Loop Dr) and FM 1110 (Clint-San Elizario) have a two-lane configuration. Marked crosswalks are present at the intersection approaches, to facilitate pedestrian movement. An overview of the intersection is shown in **Figure 10**. Dedicated left turn lanes were observed on the west approach of FM 76 (North Loop Dr) and the north approach of FM 1110 (Clint-San Elizario). The intersection is surrounded by agriculture/open land. Celum Rd access is located about 265 ft from the stop line of the intersection.

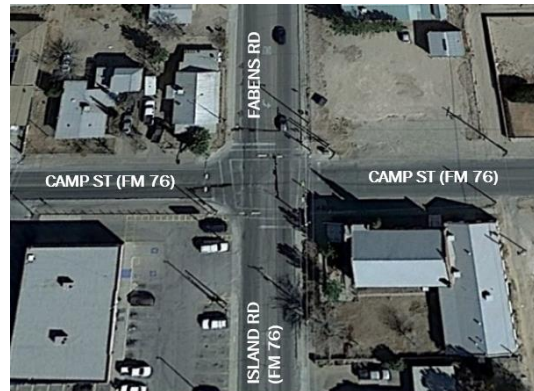
Figure 11: Camp St (FM 76), Fabens Rd, and Island Rd (FM 76) Intersection

The intersection of Camp St (FM 76), Fabens Rd and Island Rd (FM 76) is a four-legged signalized intersection, and the connecting corridors have a two-lane configuration with marked crosswalks at the intersection approaches, to facilitate pedestrian crossings. Dedicated left turn lanes were observed along Fabens Rd and Island Rd (FM 76). An overview of the intersection is shown in **Figure 11**. Commercial activities were observed abutting the intersection and access roads were observed close to the intersection area.

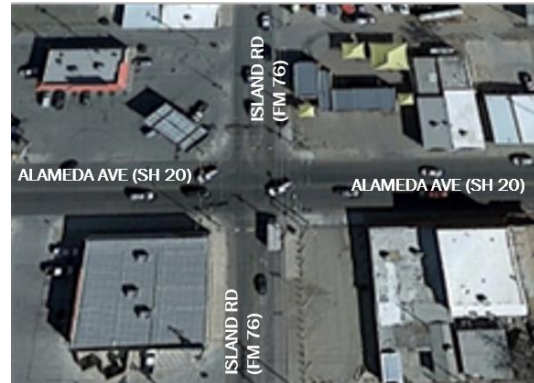
Figure 12: Island Rd (FM 76) and Alameda Ave (SH 20) Intersection

The intersection of Island Rd (FM 76) and Alameda Ave (SH 20) is a four-legged signalized intersection. The connecting corridors have a two-lane configuration with marked crosswalks at the intersection approaches to facilitate pedestrian movement. Dedicated left turn lanes were observed along Island Rd. Commercial activities were observed abutting the intersection and access roads were observed close to the intersection area, and the gas station is observed on the northwest corner of the intersection. An overview of the intersection is shown in **Figure 12**.
