Bridge Condition Surveys

Bridge Division

Construction and Maintenance

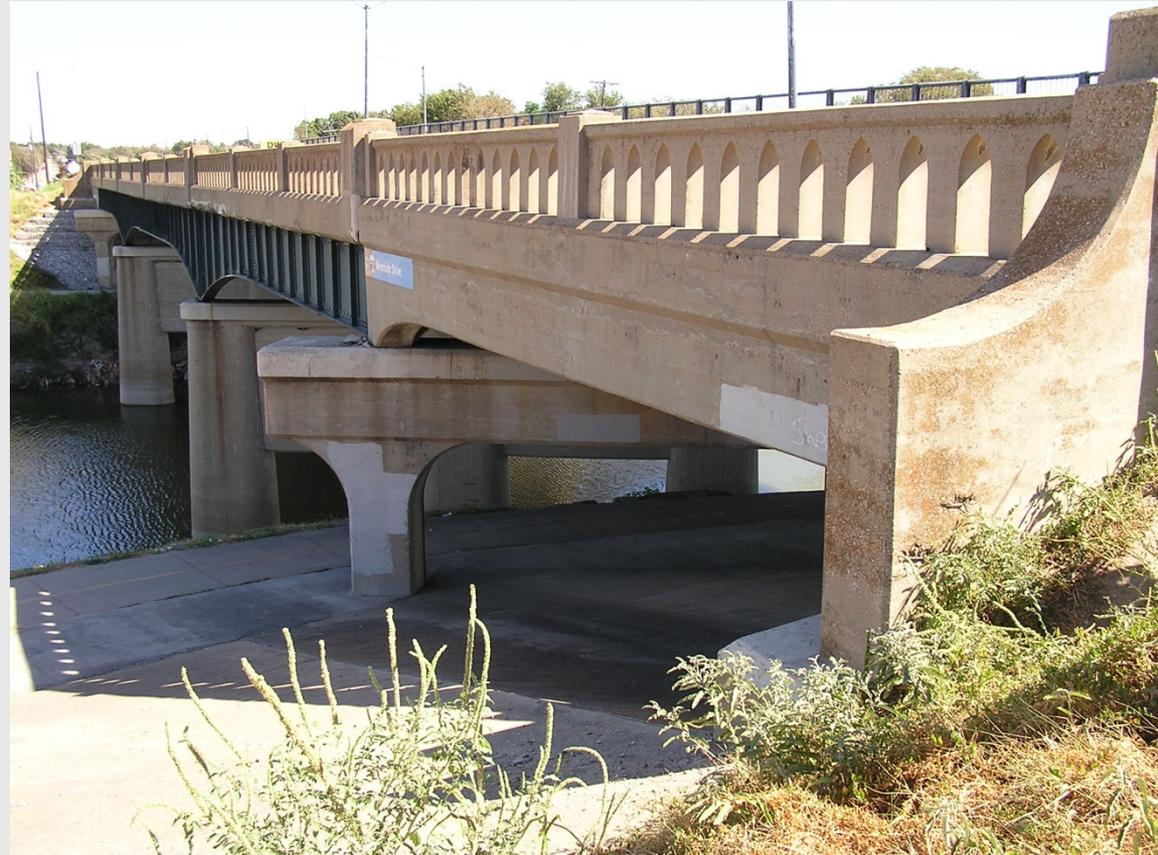
Points of Inspection

- Overall Condition (Big Picture)
 - Settlement
 - Alignment
 - Any Structure Modification

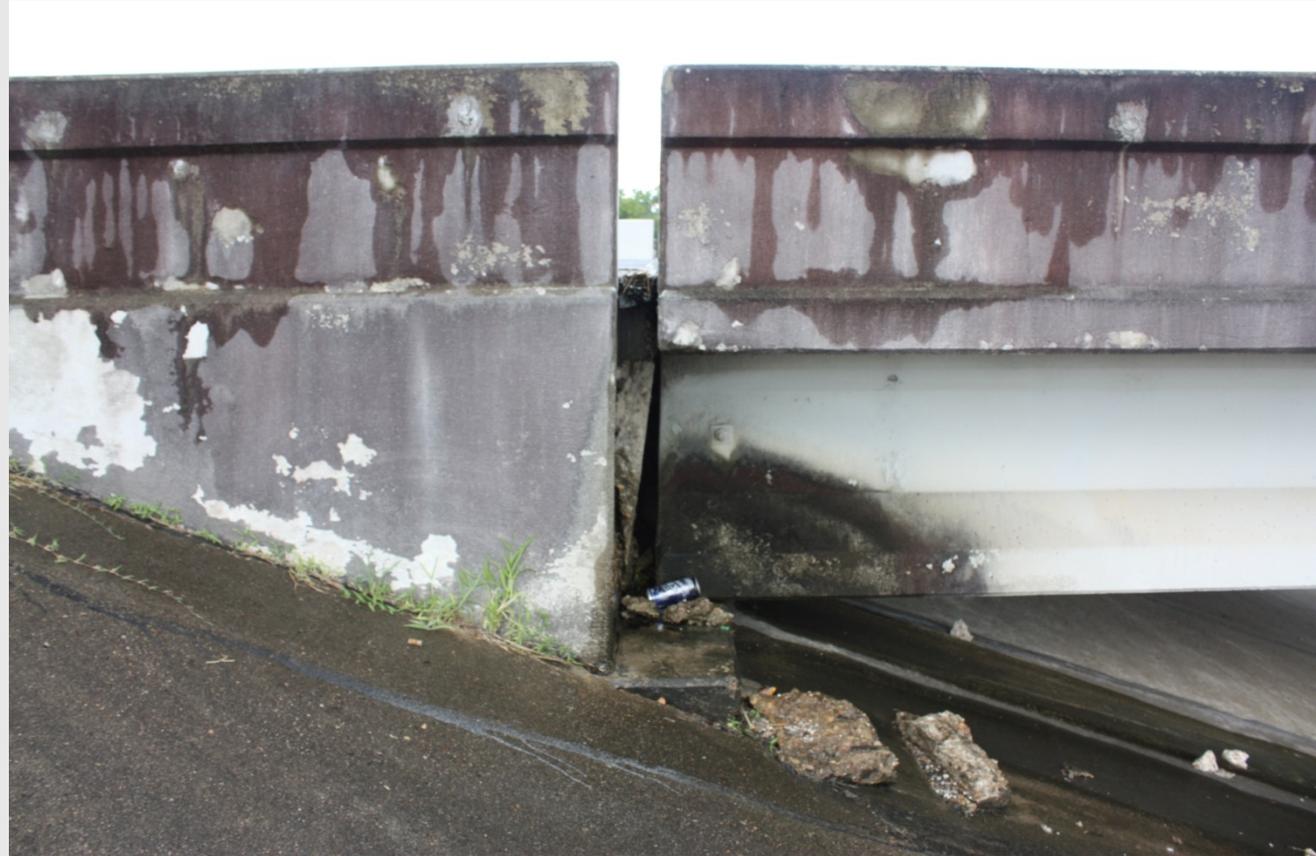
■ Abutments

- Bridge Squeeze (Bkwl Rotation, Wingwall Cracking)
- Embankment Settlement
- Bearings
- Riprap
- Retaining Walls

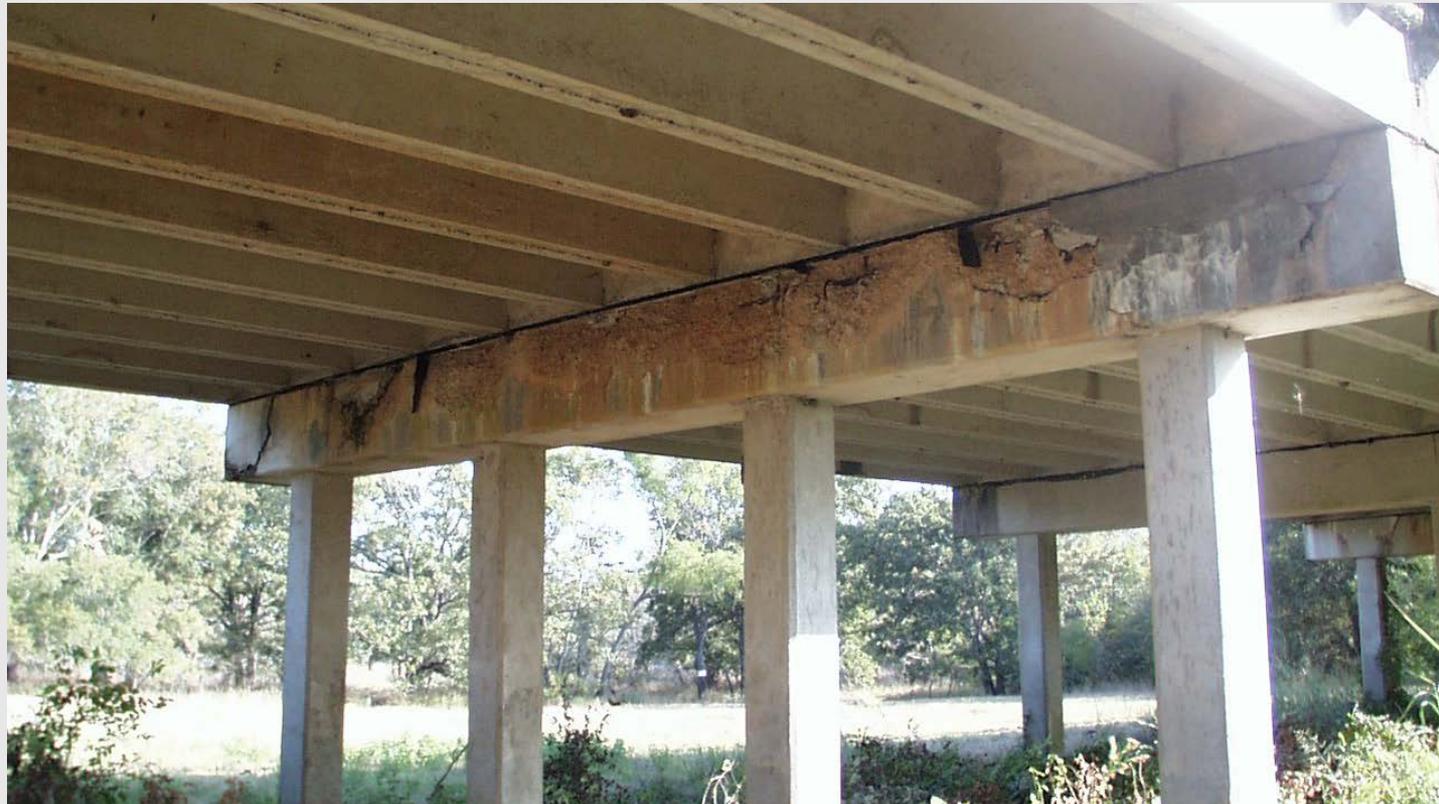
■ Interior Bents

- Stress Cracks Cap
- Spalls/Delaminations (chloride testing?) (over estimate quantity)
- Transverse Column Cracking (Bridge Squeeze)

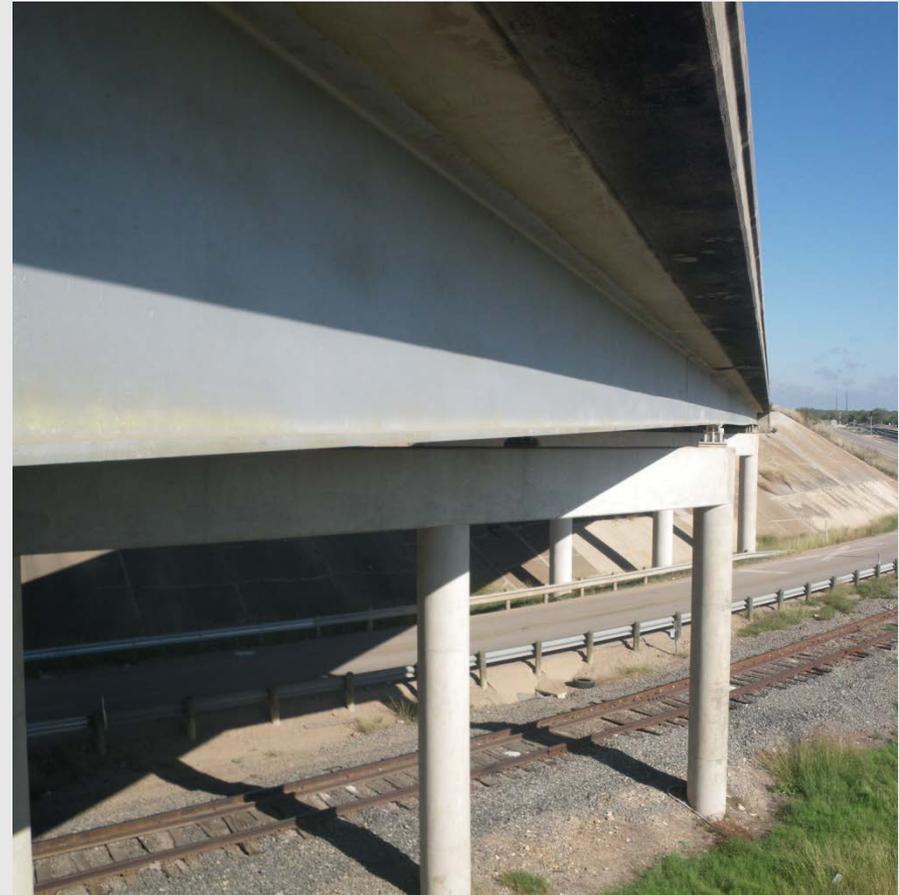
▪ Superstructure

- Girder Condition
- Bearing Condition
 - Early Elastomeric Pad Design
 - Deteriorated Pads
- Paint Condition
 - Repaint?
 - Consider Environment
 - Aesthetics
 - Zone paint?
 - Spot paint?

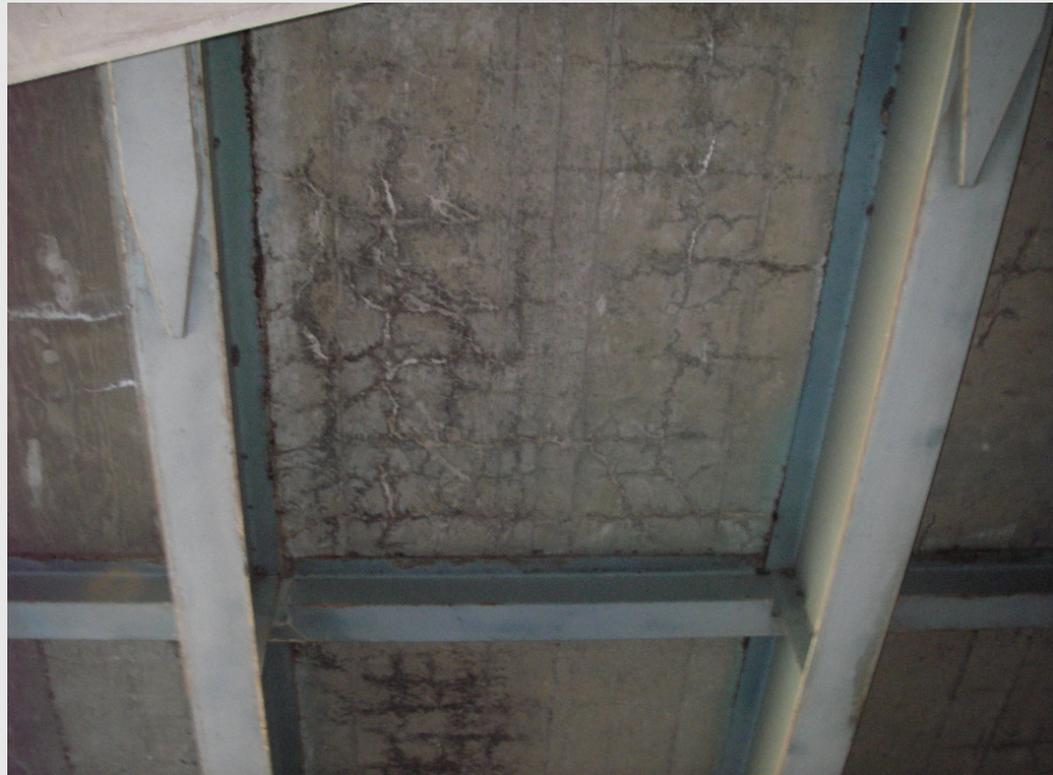
- Deck
 - Cracking (map/intersecting)
 - Discoloration/Staining/Efflorescence
 - Surface Condition/Spalling/Delamination
 - Asphalt Overlay Thickness and Condition

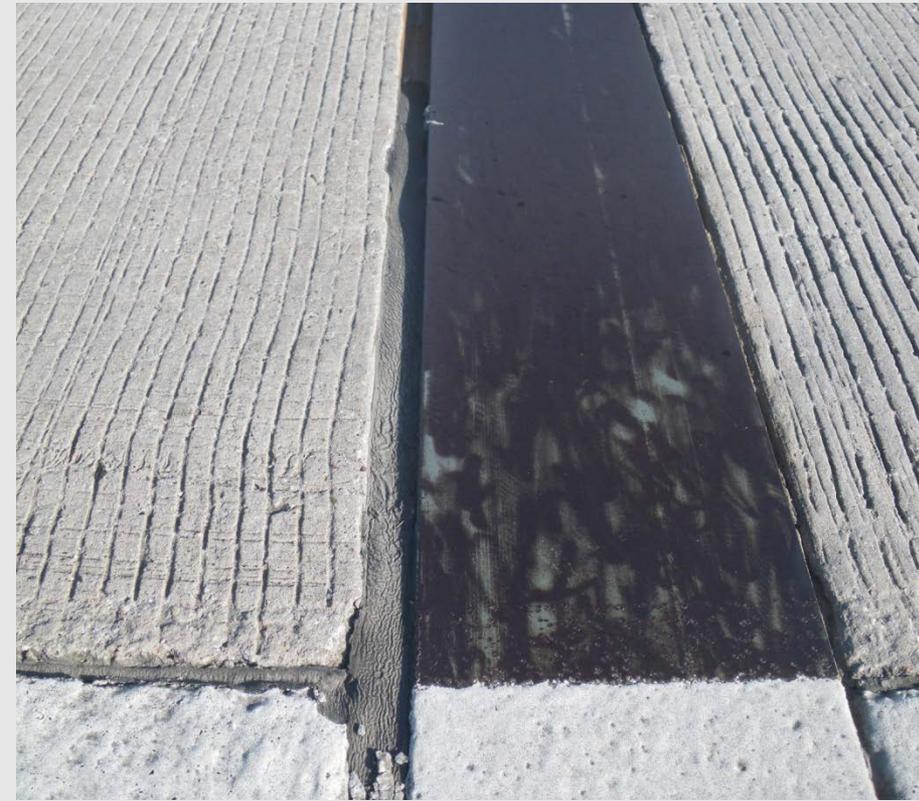
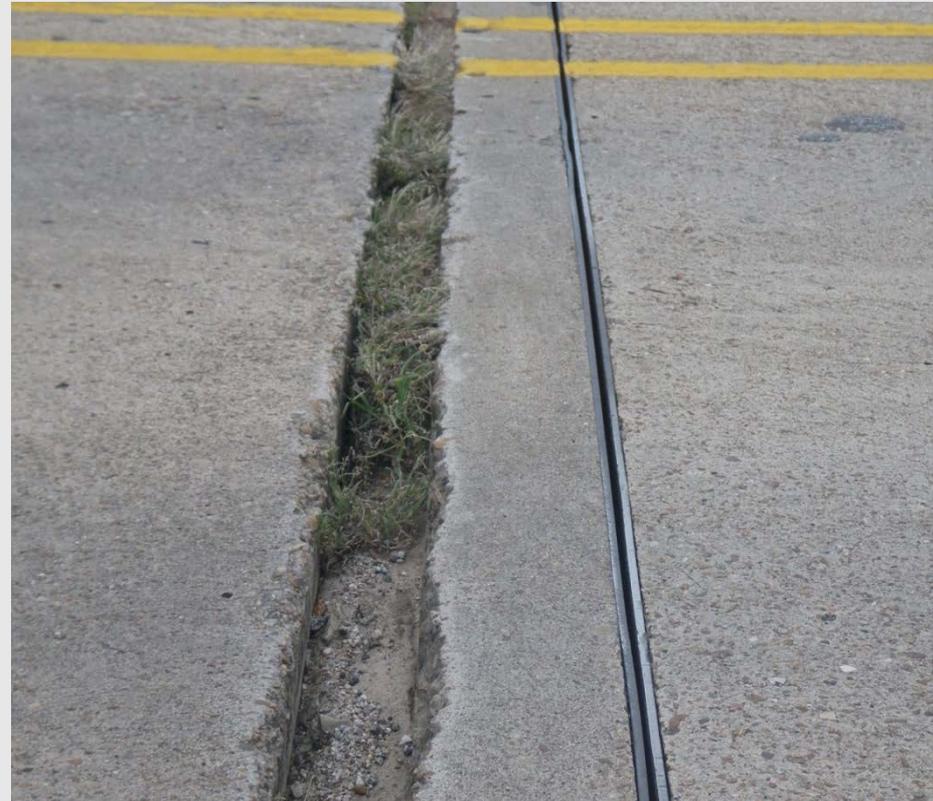
■ Approach Slab

- Is one present?
- Condition
- Joint at bridge
- Joint at end – Is concrete pavement present

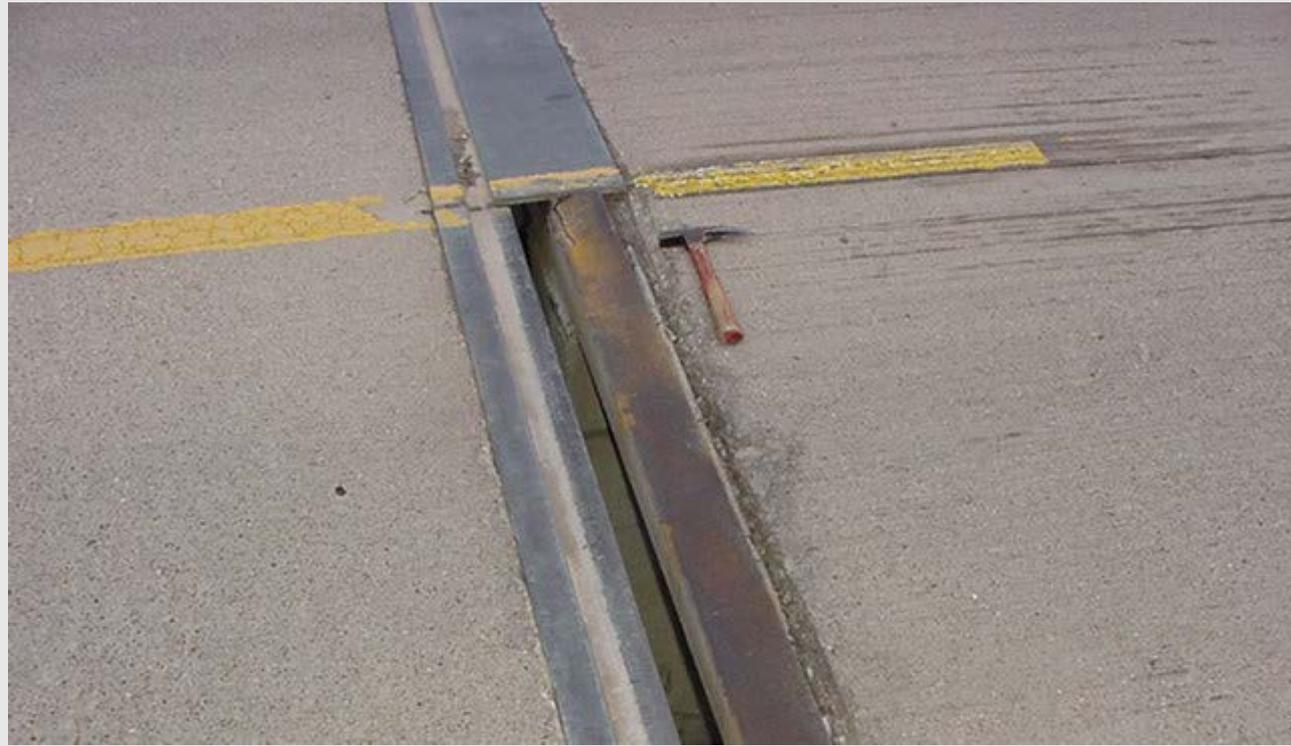
■ Joints

- Type
- Condition – Listen from below (banging sound)
- Seals – Visual and look for staining
- Debris – Note presence of debris
