Addendum - Historic Resources Constraints Analysis Report

Project Name: U.S. Highway 290 Relief Route

Addendum to Historic Resources Constraints Analysis

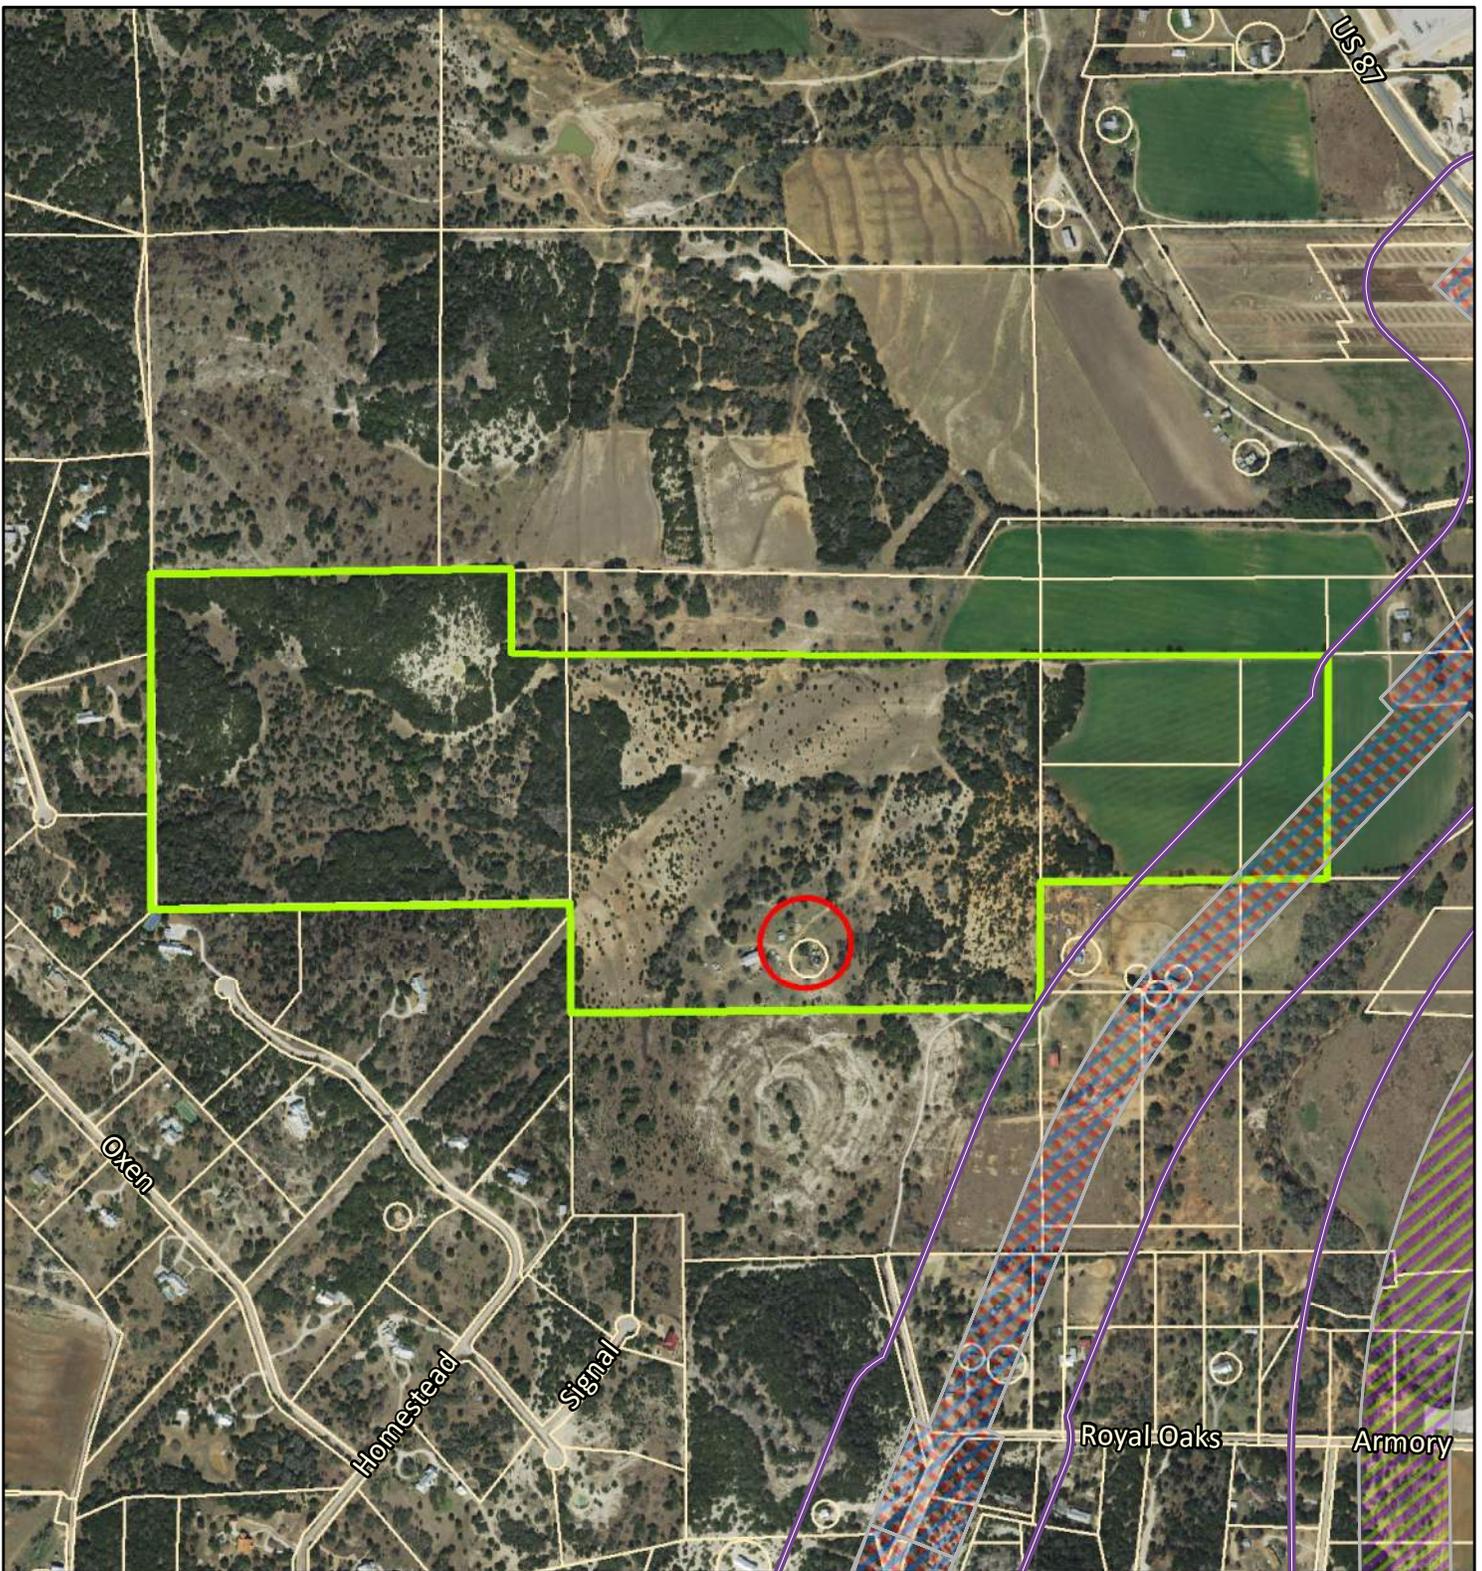
Property ID: 20853

Address: 1291 SHORTY CRENWELGE RD

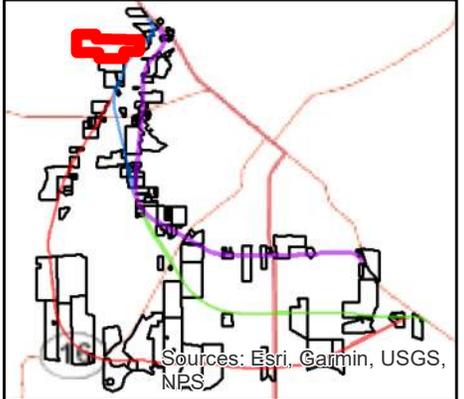
Primary Property Parcel ID: 20853

Description: Historic-age ranch complex with a two-story frame residence clad in vertical wood and metal siding and topped with metal side gable roof. Stuccoed masonry addition with shed roof attached to the rear of the building. Outbuildings include: limestone washhouse with metal gable roof, seamed metal barn, large wood barn, and non-historic-age shed. Associated features include: Aermotor windmill, water tank, concrete block cistern/wellhouse, and concrete trough.

Comments: Home of John Kraus, son of early settler Christian Kraus (RTHL Christian Kraus Homestead located to the NE). c.1890 house has undergone numerous alterations and is in poor overall condition, including changes to fenestration and removal of entire front porch.

In addition, Property ID 20853, located west of these properties, had been identified in the Historic Resources Constraints Analysis as the former farmstead of John Kraus, son of Christian Kraus. This parcel retains several historic-age buildings associated with John Kraus but received a Medium ranking due to non-historic alterations to the buildings. The September 2019 report shows only Property ID 20853 as associated with the John Kraus farmstead. However, at the January 14th Open House, the current property owners (descendants of John Kraus) noted that the John Kraus property also includes four adjacent associated parcels. These parcels are numbered as 20850, 20851, 20852, and 20854 by the Gillespie County Appraisal District. Although these parcels do not contain historic-age buildings, they are still owned and farmed by the Kraus family and exhibit few non-historic-age intrusions. Furthermore, incorporation of these additional parcels reveals a larger contiguous area connecting the historically associated John Kraus and Christian Kraus farmsteads.

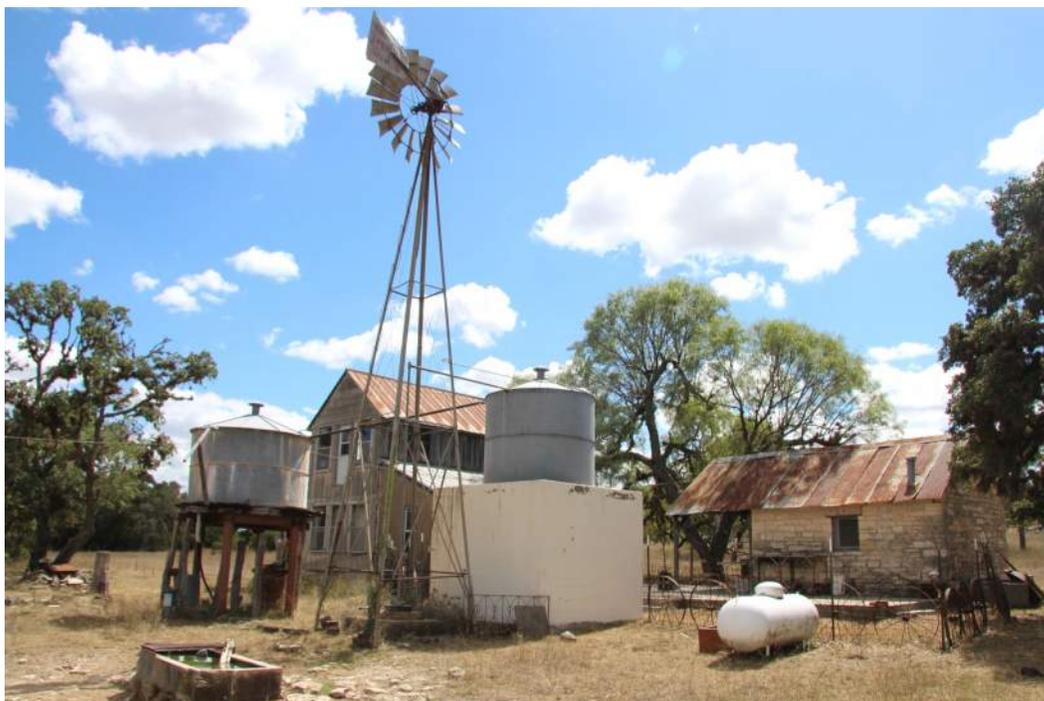
Primary Property Parcel ID: 20853

Description: Historic-age ranch complex with a two-story frame residence clad in vertical wood and metal siding and topped with metal side gable roof. Stuccoed masonry addition with shed roof attached to the rear of the building. Outbuildings include: limestone washhouse with metal gable roof, seamed metal barn, large wood barn, and non-historic-age shed. Associated features include: Aermotor windmill, water tank, concrete block cistern/wellhouse, and concrete trough.

Comments: Home of John Kraus, son of early settler Christian Kraus (RTHL Christian Kraus Homestead located to the NE). c.1890 house has undergone numerous alterations and is in poor overall condition, including changes to fenestration and removal of entire front porch.

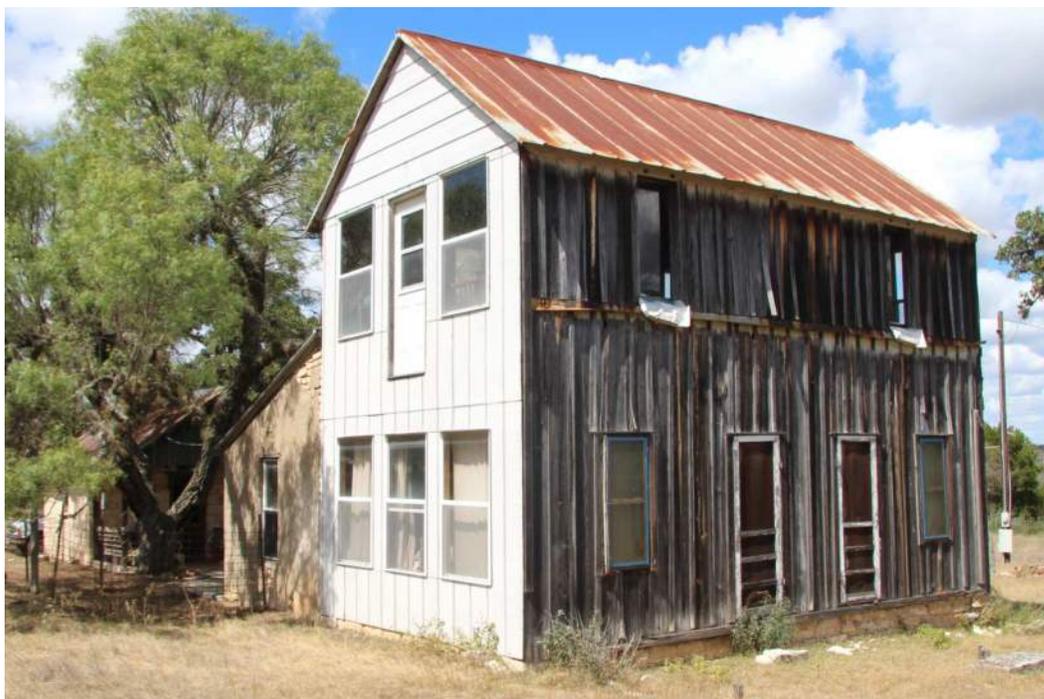
Primary Property Parcel ID: 20853

Description: Historic-age ranch complex with a two-story frame residence clad in vertical wood and metal siding and topped with metal side gable roof. Stuccoed masonry addition with shed roof attached to the rear of the building. Outbuildings include: limestone washhouse with metal gable roof, seamed metal barn, large wood barn, and non-historic-age shed. Associated features include: Aermotor windmill, water tank, concrete block cistern/wellhouse, and concrete trough.

Comments: Home of John Kraus, son of early settler Christian Kraus (RTHL Christian Kraus Homestead located to the NE). c.1890 house has undergone numerous alterations and is in poor overall condition, including changes to fenestration and removal of entire front porch.

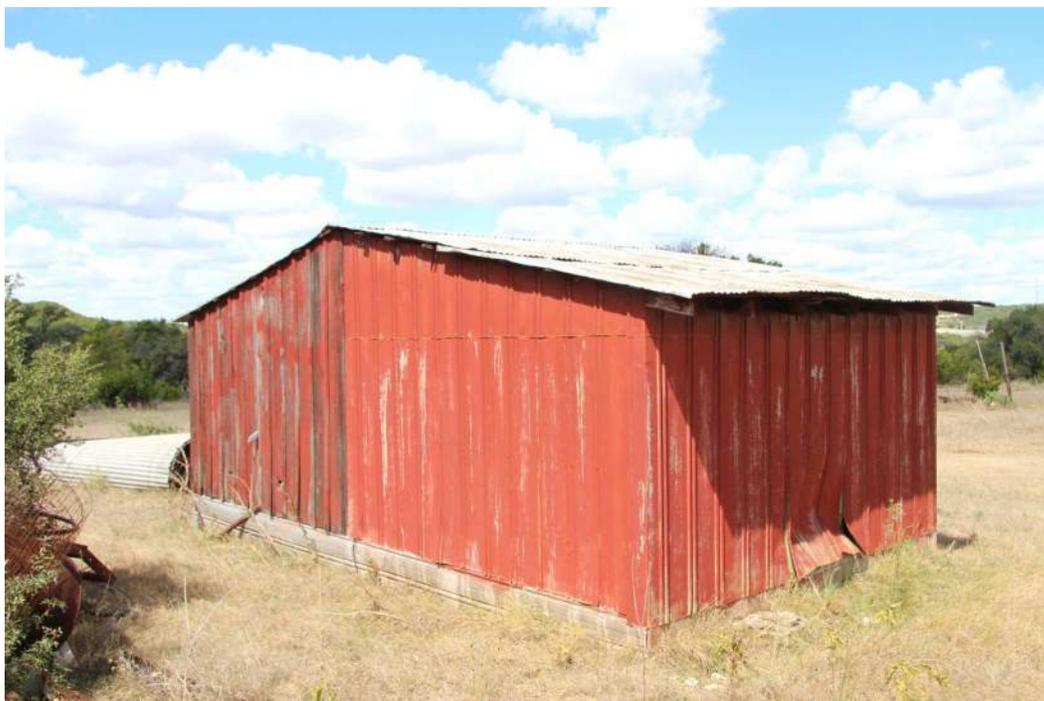
Primary Property Parcel ID: 20853

Description: Historic-age ranch complex with a two-story frame residence clad in vertical wood and metal siding and topped with metal side gable roof. Stuccoed masonry addition with shed roof attached to the rear of the building. Outbuildings include: limestone washhouse with metal gable roof, seamed metal barn, large wood barn, and non-historic-age shed. Associated features include: Aermotor windmill, water tank, concrete block cistern/wellhouse, and concrete trough.

Comments: Home of John Kraus, son of early settler Christian Kraus (RTHL Christian Kraus Homestead located to the NE). c.1890 house has undergone numerous alterations and is in poor overall condition, including changes to fenestration and removal of entire front porch.

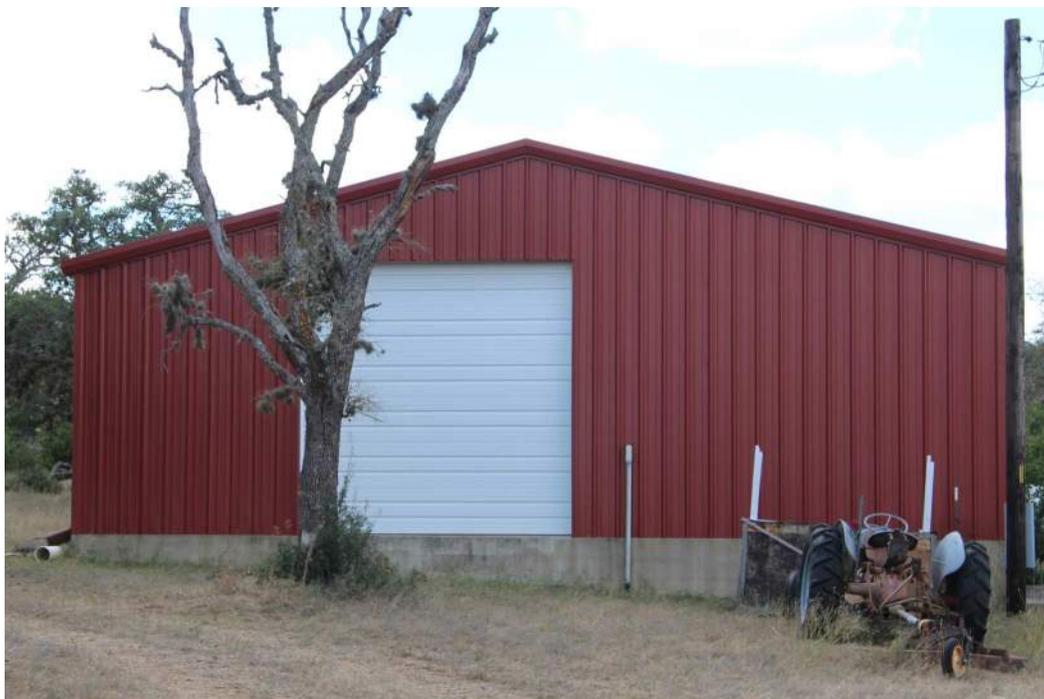
Primary Property Parcel ID: 20853

Description: Historic-age ranch complex with a two-story frame residence clad in vertical wood and metal siding and topped with metal side gable roof. Stuccoed masonry addition with shed roof attached to the rear of the building. Outbuildings include: limestone washhouse with metal gable roof, seamed metal barn, large wood barn, and non-historic-age shed. Associated features include: Aermotor windmill, water tank, concrete block cistern/wellhouse, and concrete trough.

Comments: Home of John Kraus, son of early settler Christian Kraus (RTHL Christian Kraus Homestead located to the NE). c.1890 house has undergone numerous alterations and is in poor overall condition, including changes to fenestration and removal of entire front porch.
